Department of Water Resources

COMMUNICATION DOCUMENTATION

SUBJECT: 43-07322
phone call (.) walk-in (.) other (x)

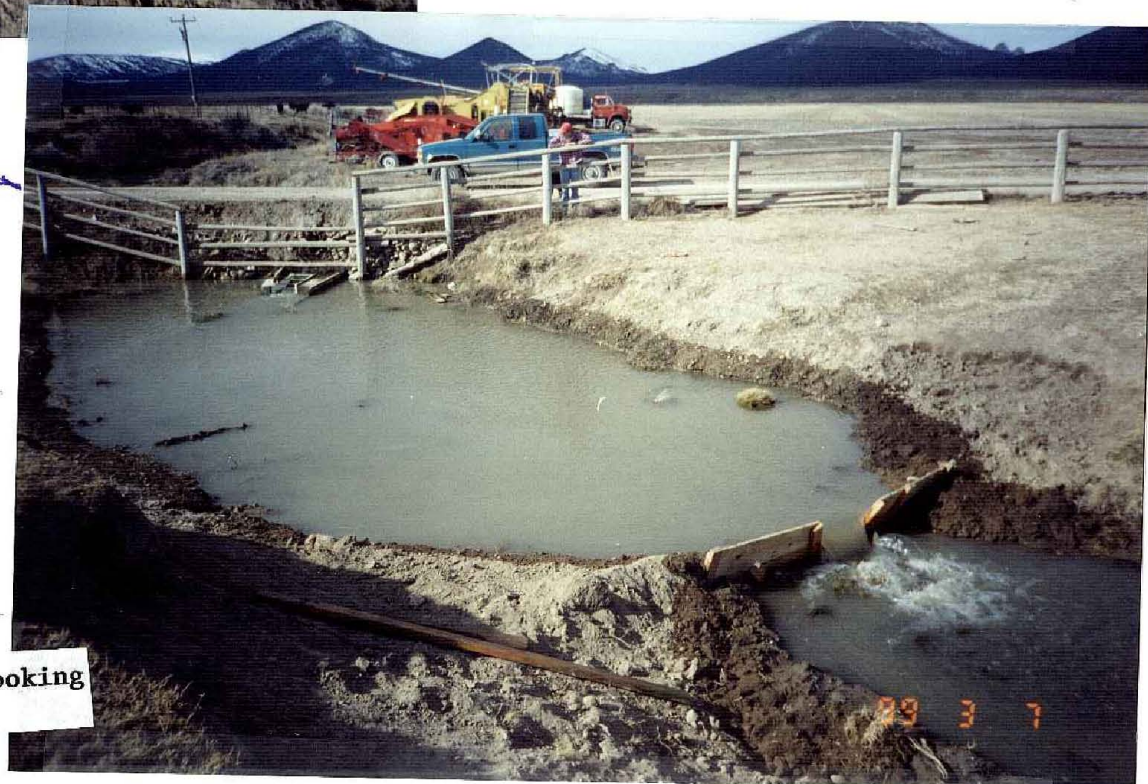
photo looking NE'ly from farm rd

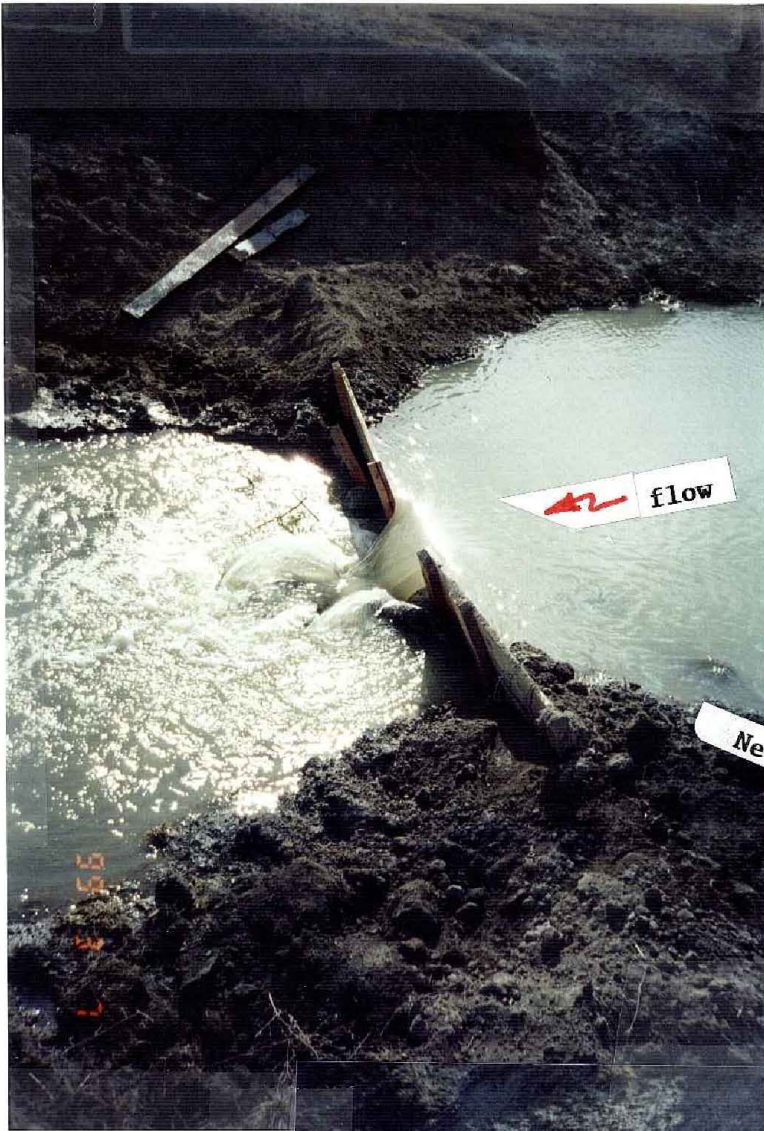
photo looking SW'ly

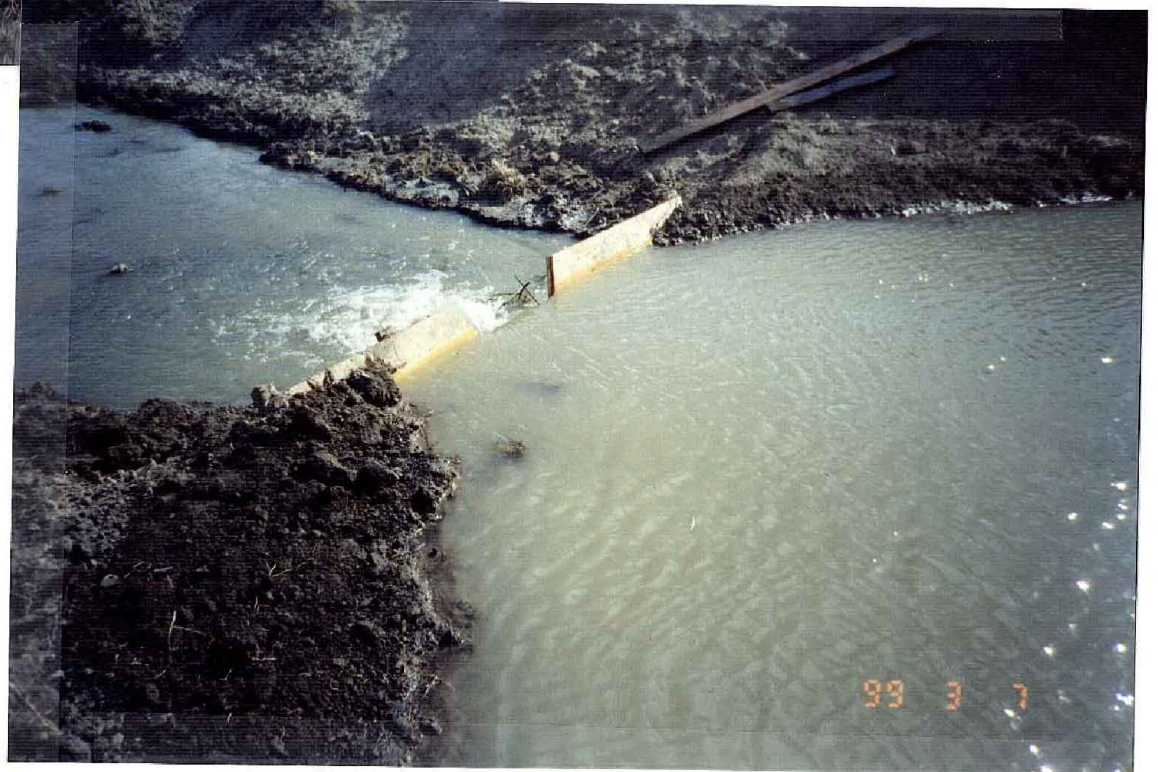
I met with Dave Sundberg and Garth Steed. The new structure still isn't up to par. See photographs. The items that will be corrected:

upstream
New diversion structure

1. The rectangular weir will have a crest length of 2.0'.
2. The fall distance seems to be acceptable, however the structure was leaning downstream and it will be necessary to plumb it up.
