DEPARTMENT OF
WATER RESOURCES

April 6, 2009

Jim Rindfleisch, Manager
Big Lost River Irrigation Dist
P. O. Box 205
Mackay, Idaho 83251

RE: Response to March 4, 2009 Letter

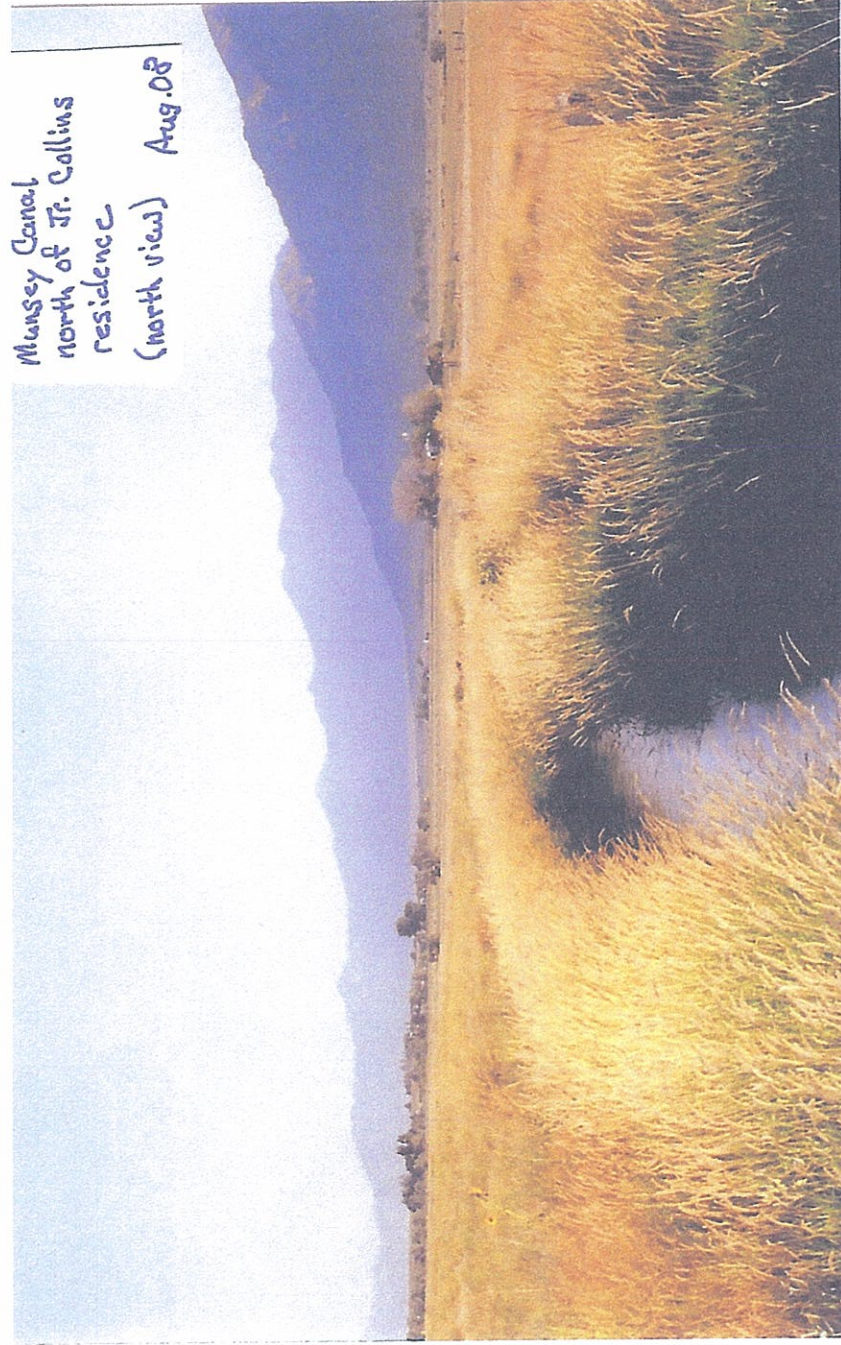
We have attached to this letter pictures taken of the Munsey Canal in August of 2008. They clearly show a substantial amount of vegetative over-growth in the canal and its laterals. A closer inspection of the canal will show that in some locations the banks have sedimentary fill extending into the main channel of the canal by as much as 5-6 feet. There is no doubt some pumping stations and fence crossings cause obstructions to water flows. But the larger cause of water flow obstruction and impediment (effecting higher

"shrink") are the vast reaches of the canal that have obstructing trash, sediment fills, protruding vegetation, and misshapen banks.

Munsey Canal
north of J. Collins
residence
(north view) Aug. 08

The entire 5 mile reach of the Munsey Canal is in major need of a complete reshaping of the channel and canal banks. Partial burning of vegetation, removal of debris and obstructions, and installing measuring devices is helpful, but will still fall short of what is needed to properly provide for the efficient conveyance of our valuable water resources. A substantial portion of the assessment revenue BLRID receives from Munsey Canal water users should be used for this repair and maintenance project.

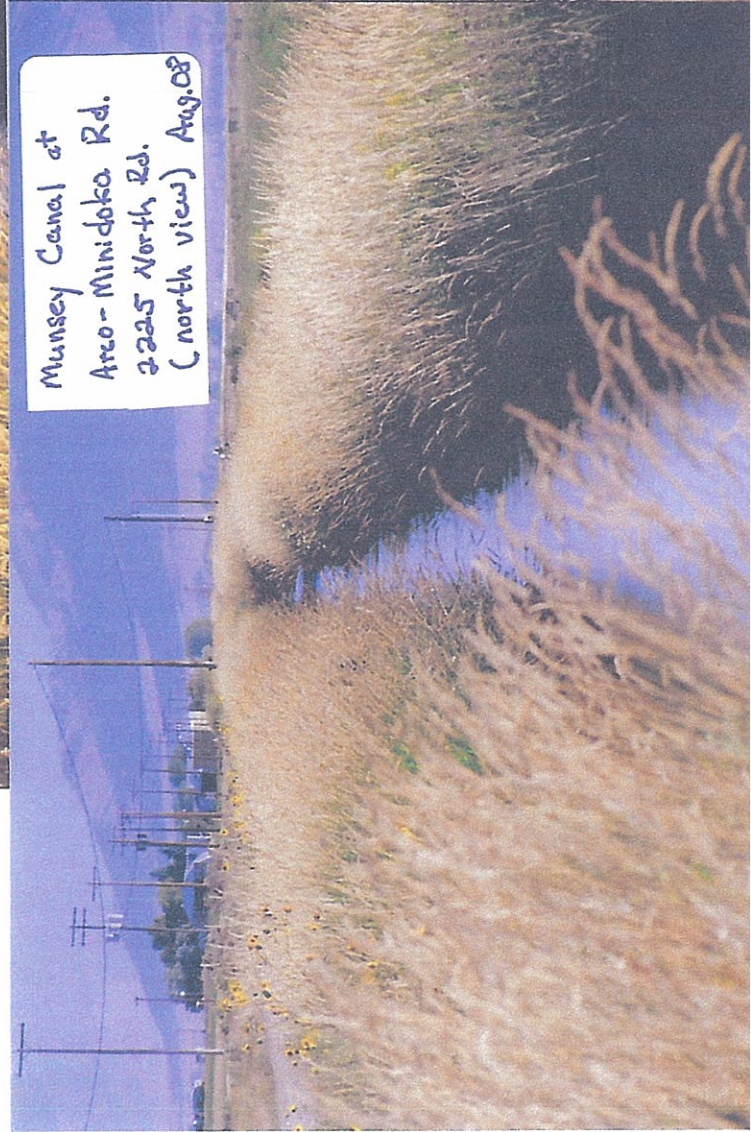
Munsey Canal at
Area - Minidoka Rd.
2225 North Rd.
(north view) Aug. 08

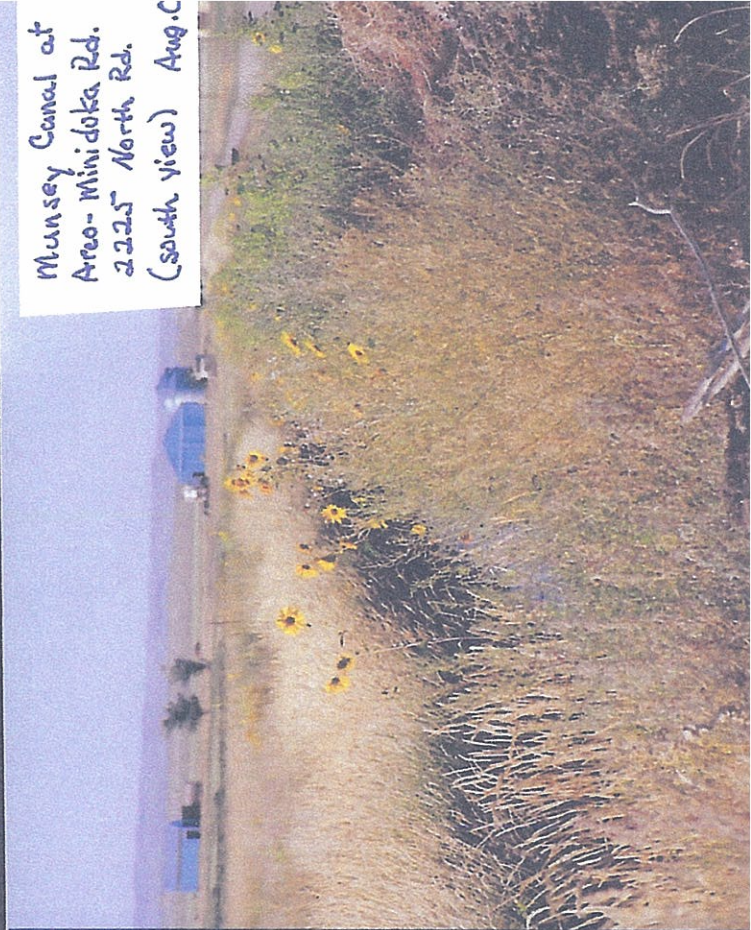
Munsey Canal at
Area - Minidoka Rd.
2225 North Rd.
(south view) Aug. 08

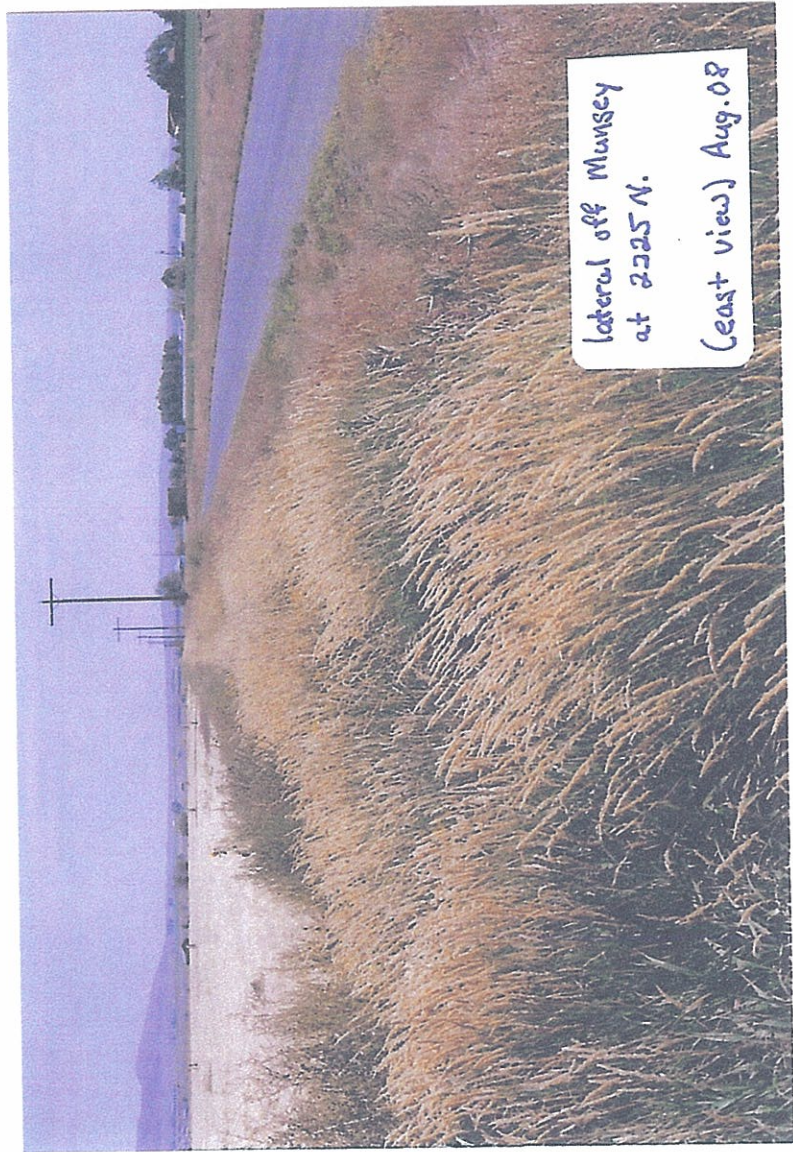
lateral off Munsey
at 2225 N.
(east view) Aug. 08

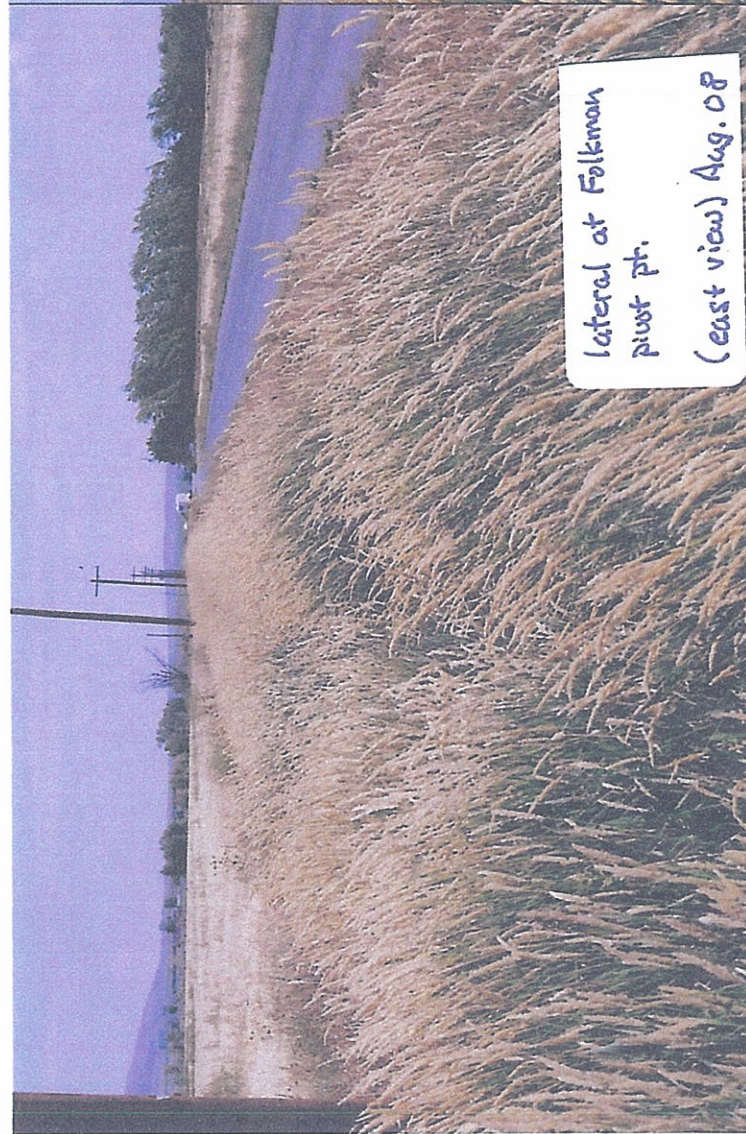
lateral at Folkman
pivot pt.
(east view) Aug. 08

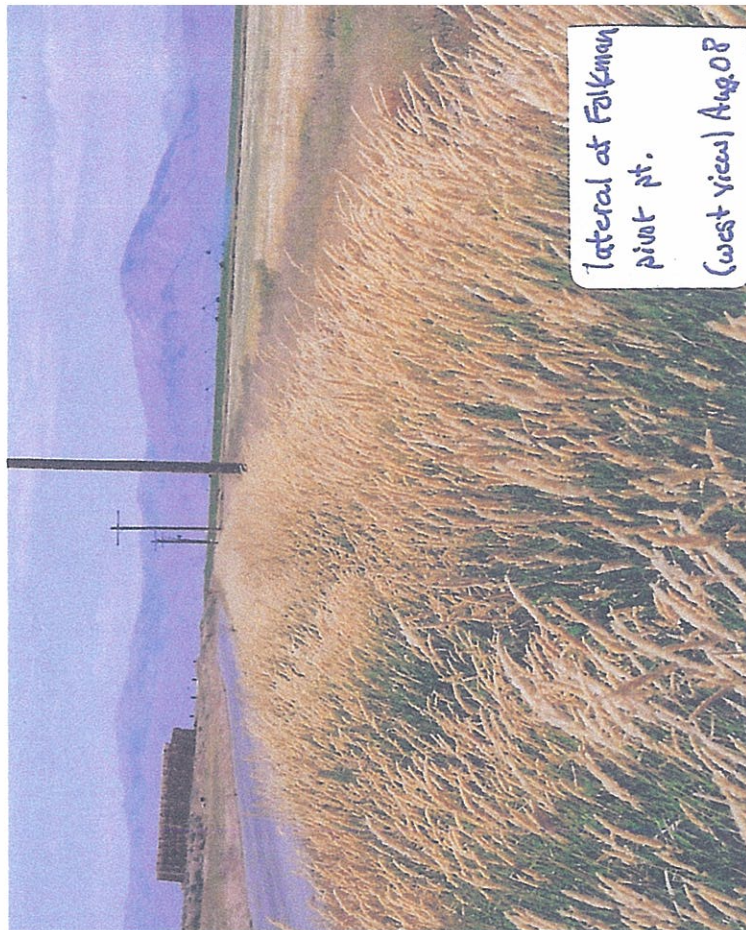
lateral at Folkman
pivot pt.
(west view) Aug. 08
