Memorandum

Date: June 02, 2006

Re: Lime Creek / BLM complaint

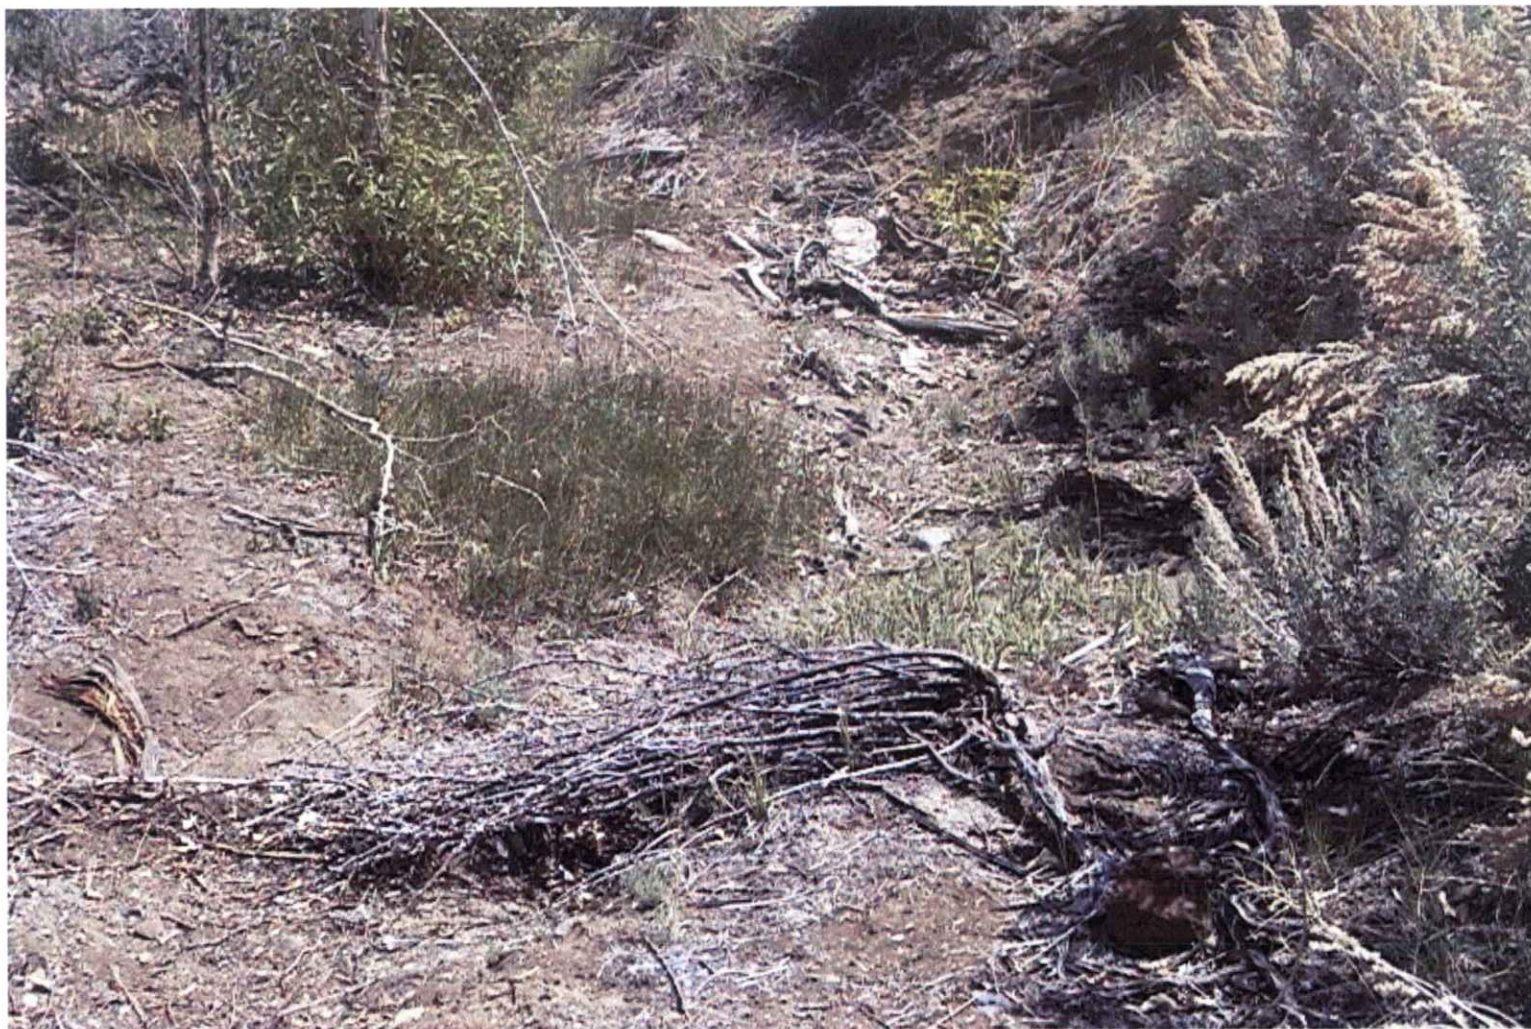
The lower 1.5 miles of the Lime creek channel east of HWY 93 is dewatered. It appears that this stretch of Lime Creek flows only at peak high water. I traveled upstream approximately 1.75 miles east of the highway and observed a small amount of water in the Lime Creek channel. This amount of water may be marginally adequate for stock water. Approximately 2 miles up Lime Creek and roughly 200 yards downstream from the Nagy property the Lime creek channel is dry. It appears this stream sinks and then resurfaces a short distance above where I initially observed water in the stream channel.

LIME CREEK CHANNEL 1.5 MILES EAST OF HWY 93

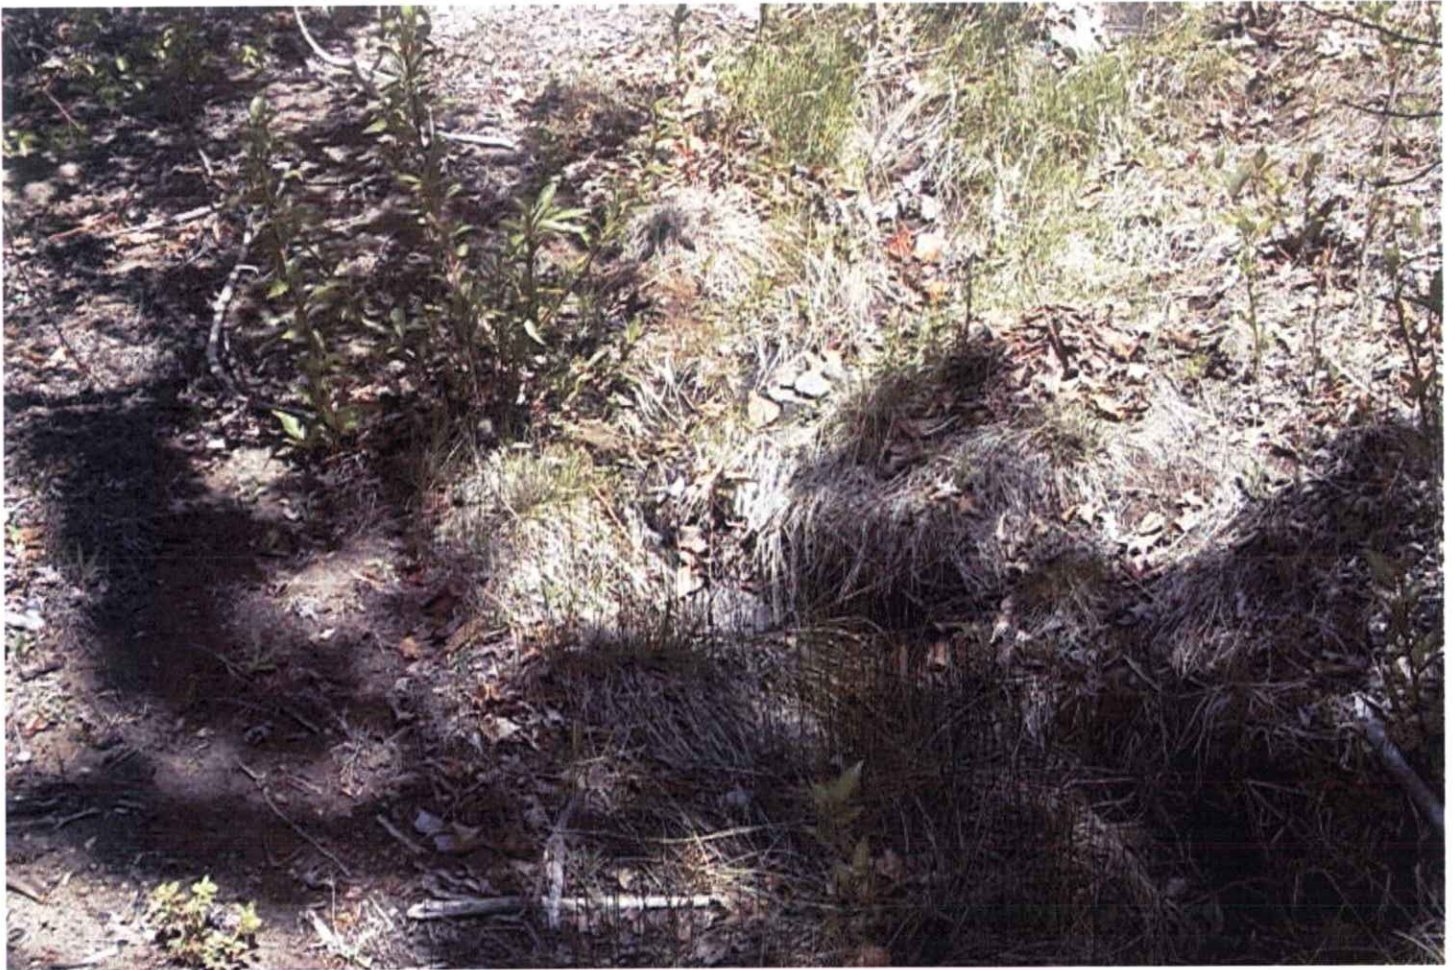
LIME CREEK CHANNEL 100 YARDS BELOW NAGY PROPERTY

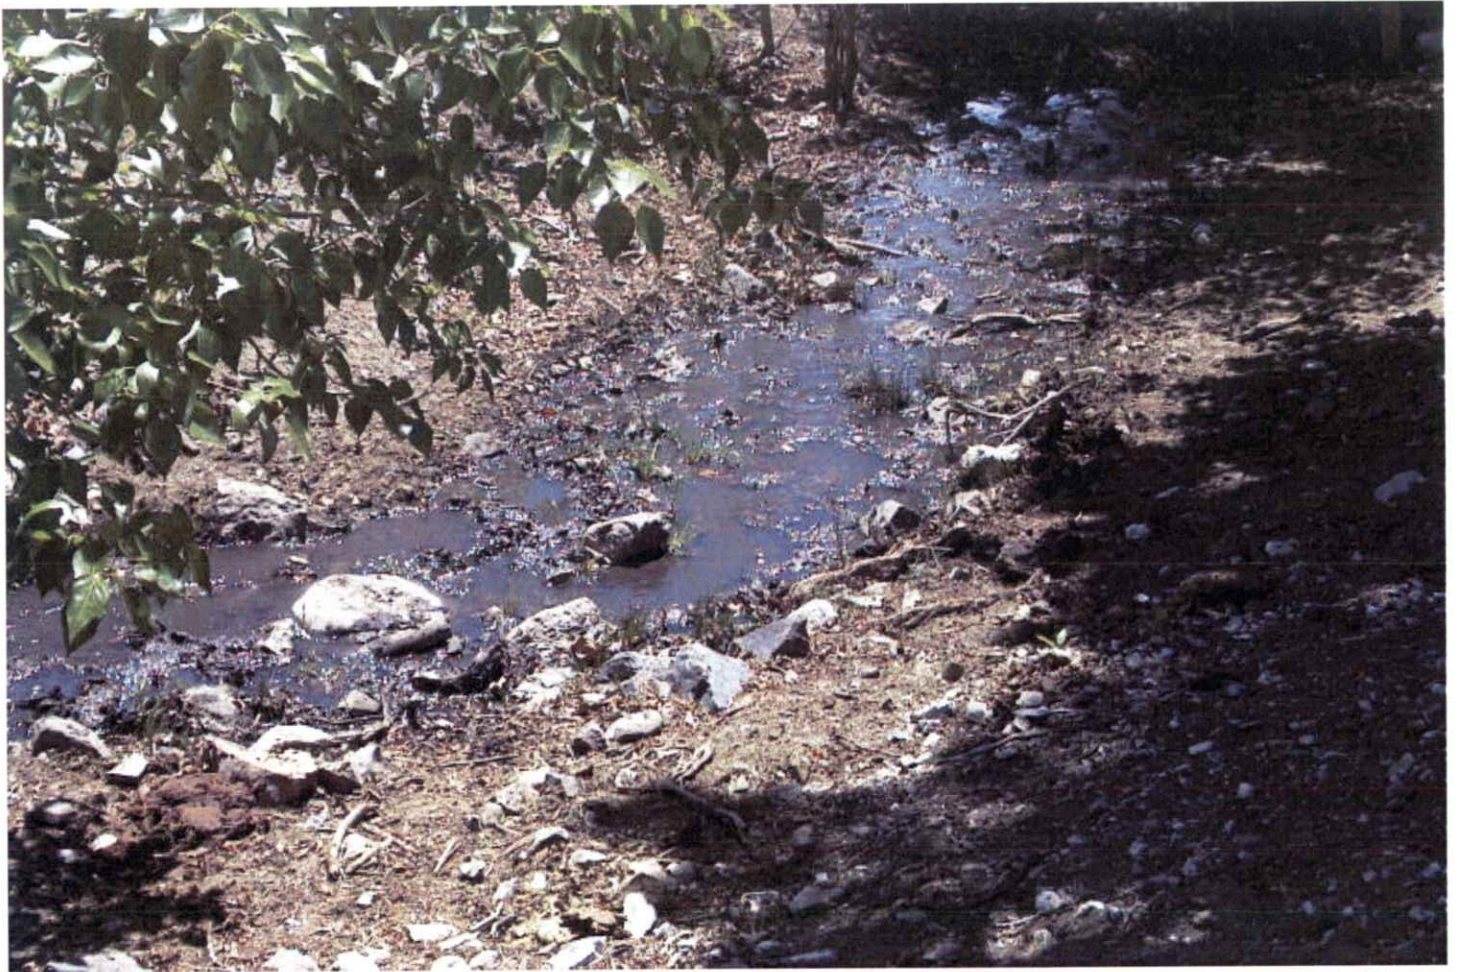
LIME CREEK ON QUARTER MILE BELOW HAGY PROPERTY

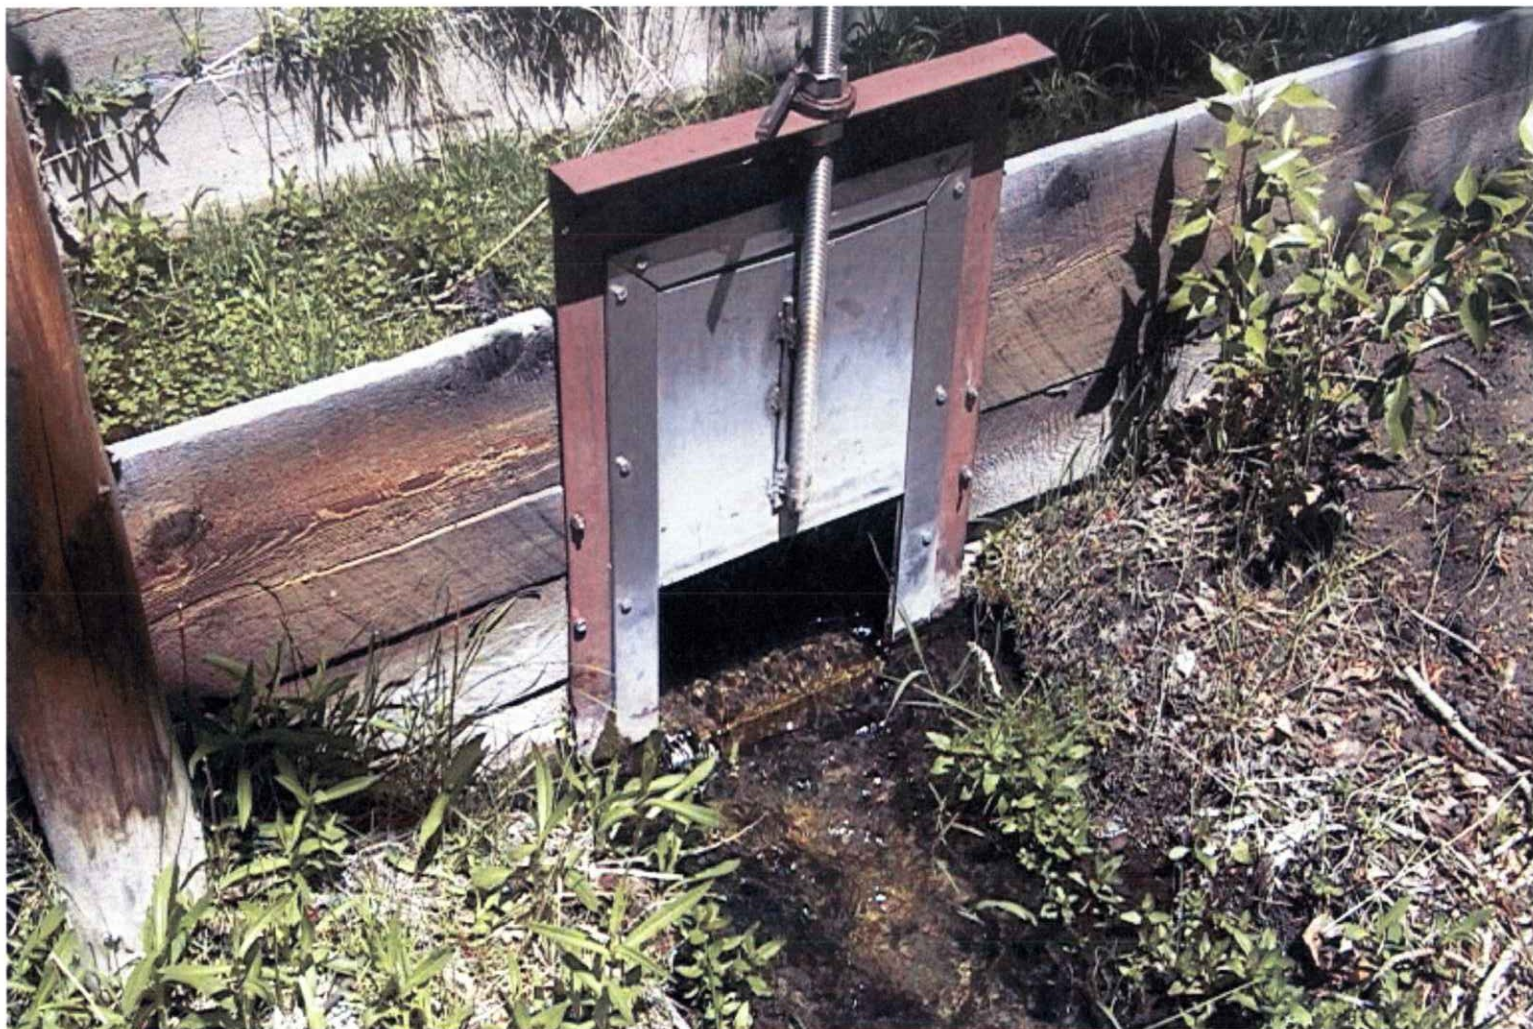
NAGY HEADGATE

Approximately 1 mile above the Nagy property Lime Creek passes over the access road. I took a flow measurement at this location. The flow in Lime Creek is .36 cfs at this location. I returned to the Nagy property and observed that seventy-five to eighty percent of the flow in Lime Creek was being diverted into a wildlife pond under water right 72-7532. No further action was taken at that time.

On June 01, 2006, I returned to Nagy property with instructions to close the head gate at the pond inlet. This was done and a warning tag was attached to the head gate along with my business card as well as Roxanne Brown's business card.
