**Memorandum**

**Date:** August 03, 2001

**Re:** Gydesen complaint WD-73

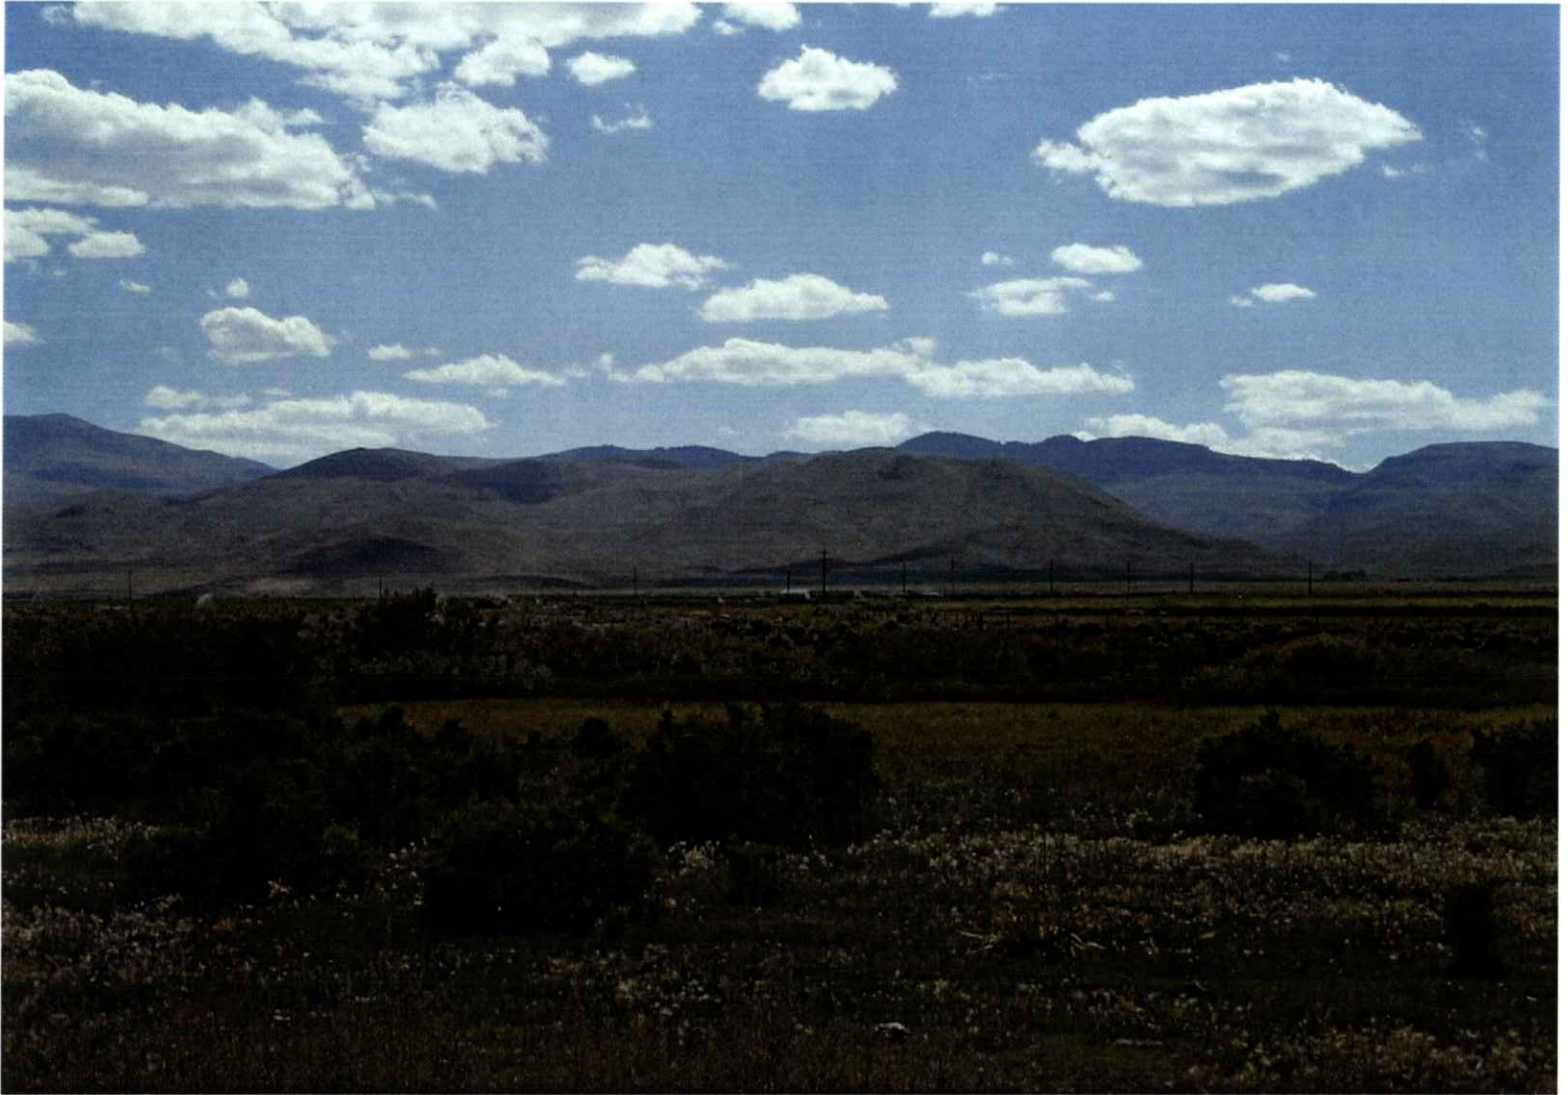
The well operated by Circle Pie Ranches, which Mr. Gydesen alleges an expansion is licensed for 2.12 cfs and 106 acres under 73-7025. There is also an expansion claim 73-10064 for 1.05 cfs and 105 acres. The well was operating one seven-tower pivot; two six tower pivots and two eighth-mile hand lines at the time of my visit. There was also approximately .50 cfs being pumped into P-13 ditch from this well. This appears to be an obvious expansion of the water right and probably warrants further investigation. The correlation between the pumping of the well and the drop in the water level in the Gydesen diversion is difficult to connect as the well appears to approximately 30 feet higher in elevation and downstream from the Gydesen diversion.

**Circle Pie well (73-7025) taken from P-12 ditch looking west. 08/02/01**

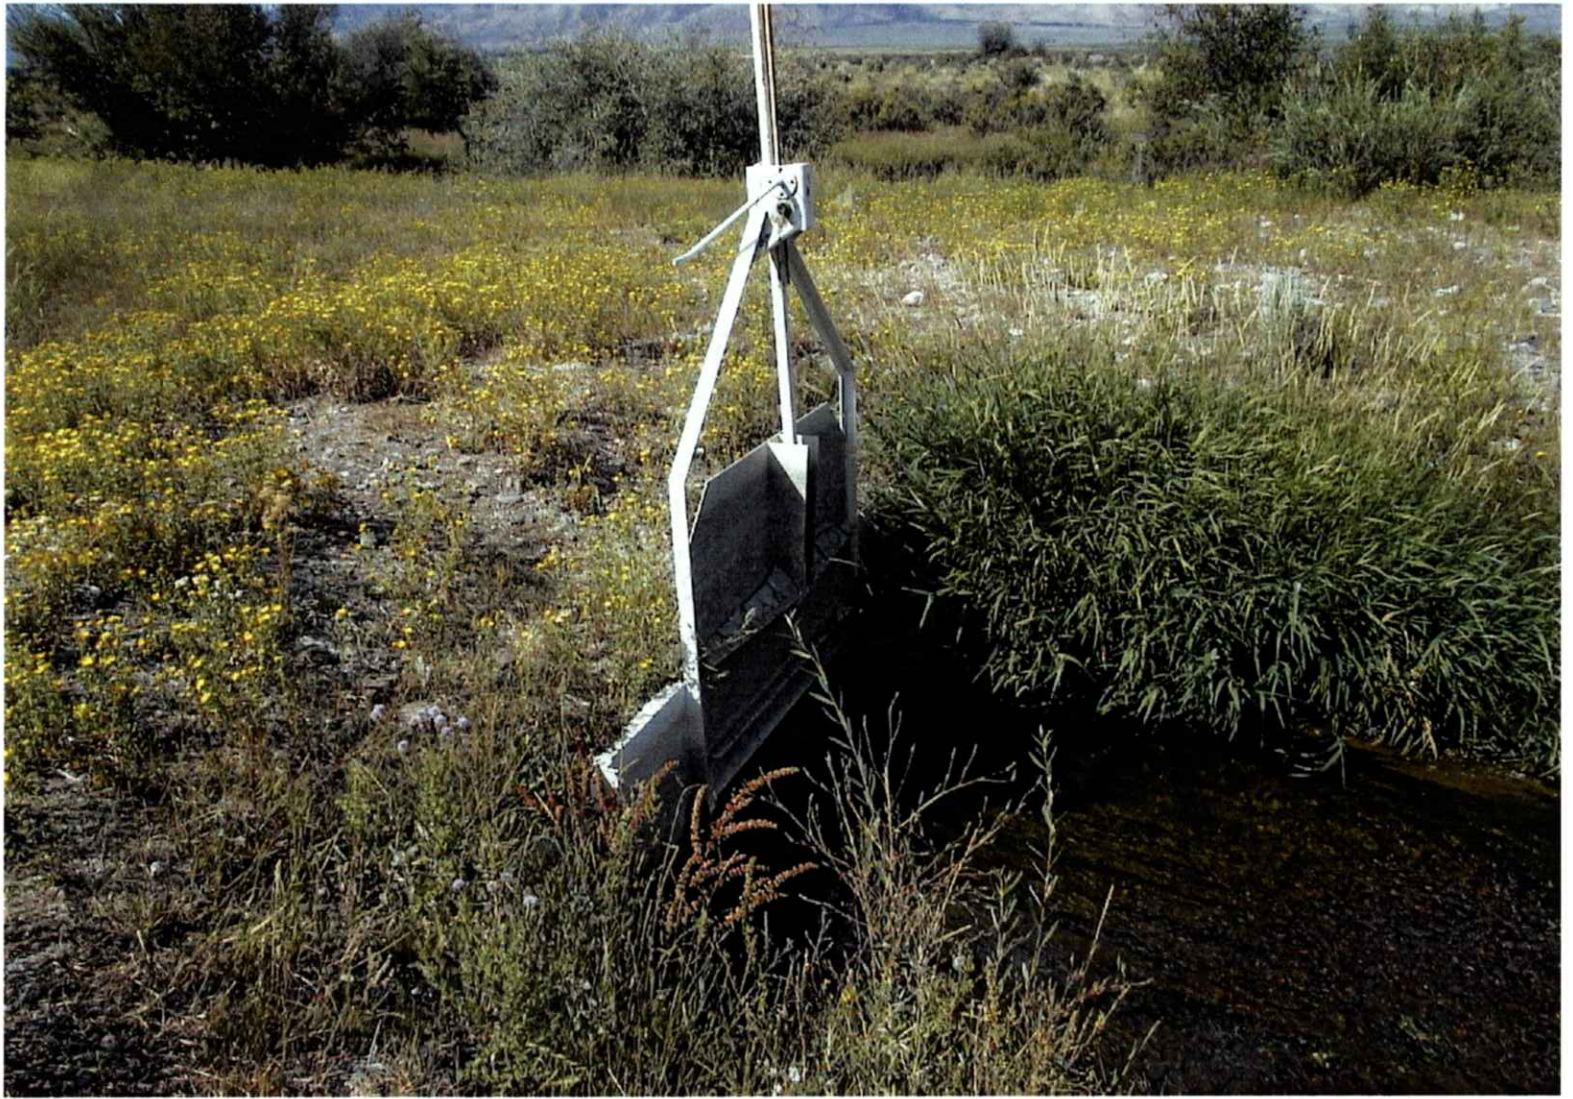
The P-11 diversion was measured at the time of my visit. There was a flow of 10.96 cfs in the P-11 ditch. This was exceeding the decreed water rights by nearly 6 cfs. Mr. Gydesen stated the flows at this level do not erode his land. I instructed Mr. Anderson he should insure the excessive diversions at P-12 and P-11 were not impacting other senior users.

**P-11 diversion. 08/02/01**

Due to the problems associated with the regulation of water right(s) in WD-73 my recommendation would be for IDWR to issue an order requiring lockable headgates and measuring devices within the district and to have these installed prior to the 2002 irrigation season. The ability of the watermaster to regulate water rights fairly is difficult if not impossible with the current condition of headgates and measuring devices within WD-73.

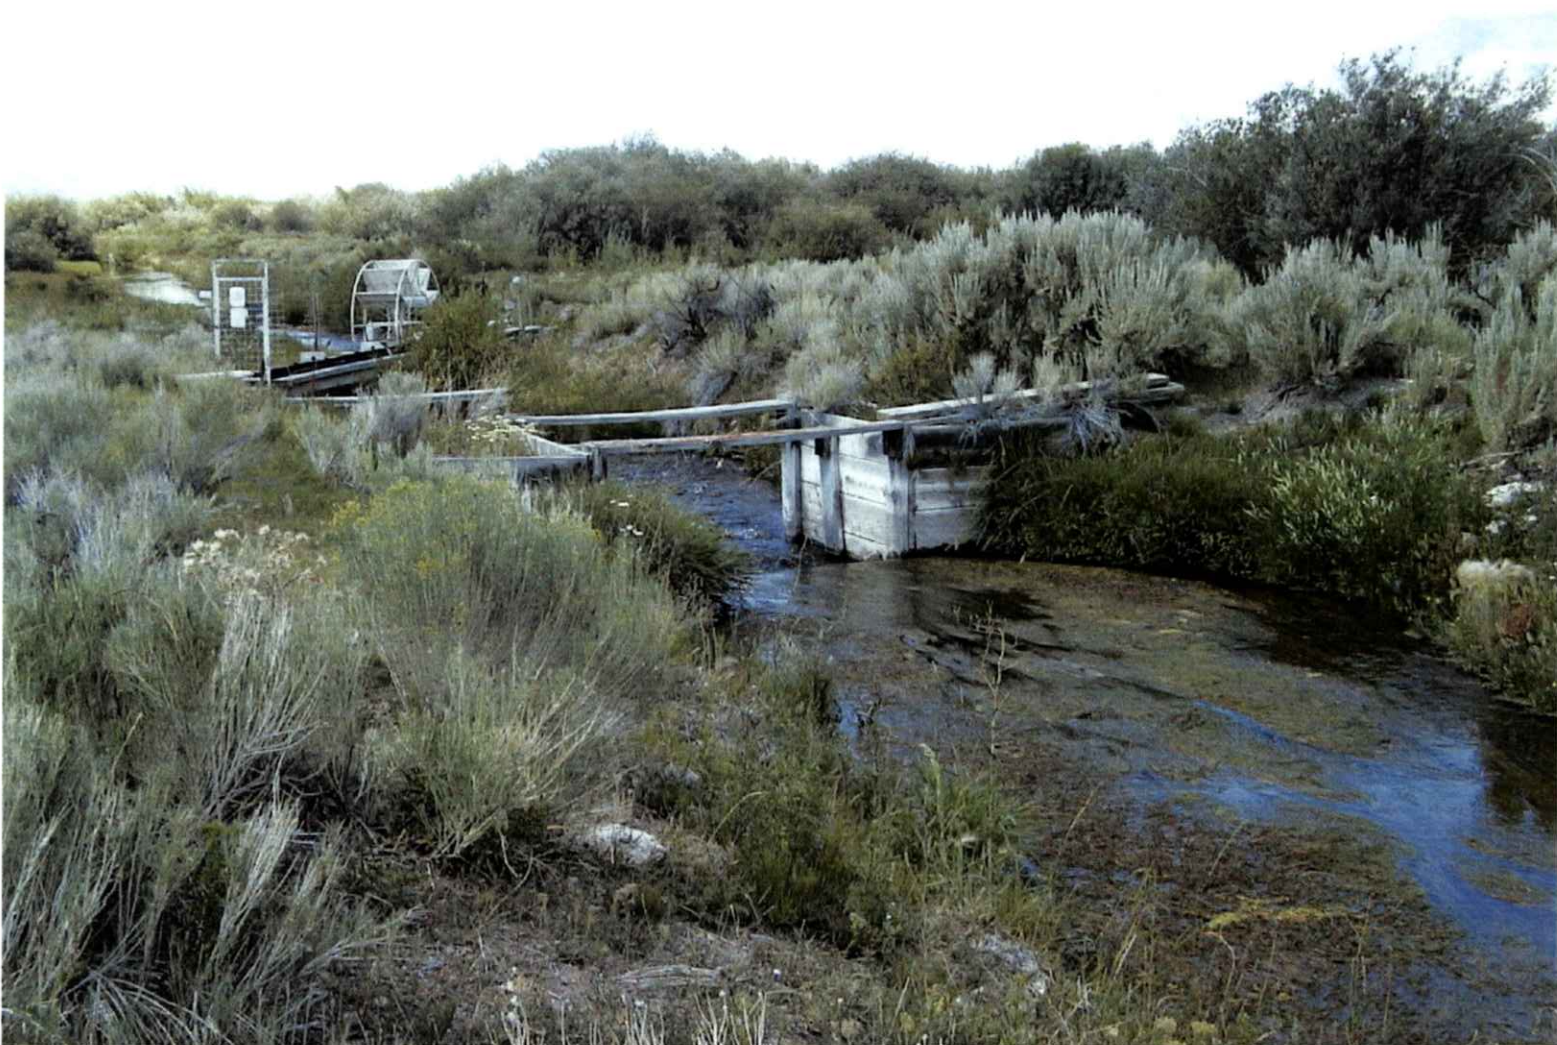
**P-12 diversion. 08/02/01**

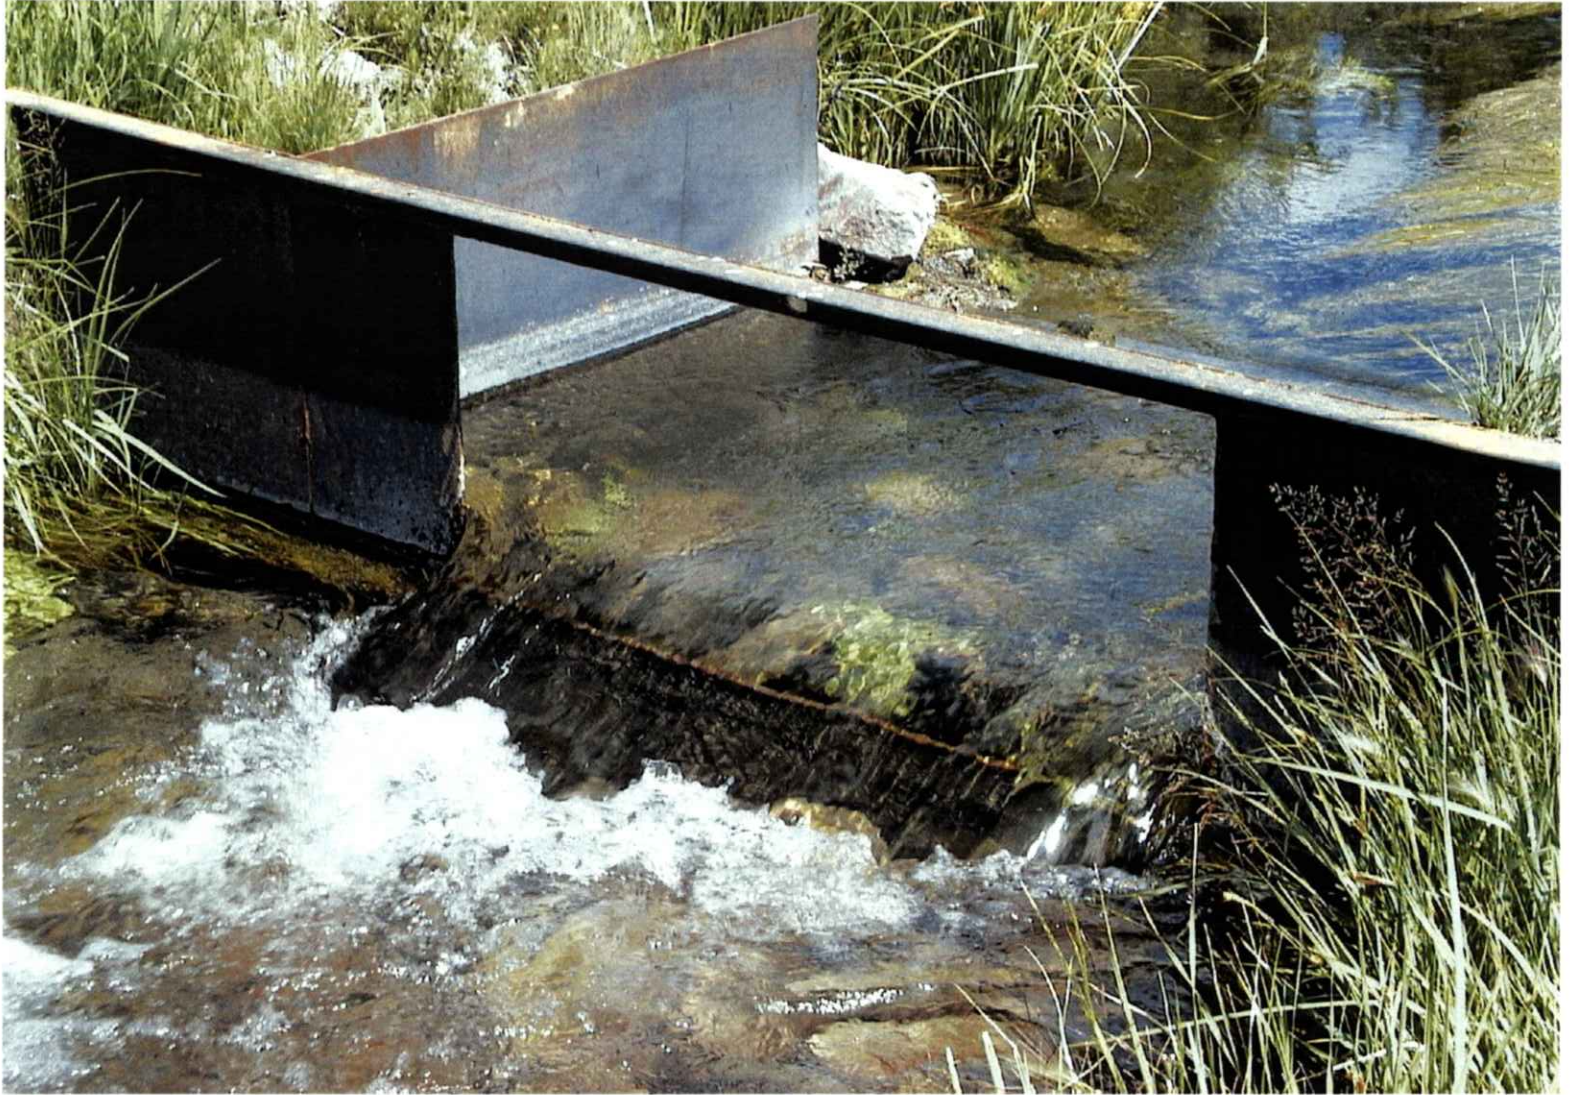
The measuring device at the P-12 diversion (Gydesen) is a four-foot rectangular weir. At the time of my visit the weir read .50 over the crest or 4.59 cfs. This was in excess of the Gydesen water right of 3.9 cfs. The weir may not be accurate as there was no hydraulic jump over the crest and the weir appeared to be low on the downstream end.

**P-12 weir (Gydesen) 08/02/01**

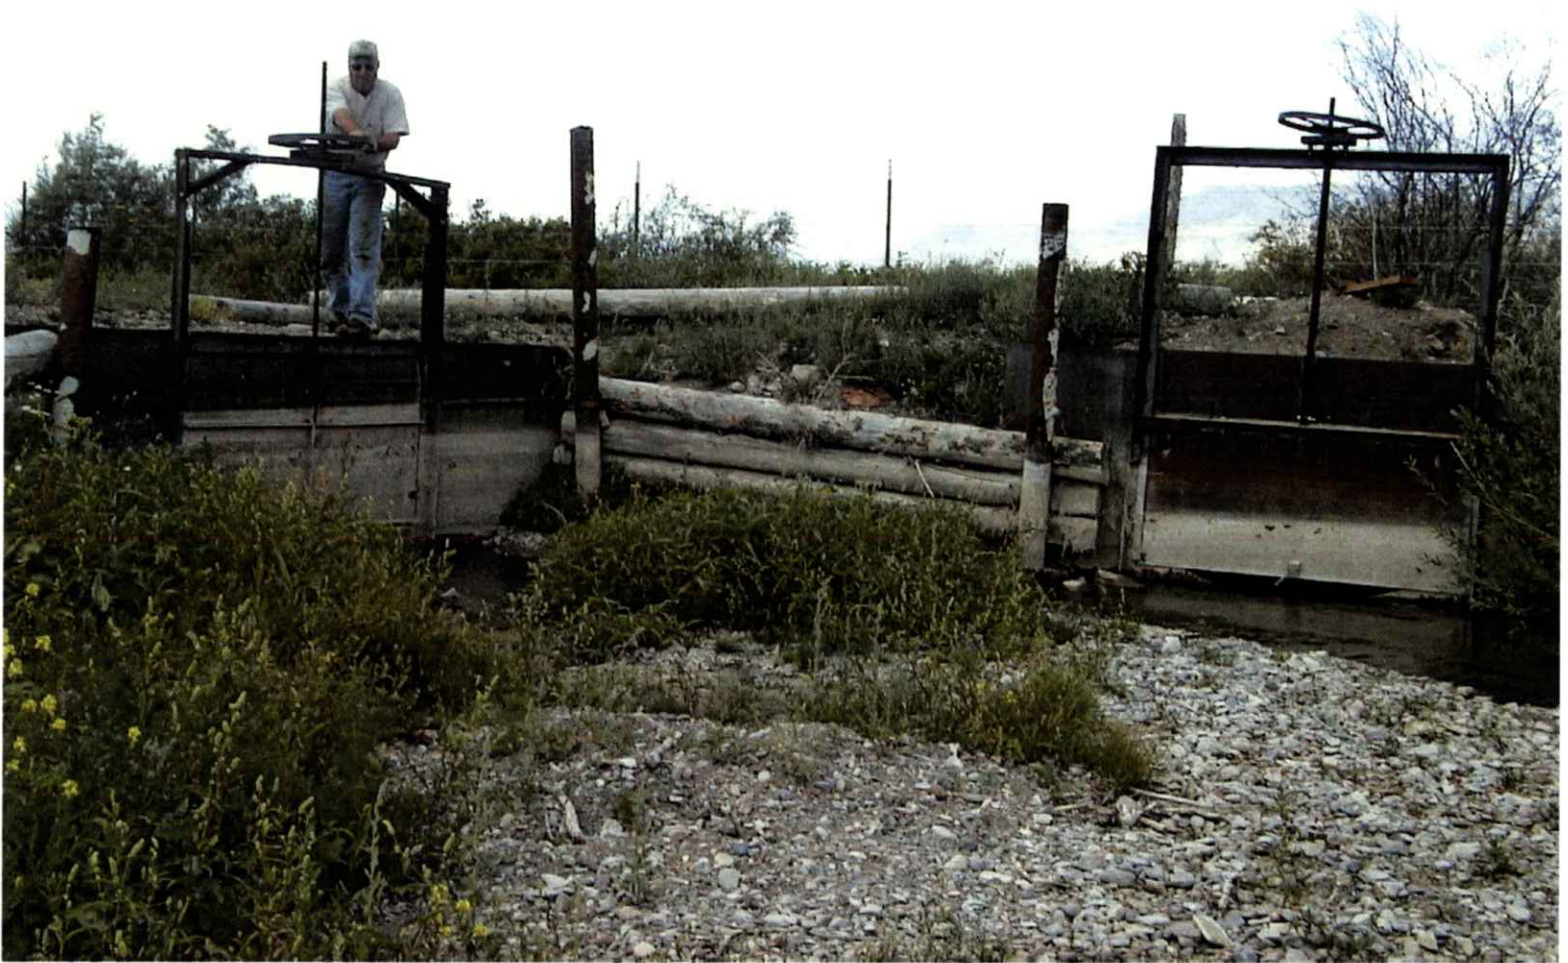
The P-11 and P-13 diversions do not have adequate measuring devices. The P-11 has a lockable headgate. The P-13 headgate(s) need replaced.

**P-13 diversion. 08/02/01**

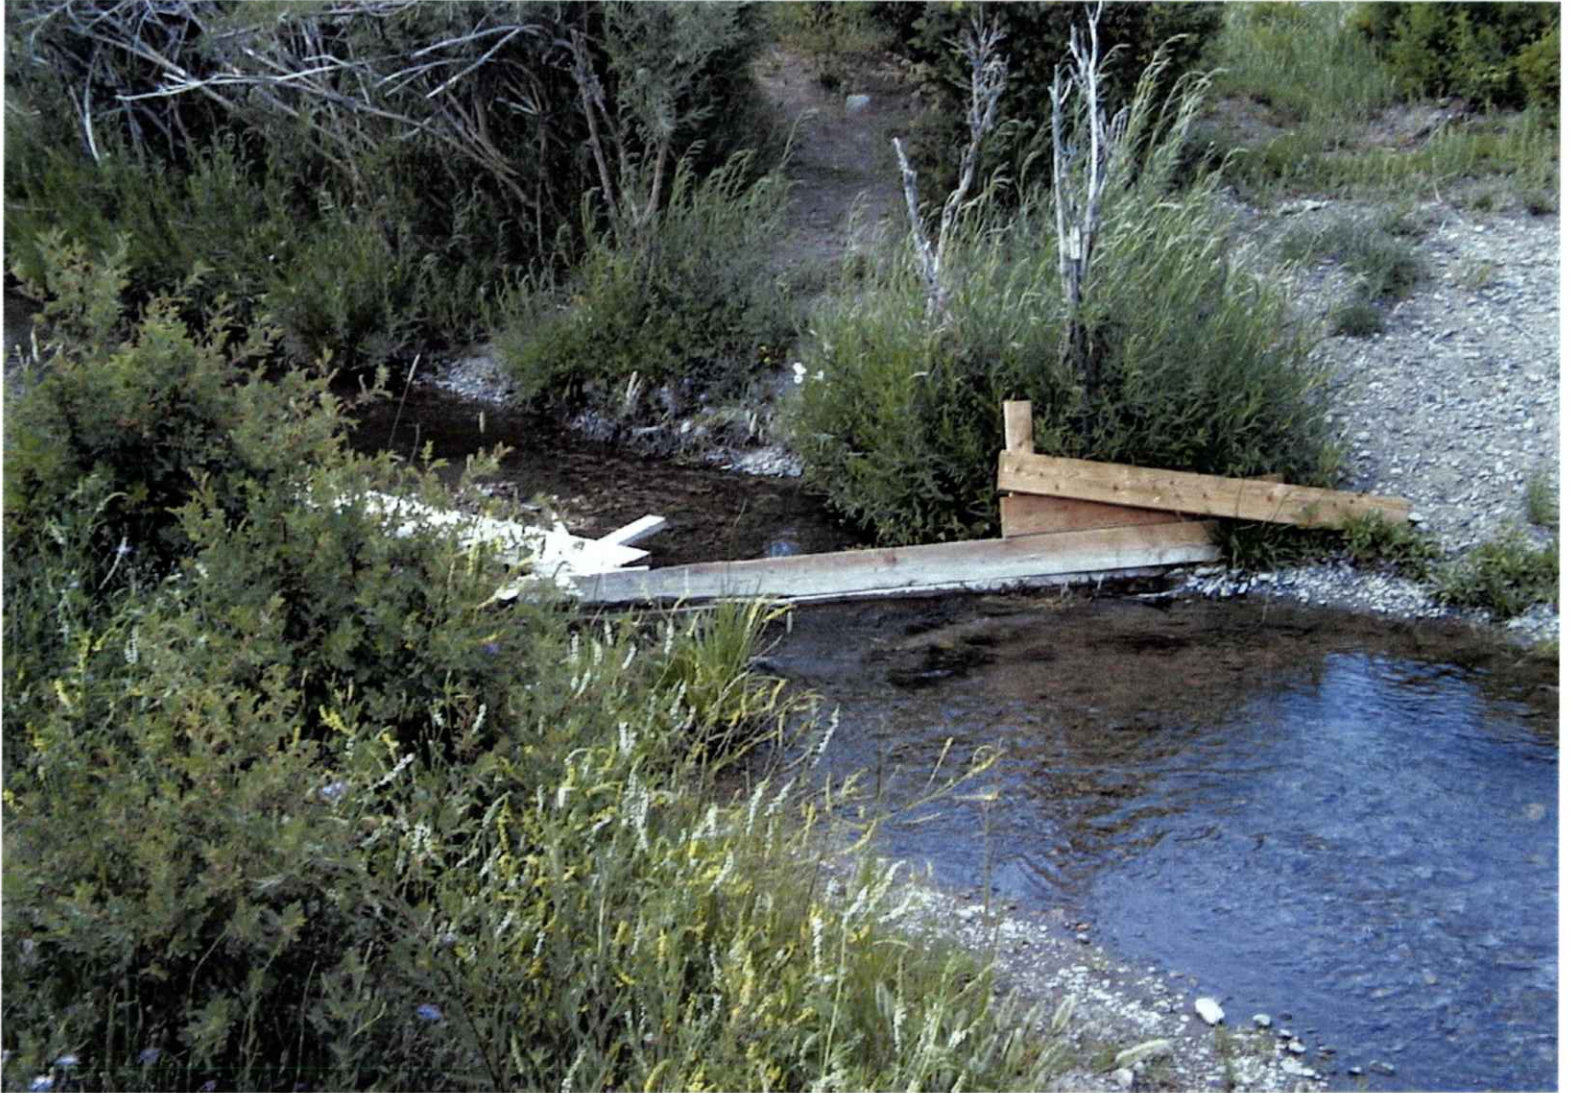
**P-13 weir. 08/02/01**

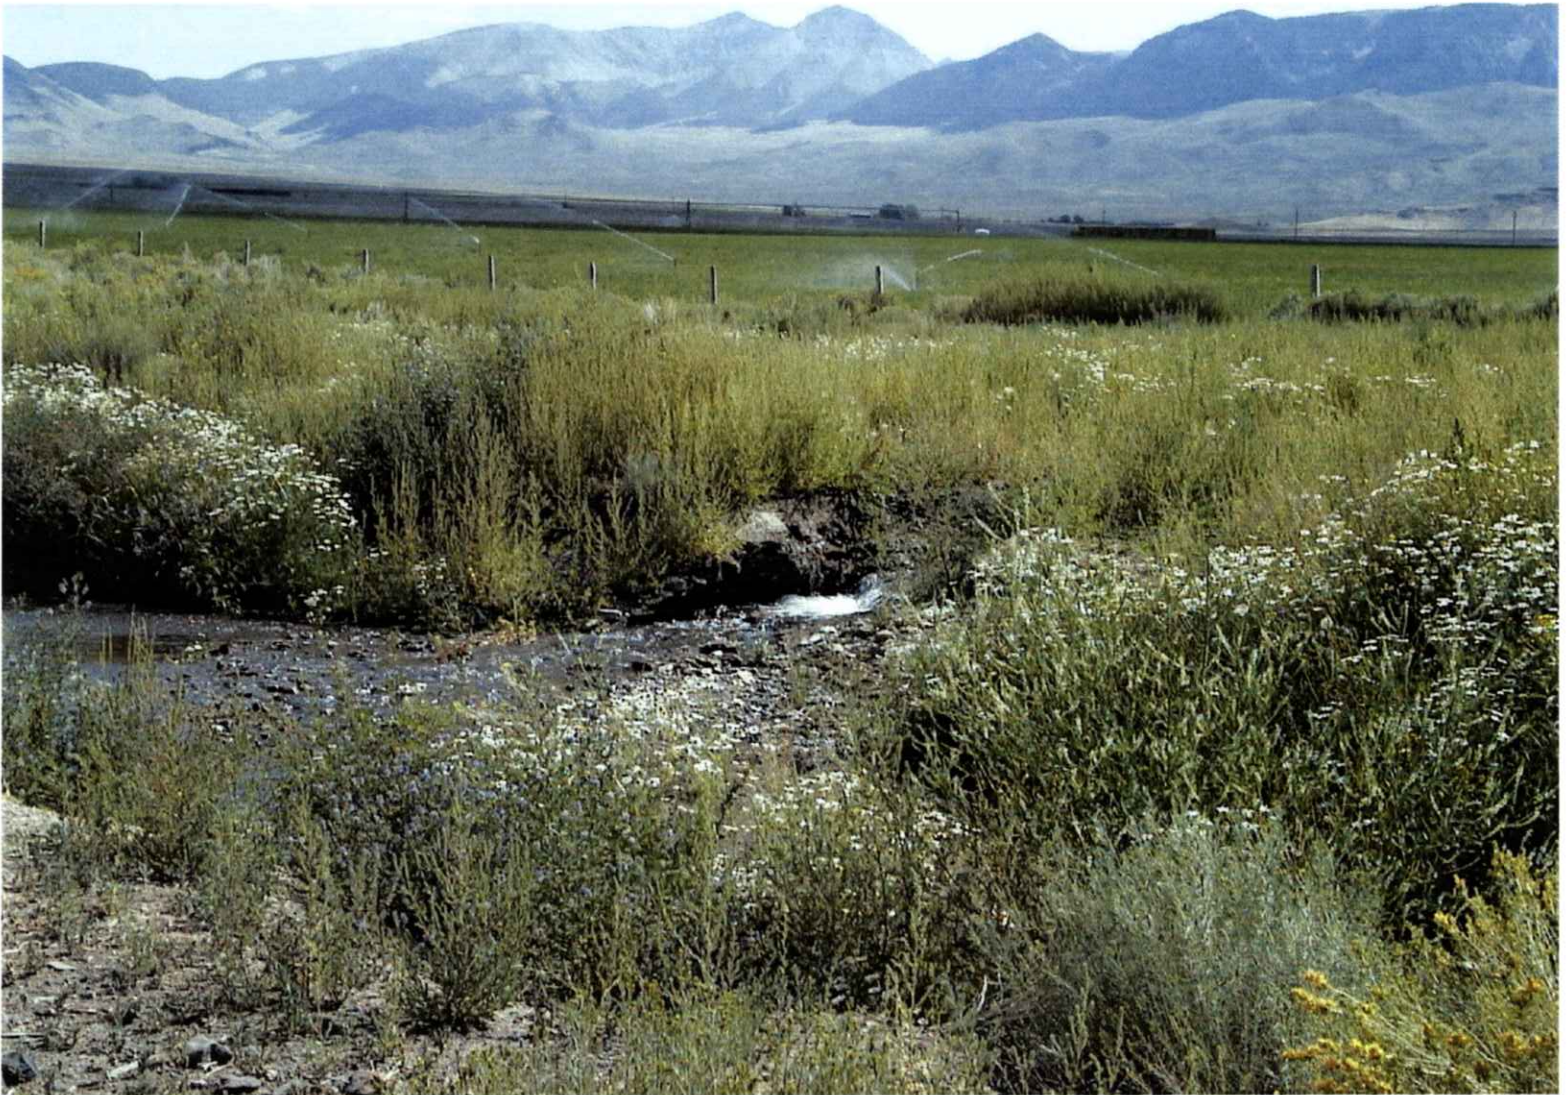
**Water from Circle Pie well (73-7025) being pumped into P-13 ditch.  
Pivot and handlines in background. 08/02/01**
