MEMORANDUM

DATE: August 12, 2008

SUBJECT: July 29, 2008 Field Visit

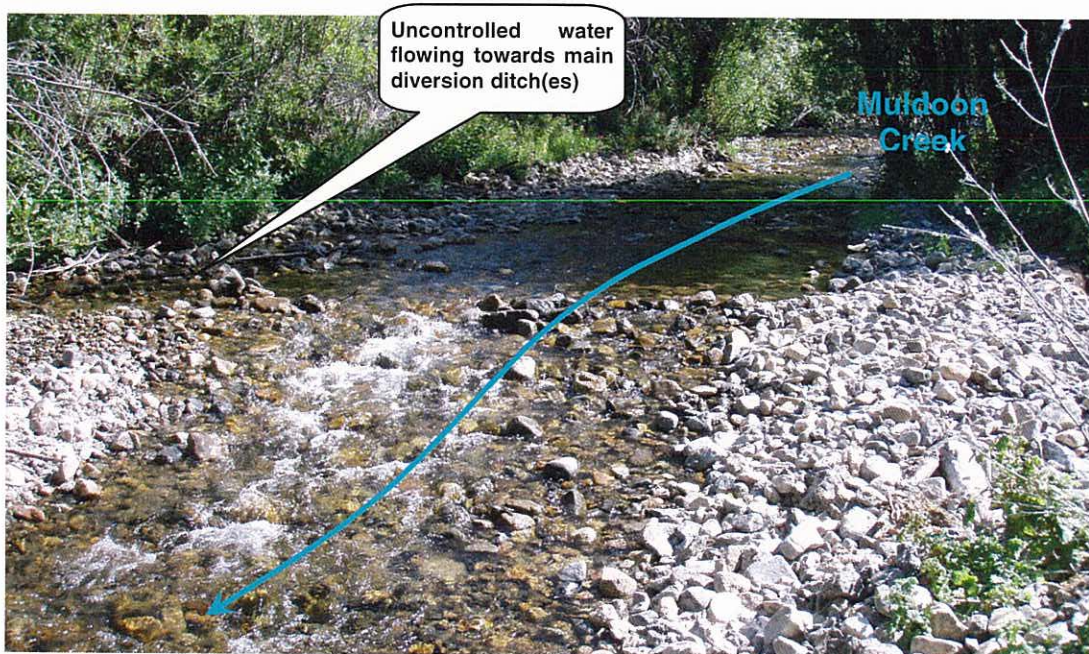
The visit to Guy Peterson's property revealed conditions similar to what was observed during visits to the property last September. Jeff and I observed that approximately 2.46 cfs of water (0.39 feet of head over 3.0 foot Cipolletti weir) was flowing over the measuring device at Guy Peterson's diversion from Muldoon Creek (site tag #A0011848). We also observed that the diversion gate was open to a position that would allow additional flow to be diverted (the gate was not regulating the amount of flow). Several items of concern noted in the September 20, 2007 Guy Peterson memo still appear to be items of concern. Jeff and I observed additional water from Muldoon Creek flowing towards his ditch below his Muldoon Creek diversion (see "photo A" on following pages). Note that during last year's September 5th visit, significantly more water was flowing in Guy Peterson's main diversion ditch(es) than what was observed at his diversion from Muldoon Creek. Jeff and I also observed water flowing in the "East Ditch" (see "photo B" on following pages) on the Guy Peterson property.

ABOVE: "PHOTO A" looking up Muldoon Creek downstream of Guy Peterson's diversion (site tag #A0011848) showing uncontrolled water running towards Guy Peterson's main diversion ditch(es) west of Muldoon Creek. **Photo taken July 29, 2008.**

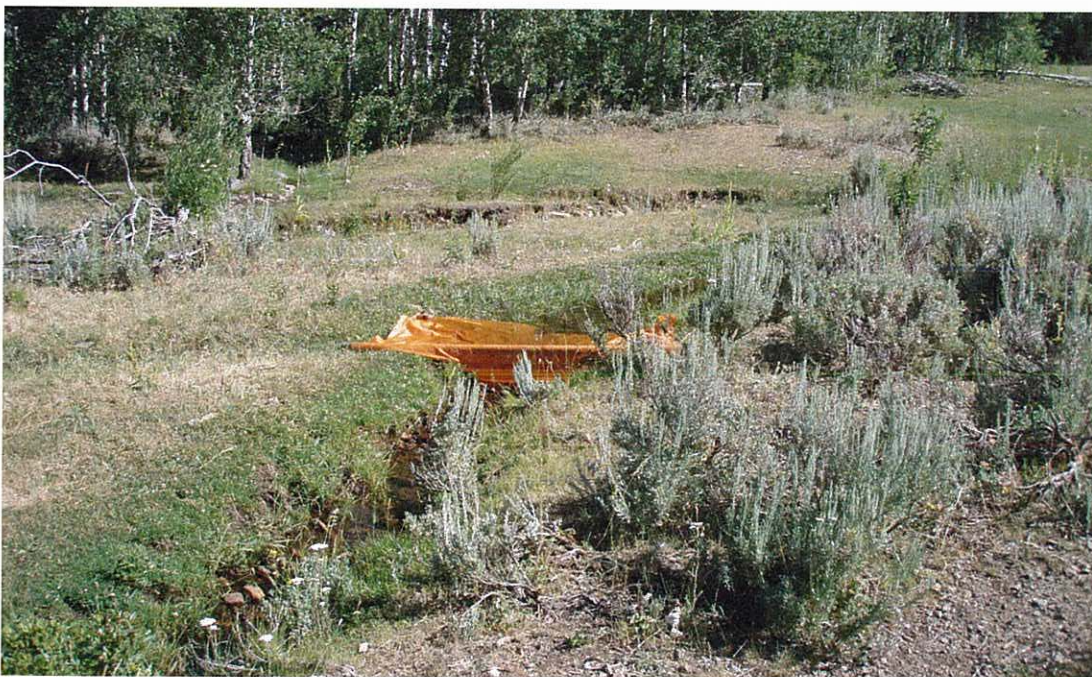
BELOW: "PHOTO B" showing water in ditch east of Muldoon Creek on Guy Peterson's property. Note plastic dam in ditch showing efforts to direct water in ditch. **Photo taken July 29, 2008.**

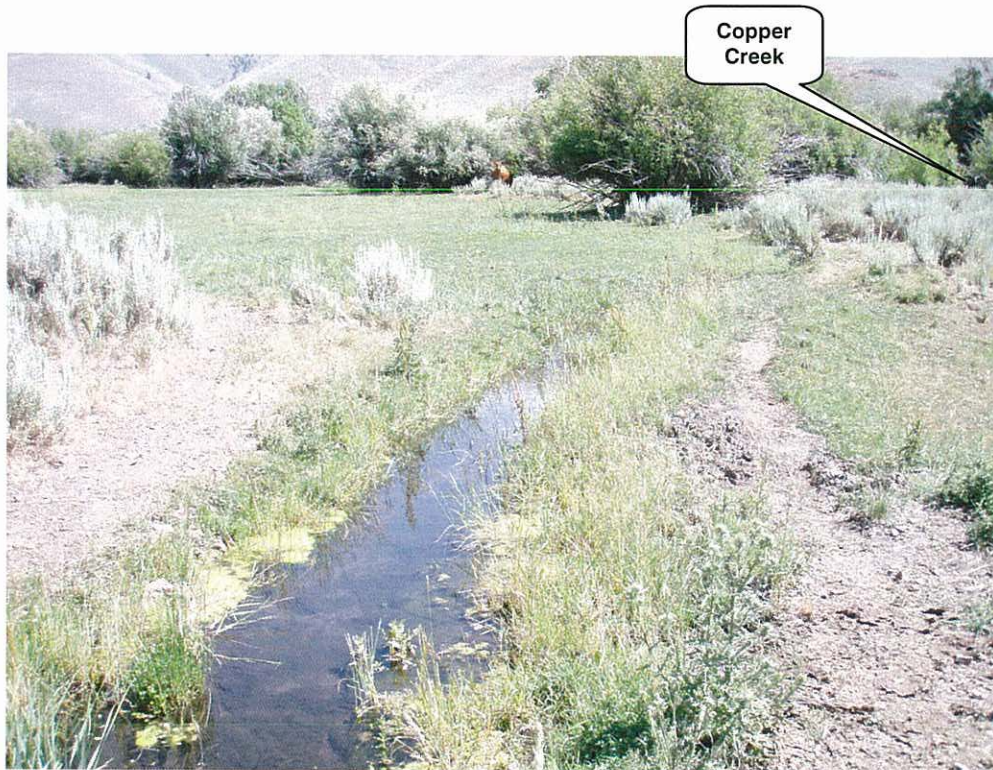
The visit to the Muldoon Creek Grazing Association property revealed conditions similar to what was observed during last year's September 5th and 6th visits to the property. Several items of concern noted in the September 26, 2007 Muldoon Grazing Association memo still appear to be items of concern. Jeff and I observed that water was flowing in the ditch on the west side of Copper Creek (see "photo C" on following pages), a tributary of Muldoon Creek, and that areas in Sections 23 and 24 may be irrigated not in accordance with water rights.

ABOVE: “PHOTO C” looking up the ditch on the west side of Copper Creek on land owned by the Muldoon Creek Grazing Association. **Photo taken July 29, 2008.**

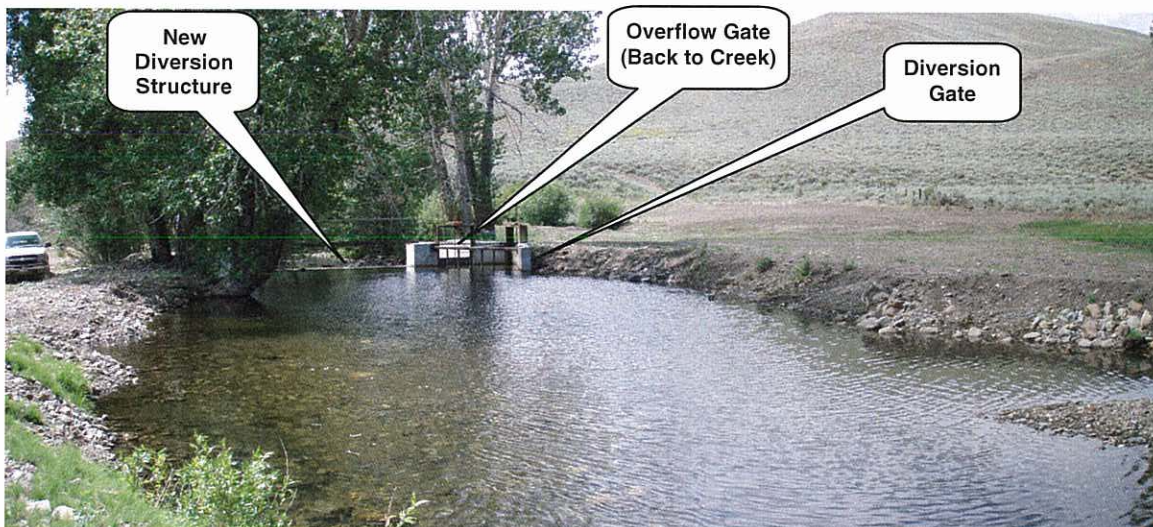
The visit to the Muldoon Ranch Company (Crouch) property revealed that significant improvements have been made to the "Muldoon Ranch Co. Upper Diversion" (site tag # A0011841). These improvements now allow for all of the water diverted into the "Muldoon Ranch Co. Upper Diversion Ditch" to be delivered through a single controlled (gated) diversion (see "photo D" on following pages). However, the "Muldoon Ranch Co. Middle Diversion" still does not have adequate control works to

BELOW: “PHOTO D” looking down Muldoon Creek at the new “Muldoon Ranch Co. Upper Diversion” (site tag # A0011841) showing that all the water at this particular diversion is now diverted through a single controlled diversion. **Photo taken July 29, 2008.**

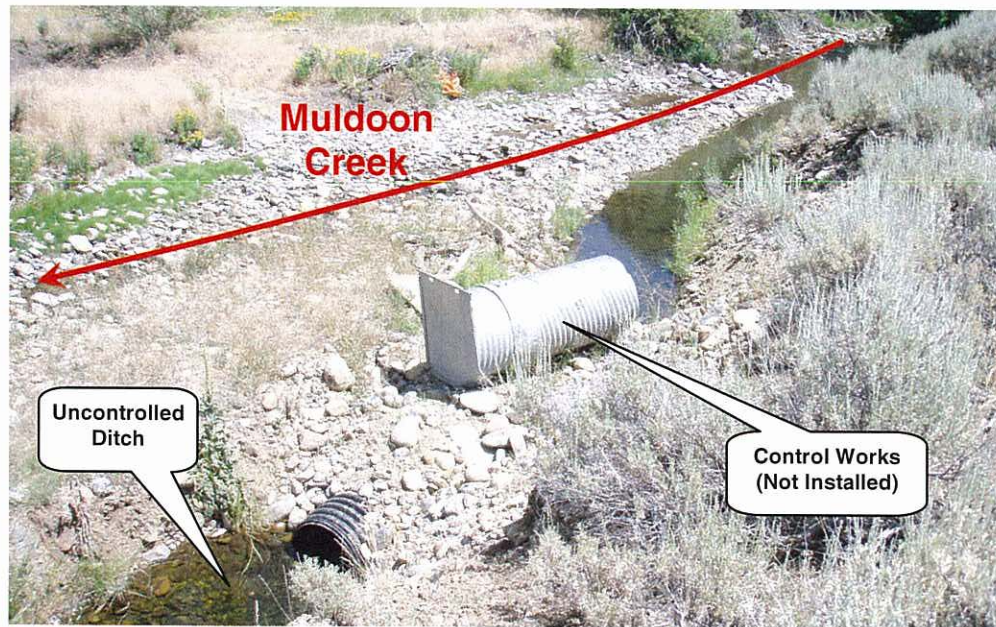
regulate the diversion (see "photo E" on following pages). In addition, it was observed that a pond (at least ½ acre in size) is under construction near the home near the ditch fed from the "Muldoon Ranch Co. Middle Diversion". Apparently this is some sort of aesthetic feature for the nearby house. It was observed that water was not running into the pond. Since the July 29th visit to the area, Arlon Crouch of Muldoon Ranch Company called on another matter. Mr. Crouch and I discussed the need to have some sort of water right to allow for use of water in the pond that is under construction.

ABOVE: "PHOTO E" looking at the "Muldoon Ranch Co. Middle Diversion" showing the uncontrolled diversion of water from Muldoon Creek. **Photo taken July 29, 2008.**

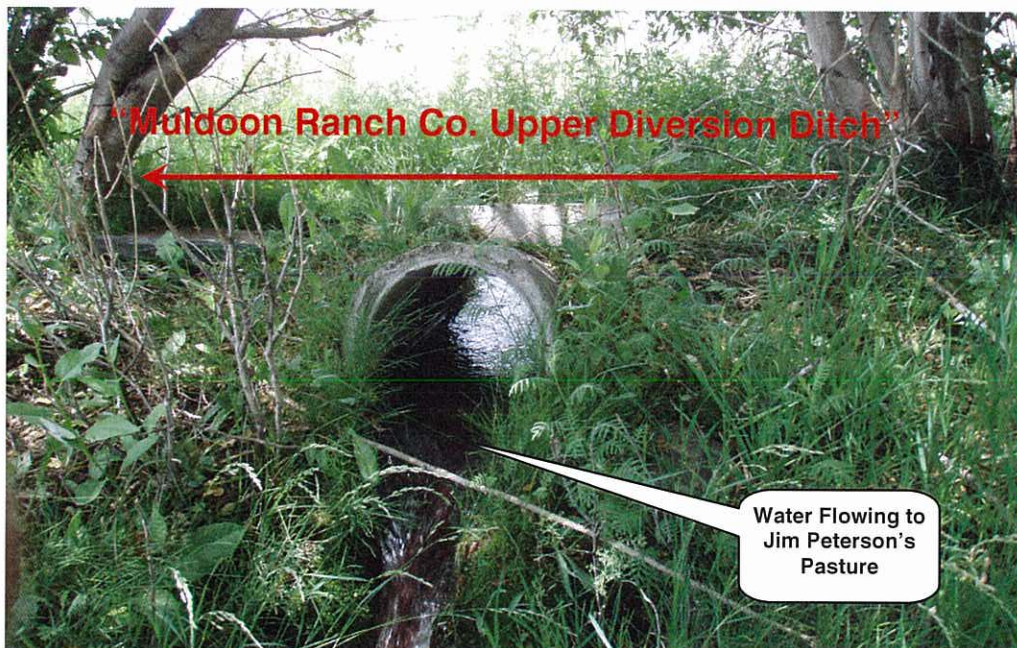
The visit to the Jim Peterson property revealed that water was actually being diverted from the "Muldoon Ranch Co. Upper Diversion Ditch" as alleged by Muldoon Ranch Company representatives last year (see "photo F" on following pages). The September 27, 2007 Jim Peterson memo provides more detail relating to this particular item of concern.

BELOW: "PHOTO F" showing diversion of water from the "Muldoon Ranch Co. Upper Diversion Ditch" via a 14" diameter pipe that empties into a ditch that leads to Jim Peterson's irrigated pasture. **Photo taken July 29, 2008.**
