MEMORANDUM

TO: Muldoon Creek Water District (37-O) File

DATE: September 23, 2004

SUBJECT: Field Visit

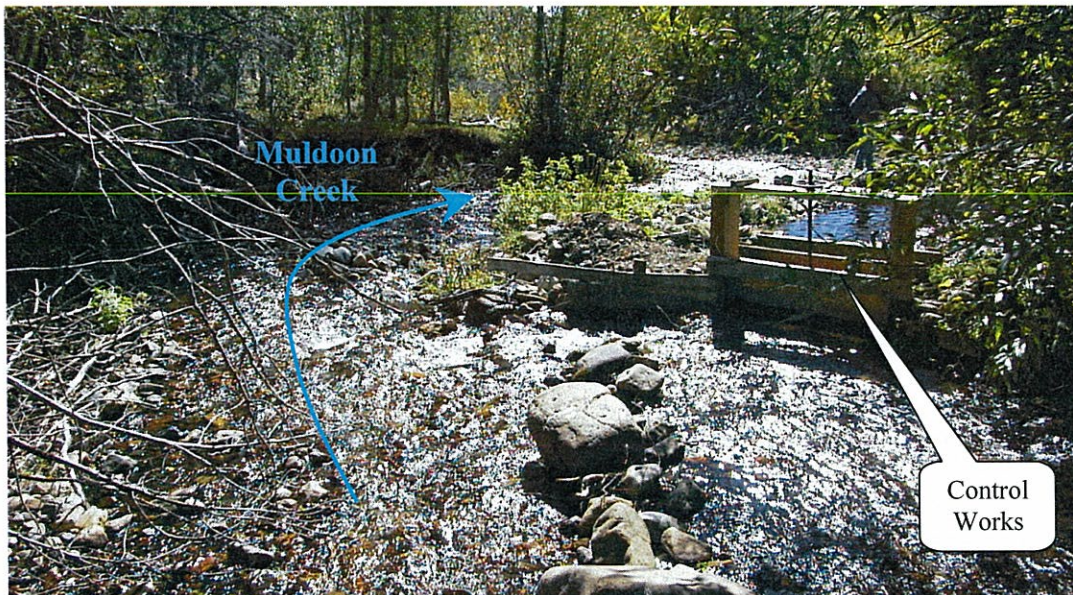
ABOVE: View looking down Muldoon Creek with control works visible at the head of Guy Peterson's ditch.

Control works consist of wooden gate structure with wooden gate and metal gate stem. Measuring device consists of a 3.0 foot Cipoletti Weir (metal blade in wood structure). No staff gage was present for the measuring device. Flow through measuring device was measured at 2.16 cfs.

Concerns: Durability of wooden control works and measuring device structure? Lack of staff gage. Guy Peterson's SRBA filing, 37-1143 for 2.8 cfs, identifies point of diversion in Section 24 (T03N, R21E).

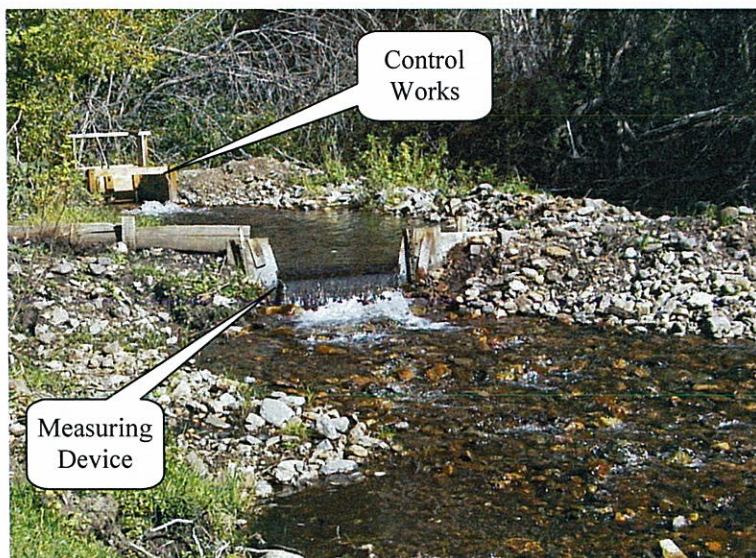
LEFT: View looking up Guy Peterson's ditch through the measuring device towards the control works.

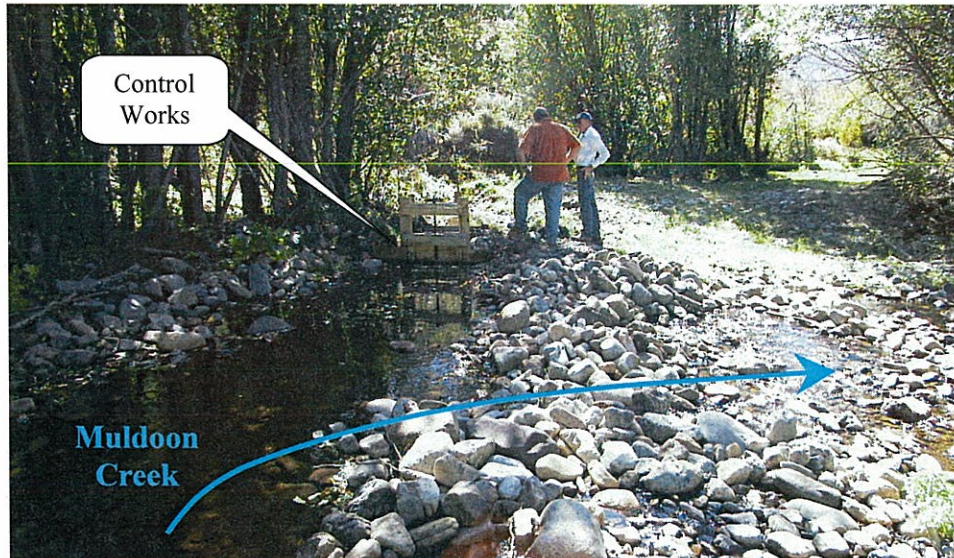
ABOVE: View looking down Muldoon Creek with the Muldoon Grazing Association's upper diversion works visible at the head of their ditch.

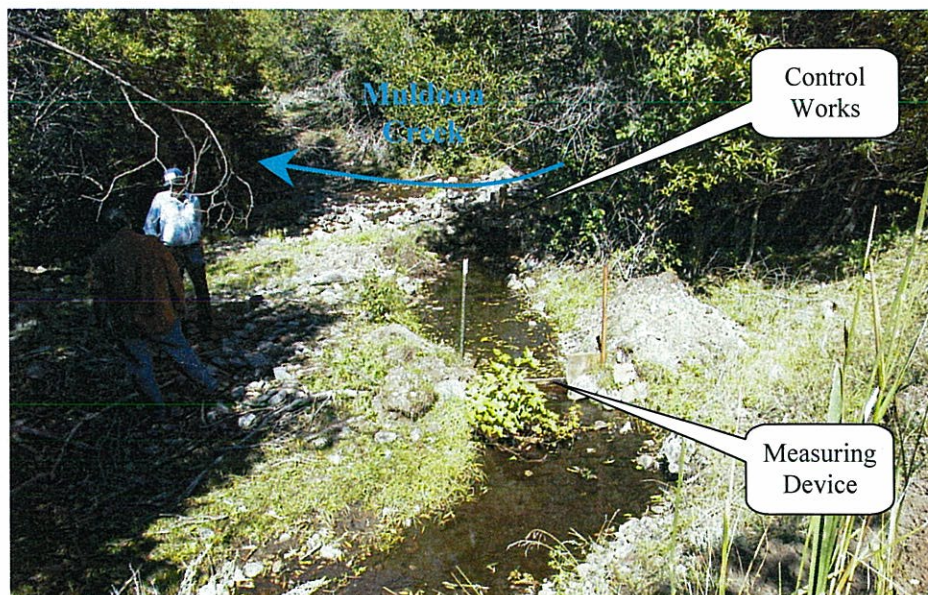
BELOW: View from hillside looking down towards the Muldoon Grazing Association's upper diversion works and ditch. Note standing water in ditch, but no flow over the measuring device.

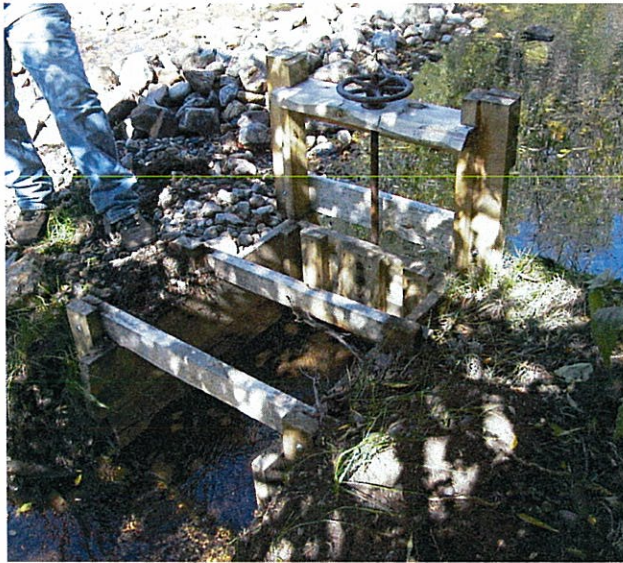
LEFT: View of wooden control works at the head of the ditch.

Concerns: Durability of wooden control works and measuring device structure? Lack of staff gage and metal weir plate.

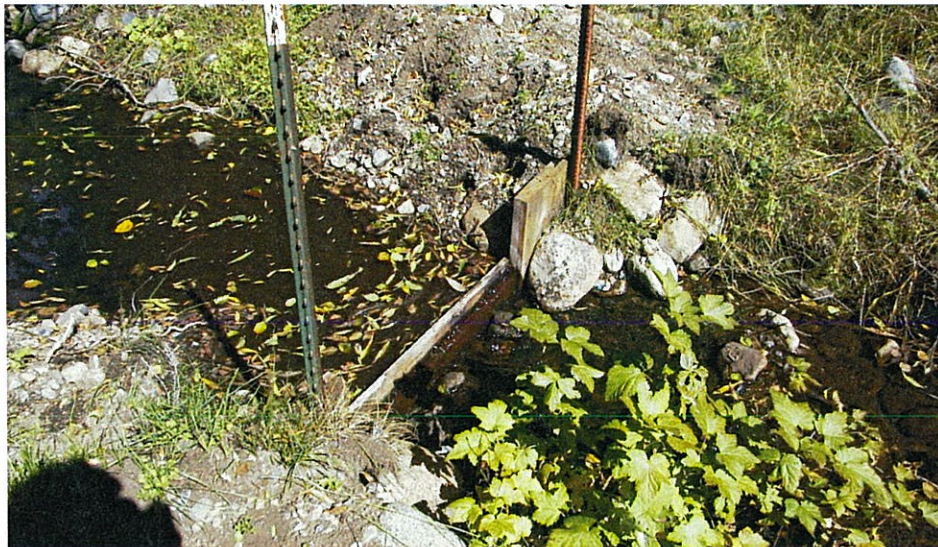
BELOW: View of wooden measuring device (rectangular weir). Note lack of a metal weir blade, device leaning downstream, and standing water upstream and downstream (possible leakage?).

no diversion
moved
3' rectangular
weir
no
steel
plate

Control works consist of wooden gate structure with wooden gate and metal gate stem. Measuring device consists of a 3.0-foot rectangular weir (no metal blade in wood structure). No staff gage was present for the measuring device. The wooden device was leaning and water may have been leaking around device. No flow measurement was made.

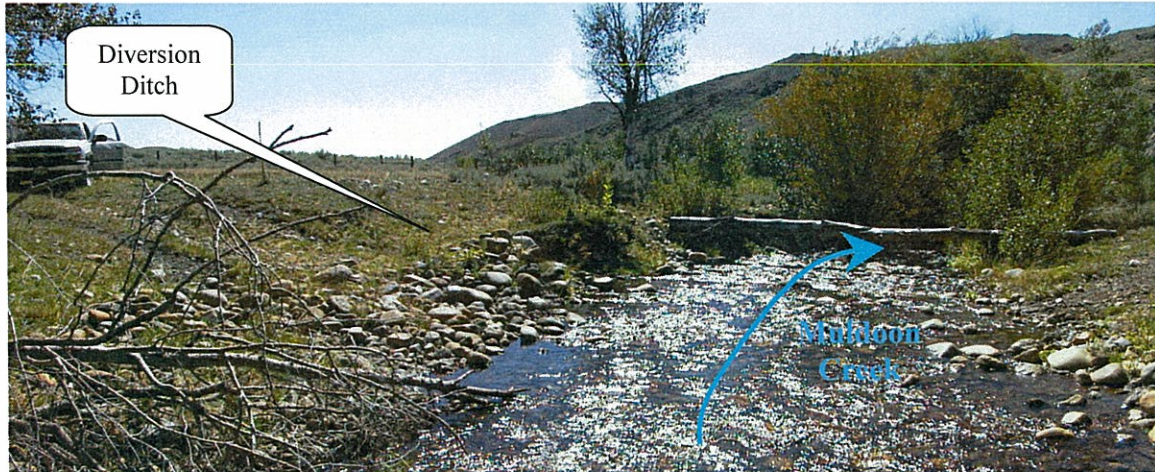
View looking down Muldoon Creek at the head of the Muldoon Grazing Association middle diversion ditch. Note relative height of ditch in relation to the creek, lack of control works, measuring device, and overall appearance that appears to indicate lack of recent use of this diversion.

Concerns: No control works or measuring device present. Possible lack of use of this particular diversion? Muldoon Grazing Association's SRBA filing, 37-2751 for 5.33 cfs, appears to identify this point of diversion in the SWNE of Section 26 (T03N, R21E).

*no control works
no measuring device*

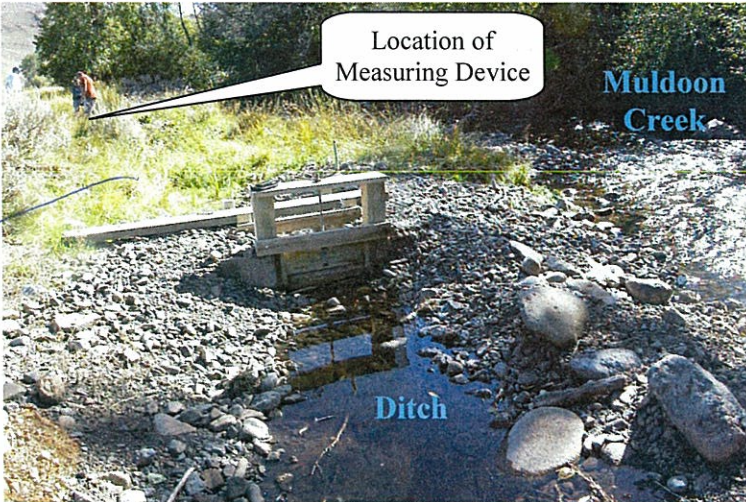
LEFT: View looking down Muldoon Creek showing the diversion works for the Muldoon Grazing Association Lower Diversion Ditch.

Concerns: Durability of wooden control works and measuring device structure? Lack of staff gage and metal weir plate. Muldoon Grazing Association's SRBA filing, 37-2751 for 5.33 cfs, appears to identify this point of diversion in the NENW of Section 35 (T03N, R21E).

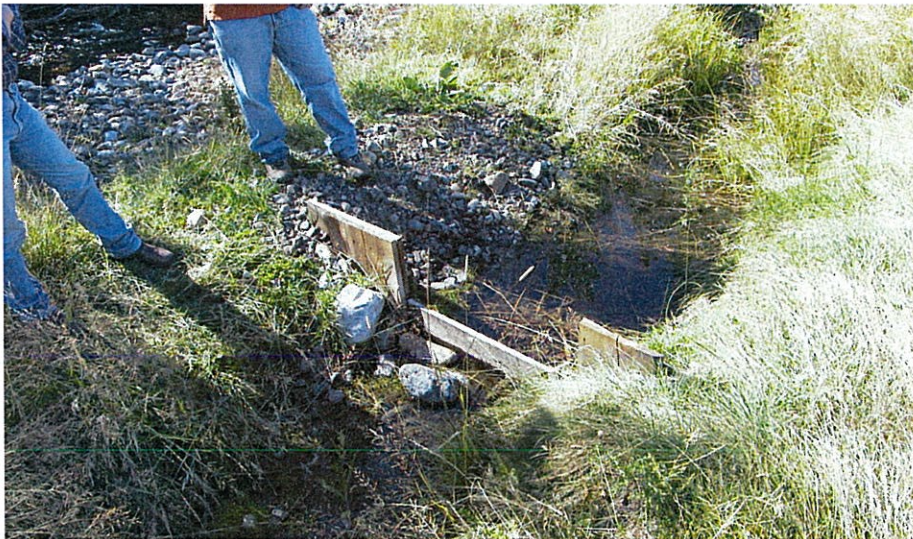
BELOW: View of wooden measuring device (rectangular weir). Note lack of a metal weir blade, device leaning downstream, and standing water upstream and downstream (possible leakage?).

Control works consist of wooden gate structure with wooden gate and metal gate stem. Measuring device consists of a 3.0-foot rectangular weir (no metal blade in wood structure). No staff gage was present for the measuring device.

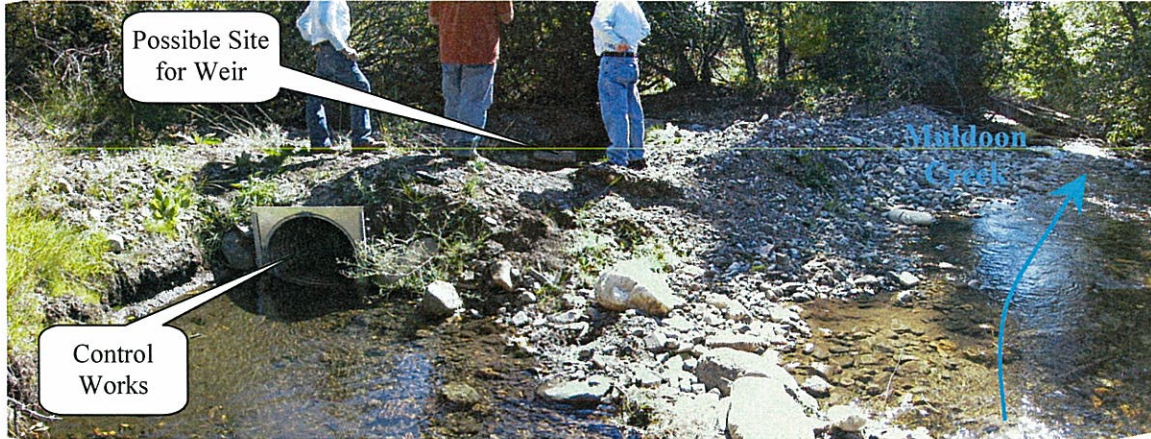
ABOVE: View looking down Muldoon Creek showing the diversion works for the Upper Clark Diversion.

Concerns: Lack of gate on diversion works. Accuracy of the device? Flume may be too large for measurements at lower flows (< 0.20 ft of head). Clark's SRBA filings, 37-1120 and 37-1140, for 7.3 total cfs?, identifies point of diversion in NWSW Section 35 (T03N, R21E).

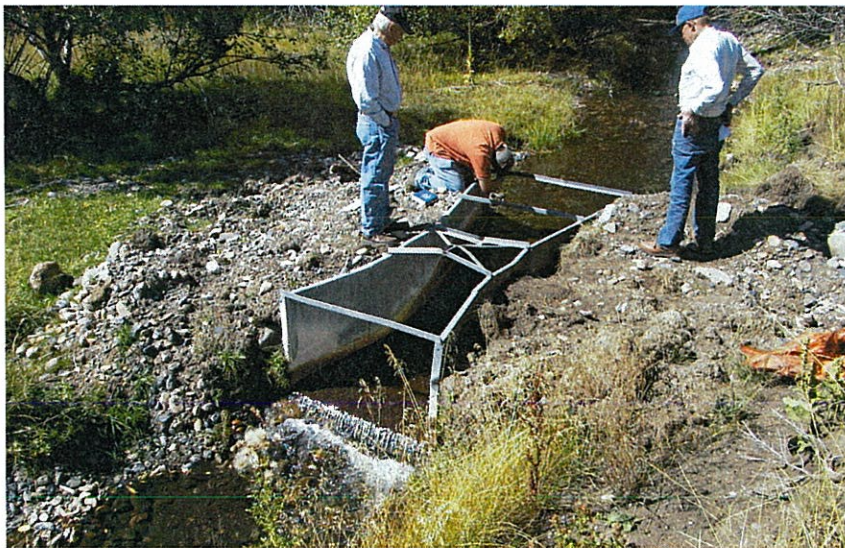
LEFT: View of the measuring device (2.5 ft Parshall flume) on the Clark Upper Diversion Ditch.

.31' head
Diversion works consist of metal slide gate structure, but gate was not on the structure. Measuring device consists of a 2.5 foot Parshall flume. Converging section of the flume was not level. Flow through measuring device was measured at 0.81cfs. Device appears large for small flows later in summer. It may be possible to install a weir just downstream of the diversion to measure smaller flows.

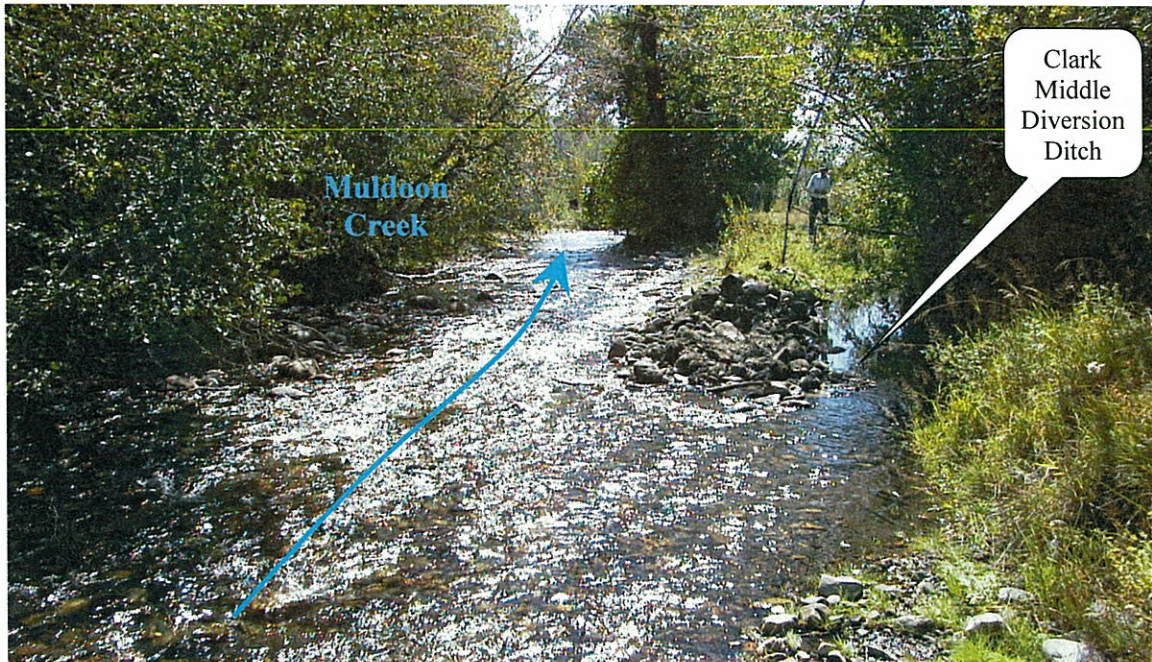
View looking down Muldoon Creek at the head of the Clark middle diversion ditch. Note lack of control works. In addition, no measuring device was present on this particular ditch.

Concerns: No control works or measuring device present. Clark's SRBA filings, 37-1120 and 37-1140, for 7.3 total cfs?, identifies point of diversion in NWSW Section 35 (T03N, R21E).

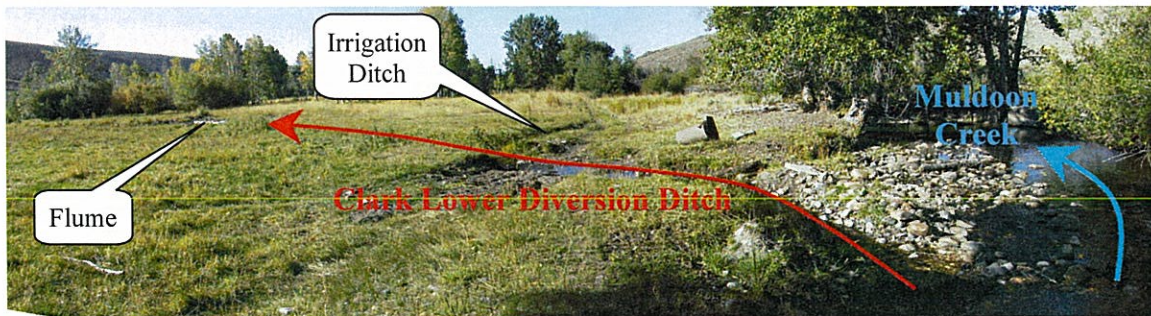
ABOVE: View looking down Muldoon Creek with Clark Lower Diversion Ditch shown. Note lack of control works and irrigation ditch, off of the main diversion ditch, located upstream of the flume.

Concerns: Lack of diversion control works. Accuracy of the device? Flume may be too large for measurements at lower flows (< 0.20 ft of head). Water in ditch upstream of device will not be measured with current flume location. Clark's SRBA filings, 37-1120 and 37-1140, for 7.3 total cfs?, identifies point of diversion in NSW Section 35 (T03N, R21E).

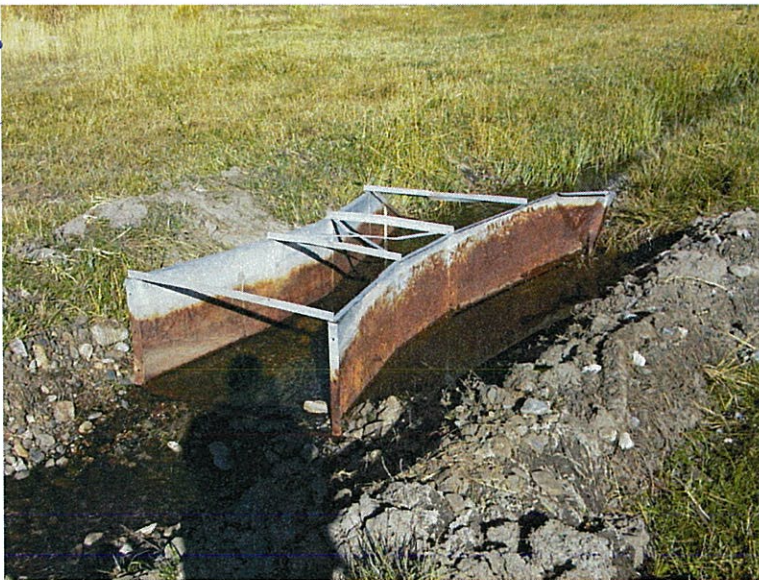
LEFT: View of Parshall flume on the Clark Lower Diversion Ditch. Note flow around the flume and overall condition, and installation of the flume. The survey revealed that the converging section slopes up, as you move downstream, and the left side is actually lower than the downstream end of the flume.

No diversion control works are present. Measuring device consists of a 2.5 foot Parshall flume. A level survey of the flume reveals that part of the converging (upstream) section is actually lower than the downstream end of the flume. In addition, the converging section was 0.16 feet lower on the right side than the left side. Quite a bit of water was flowing around the flume. An irrigation ditch, off of the main diversion ditch, was also located upstream of the flume. The gage on the flume measured 0.23 feet of head, but the problems with the device did not provide an accurate measurement of flow through the ditch.

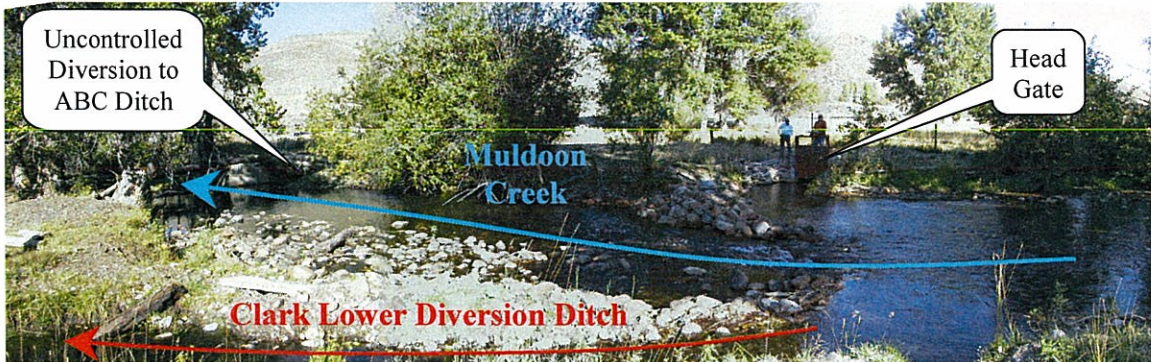
ABOVE: View looking across Muldoon Creek towards the ABC Agra Upper Diversion(s). Note a head gate has been installed, but water from Muldoon Creek still enters the diversion ditch via an uncontrolled diversion just downstream of the recently installed head gate. The head of the Clark Lower Diversion Ditch is visible in the foreground of this view.

Concerns: Lack of control on all of the water entering the ditch. Measuring device needs a staff gage on both weirs. ABC Agra's SRBA filings identify point of diversion in SWNE Section 3 (T02N, R21E).

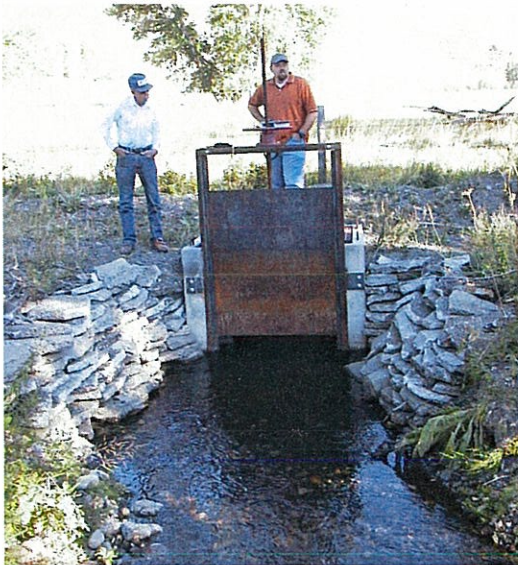
LEFT: View of the recently installed head gate for the ABC Agra Upper Diversion. This head gate is tied into a buried 30" diameter pipeline that discharges into the upper diversion ditch.

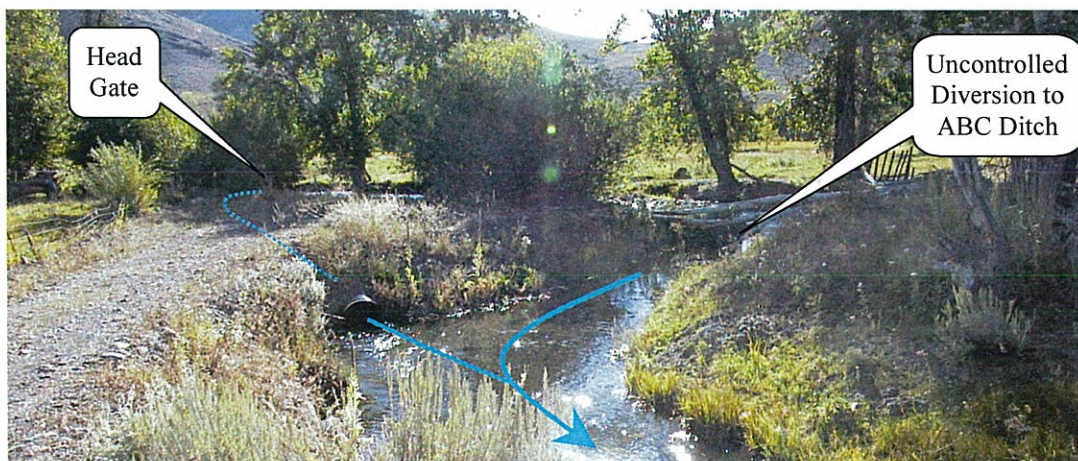
BELOW: View looking back up the ABC Agra Upper Diversion Ditch showing the location of the discharge from the pipeline from the head gate. Also note uncontrolled water from Muldoon Creek entering the ditch.

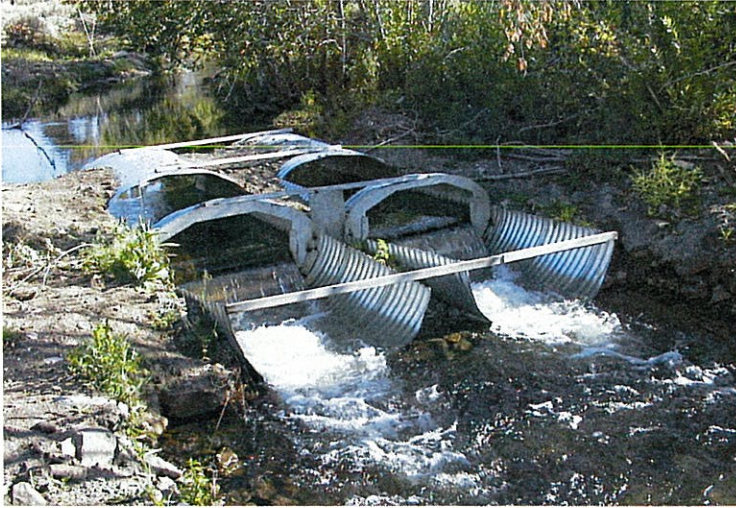
LEFT: View of measuring device, two 42" rectangular weirs, in ABC Agra Upper Diversion Ditch.

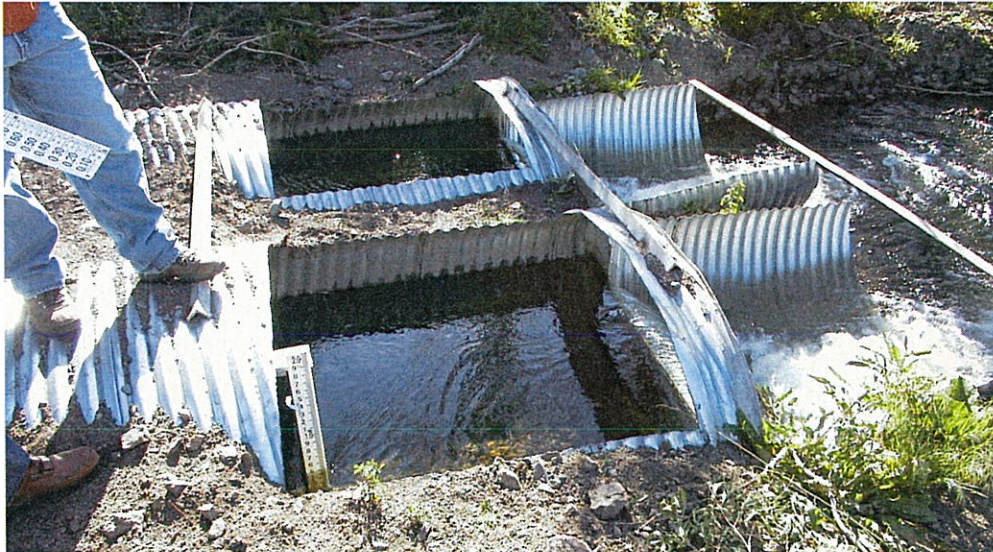
BELOW: Close up view of measuring device showing presence of only one staff gage, but weirs are not at the same elevation.

Diversion works consist of metal screw gate structure. However, another uncontrolled diversion also enters the ditch. Measuring device consists of two 42-inch rectangular weirs placed in parallel. One staff gage was present for one of the weirs, but the two weirs were not at the same elevation. Flow through left (east) weir was measured at 3.52 cfs and flow through right (west) weir was measured at 3.88 cfs.

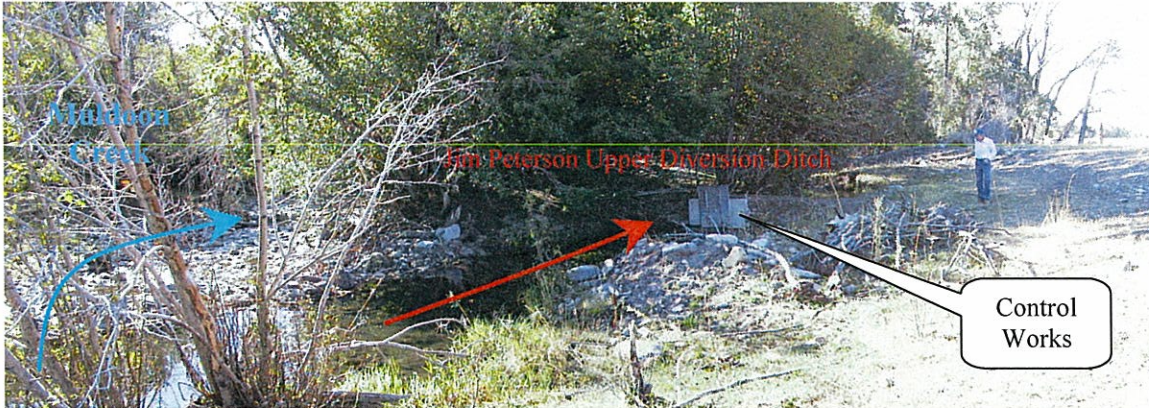
ABOVE: View looking down Muldoon Creek showing the diversion location for the head of Jim Peterson's upper diversion ditch.

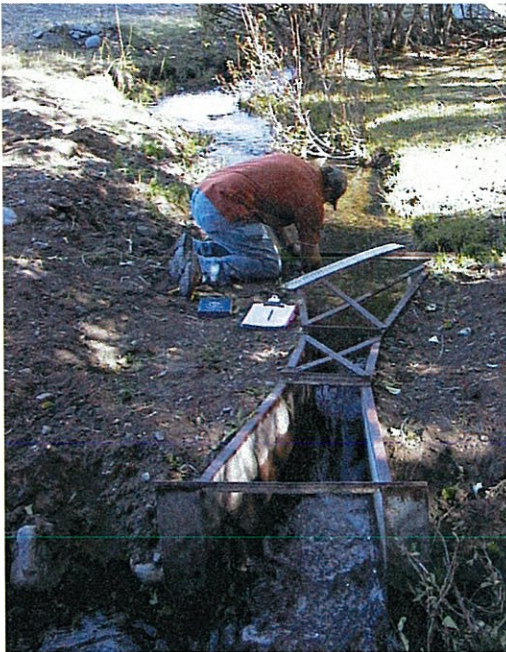
LEFT: View of one foot Parshall flume installed in Jim Peterson's upper diversion ditch.

Control works consist of a concrete structure with metal slide gate. Measuring device consists of a 1.0 foot Parshall Flume. The staff gage on the flume was bent and read 0.84 feet, but the actual head reading was 0.95 feet. Flow through measuring device according to the gage was 3.07 cfs, but the actual flow was 3.70 cfs.

Concerns: Bent staff gage. Jim Peterson's SRBA filings, 37-99 and 37-1141, have claimant ownership issues (Muldoon Livestock vs Muldoon Grazing Assoc). Maybe database issues?

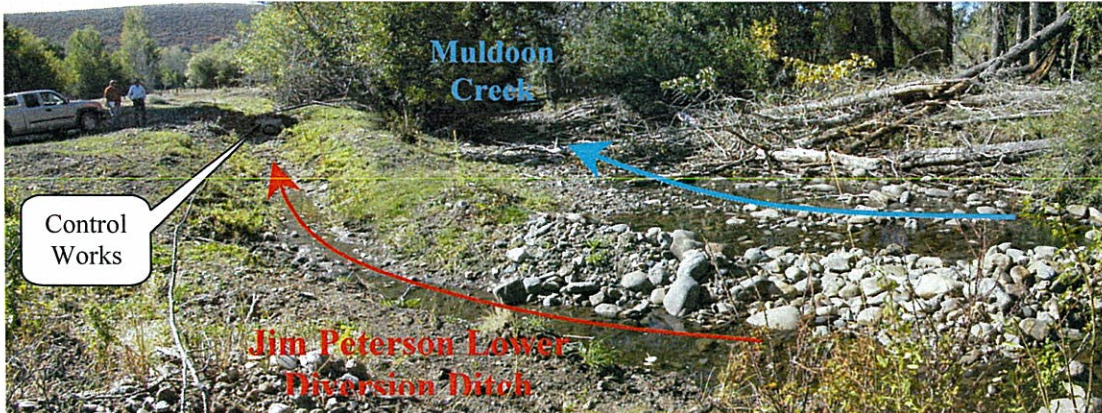
ABOVE: View looking down Muldoon Creek showing Jim Peterson's lower diversion ditch.

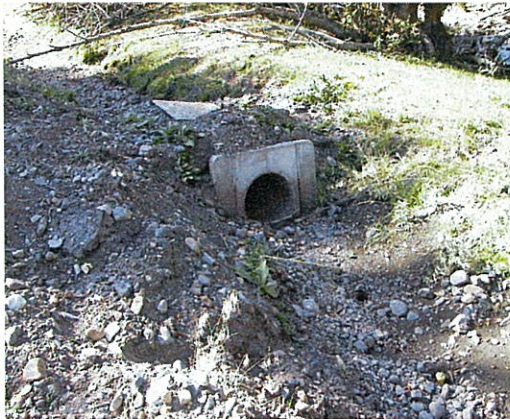
LEFT: View of control works in Jim Peterson's lower diversion ditch

Control works consist of a concrete structure with no slide gate. Measuring device consists of a 1.0 foot Parshall Flume. The staff gage on the flume was bent. At the time of the inspection, no water was flowing through the flume.

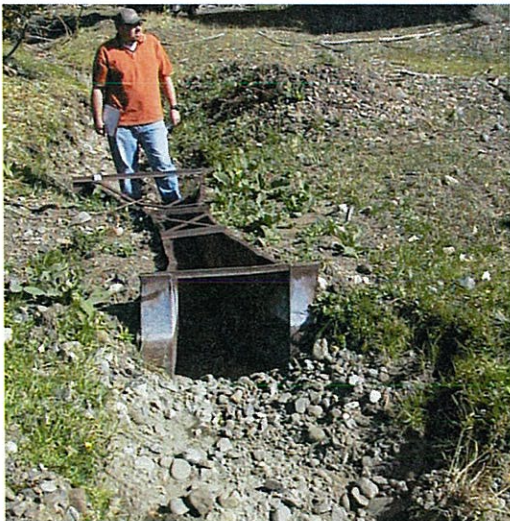
LOWER LEFT: View of one foot Parshall flume installed in Jim Peterson's lower diversion ditch.

Concerns: Bent staff gage. Jim Peterson's SRBA filings, 37-99 and 37-1141, have claimant ownership issues (Muldoon Livestock vs Muldoon Grazing Assoc). Maybe database issues?

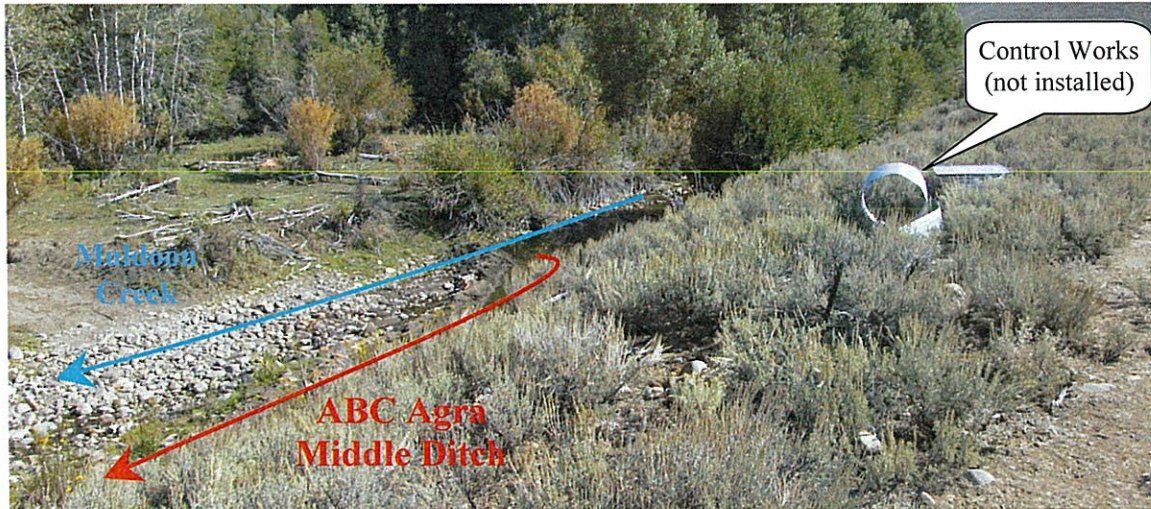
ABOVE: View looking down on the ABC Middle Diversion. Note control works not yet installed.

Concerns: Lack of control works. Measuring device located quite a ways downstream from the point of diversion.

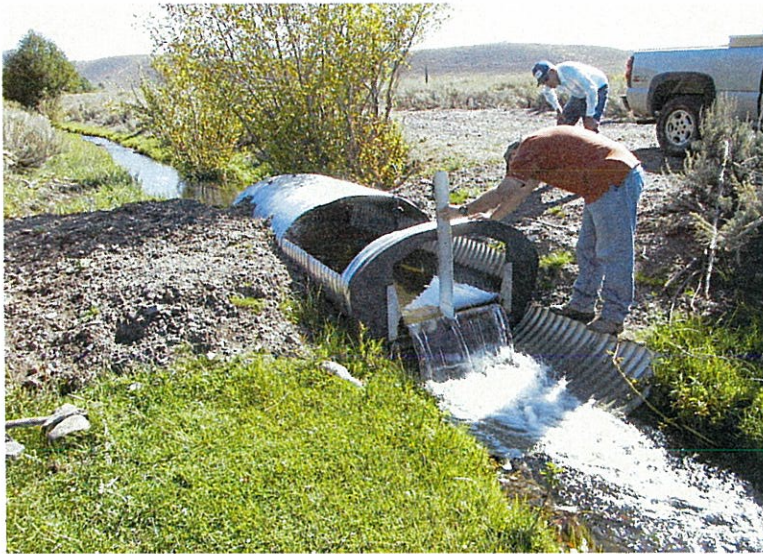
LEFT: View of measuring device located in the ABC Middle Diversion Ditch. Note that this point is approximately 0.20 mile downstream of the diversion location shown in view above.

Control works not yet installed. Measuring device consists of a 2.5 foot Cipoletti weir. However the measuring device is located approximately 0.20 mile down the ditch from the diversion point. Flow through measuring device was measured at 1.05 cfs. Only SRBA claim 37-1142 lists this diversion location.

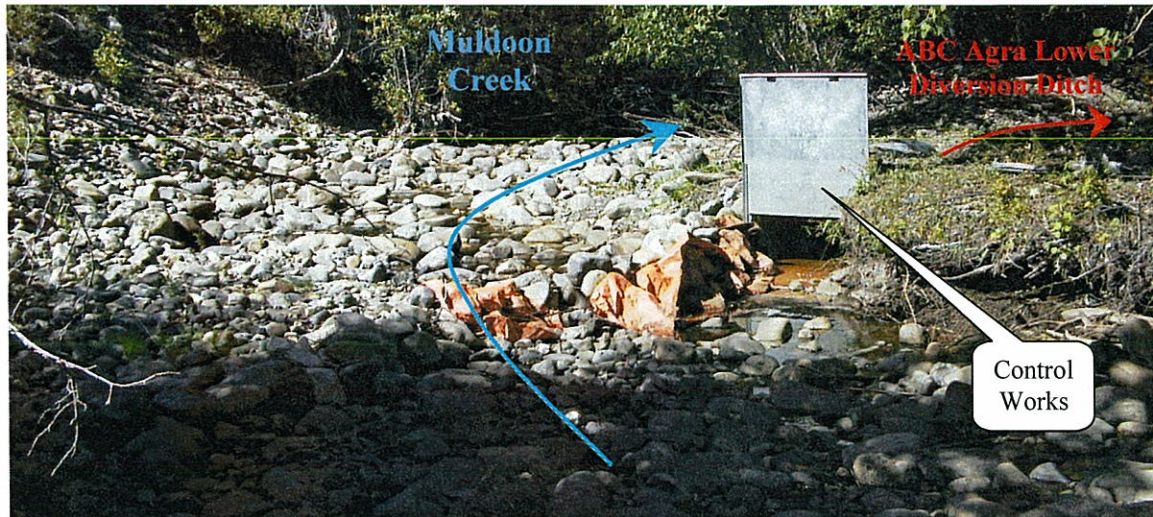
ABOVE: View looking down Muldoon Creek towards the ABC Agra Lower Diversion.

Concerns: No water right or SRBA filings list a point of diversion in the NWNW Section 16 (T02N, R21E). Perhaps, claim 37-7006 with a claimed point of diversion in the NENE of Section 17 is supposed to describe this diversion? Note that this claim also identifies other diversions further down Muldoon Creek that have not been documented.

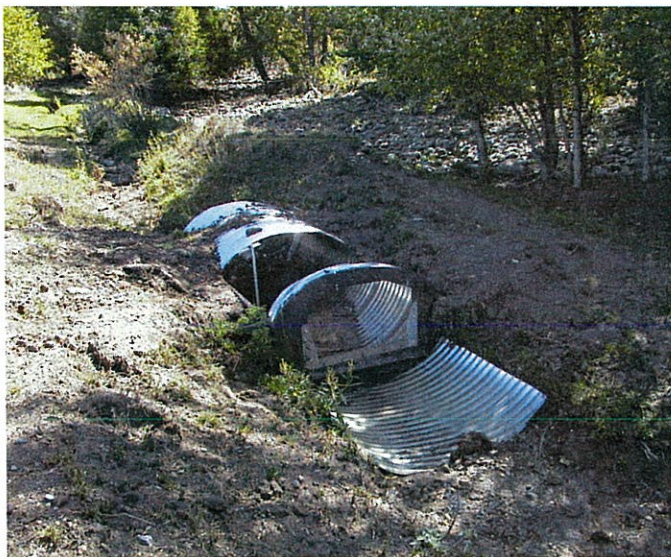
LEFT: View of measuring device located in the ABC Agra Lower Diversion Ditch.

Diversion works consist of metal slide gate structure. Measuring device consists of a 2.5 foot Cipoletti weir. No flow through the diversion or device at the time of the inspection.
