## MEMORANDUM

**TO:** CARTER FRITSCHLE  
**FROM:** NORM YOUNG  
**RE:** CLAIM NOS. 78- 10286 AND 78-12327 (LIGHTFORCE USA INC.)  
**DATE:** APRIL 6, 2010

Accompanying this memorandum are maps, photographs and other information documenting the location and nature of the works constructed to divert and use water in LightForce's domestic system.

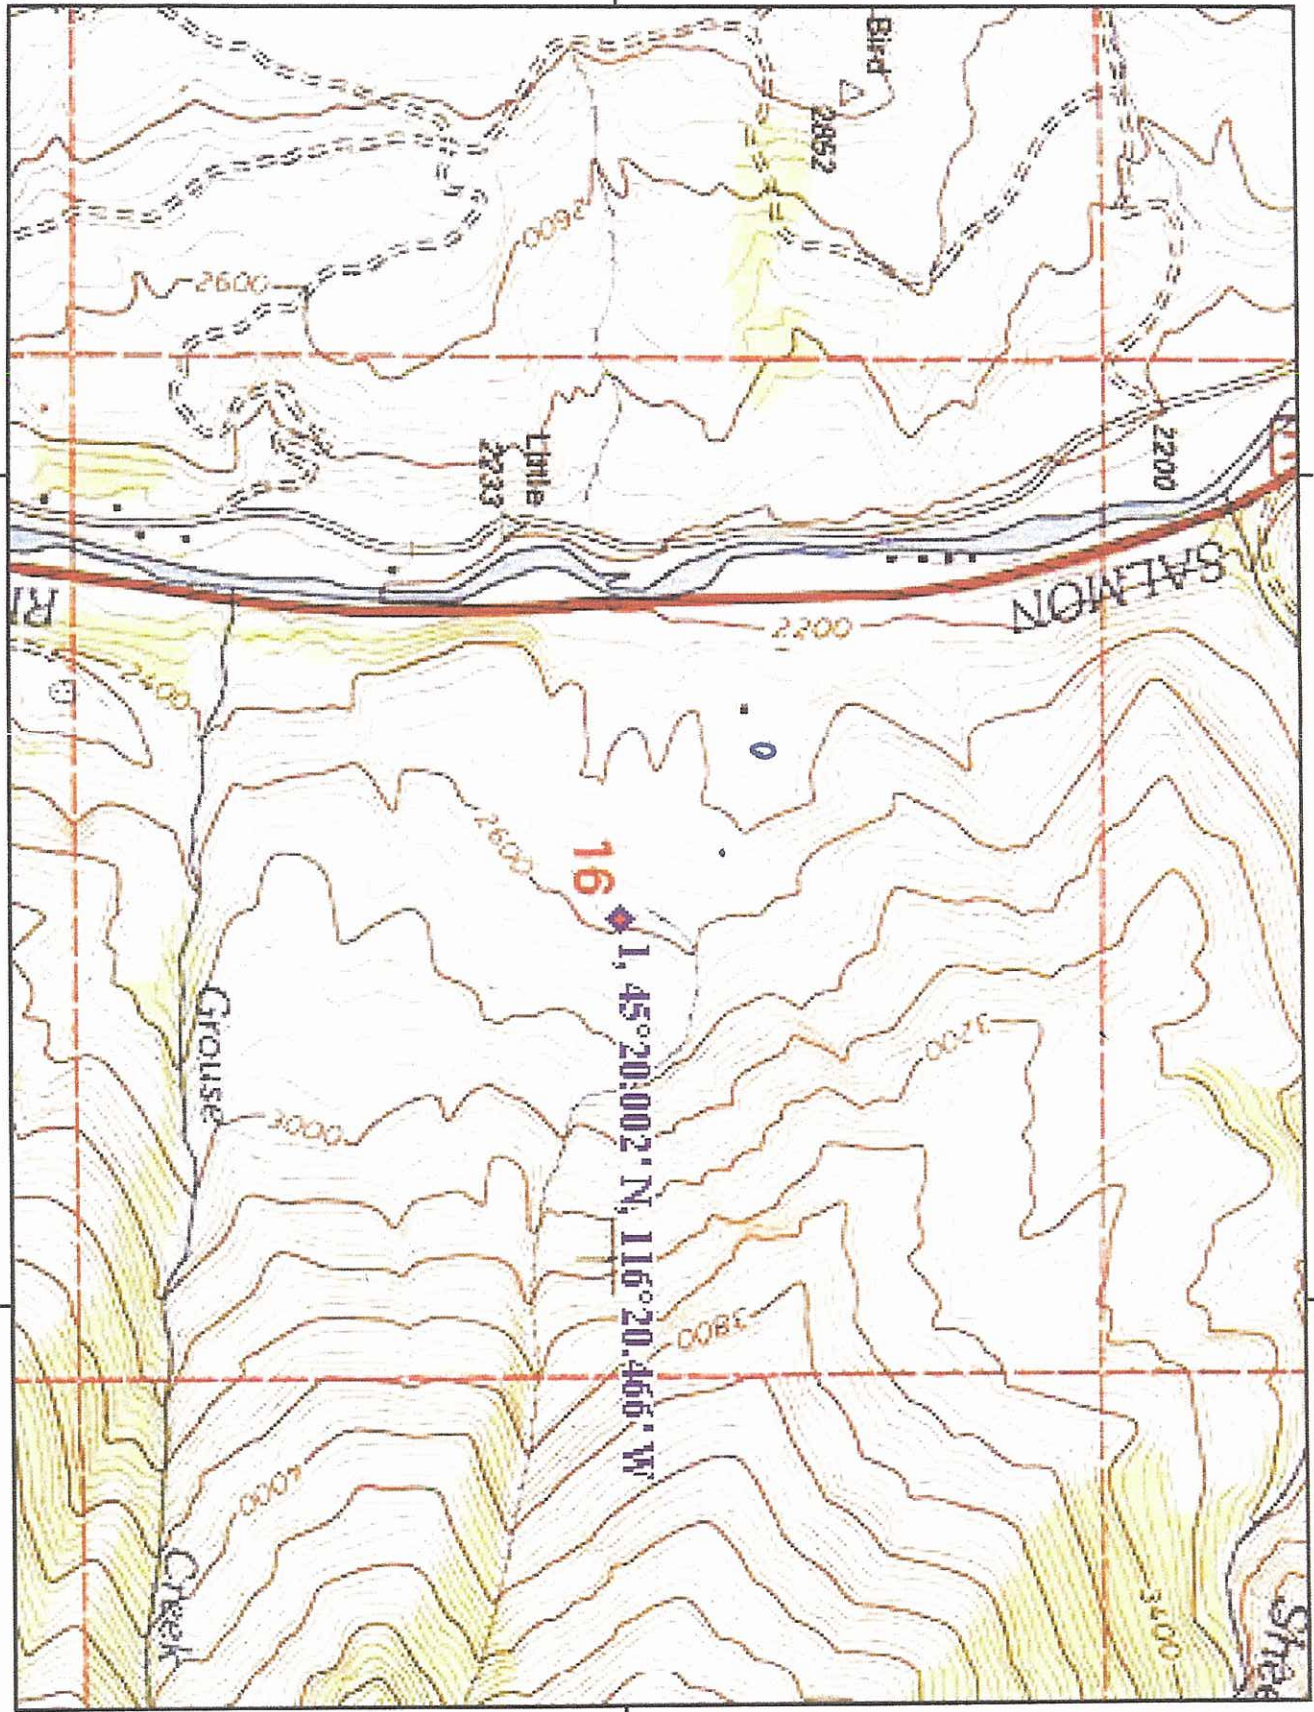
Item No. 1

Item Nos. 1 and 2 are maps showing the location of Springs 1 and 2 with coordinates in WGS 84 format noting the spatial location obtained by GPS readings taken at the spring. Fritz Brownell, an Idaho-licensed surveyor with Landmark Engineering & Planning, Inc., 332 North Broadmore Way, Nampa, Idaho, determined the locations of the springs, prepared the maps, and photographed the system. I have prepared this memorandum based upon this information and discussions with Mr. Brownell.

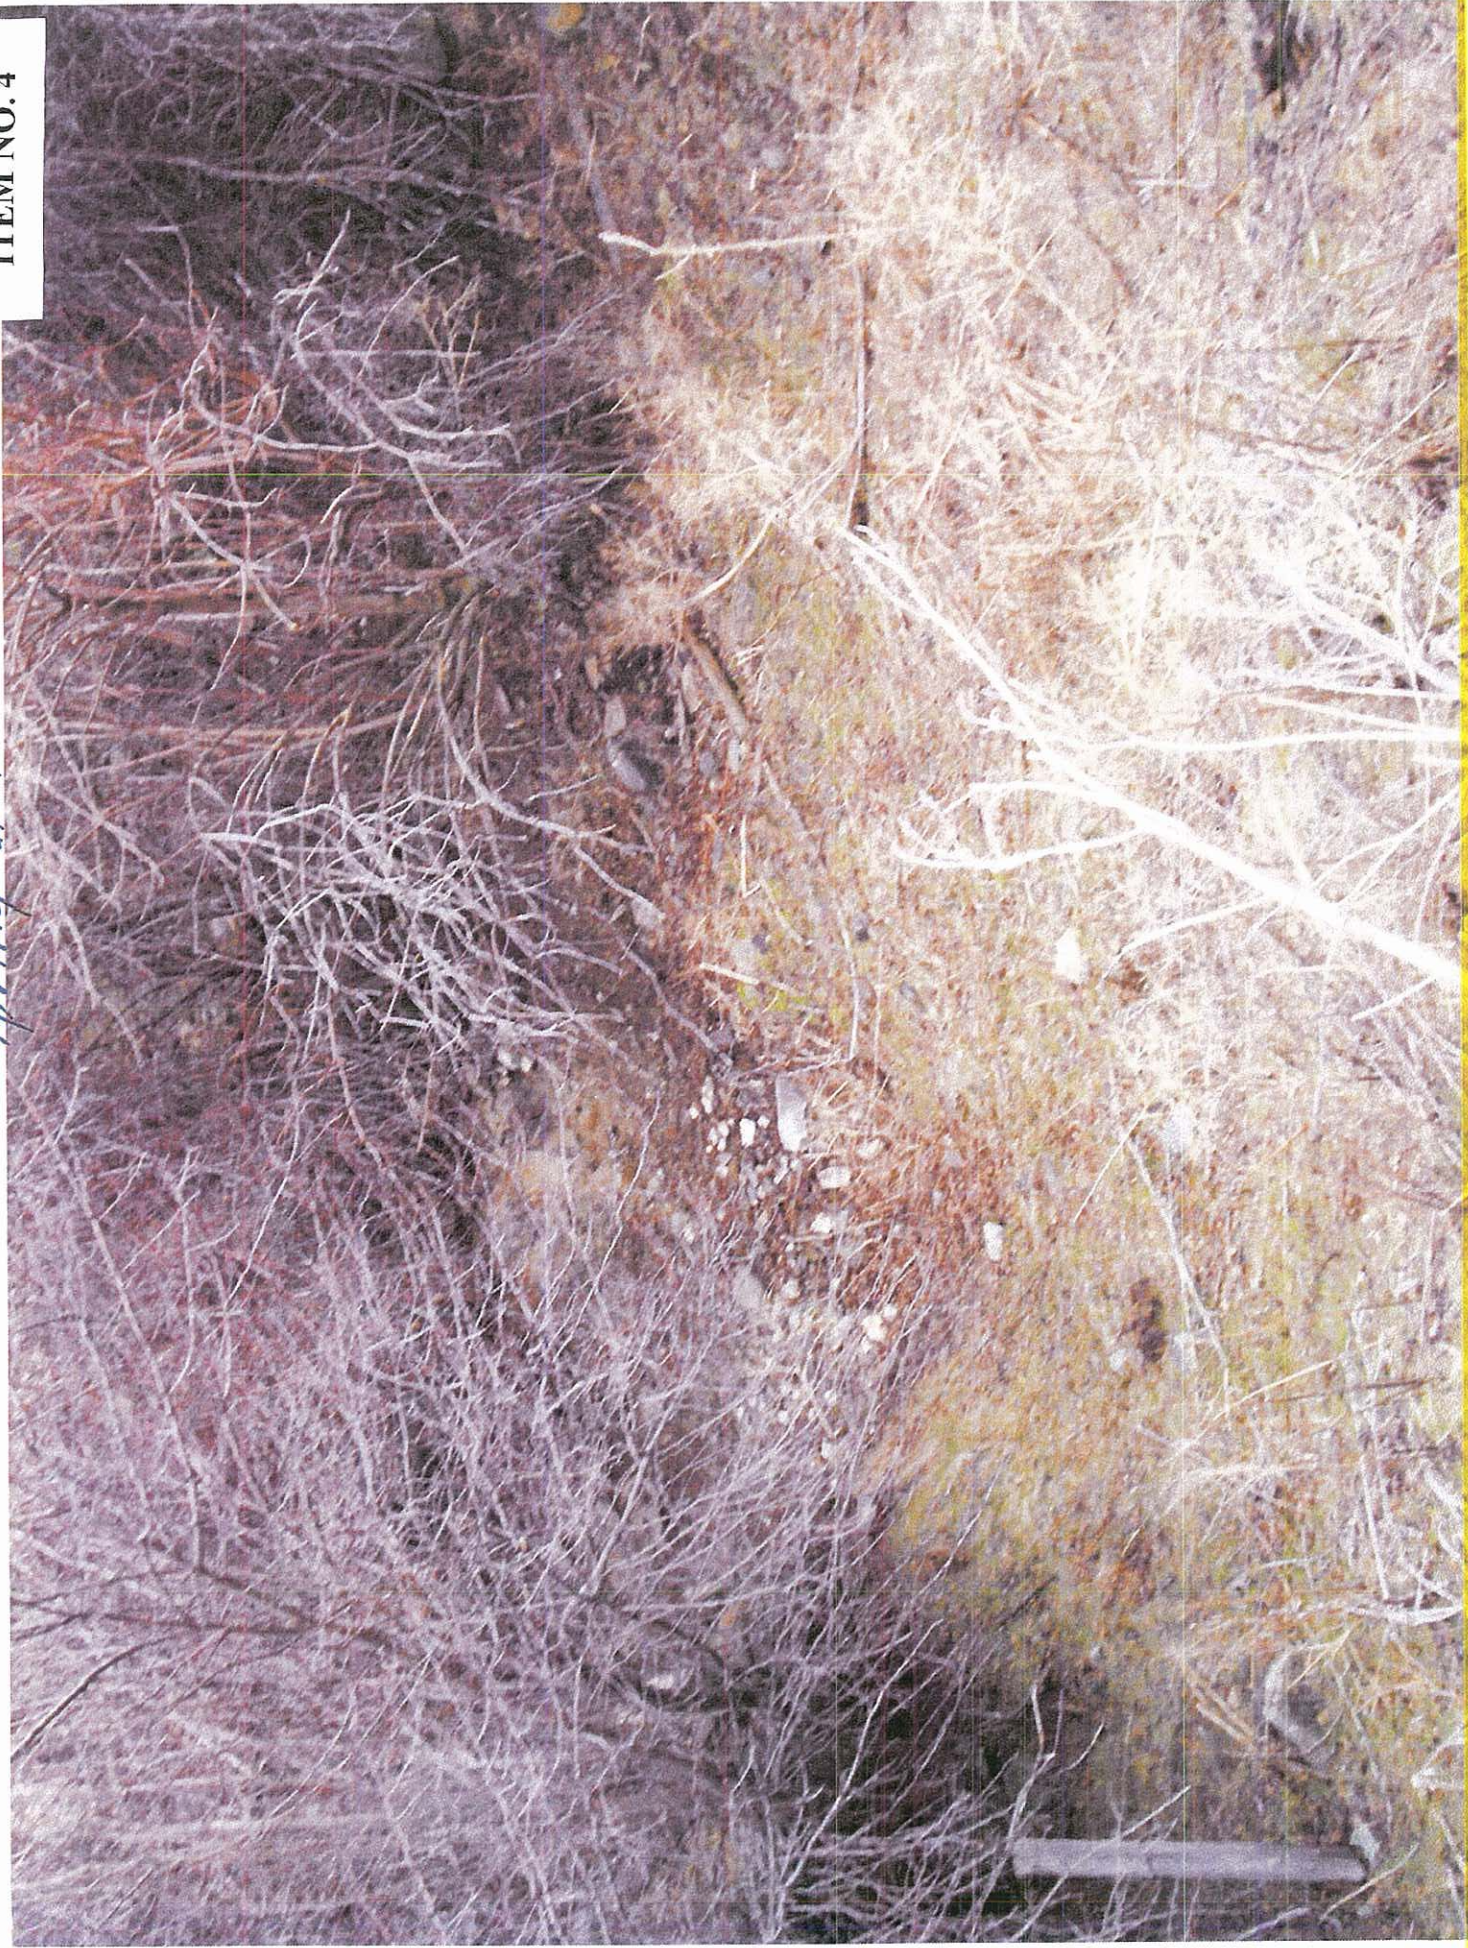
ITEM NO. 4

Item No. 4 is a photograph of the collection area at Spring 1. Although the collection works are buried, the location of the spring can be determined from evidence of construction activity, remnants of pipes and enclosure fence.

spring #1

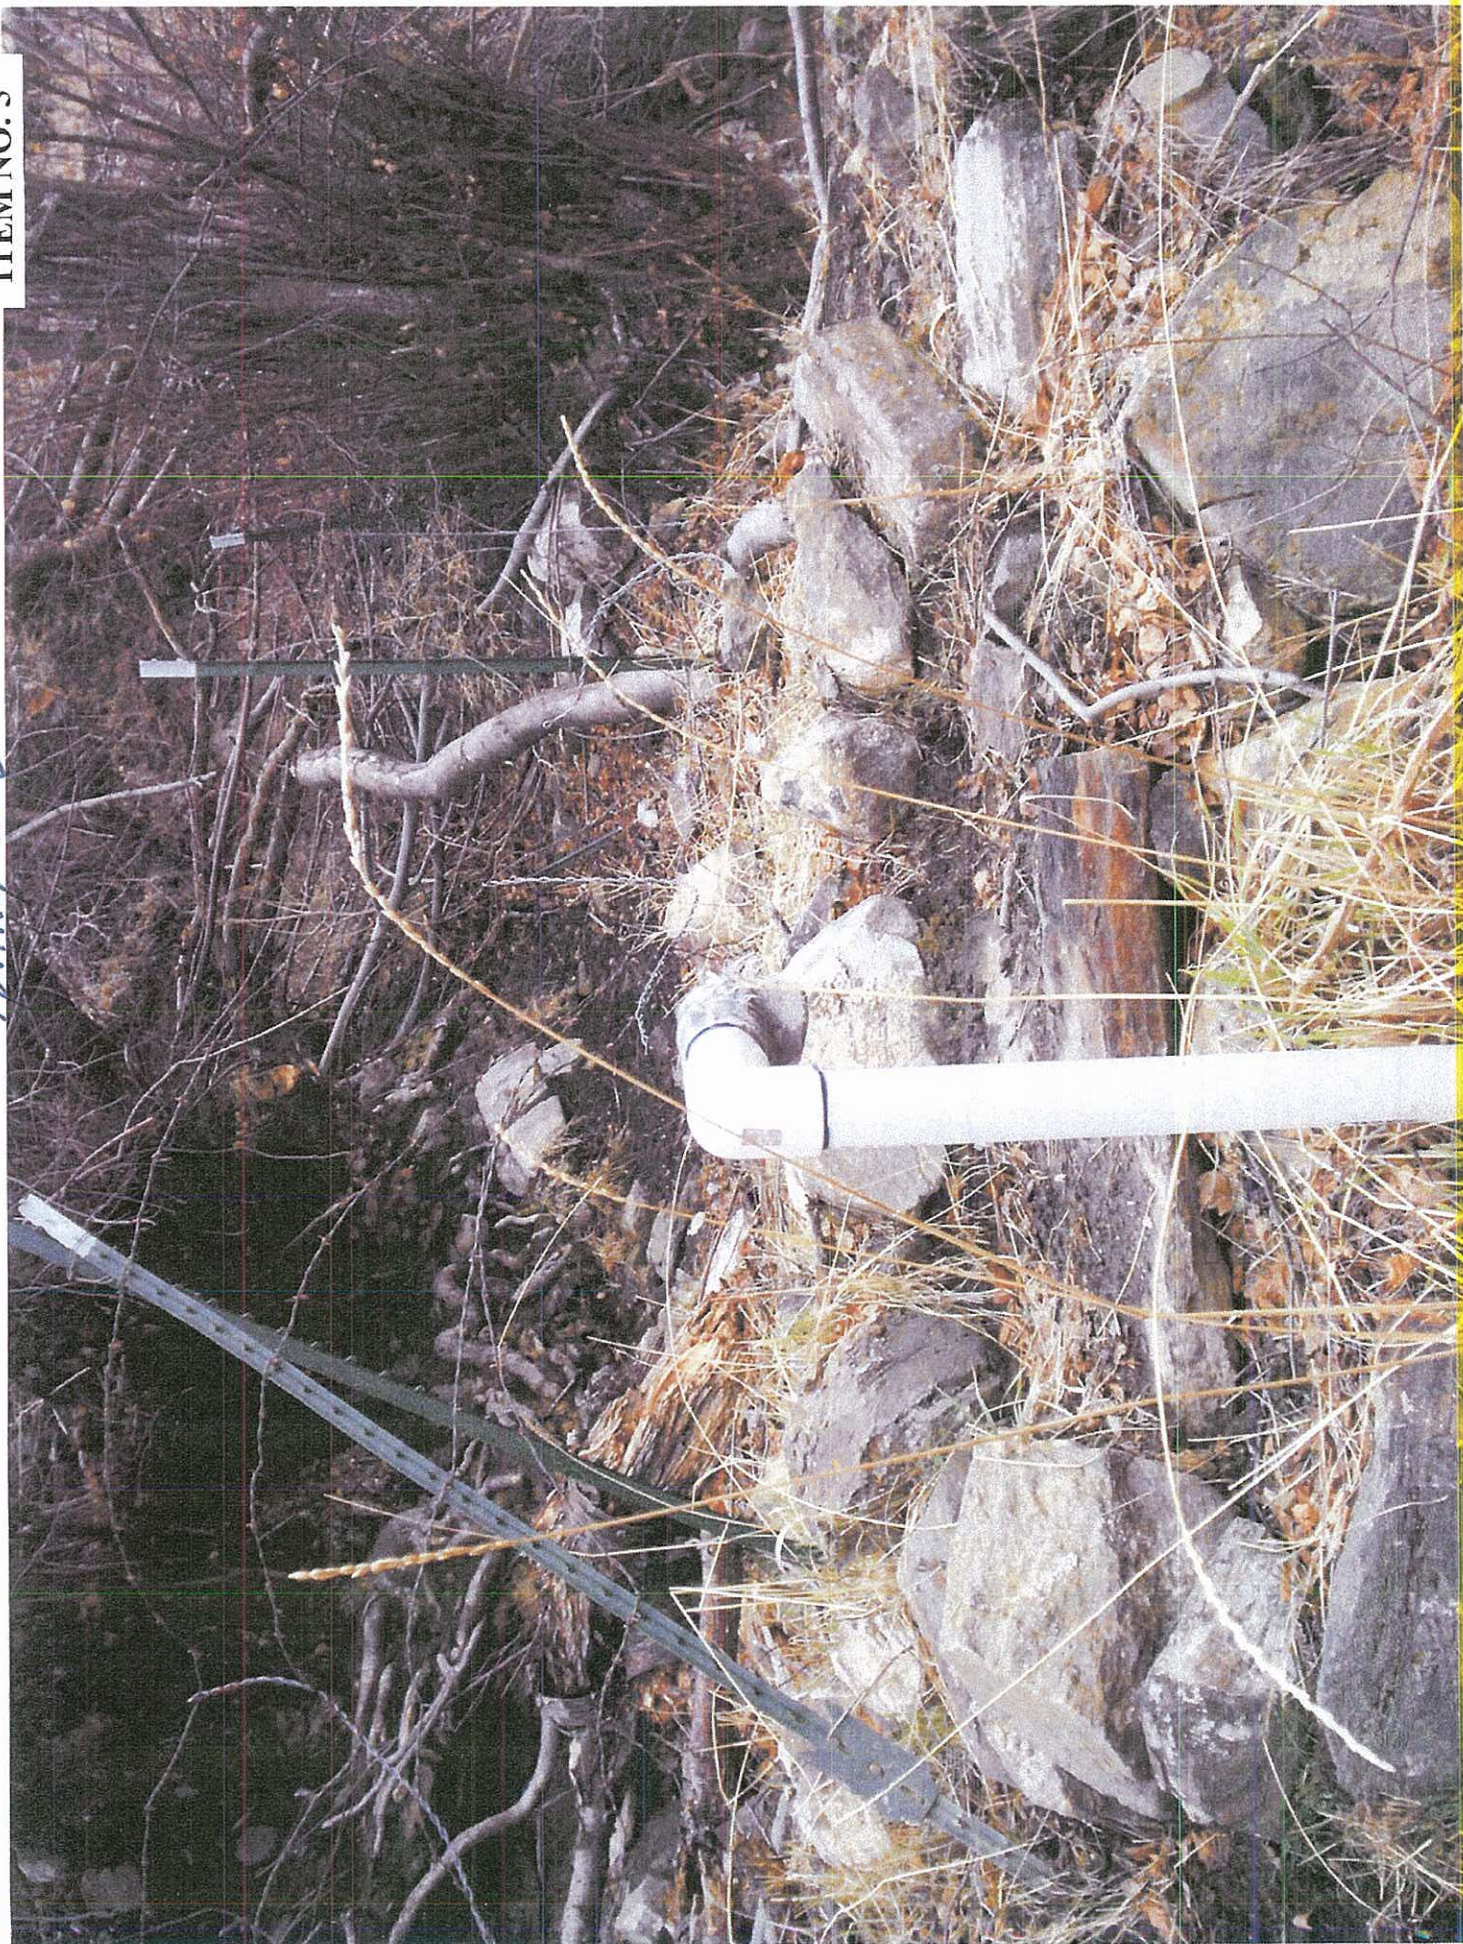
ITEM NO. 5

Item No. 5 is a photograph of the collection area at Spring 2. The spring location is identifiable by the incompletely filled trench containing the pipeline leading from the spring to the "collection box," evidence of excavation at the spring with large rock backfill, a vent pipe (foreground of photo) and the remnants of the enclosure fence.

Spring #2

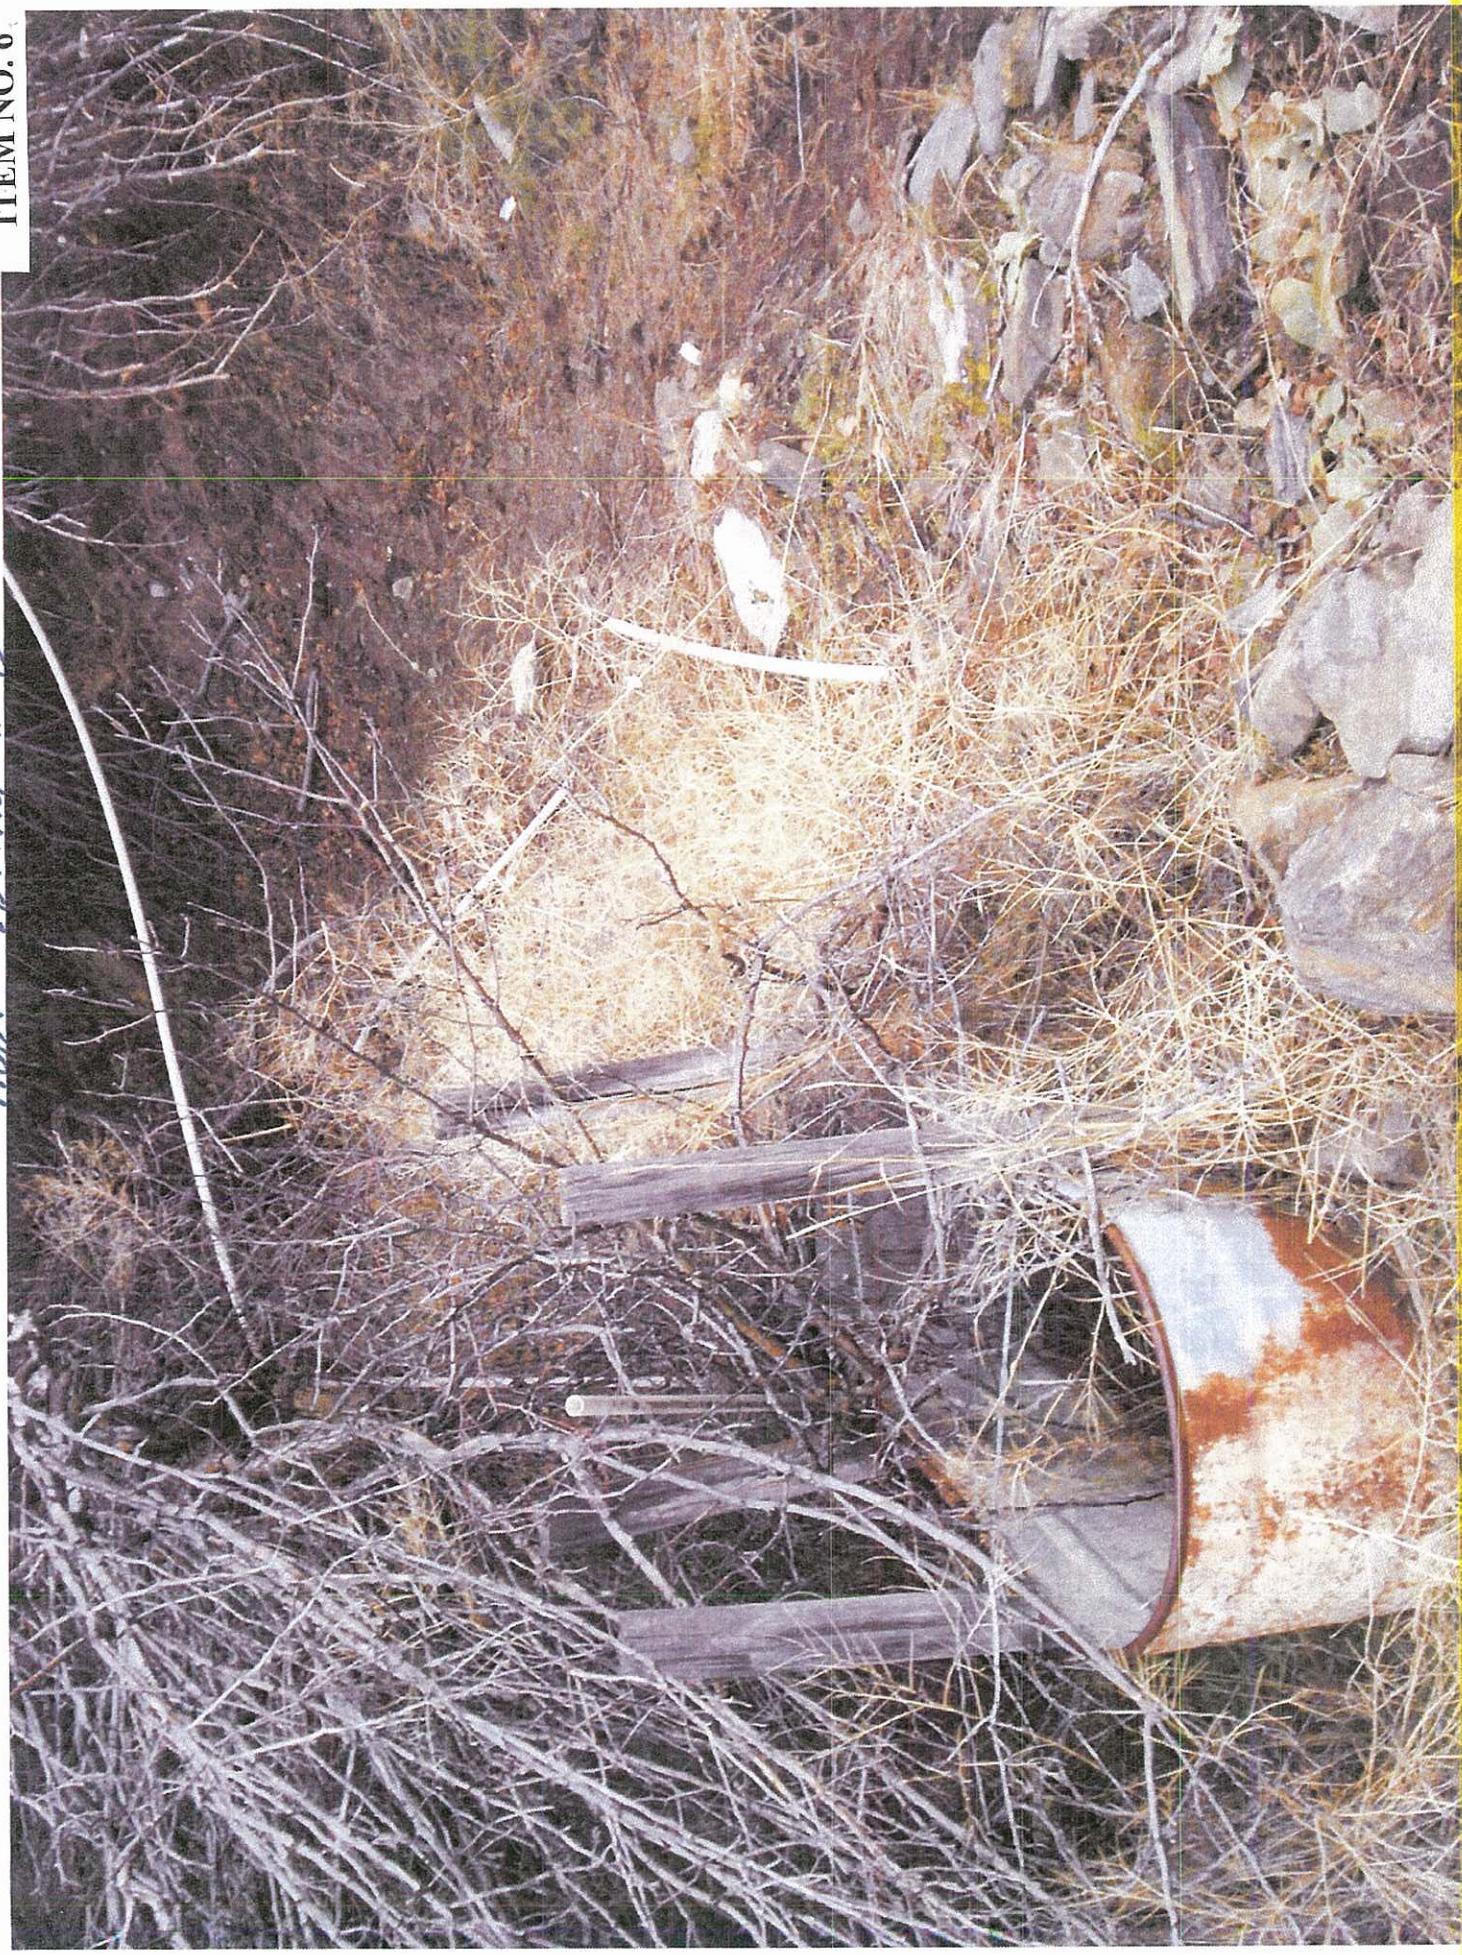
ITEM NO. 6

Item No. 6 is a photograph of a watering trough located below and supplied by the pipeline from Spring 2. Small pools were noted in the surface channels below the springs indicating that flows in excess of that diverted into the buried collection systems are available and used for watering of livestock and wildlife.

DEAR SPRING #2

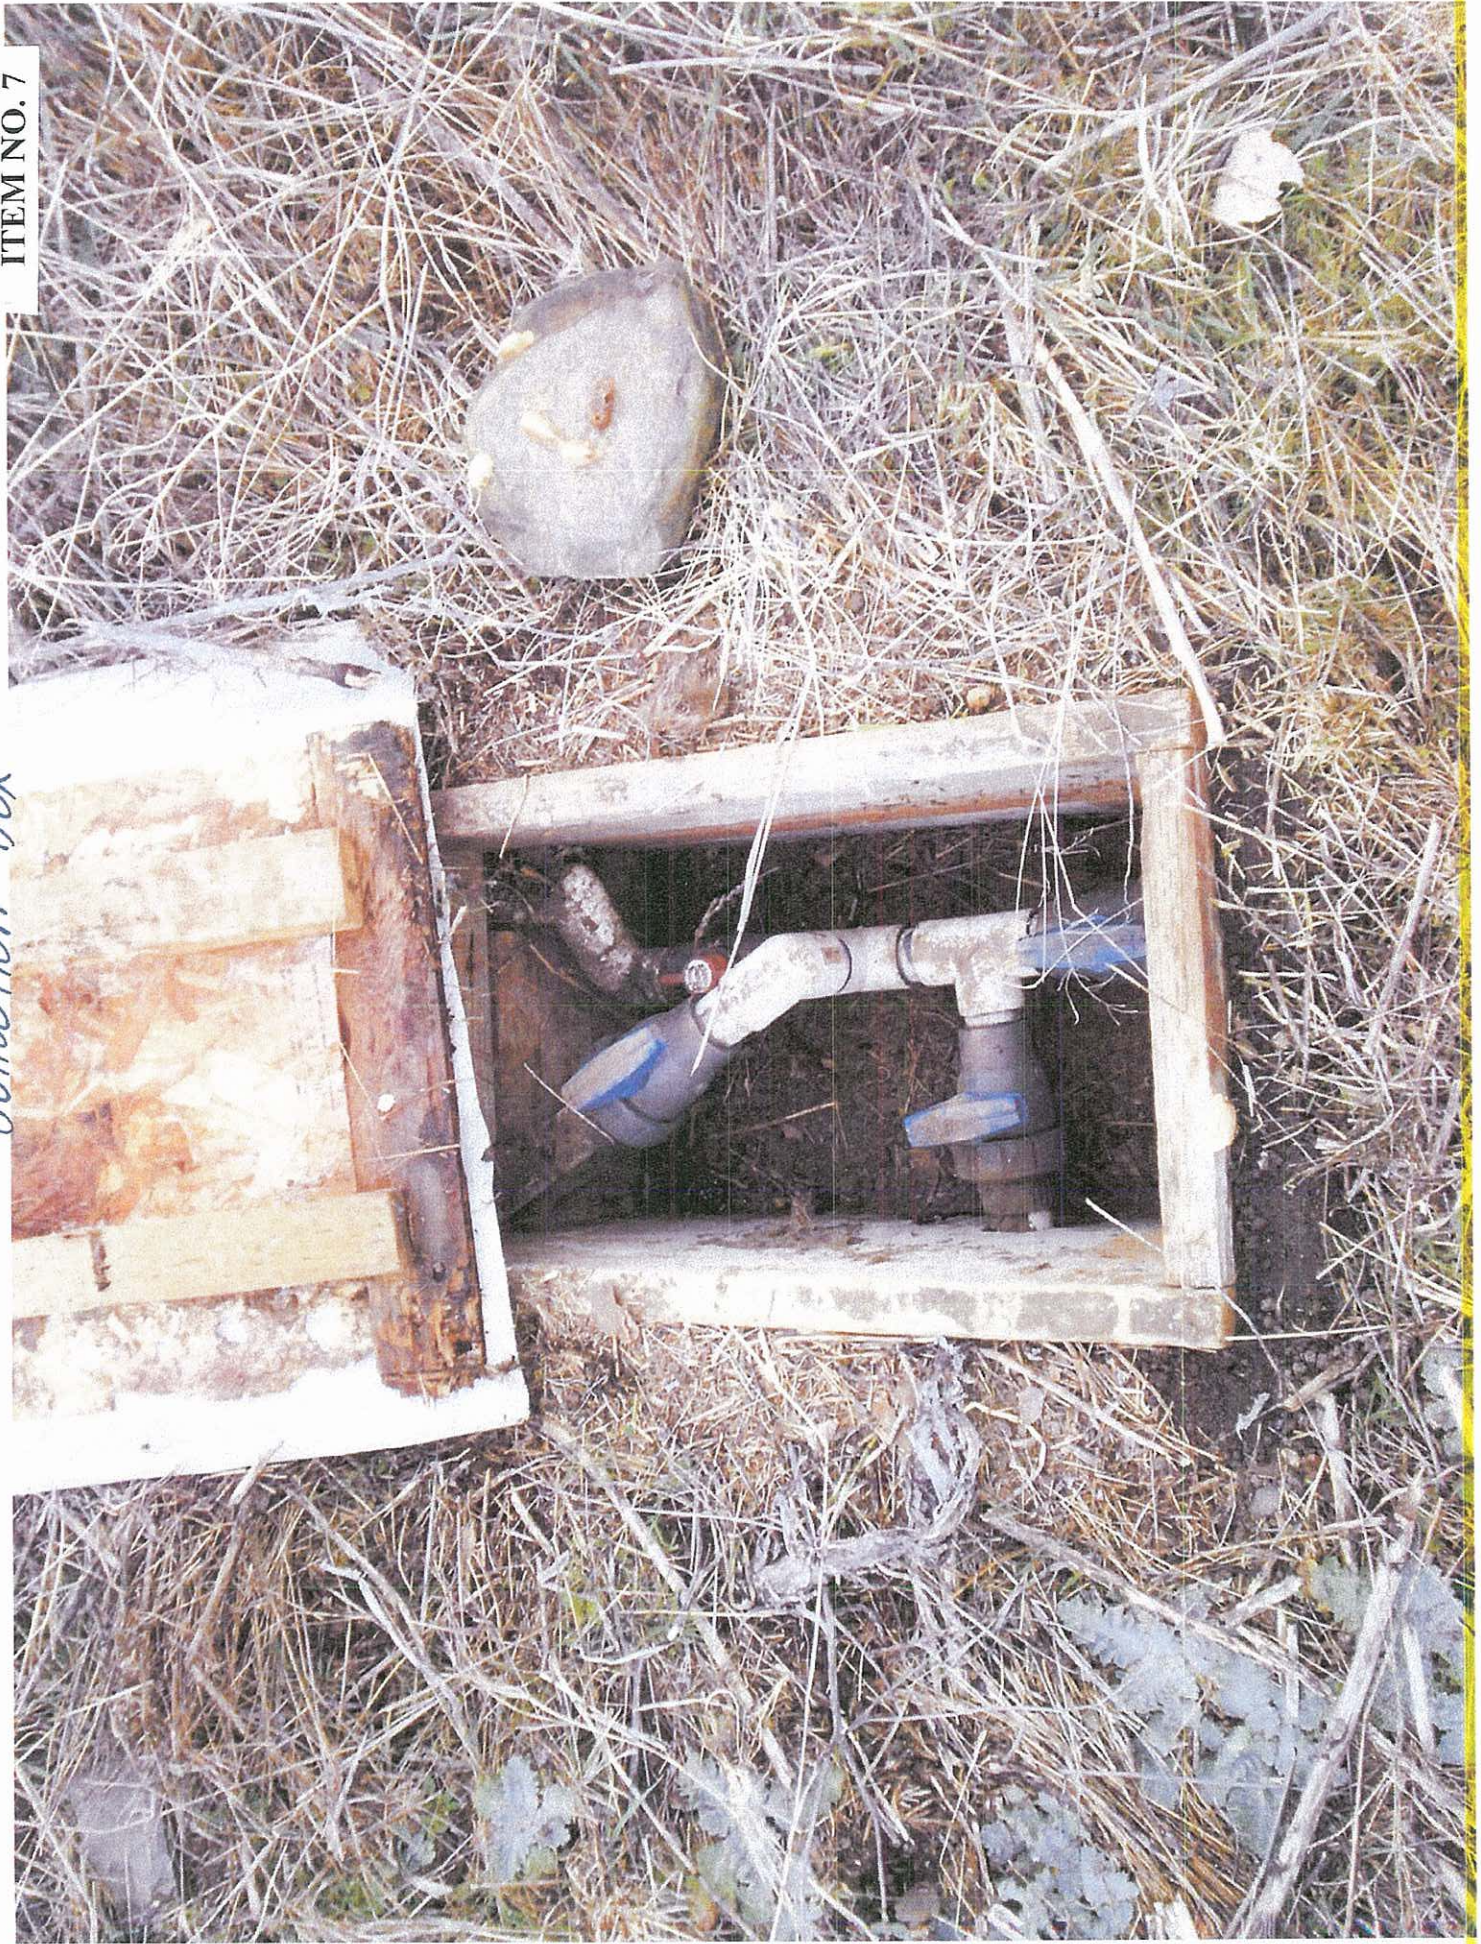
ITEM NO. 7

Item No. 7 is a photograph of the "collection box" used to combine flow from the pipelines from the collectors at Springs 1 and 2. The pipeline from Spring 1 enters the box at the upper right side in the photograph. The pipeline from Spring 2 enters the box at the upper left side in the photograph and the pipeline to the storage vaults and house exists the box at the lower edge in the photograph. The pipeline exiting the left side of the box is an overflow.

collection box

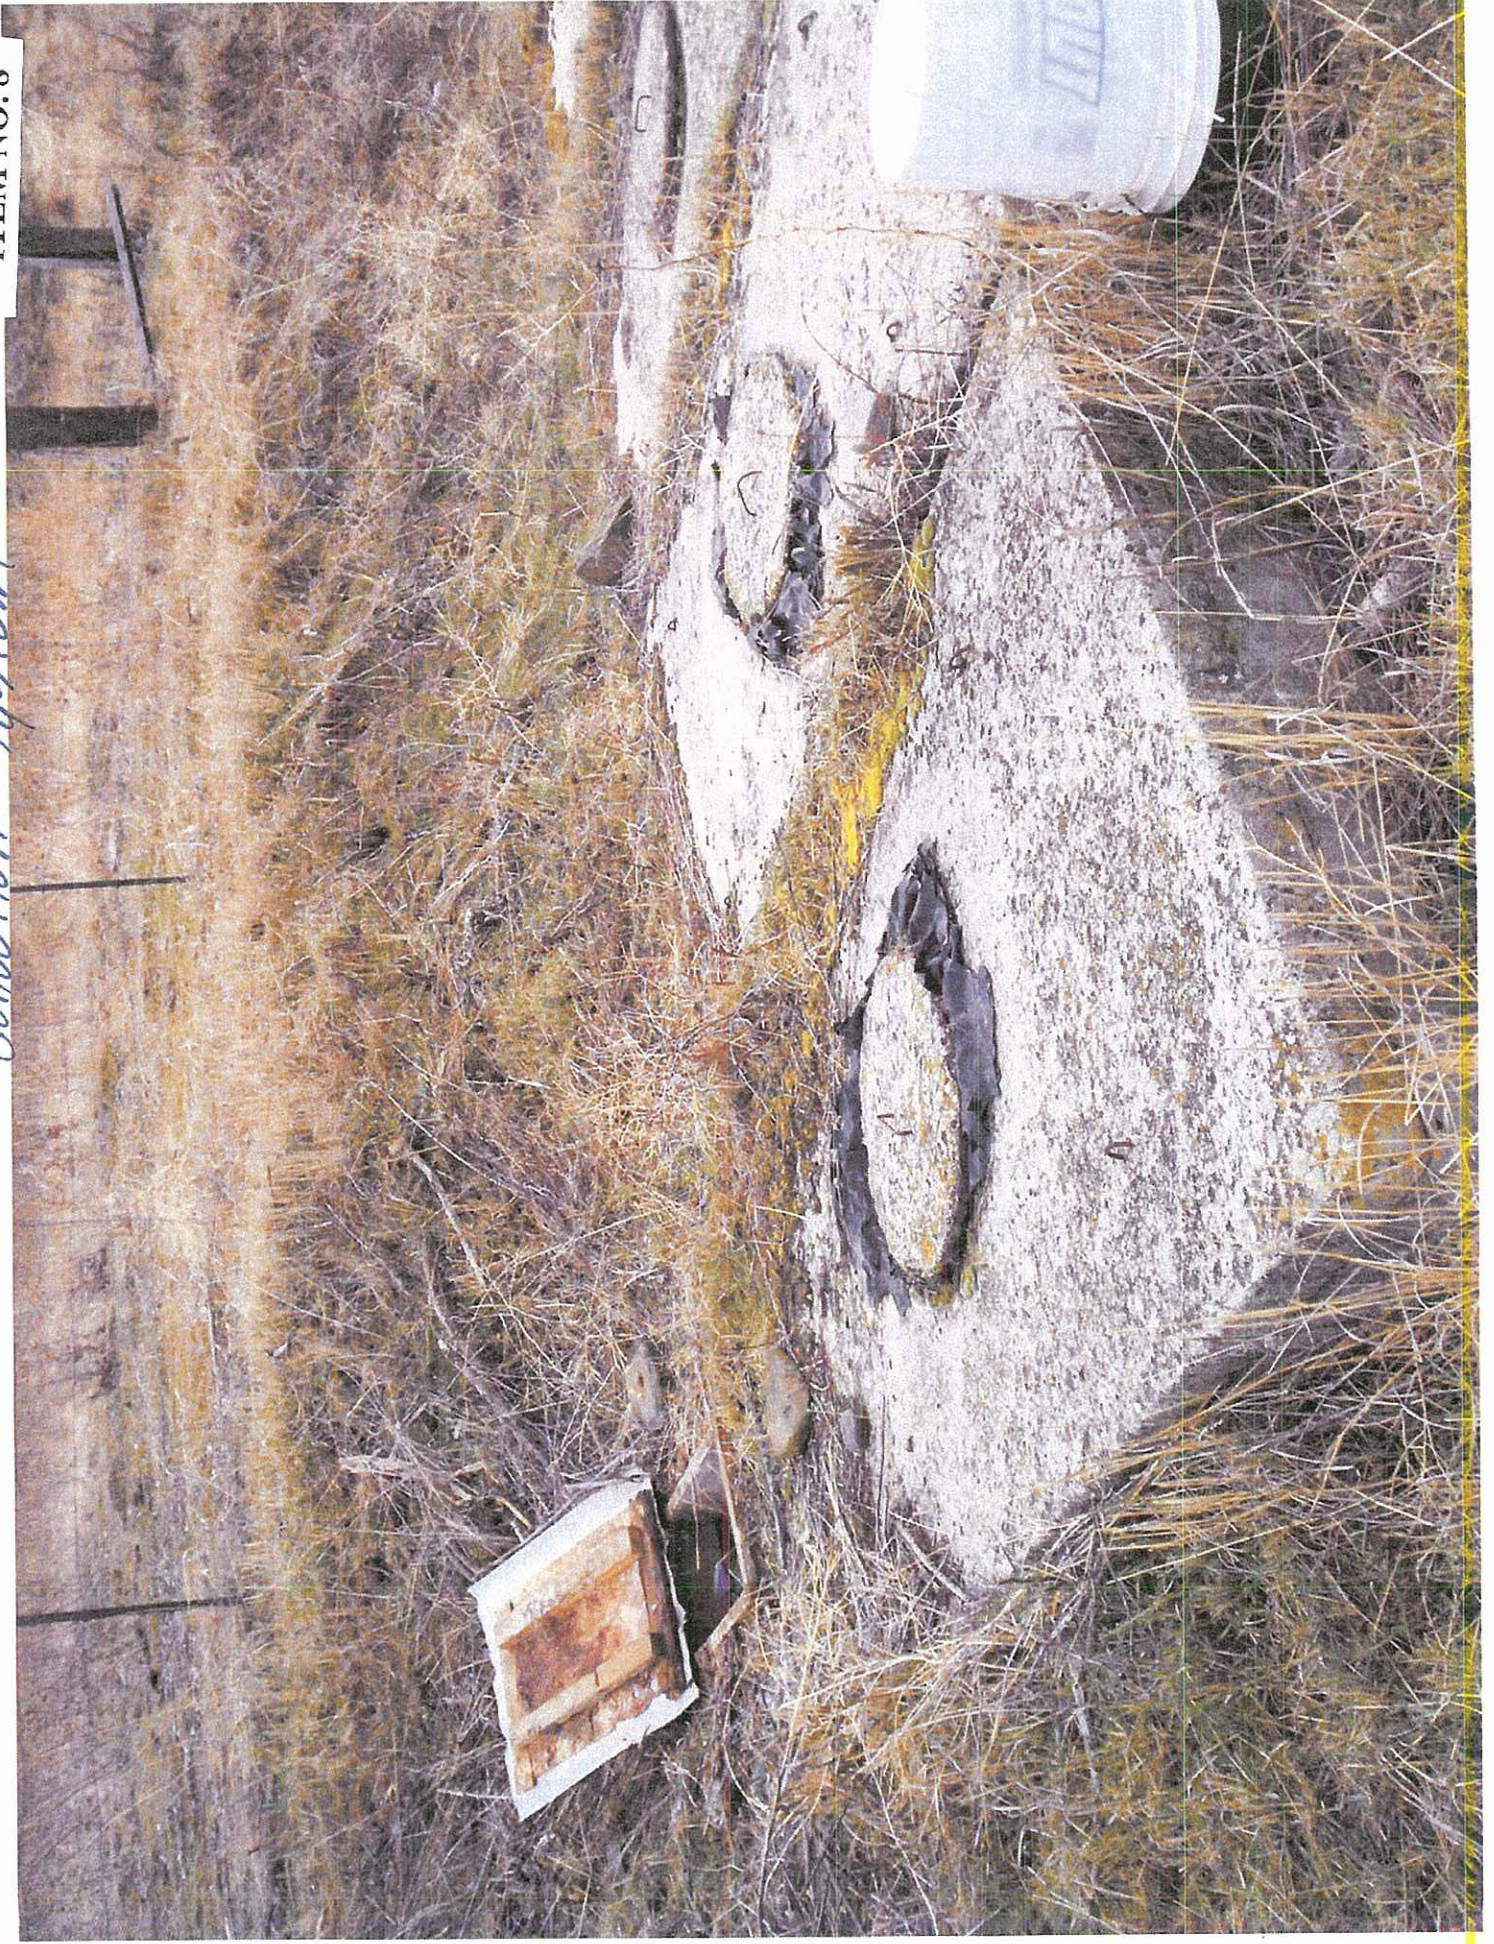
Item No. 8 is a photograph of the four concrete vaults used for storage/flow modulation. Mr. Brownell estimated the capacity of each vault to be approximately 1200 gallons. The plastic bucket at the lower right edge of the photograph covers a valve box and the inlet of a 2-inch PVC pipeline extending to the house.

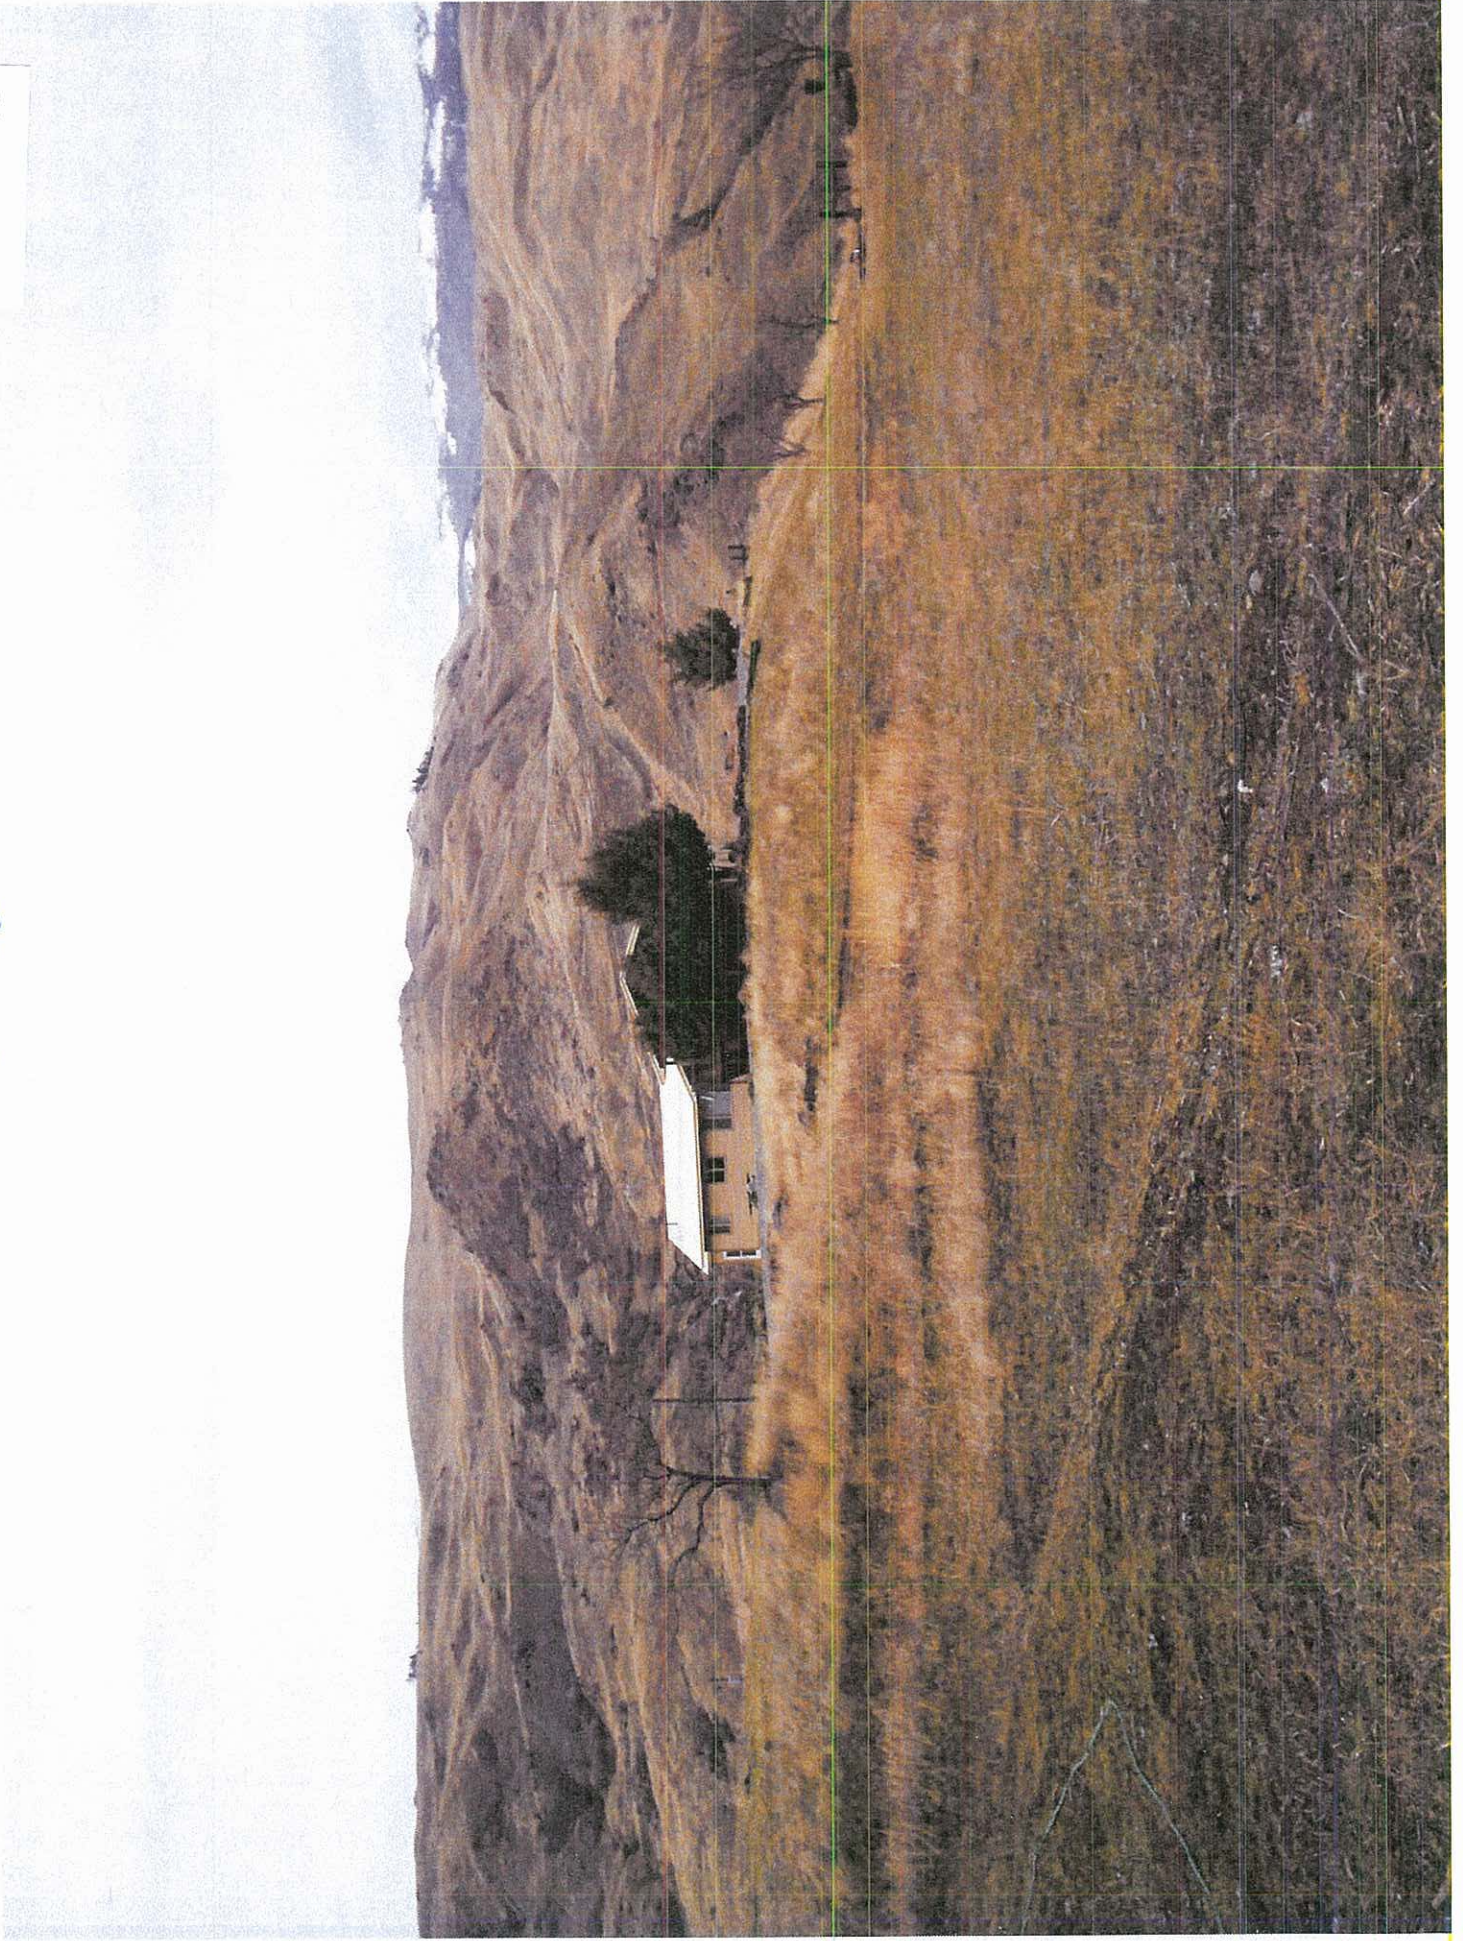
ITEM NO. 9

Item No. 9 is a photograph of the house supplied by the system. A barn/shop building, located south of the house, does not appear in the photograph. In addition to internal domestic uses in the house and barn, water is used to irrigate landscaping and trees near the house. Mr. Brownell was not requested to measure the irrigated area, but, based upon his visual observation, estimated the area irrigated is less than 0.2 acre.

House
