## Galloway Photograph Log

St. Maries, Idaho  
April 4 2011

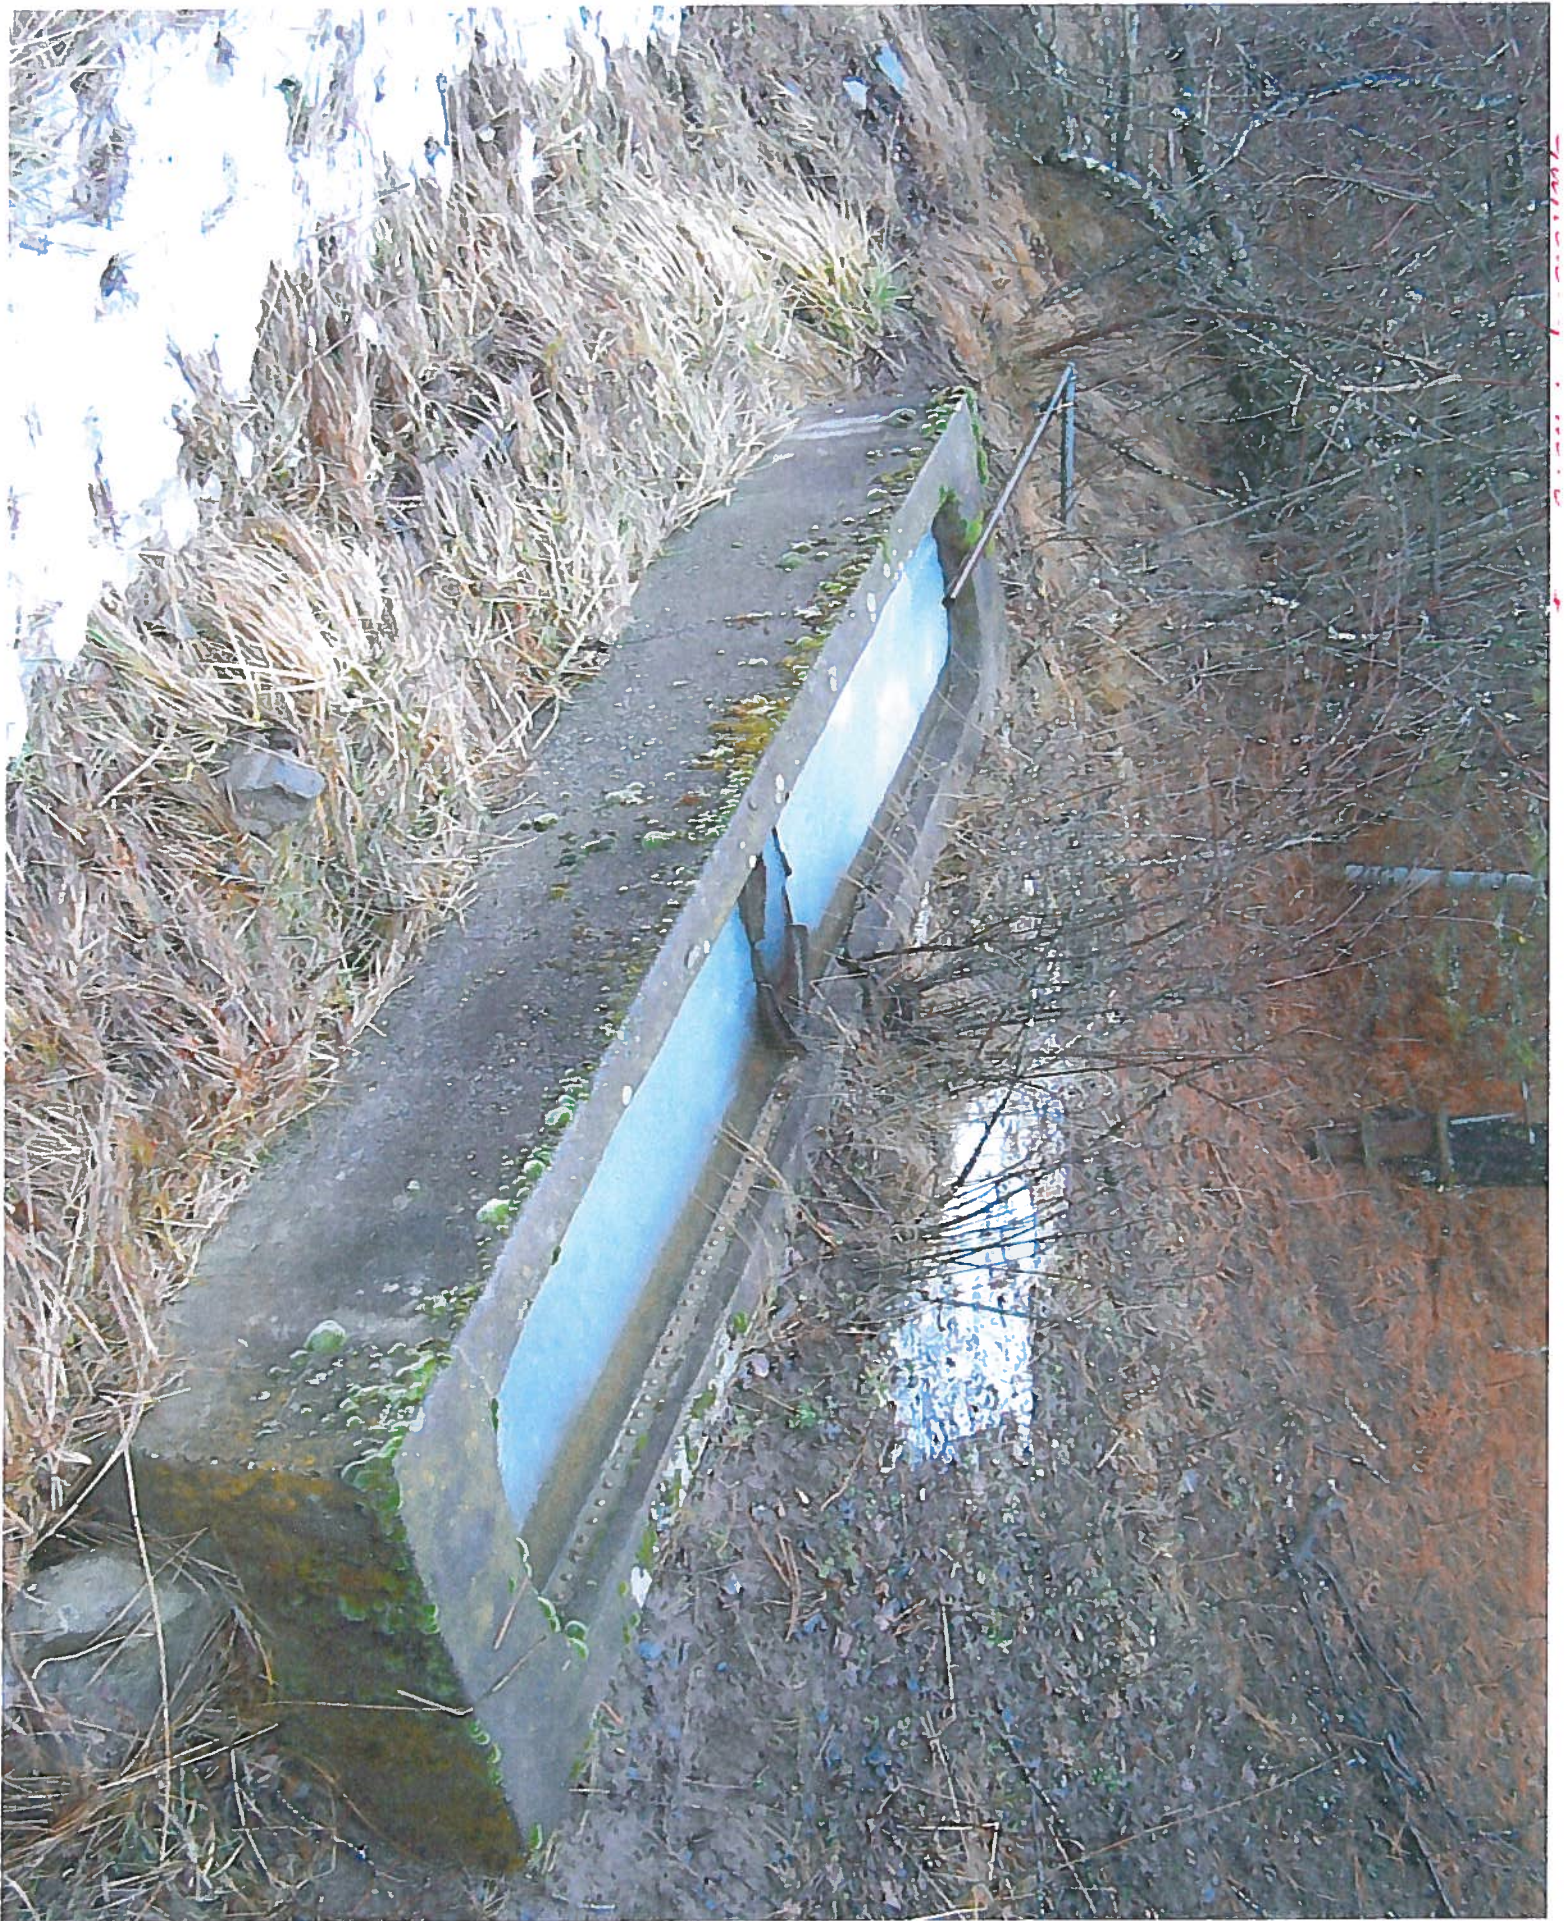
| Photograph # | Comments |
|---|---|
| 1 | Trough shown in foreground, shut-off valve in top center; note weathering of concrete |

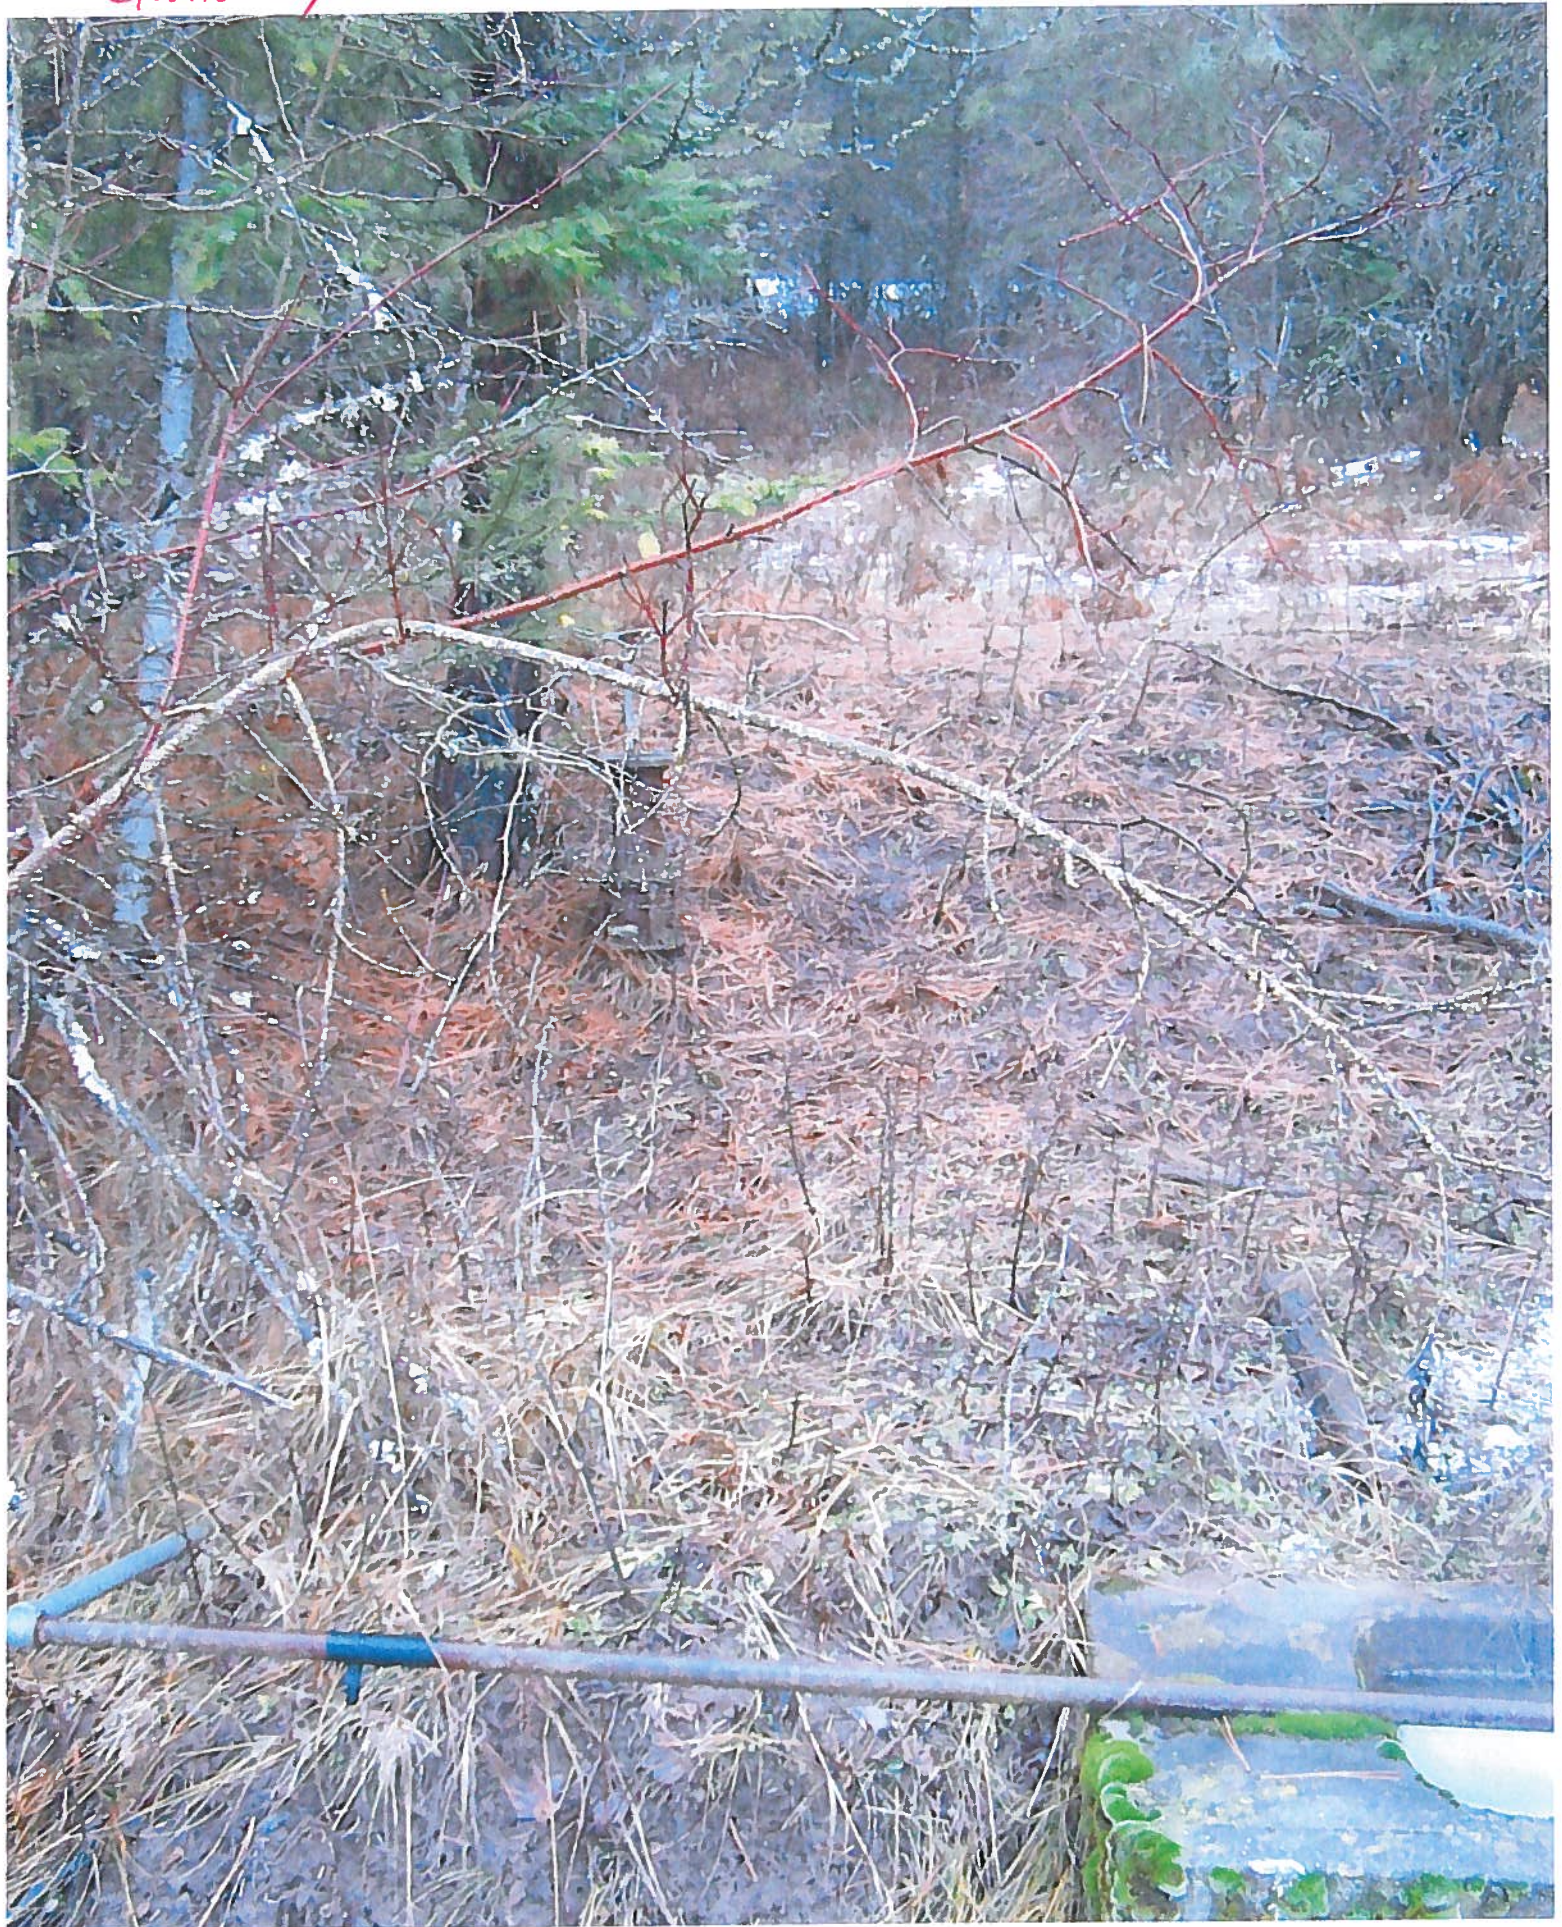
Galloway Photo #2

| Photograph # | Comments |
|---|---|
| 2 | Trough in lower right showing pipe in lower part of photo, shut-off in left center |

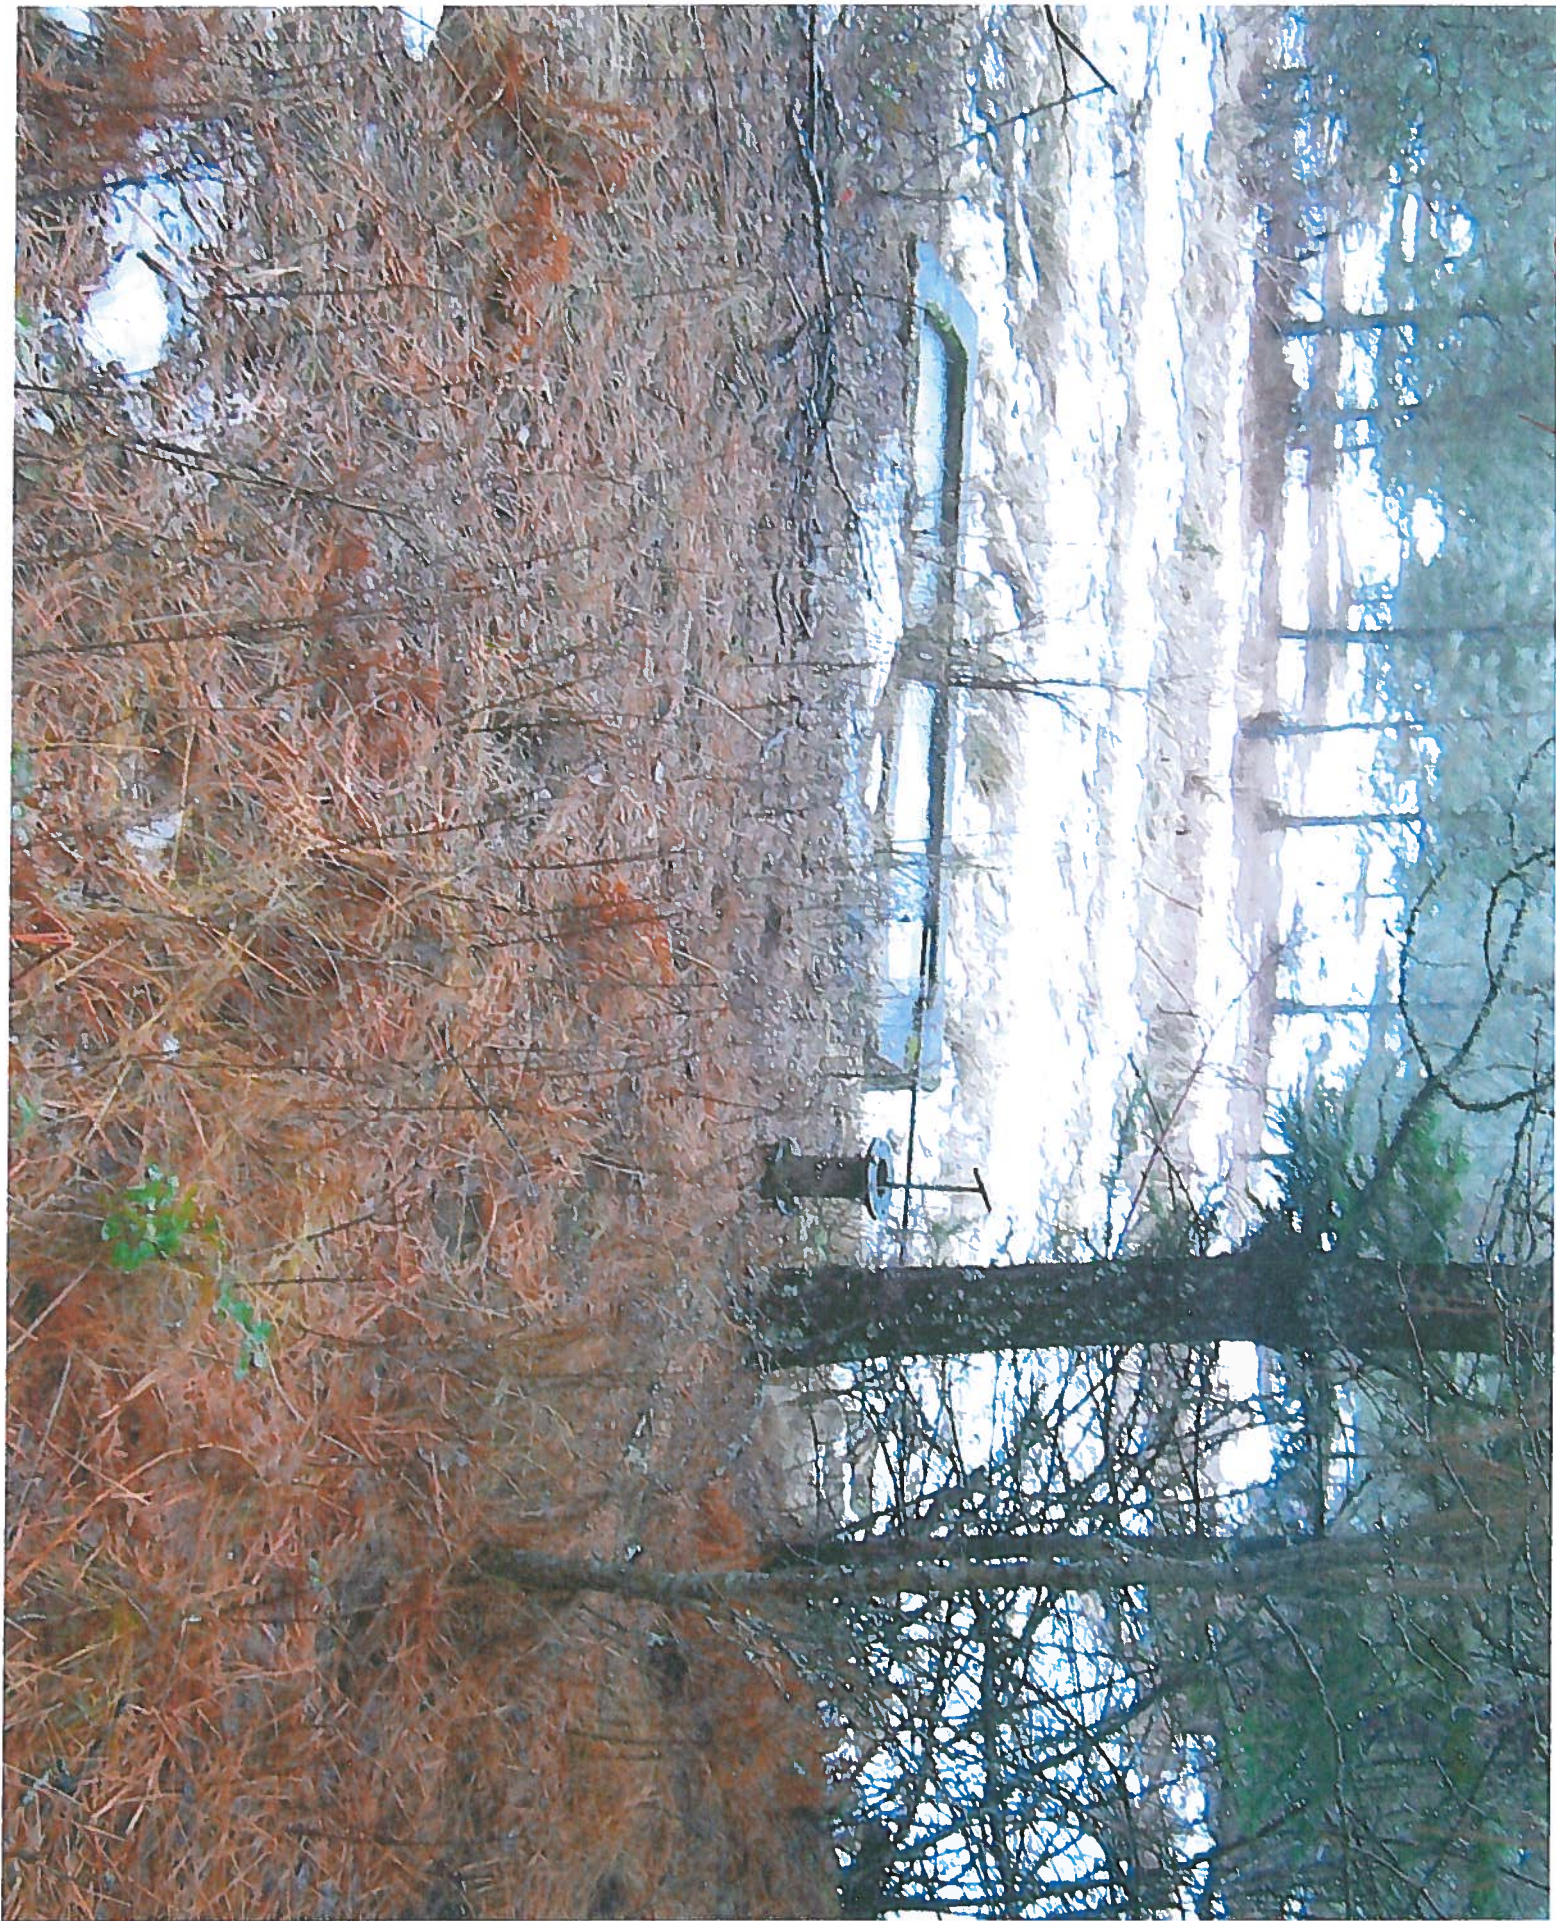
| Photograph # | Comments |
|---|---|
| 3 | Looking downslope to trough, photo point is on top of cistern |

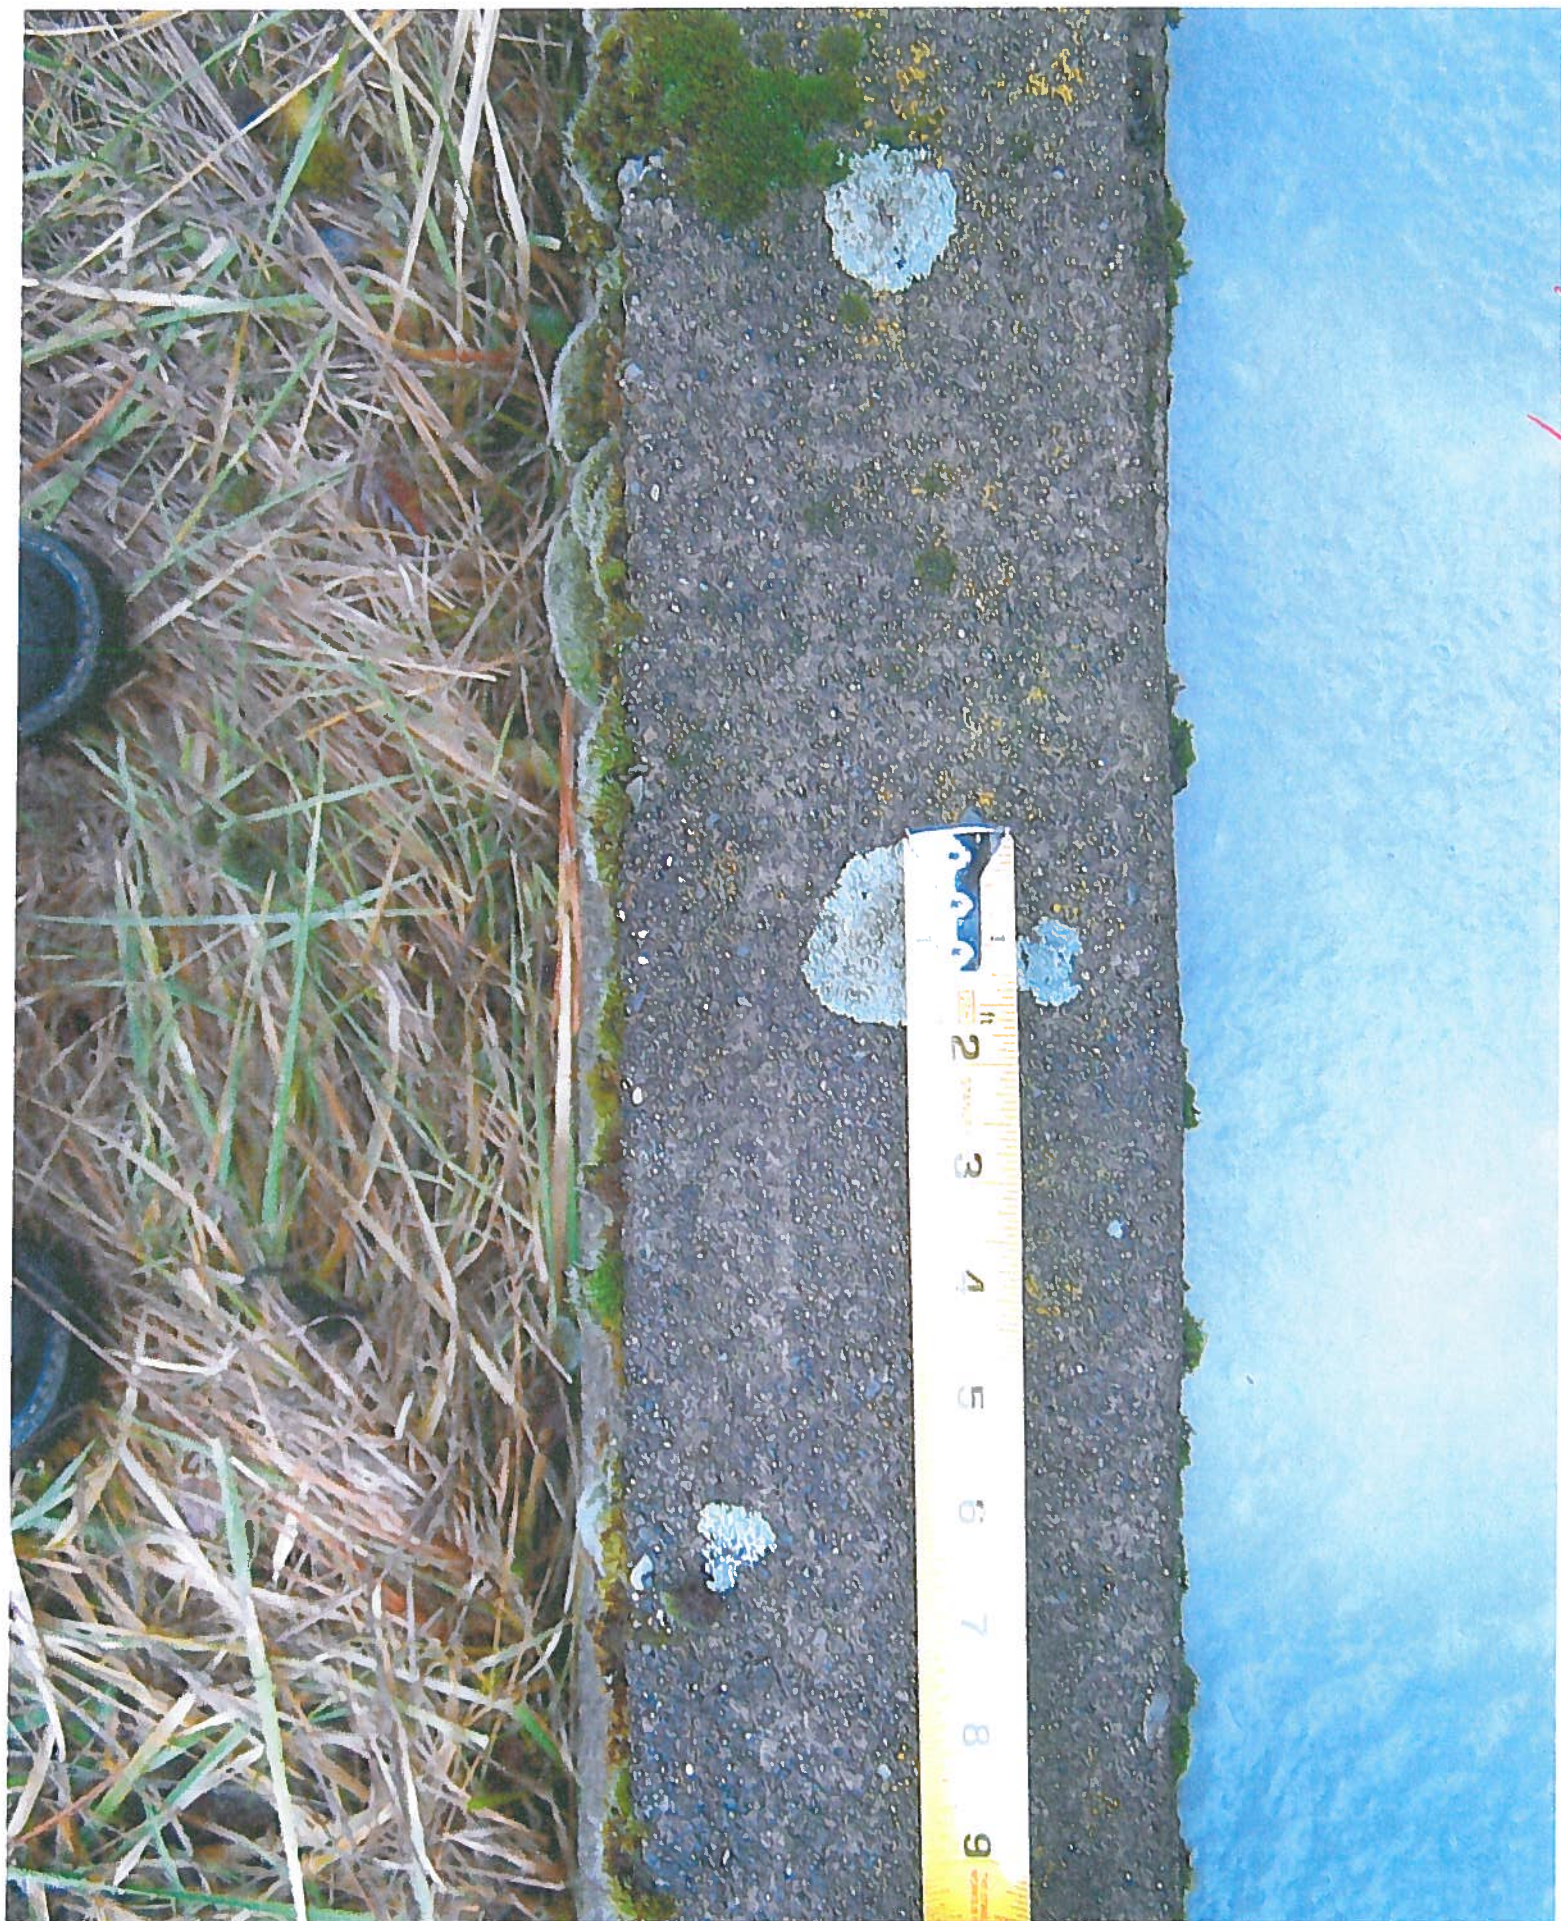
| Photograph # | Comments |
|---|---|
| 4 | Photo of crustose lichen imbedded in the concrete with scale |

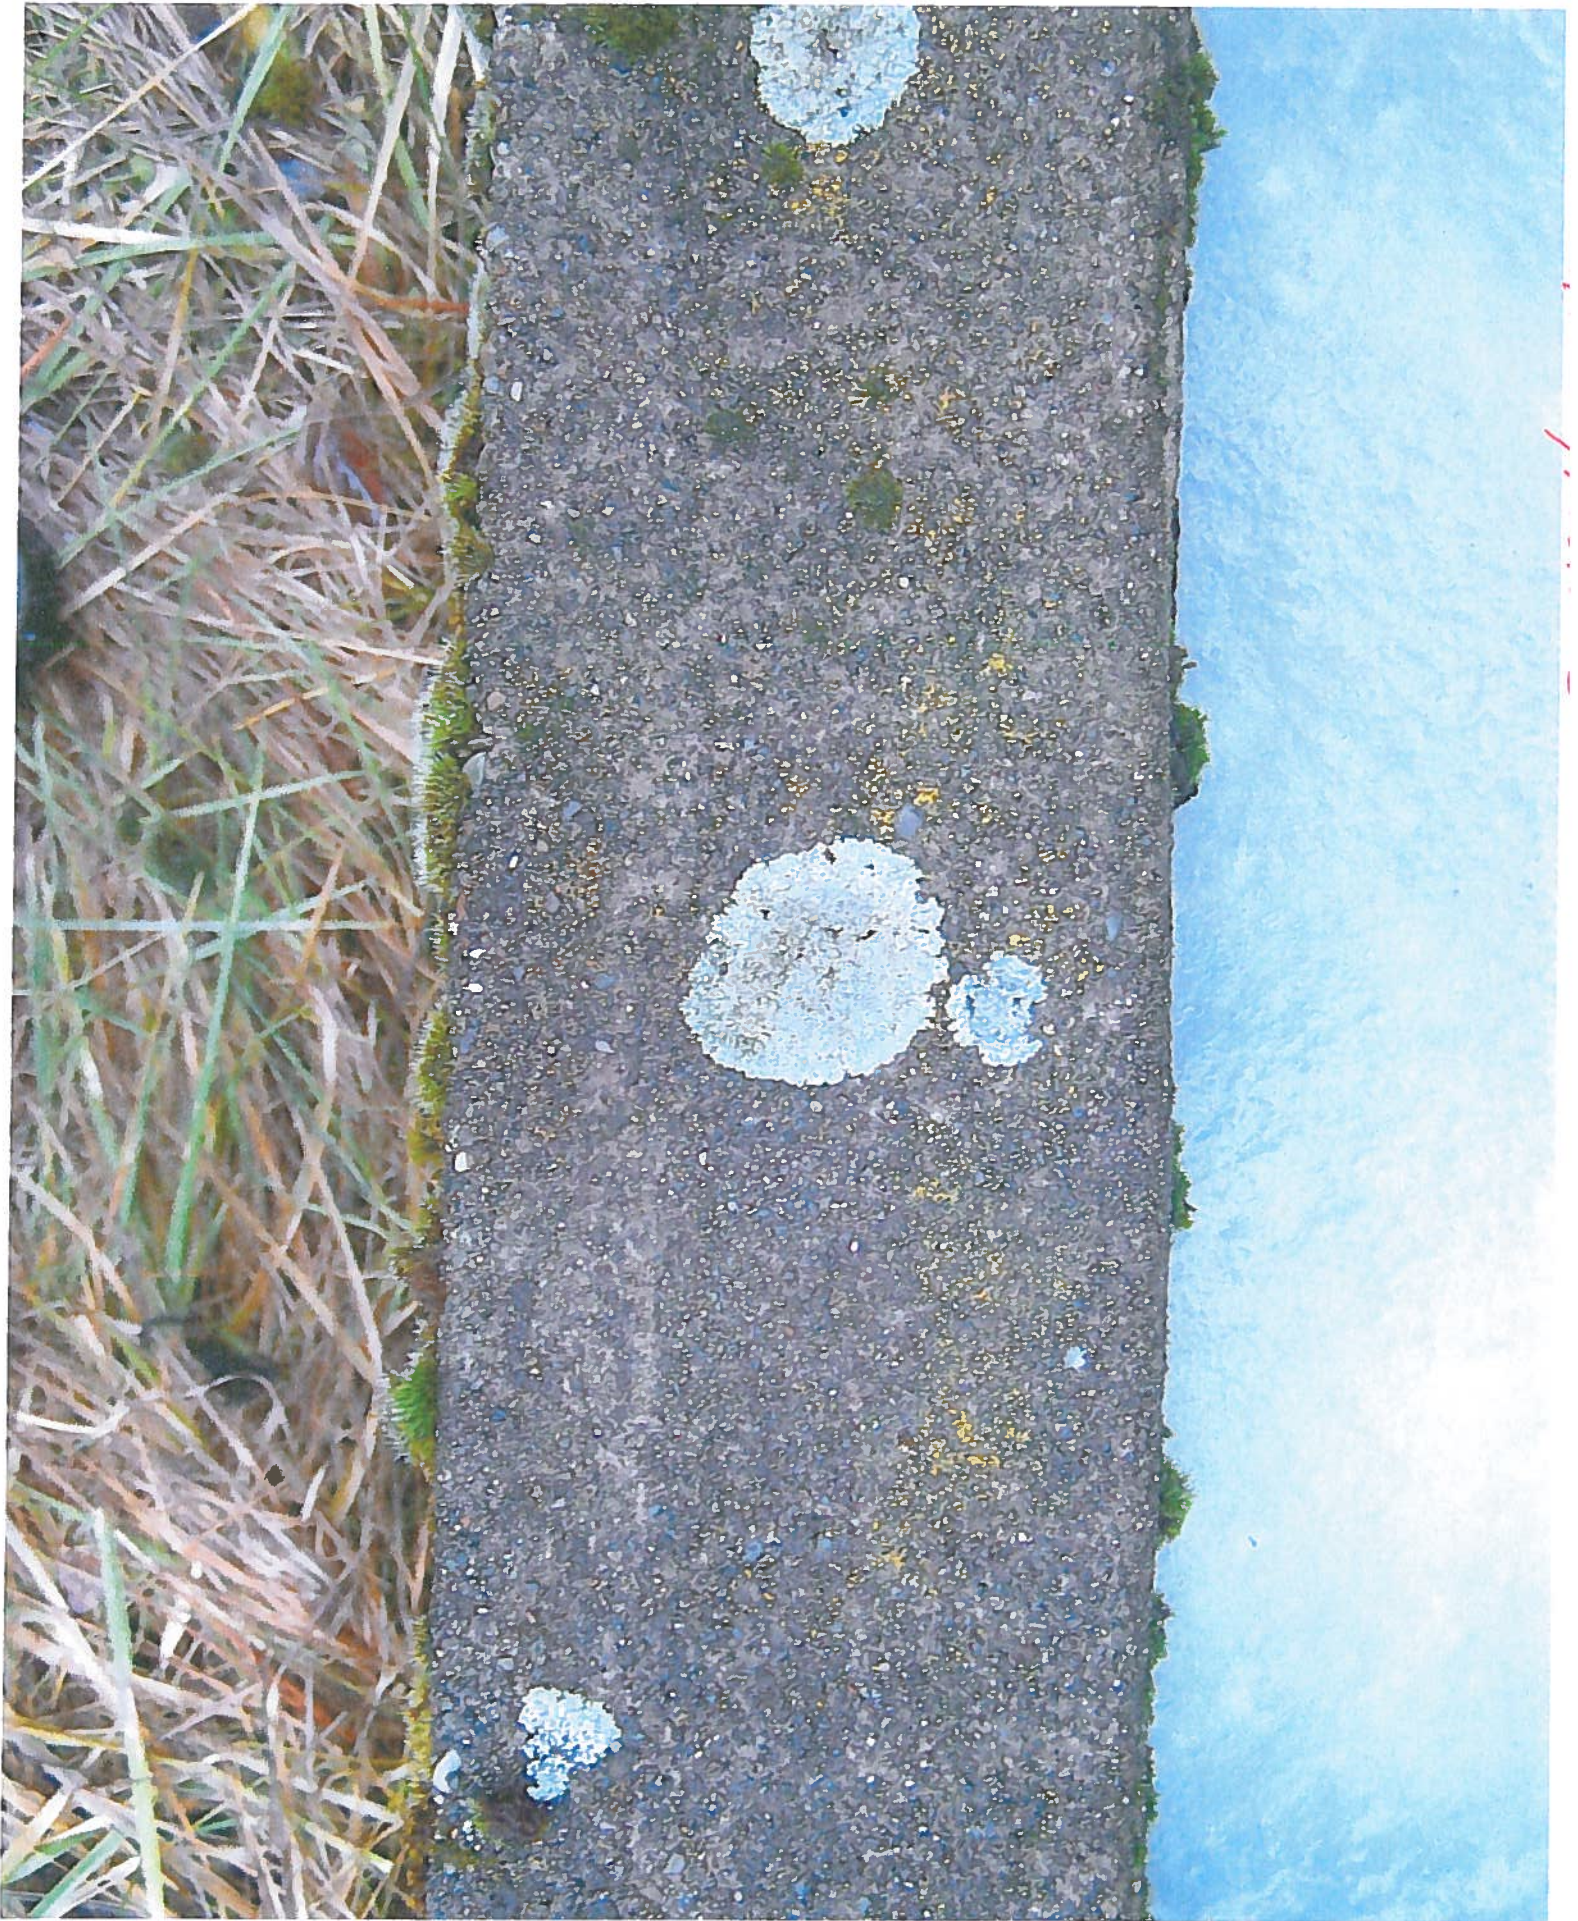
| Photograph # | Comments |
|---|---|
| 5 | Photo of crustose lichen imbedded in the concrete |
