IDAHO DEPARTMENT OF WATER RESOURCES  
RECOMMENDATION OF WATER RIGHTS ACQUIRED UNDER STATE LAW

61-7419

### Post-review follow up issues for IDL claims in basins 61 and 63.

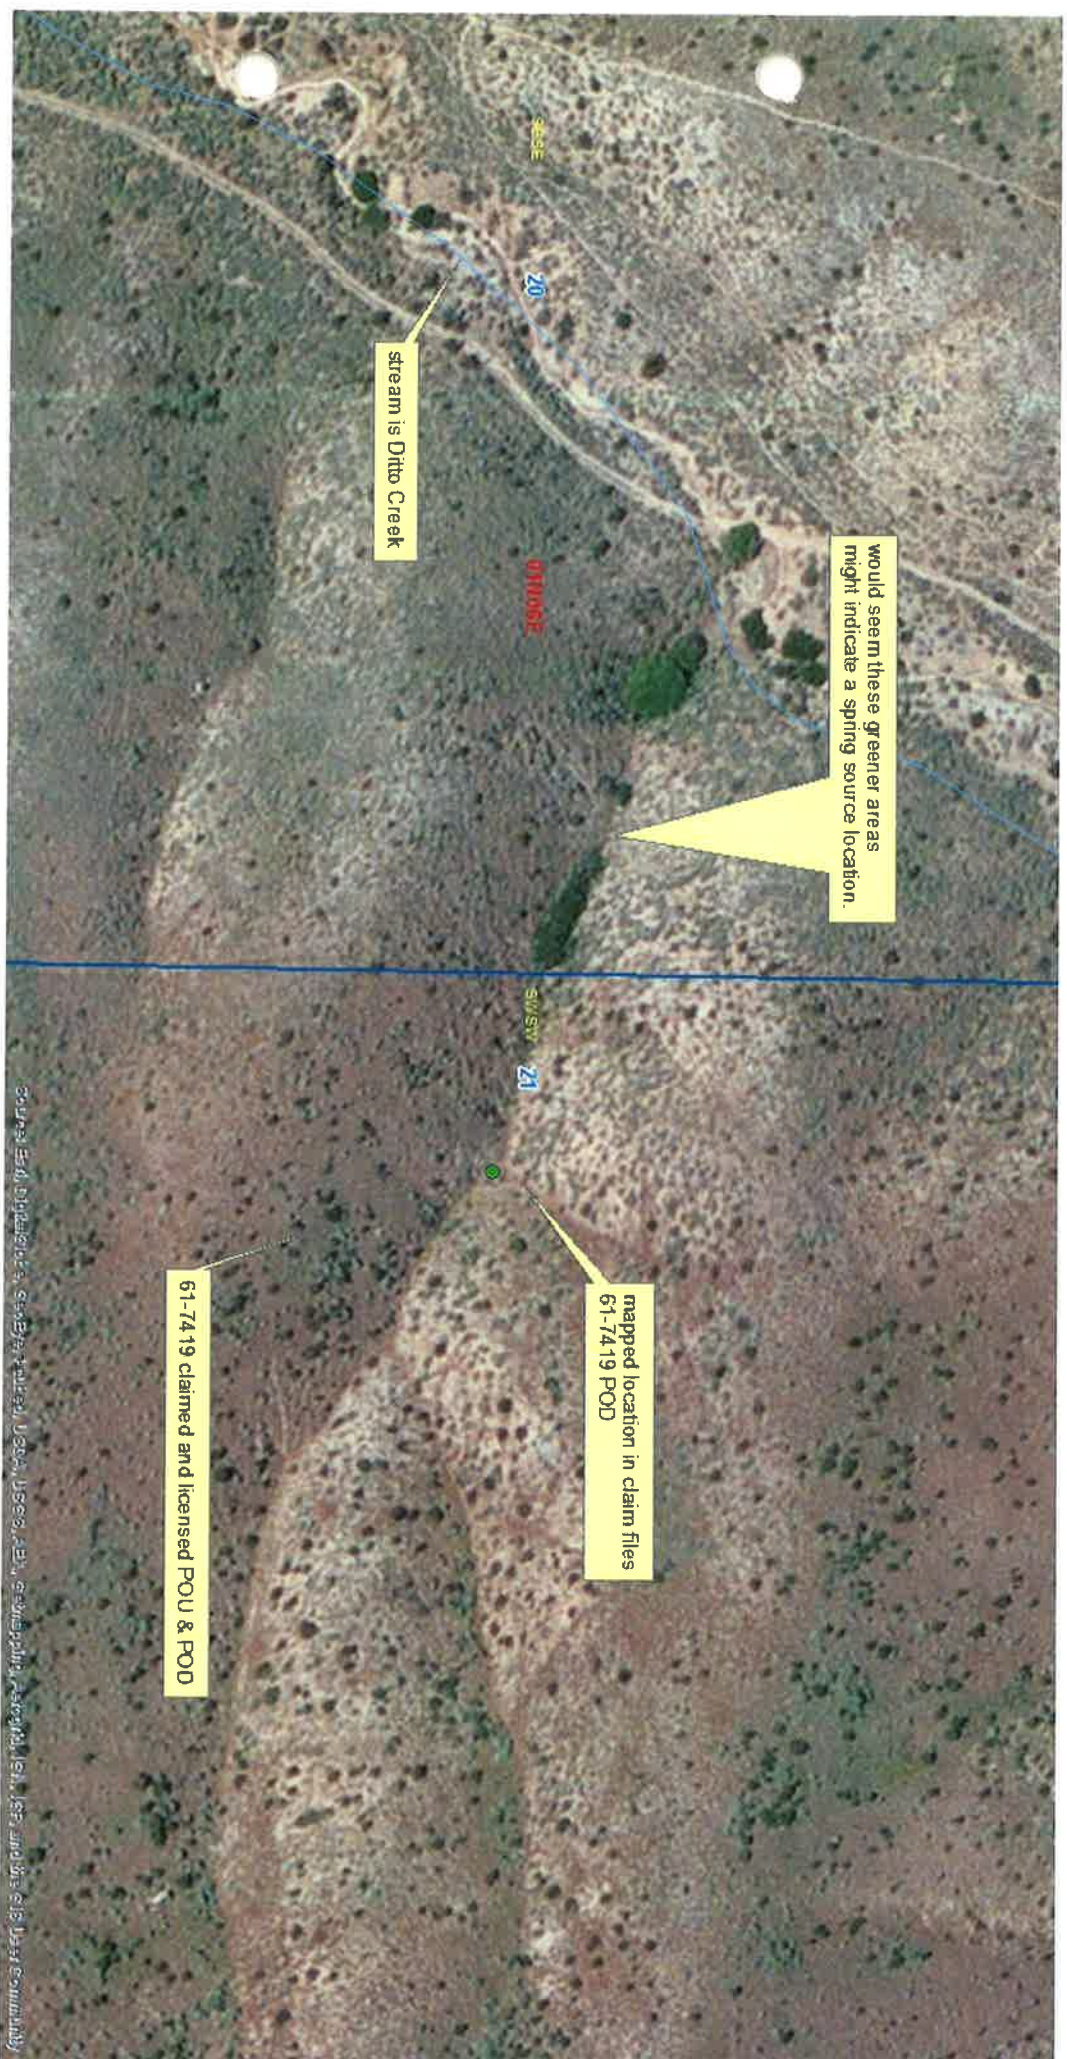
This claim file also had a POD located on the claim map. The POD and POU do not appear to be located in section 21 but might be better described in section 20 where a source of water is more likely found; based on the aerial photo. <See photo for better illustration of the issue.>
