STATE OF IDAHO  
DEPARTMENT OF WATER RESOURCES  
**BENEFICIAL USE FIELD REPORT**

**Permit No:** 36-15986  
**Exam Date:** 07/30/2019

**Permit 36-15986**

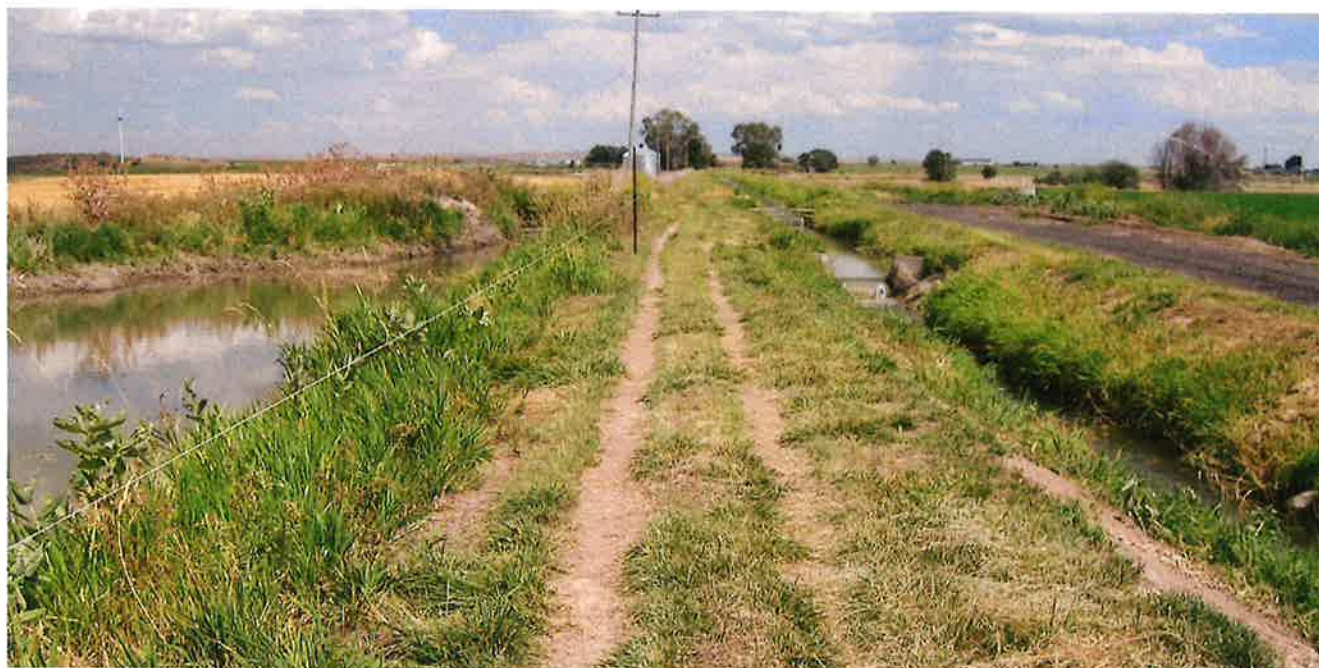
**Above:** Lateral 21 from Canal to Pond

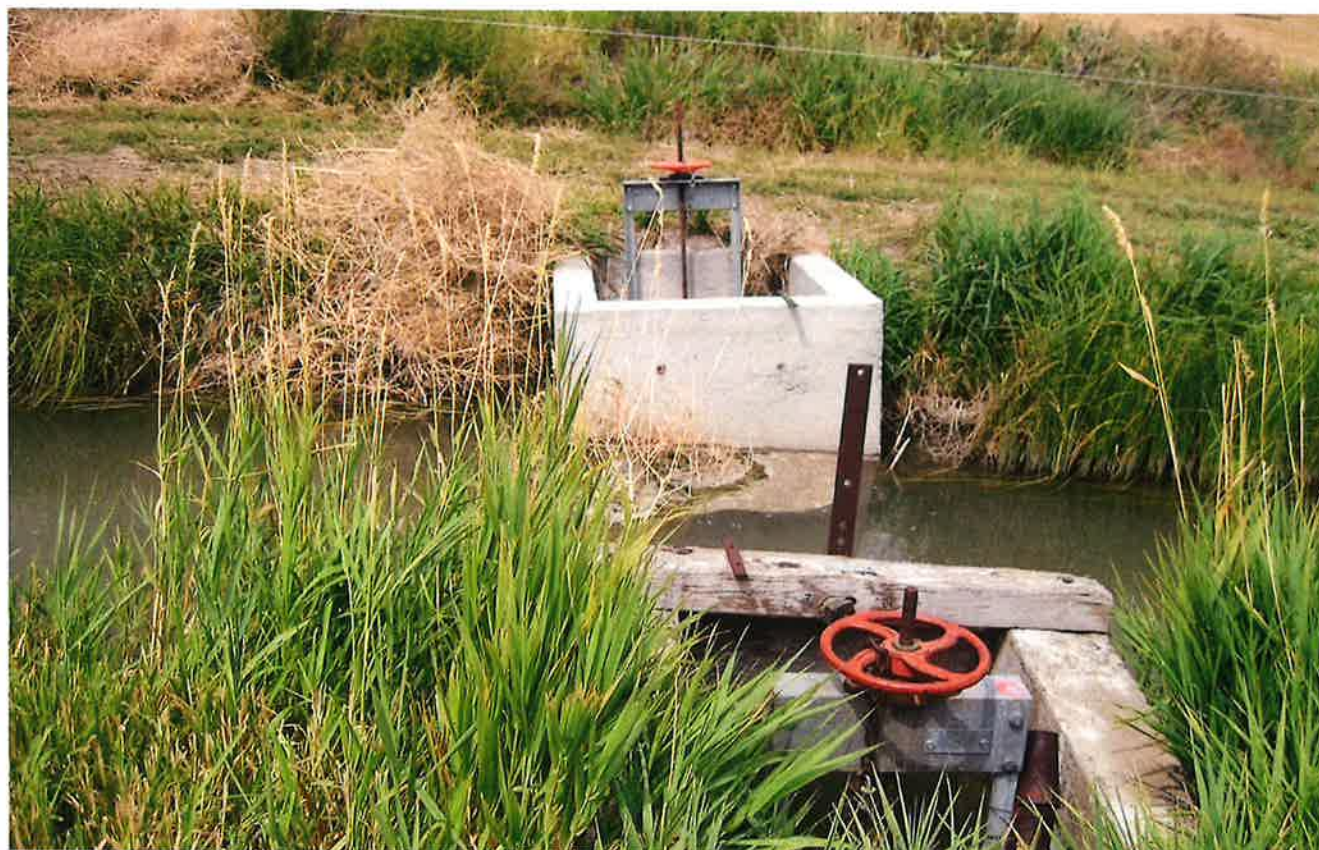
**Below:** Head gate into Pond

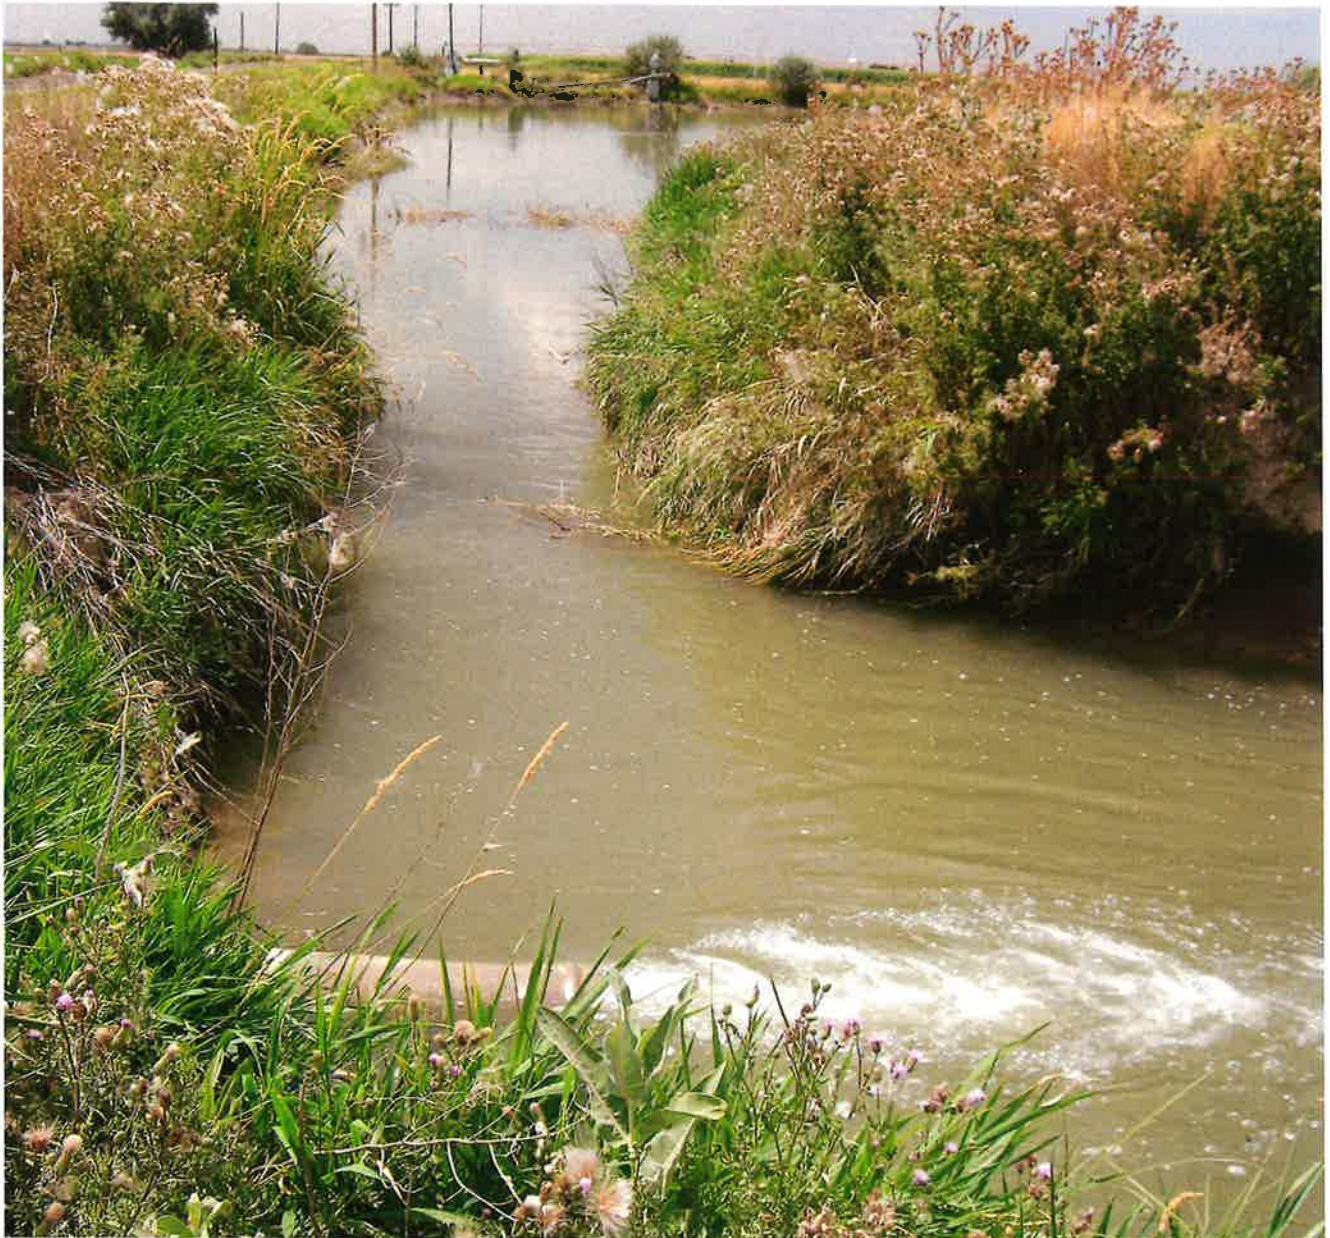
**Diversion into Pond**

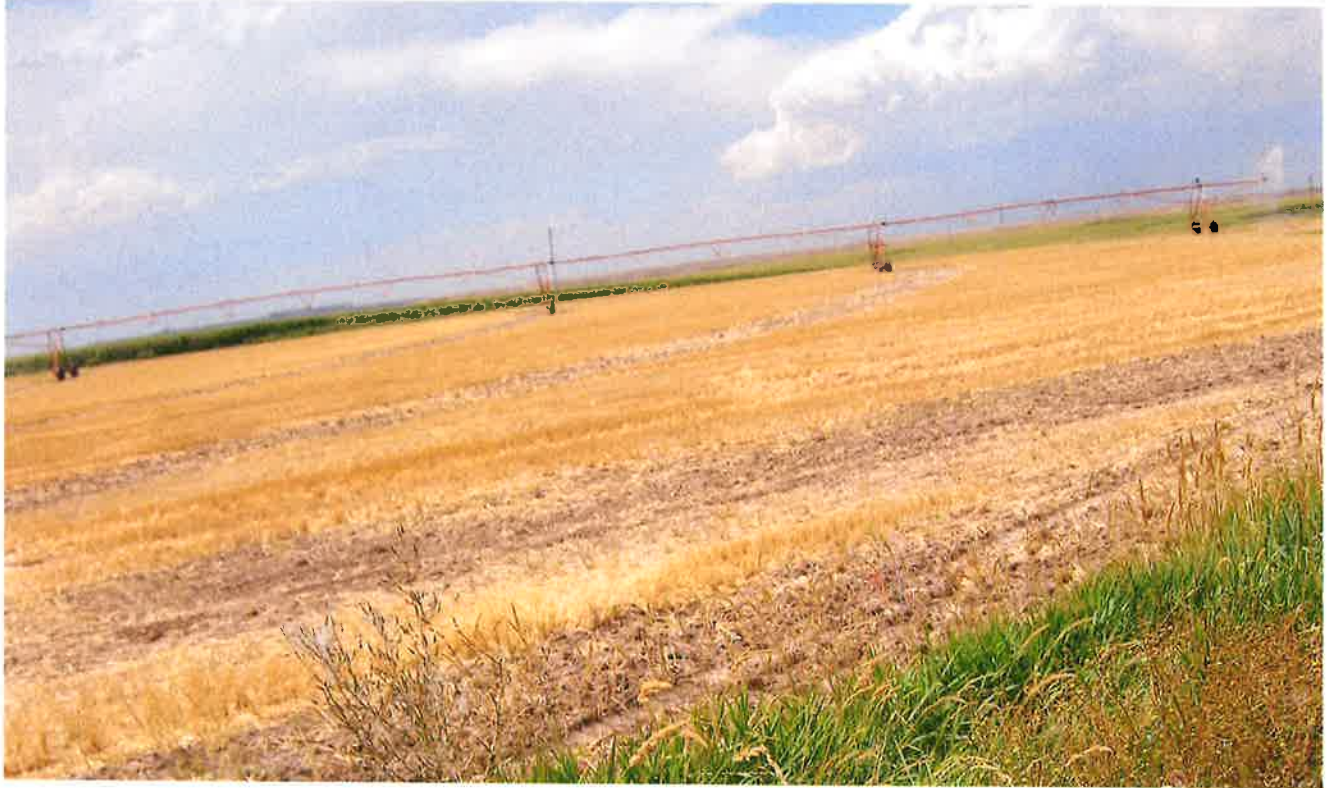
**Above:** Irrigated Land

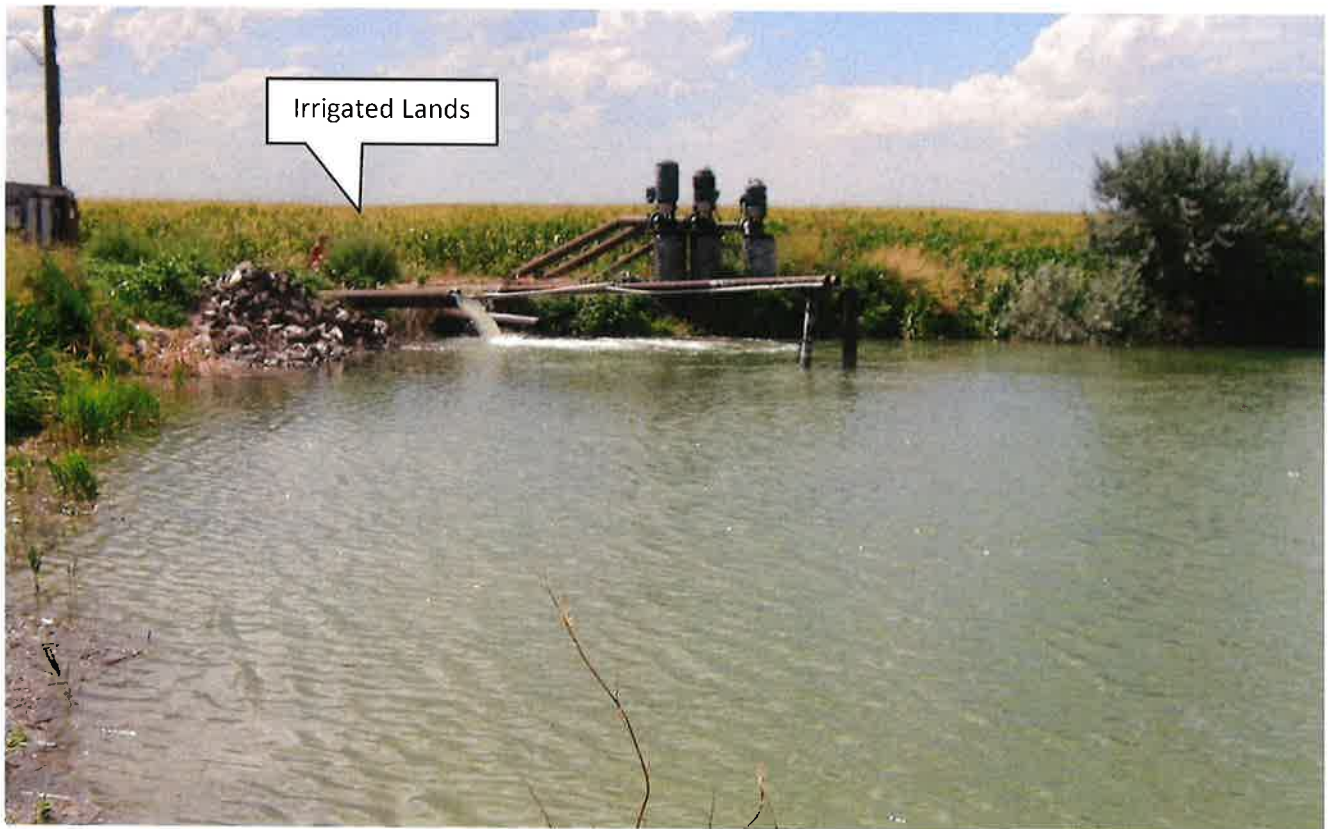
**Below:** Diversion to Secondary Pond & re-lift pumps

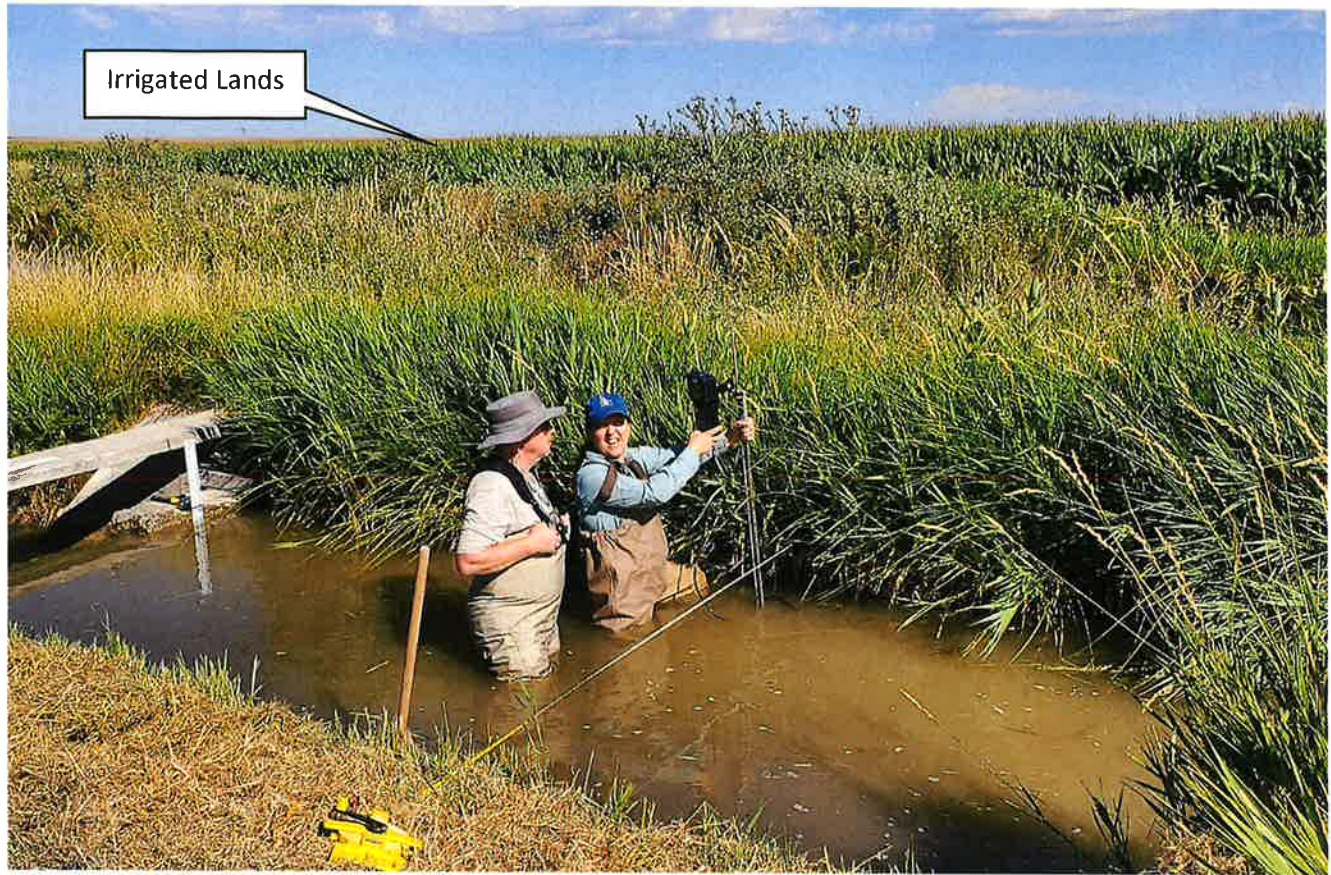
Measurement of Flow in Lateral

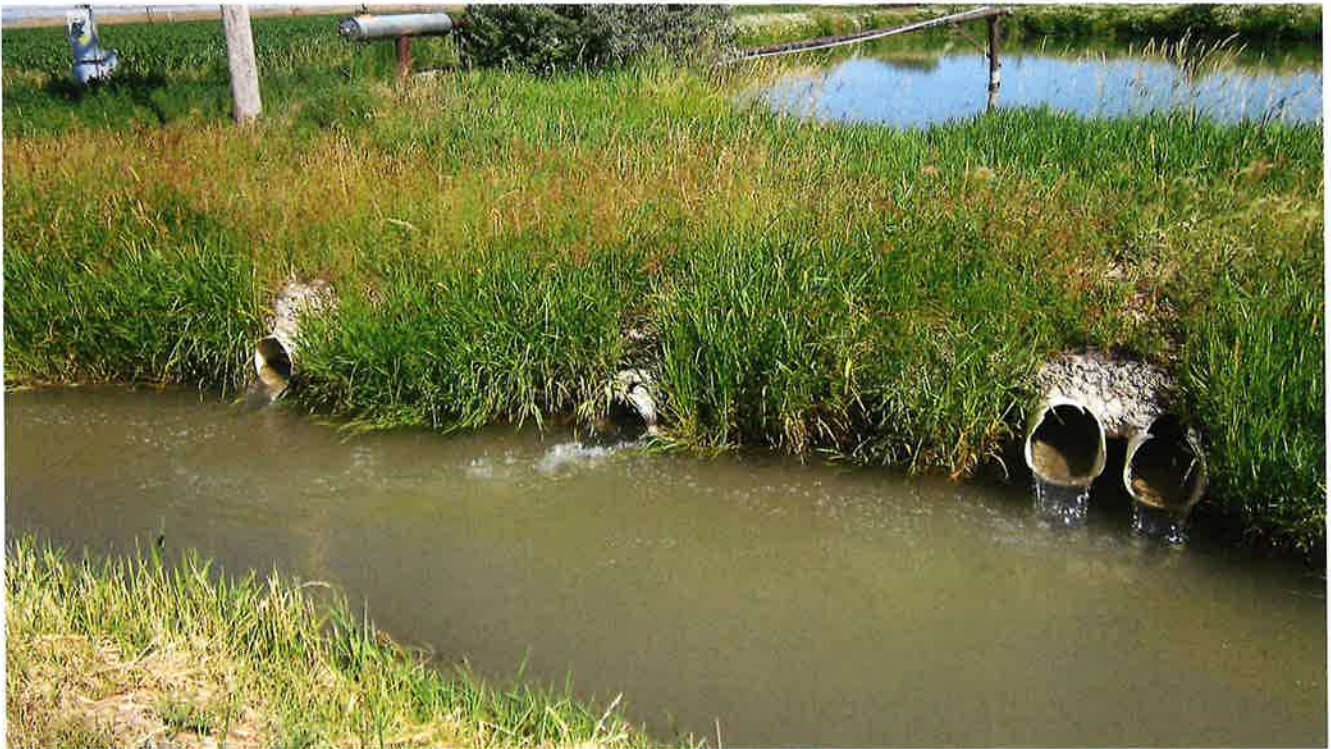
**Return Flow from Pond to Lateral**
