**APPLICATIONS FOR PERMIT NOS. 67-15292 –  
67-15298, 67-15300 AND 67-15322 AND  
APPLICATION FOR TRANSFER NO. 82712  
IN THE NAME OF ECKHARDT FAMILY LLLP**

**Applications for Permit Nos. 67-15292 – 67-15298,  
67-15300 and 67-15322 and Application for Transfer No. 82712  
In the Name of Eckhardt Family LLLP**

DATE: April 20, 2018  
SUBJECT: Eckhardt Pond Nos. 9 and 11 Site Visit

DATE: May 31, 2018  
SUBJECT: Eckhardt Pond Nos. 1, 2, 3 and 4 Site Visit

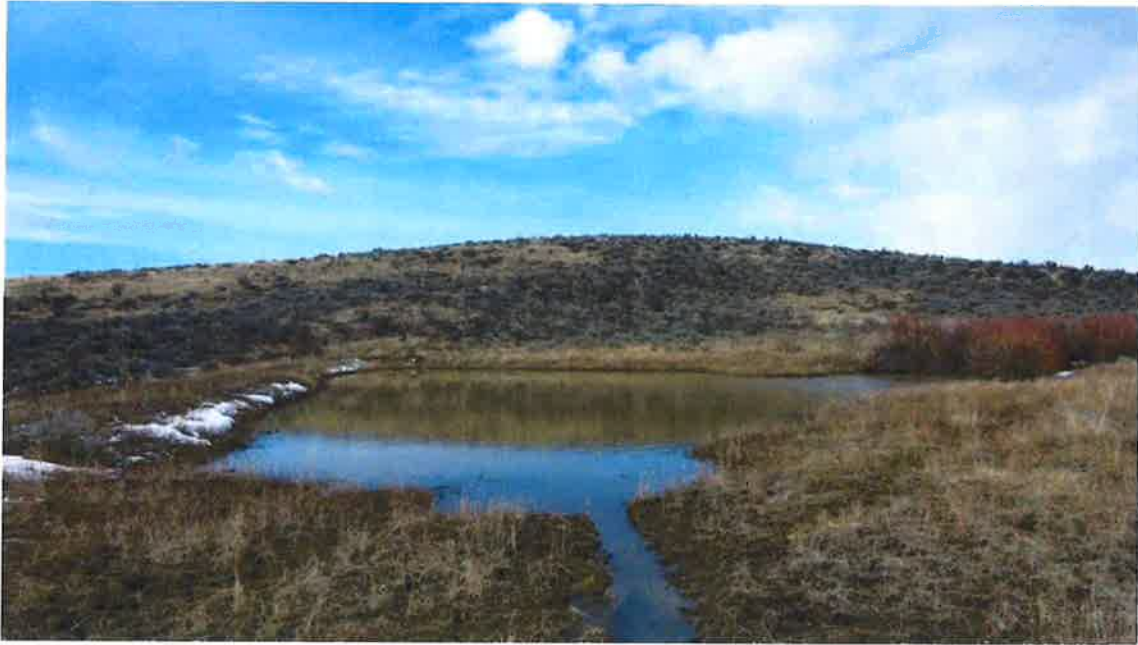
The lower of two impoundments on the basin's primary un-named natural stream (stream) channel is known as Pond No. 9. The impoundment was observed to be full and spilling water (Photos 1, 2). Pool level was approximately 5 inches above the crest of the spillway. Water was flowing into the pond from the stream which could be classified as either an intermittent or ephemeral stream. The flowing stream was observed to be in a well-defined natural channel. The stream was investigated by hiking upstream, along the natural channel, to Pond No. 11; measurements, photographs, and video recordings were collected at each of six (6) locations along the stream channel (Figure 2, Table 1, and Photos 1-6).

**Photo 1: Pond No. 9; note reservoir is full and spilling water.**

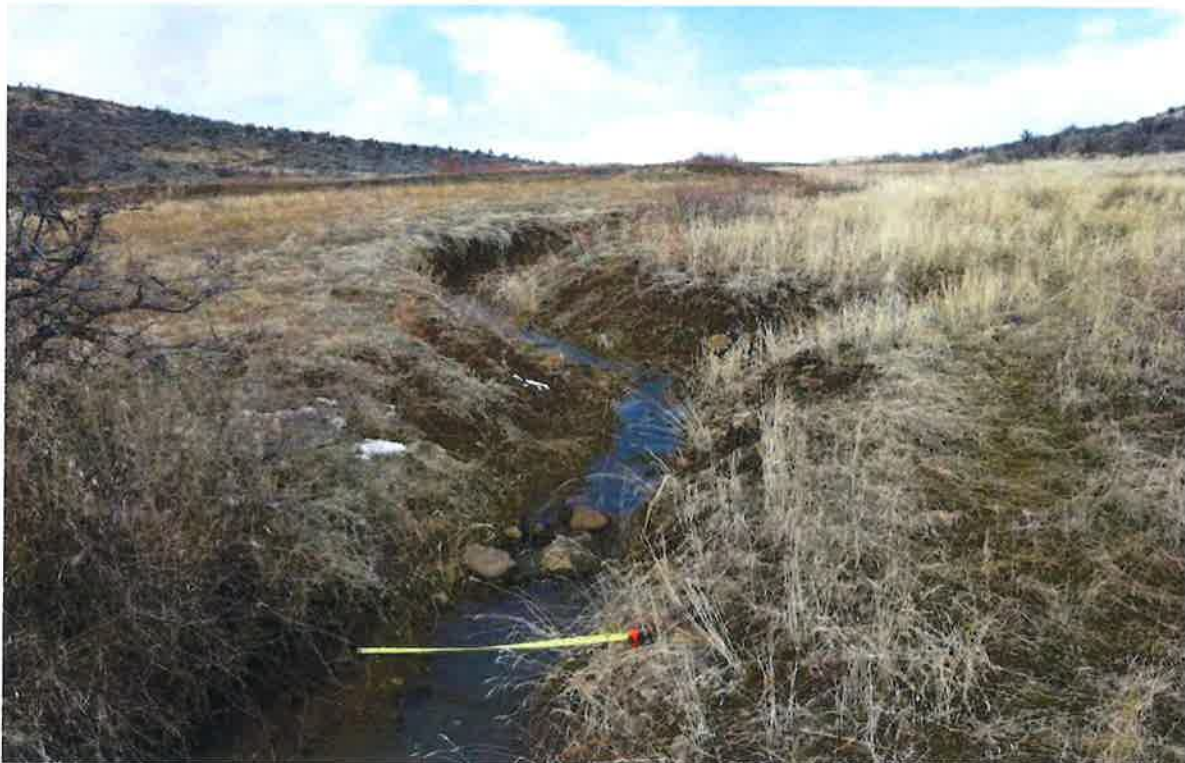
**Photo 2: Pond No. 9 spillway channel; immediately downstream of impoundment.**

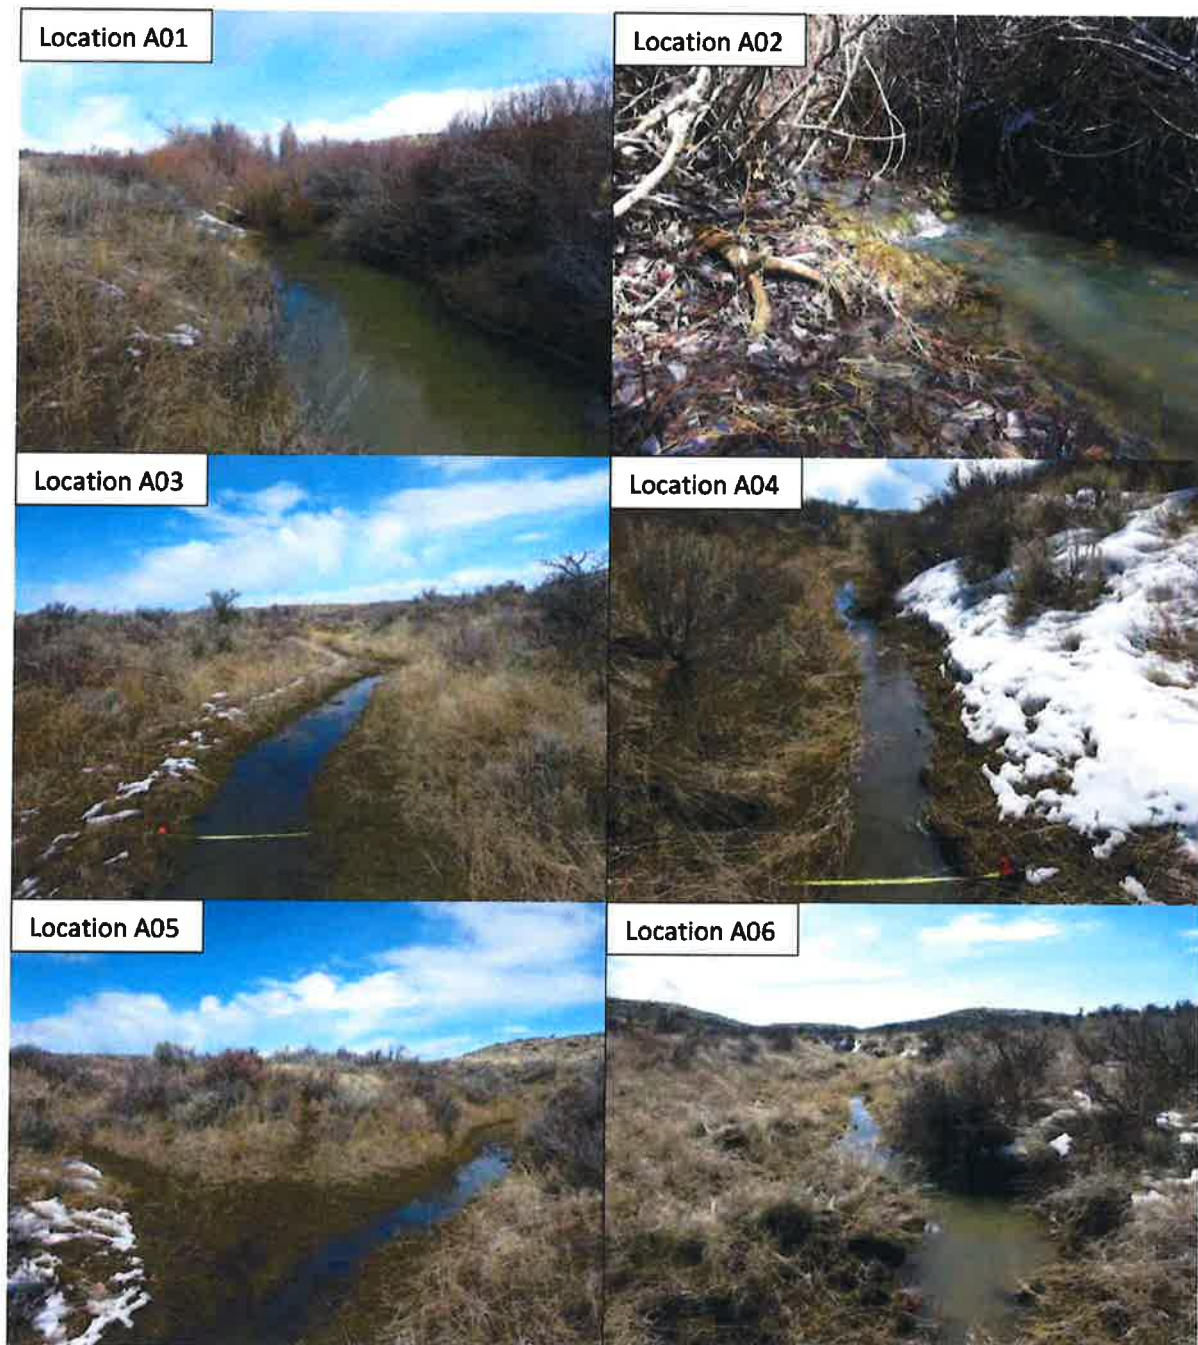
Photo 3: Photos captured at each site along the stream between Pond Nos. 9 and 11 as illustrated in Figure 2; see Table 1 for location reference.

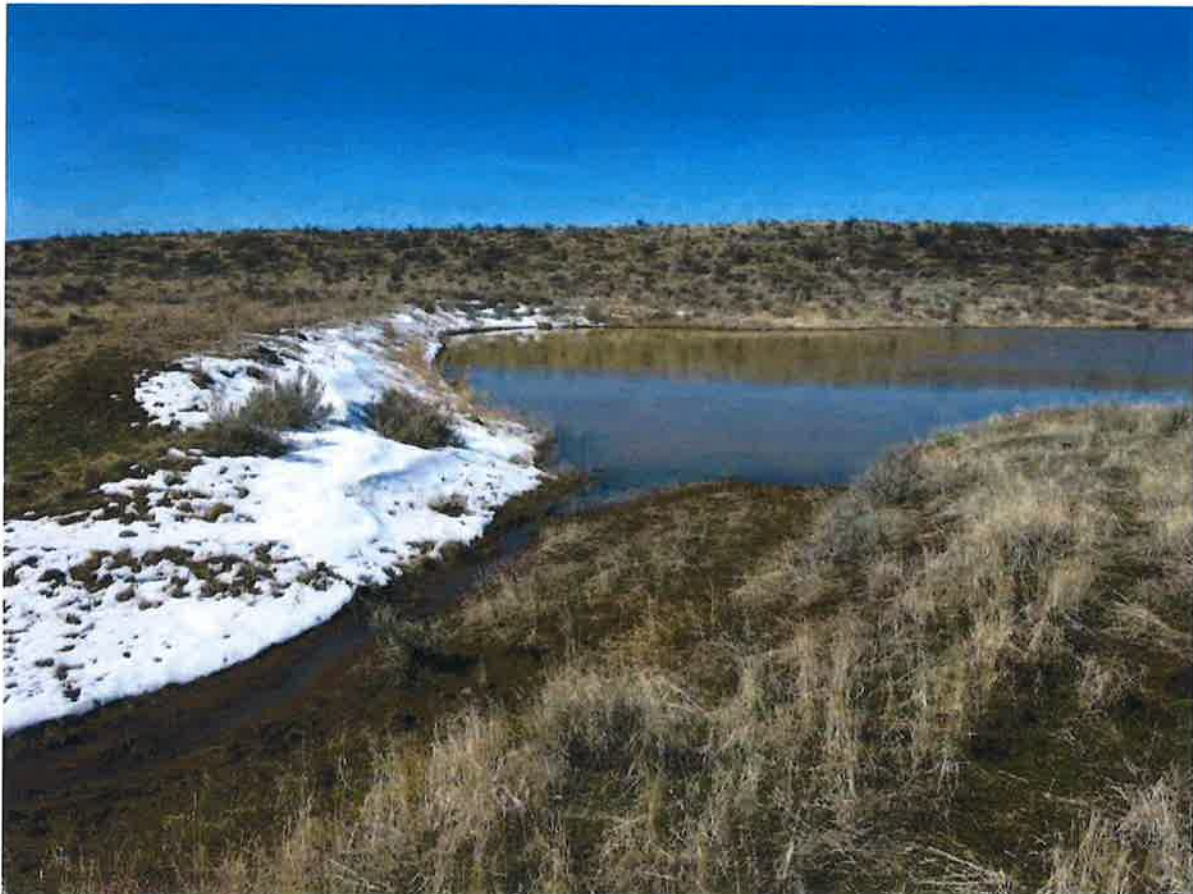
The upper of two impoundments on the basin's natural stream channel is known as Pond No. 11. The impoundment was observed to be full and spilling water (Photo 4). Pool level was approximately 2 inches above the crest of the spillway. Water was flowing into the pond from the stream which could be classified as either an intermittent or ephemeral (Photo 5). Additionally, the area/ground immediately above the pond appeared to be fully saturated which suggests some level shallow groundwater, high water table, and/or spring water were also contributing water to the pond (higher potentiometric surface than at pond level). The flowing stream was observed to be in a well-defined natural channel. The stream was investigated by hiking upstream, along the natural channel until the channel gradually blended into a wide swath of fully saturated ground (headwaters); measurements, photographs, and video recordings were collected at each of four (4) locations along the stream channel and at the headwaters of the basin (Figure 3, Table 2, and Photos 4-6).

**Photo 4. Pond No. 11; note reservoir is full and spilling water.**

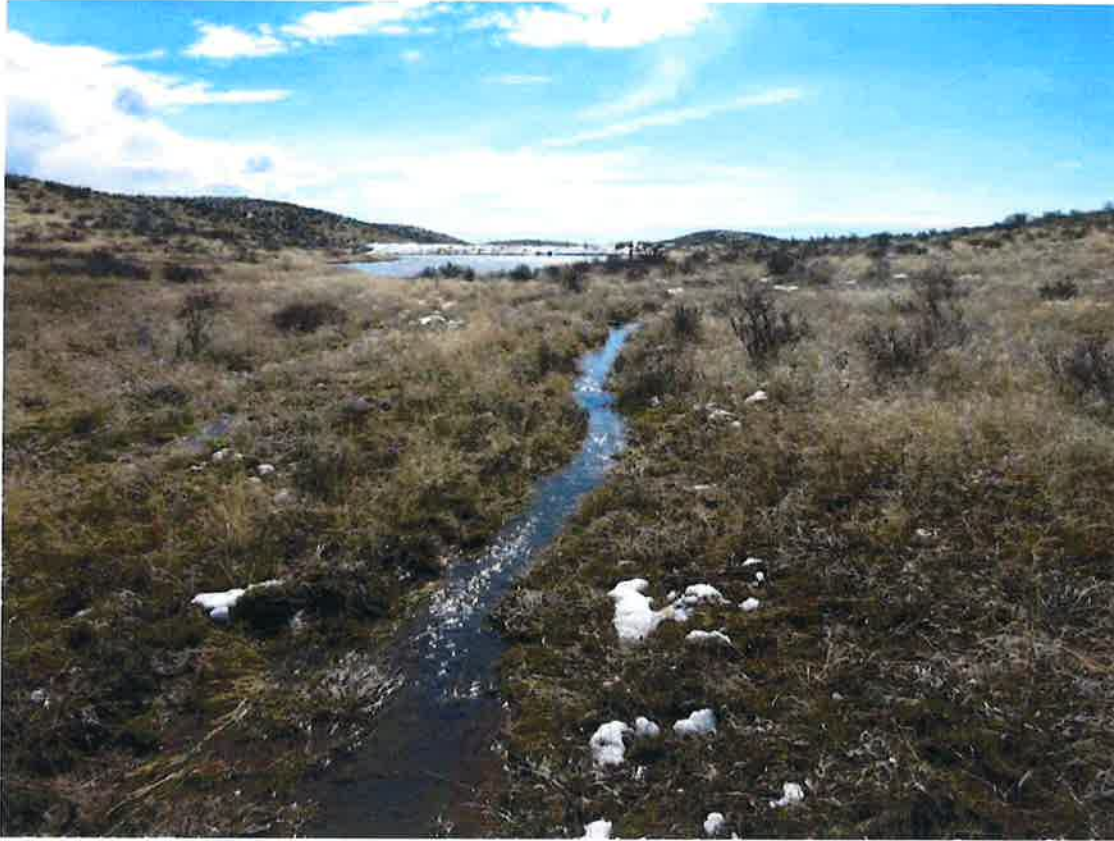
Photo 5: Channel flowing into Pond No. 11.

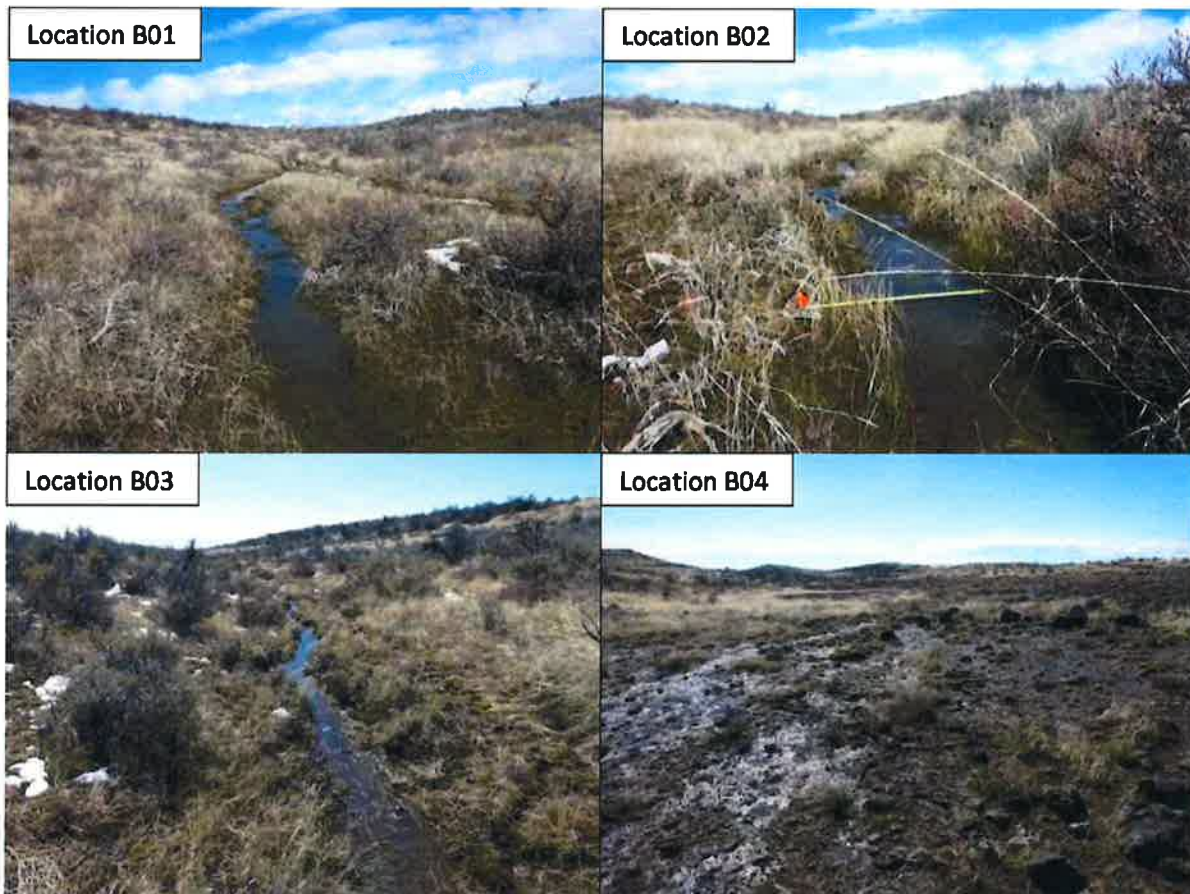
**Photo 6: Photos captured at each site along the stream above Pond No. 11 (and at the headwaters) as illustrated in Figure 3; see Table 2 for location reference.**

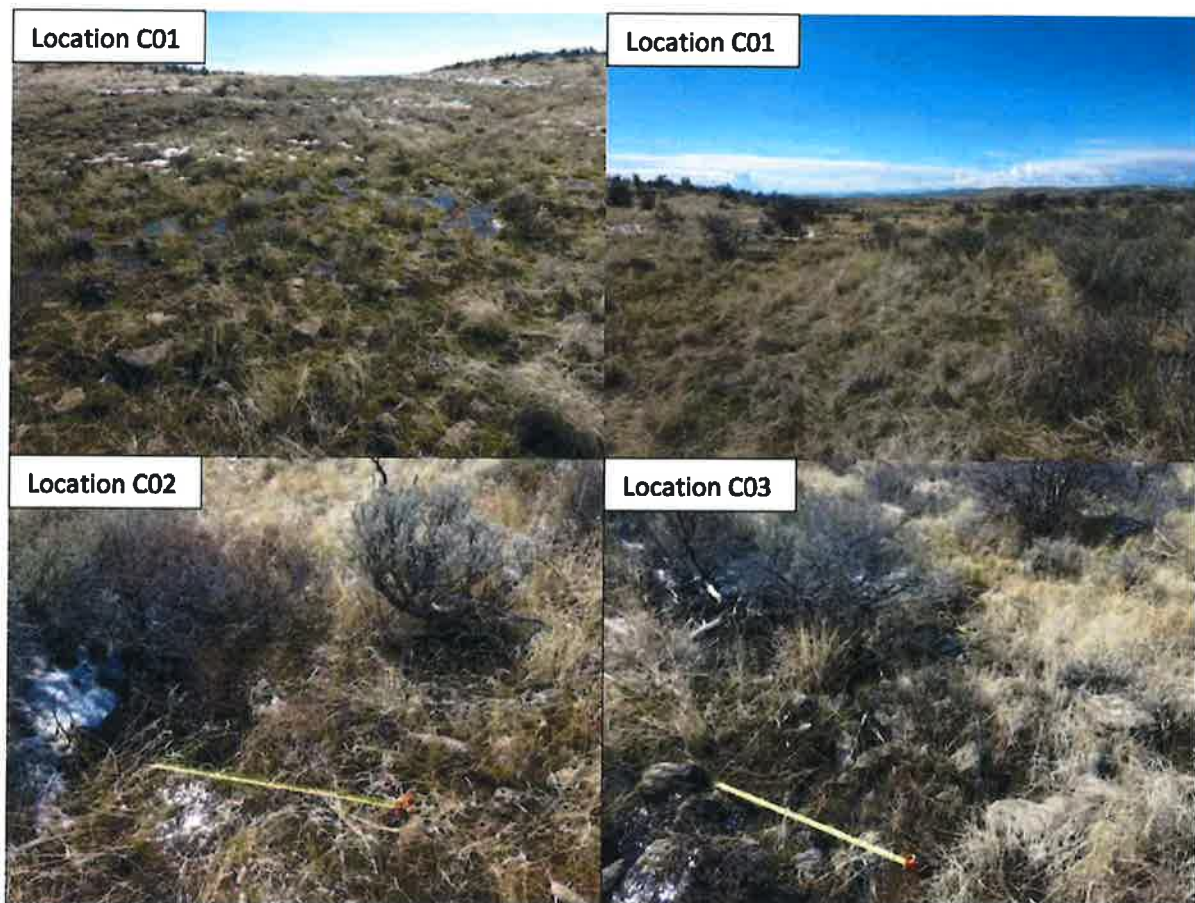
While walking back down the basin, along the west facing slope, a stream channel (likely ephemeral) was observed flowing a significant amount of water down towards the un-named basin's primary stream channel between Pond No. 9 and Pond No. 11. The stream was investigated by hiking up the sub-catchment along the stream channel until the channel gradually blended into wide a swath of fully saturated ground (headwaters of sub-catchment);

Photo 7: Photos captured at each site along the sub-catchment stream (and headwaters) as illustrated in Figure 2; see Table 3 for location reference.

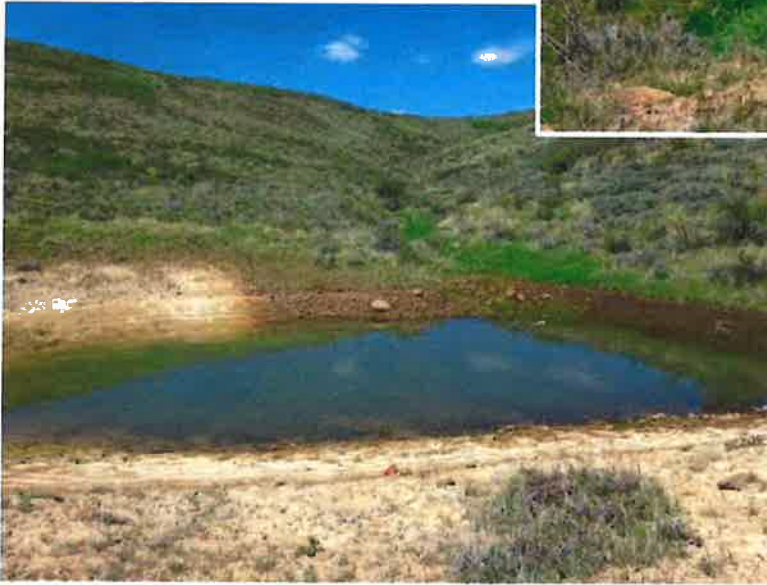
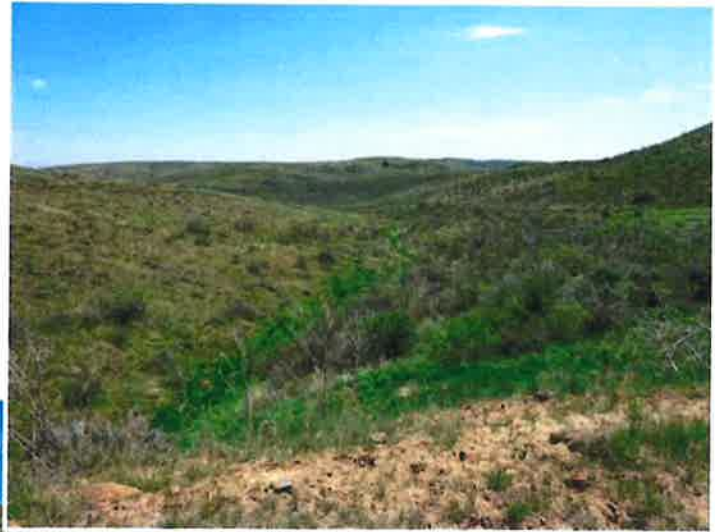
The uppermost of two impoundments constructed on the upper stretch of Jenkins Creek (Figures 2-4). The impoundment was observed to have a pool level of approximately three (3) feet below the crest of the spillway; the intermittent or ephemeral stream channel at the inlet was dry. The high water mark on the upstream slope of the earthen embankment, along with

**Photo 1: Pond No. 1 reservoir; upstream basin (bottom left), and downstream drainage (upper right).**

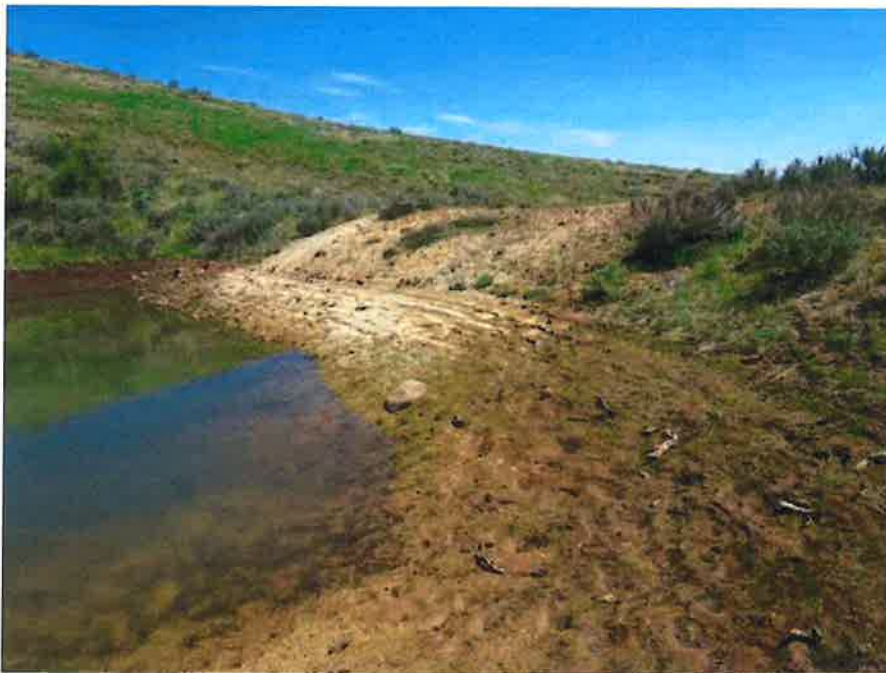
the fluvial erosion and debris within the spillway channel, suggests the pond was recently full and spilling water downstream (Photos 2 and 3). The stream channel that routes water to the pond was investigated by hiking upstream. Observations, photographs, and video recordings were collected at the impoundment and each of four (4) locations along the stream channel (Figure 5, Table 1, and Photos 1-3). Spring flow along a 250 foot stretch of the stream channel was observed between locations P1N4SPR and P1N5SPR (Figure 5). Overall, the stream channel showed signs of fluvial erosion (scoured) along with depressed grasses covered in silt and moss. Vegetation along the stream channel consisted of mostly sagebrush, grass, and weeds.

**Photo 2: Pond No. 1 upstream slope of earthen embankment; note high water mark.**

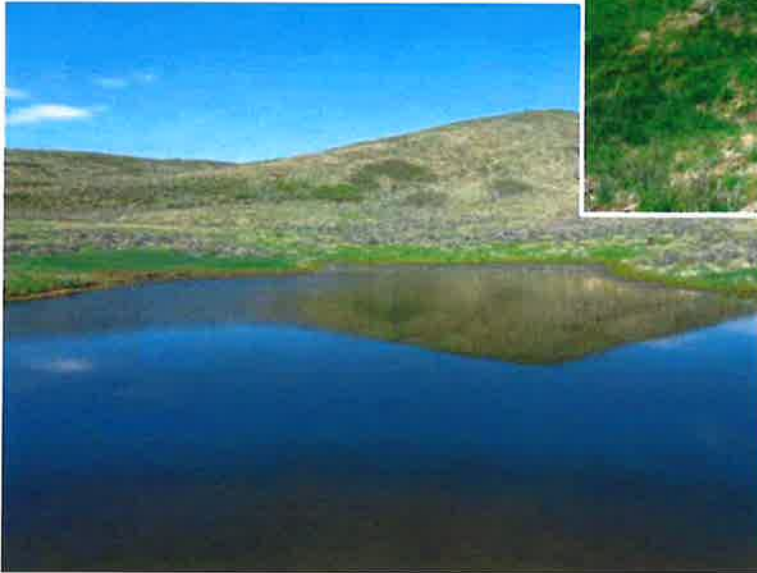
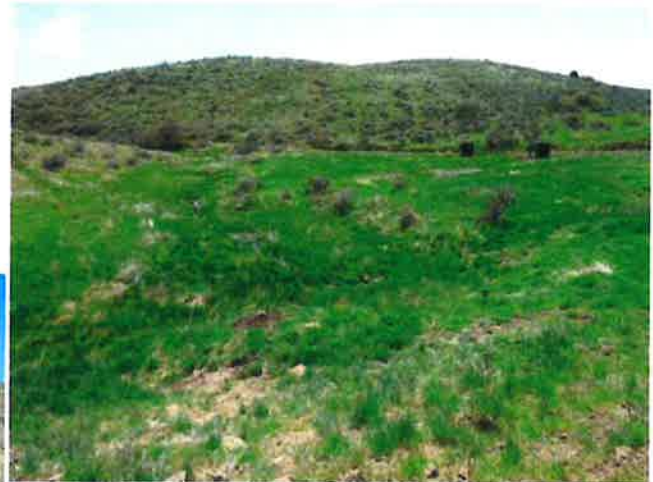
The lower of two impoundments constructed on the upper stretch of Jenkins Creek within the 23 square mile Jenkins Creek watershed (Figures 2-4). The impoundment was observed to have a pool level of approximately 0.5 feet below the crest of the spillway; at the inlet, an intermittent or ephemeral stream channel was flowing water (relatively low flowrate). The high water mark on the upstream slope of the earthen embankment, along with the fluvial erosion and debris within the spillway channel, suggests the pond was recently full and spilling water downstream (Photos 5 and 6). The stream channel flowing water to the pond was investigated by hiking upstream to Pond No. 1. Observations, photographs, and video recordings were collected at the impoundment and each of five (5) locations along the flowing stream channel (Figure 5, Table 2, and Photos 4-6). Water flowing within the stream channel ceased approximately 950 feet upstream of Pond No. 2 at location P2N5. Ultimately, it was observed that water flowing from the downstream toe of Pond No. 1 embankment, flowed to a point in the stream channel approximately 100 feet upstream of location P2N5 where it infiltrated, before resurfacing at location P2N5 and flowed continuously to Pond No. 2. Vegetation along the stream channel between Pond Nos. 1 and 2 consisted of mostly sagebrush, grass, and weeds.

**Photo 4: Pond No. 2 reservoir; upstream basin (bottom left), and downstream drainage (upper right).**

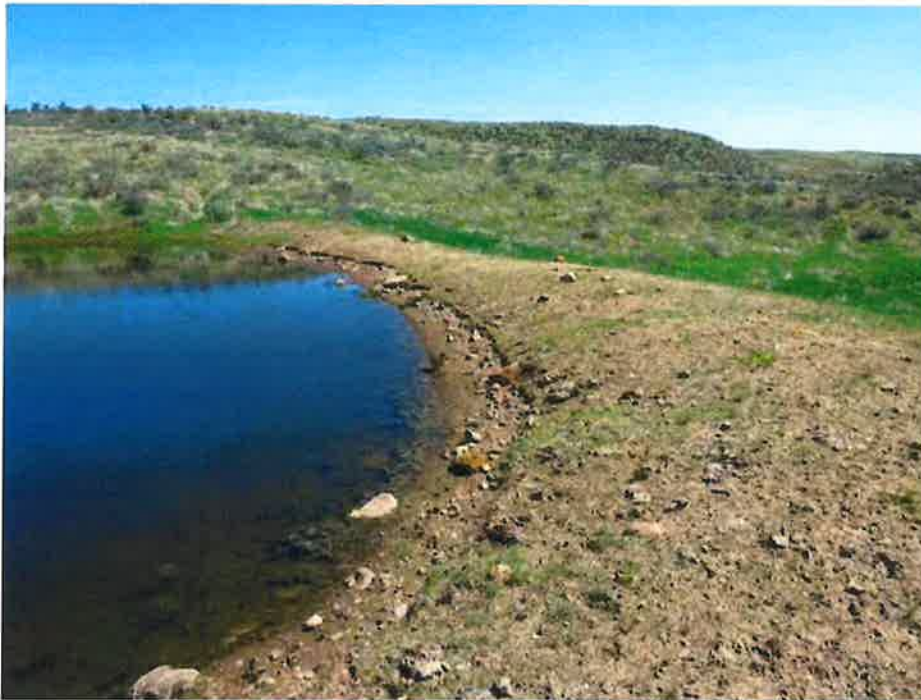
**Photo 5: Pond No. 2 upstream slope of earthen embankment; note high water mark.**

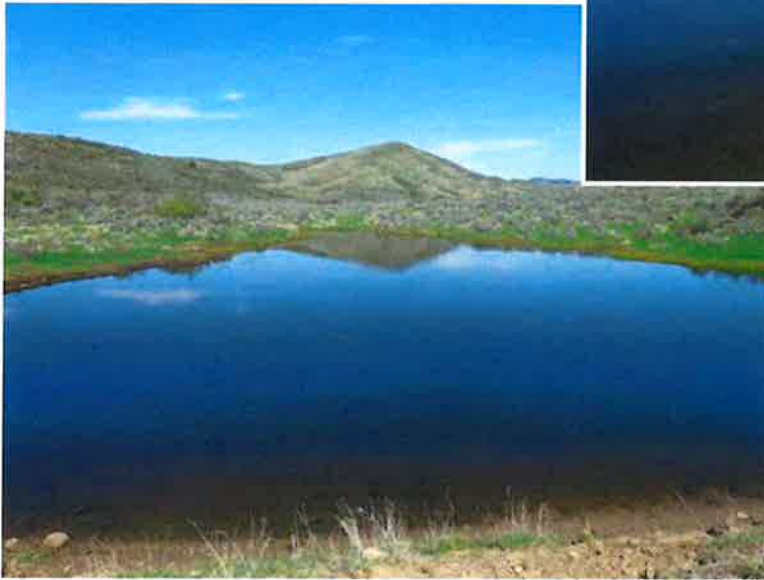
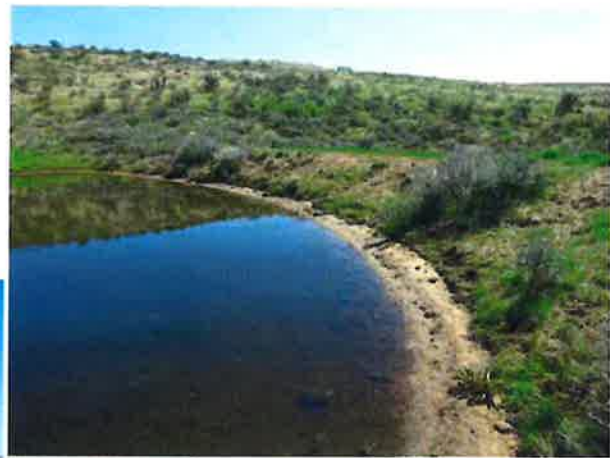
Impoundment constructed on the upper stretch of an un-named stream channel of an un-named 0.5 square mile sub-basin that routes water to Jenkins Creek (Figures 2-4). The impoundment was observed to have a pool level of approximately 0.5 feet below the crest of the spillway; the stream channel at the inlet was dry. The high water mark on the upstream slope of the earthen embankment, along with the fluvial erosion and debris within the spillway channel, suggests the pond was recently full and spilling water downstream (Photos 7 and 9). The channel within which the impoundment was constructed was investigated by hiking downstream, then upstream. Observations, photographs, and video recordings were collected at the impoundment and each of six (6) locations along the channel (Figure 6, Table 3, and Photos 7-9). Standing at the inlet to Pond No. 3, the basin upstream was relatively wide with a low profile that narrowed immediately upstream of the pond. This upper section of the sub-basin was bound by higher profile slopes. Based on where the pond is situated within the sub-basin, it seems likely that the primary source of storage water is shallow ground water drainage (from the sub-basin) or possibly a spring and/or perched water table. Vegetation along the stream channel consisted primarily sagebrush, grass, and weeds.

**Photo 7: Pond No. 3 reservoir, upstream basin (bottom left); upstream slope of earthen embankment, note high water mark. (upper right).**

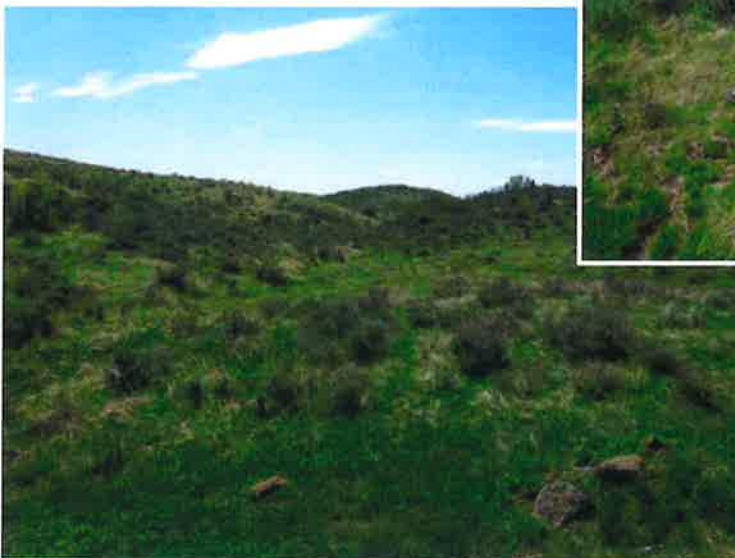
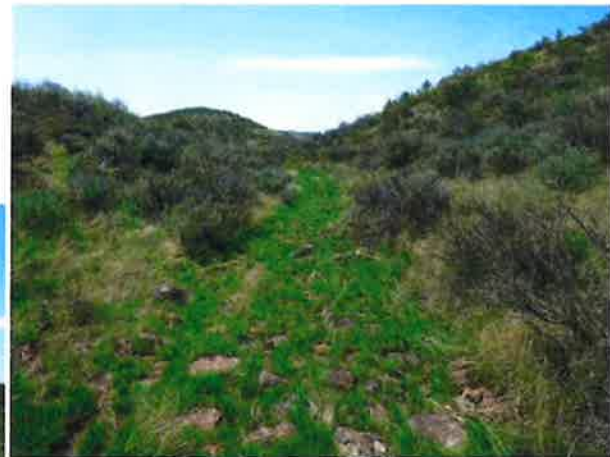
**Photo 8: Pond No. 3 downstream drainage (bottom left), note high water mark; downstream channel at location P3DS.**

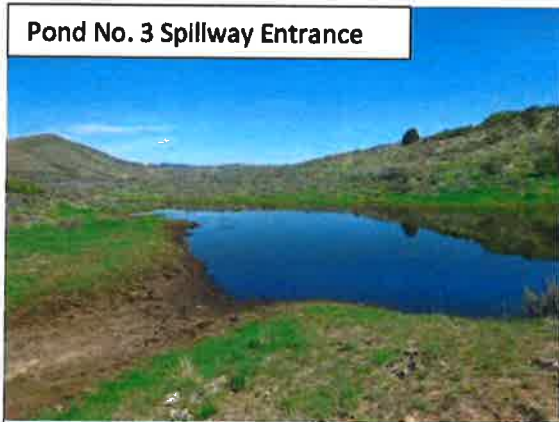
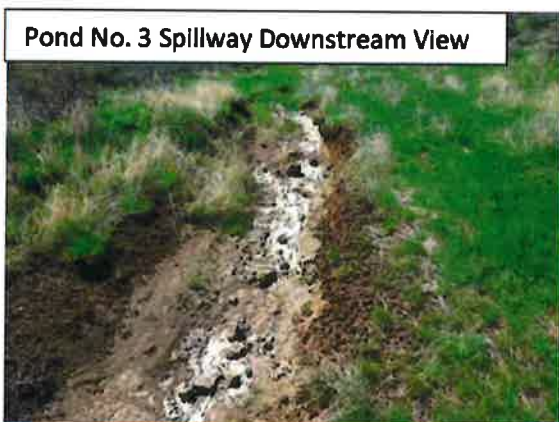
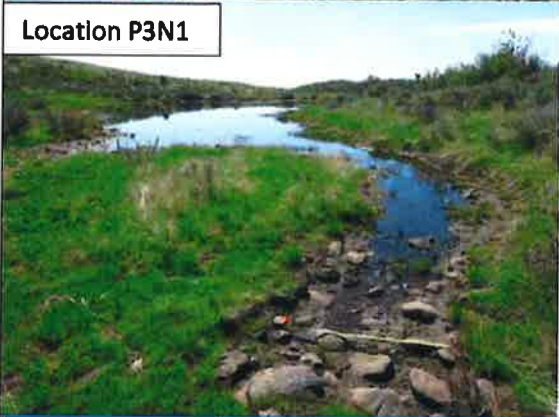
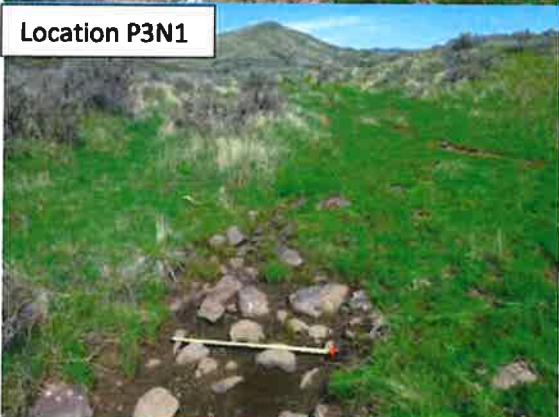
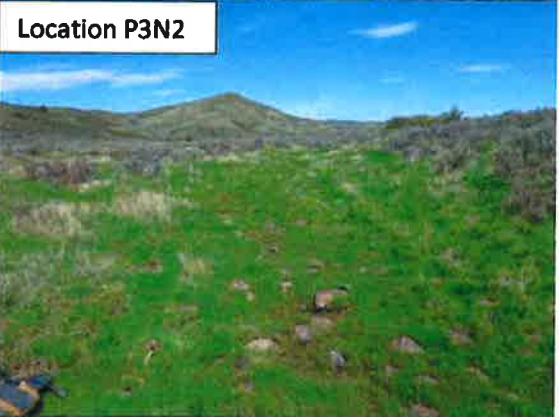
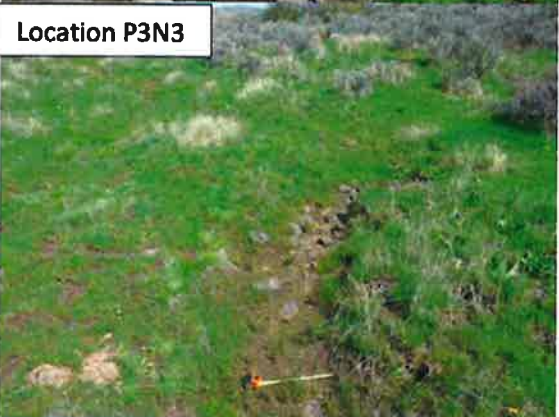
Photo 9: Photos captured at Pond No. 3 and sites along the stream channel as illustrated in Figure 6, see Table 3 for corresponding site observations.; note aquatic wildlife.

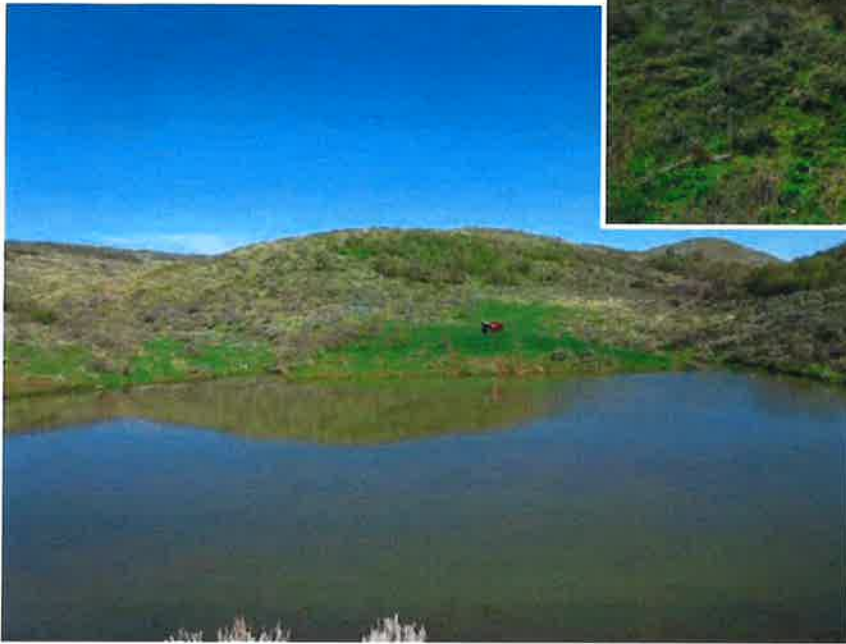
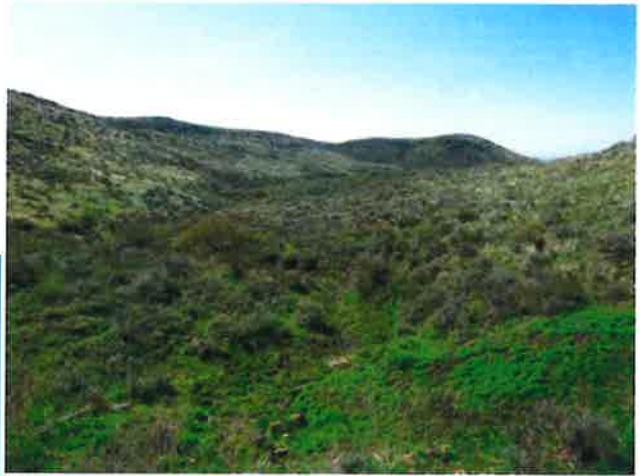
Impoundment constructed immediately below the confluence of two (2) un-named intermittent or ephemeral stream channels (northwest and north channels) within an un-named 1.2 square mile sub-basin that routes water to Jenkins Creek (Figures 2-4). The impoundment was observed to be at full pool and spilling water downstream; flow rate in spillway was visually estimated to be 5-10 gpm. The north inlet stream channel was flowing water (relatively low flow rate) to the impoundment while the northwest inlet stream channel was dry. The north and northwest stream channels were investigated by hiking upstream. Observations, photographs, and video recordings were collected at the impoundment and each of two (2) locations along the northwest stream channel and five (5) locations along the north stream channel (Figure 7, Table 4, and Photos 10-13). Water was observed flowing (low flows) along the north stream channel at locations P4N1, P4N2, P4N3, and P4N5; note the base of the stream channel at location P4N4 was saturated but no surface water was present. Between locations P4N4 and P4N5, mature aspen trees (or possibly birch) were well established along the stream channel; vegetation along the remaining stretch of the north channel consisted of primarily sagebrush, grass, and weeds. The northwest stream channel showed signs of fluvial erosion (scoured) along with depressed grasses covered in silt and moss; vegetation along the stream channel consisted of mostly sagebrush, grass, and weeds. Overall, both stream channels route water from springs, shallow groundwater drainage, or perched aquifer.

**Photo 10: Pond No. 4 reservoir; upstream basin (bottom left), and downstream drainage (upper right).**

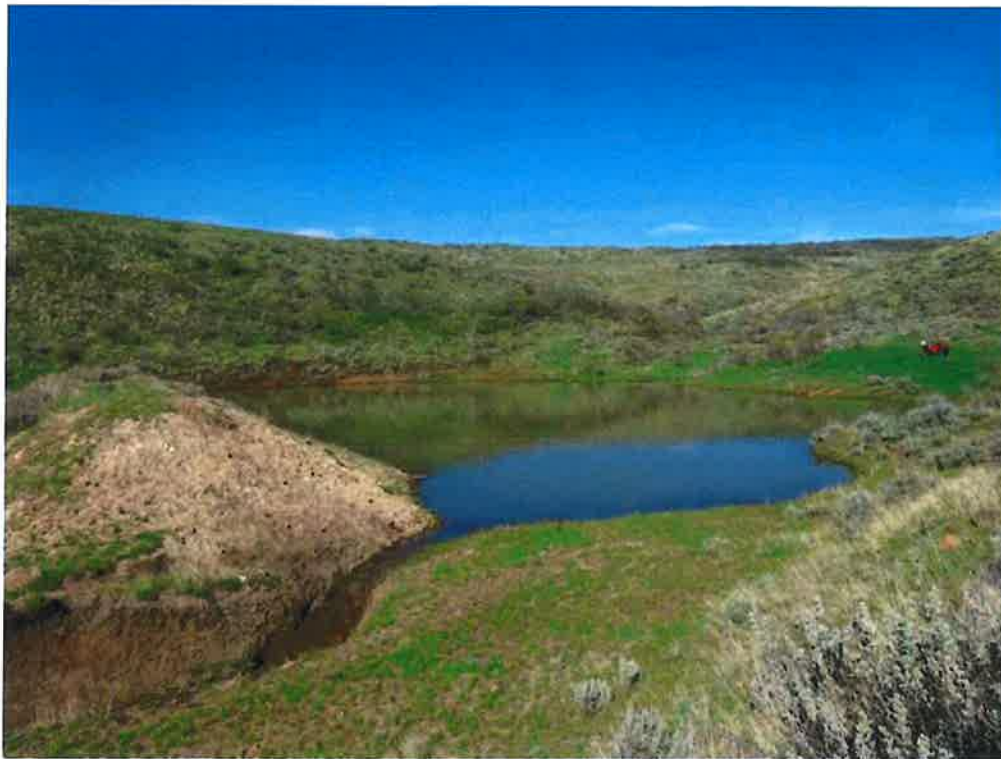
**Photo 11: Pond No 4 spillway.**

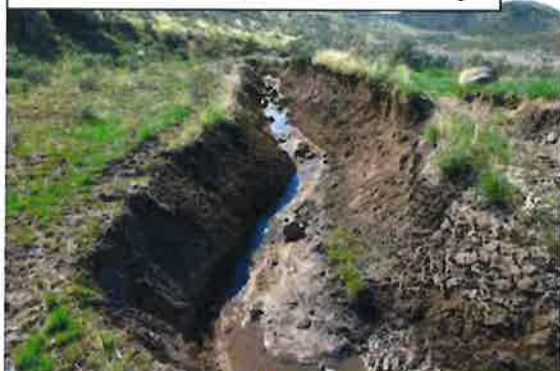
Pond No. 4 Spillway DS View – Flowing

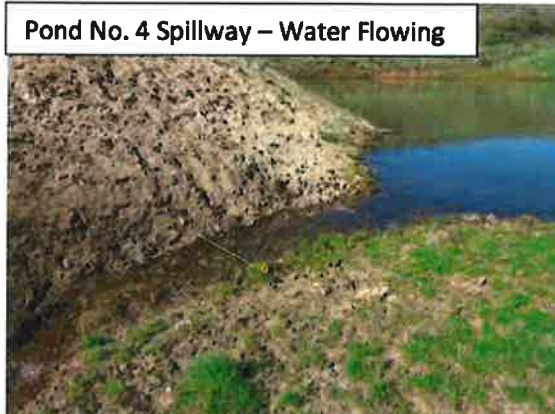
Pond No. 4 Spillway – Water Flowing

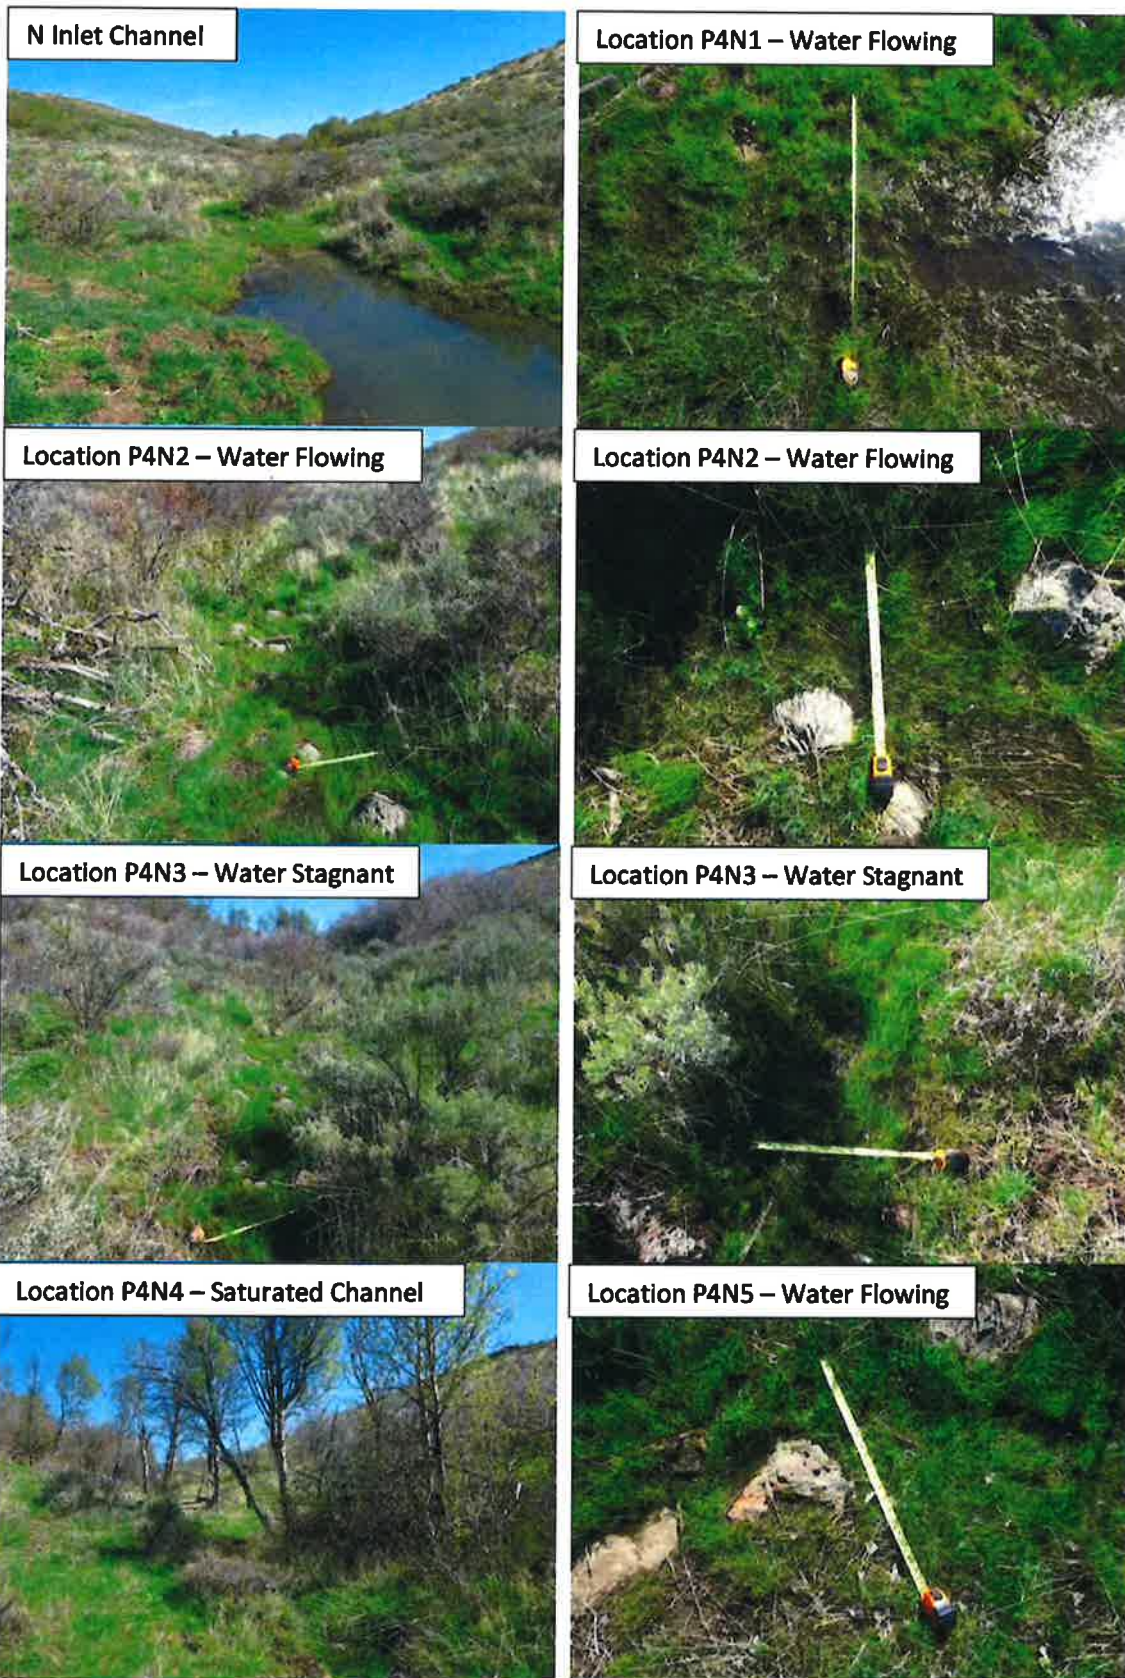
Photo 13: Photos captured at sites along the Pond No. 4 north stream channel as illustrated in Figure 7; see Table 4 for corresponding site observations.

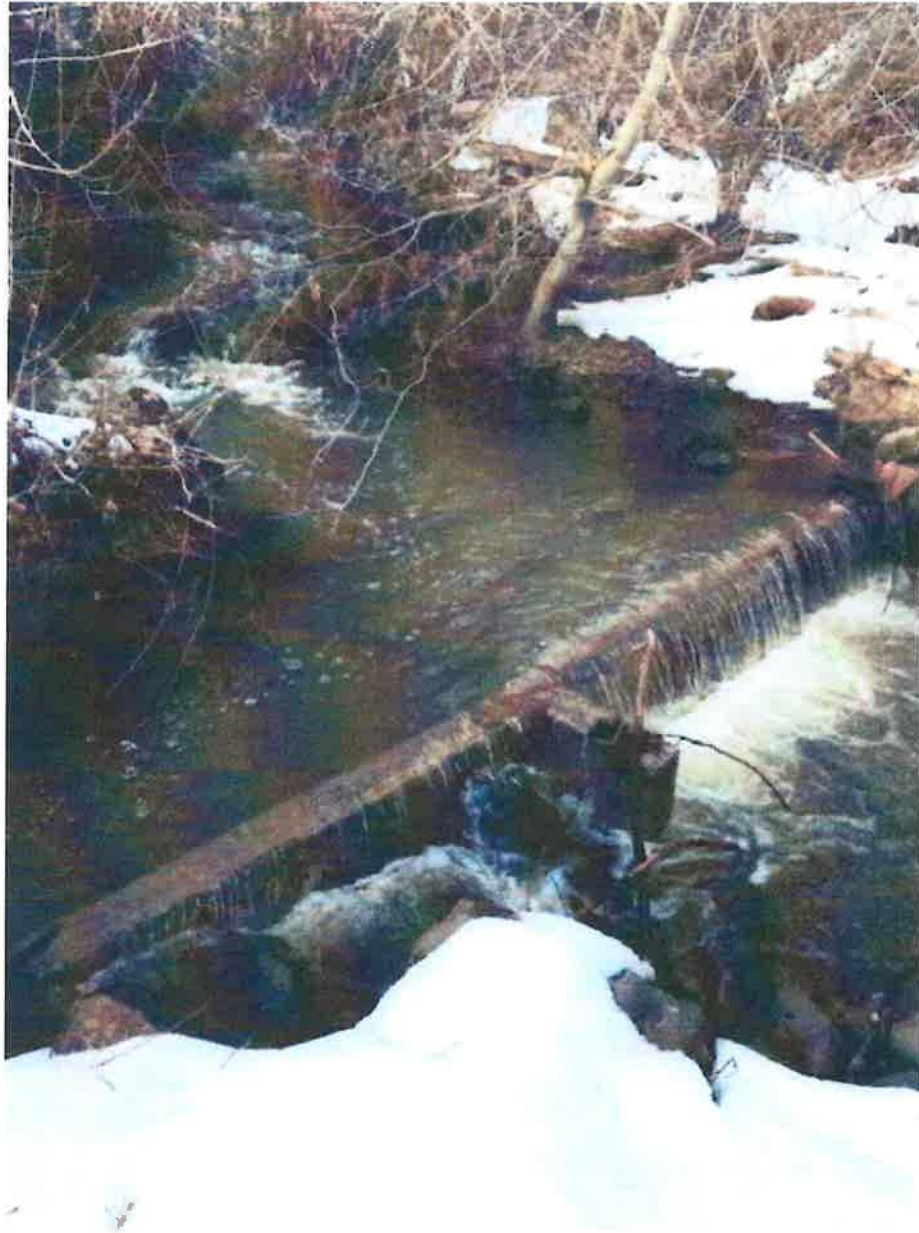
**Exhibit 7**

On March 9, 2019 Mr. Rockford Stone, an employee of Eckhardt Family LLLP, visited the Jenkins Reservoir POD and took the photo attached as Exhibit 7 showing water passing the Jenkins Reservoir POD. There were no downstream diversions occurring at the time of the photo and Exhibit 8 is a photo taken 2 days later on March 11, 2019 showing the discharge of Jenkins Creek at the Road Crossing identified on Exhibit 1. The water passing the Jenkins Reservoir POD shown in Exhibit 7 is unappropriated water that discharged to the Snake River.

On March 9, 2019 there was unappropriated water leaving the basin as shown in Exhibit 7. That unappropriated water is available for the applicant's stock watering ponds.

Jenkins Creek Reservoir Diversion 3-9-2019
