**APPLICATIONS FOR PERMIT NOS. 67-15292 –  
67-15298, 67-15300 AND 67-15322 AND  
APPLICATION FOR TRANSFER NO. 82712  
IN THE NAME OF ECKHARDT FAMILY LLLP**

**Applications for Permit Nos. 67-15292 – 67-15298,  
67-15300 and 67-15322 and Application for Transfer No. 82712  
In the Name of Eckhardt Family LLLP**

DATE: April 20, 2018  
SUBJECT: Eckhardt Pond Nos. 9 and 11 Site Visit

DATE: May 31, 2018  
SUBJECT: Eckhardt Pond Nos. 1, 2, 3 and 4 Site Visit

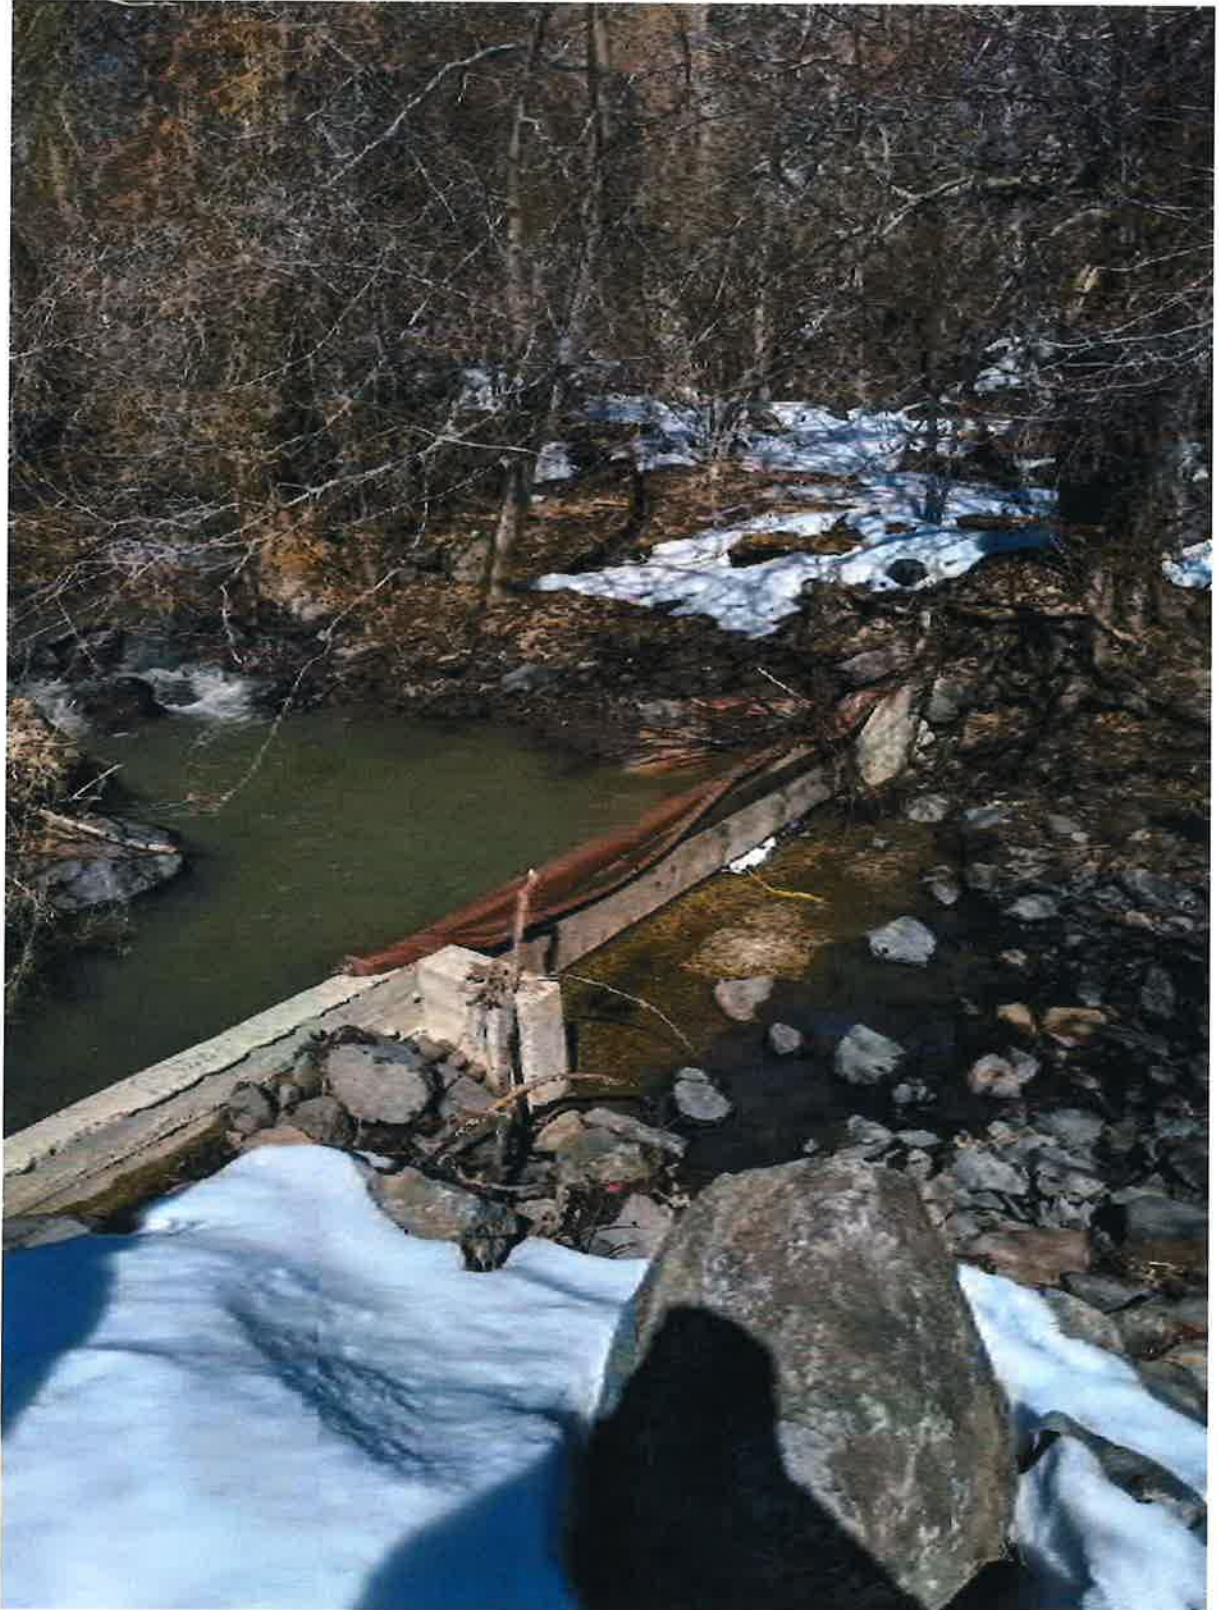
**Exhibit 9**

The Jenkins Reservoir POD was visited again on March 11, 2019 at which time the reservoir diversion was taking all the available water as shown in Exhibit 9. The difference in the water supply at the Jenkins Reservoir diversion and downstream at Mr. Hoff's diversion to his Lower Reservoir, a short distance upstream of the Road Crossing as shown on Exhibit 1, is significant. Jenkins Creek gains more discharge between the Jenkins Reservoir POD and the Road Crossing than was present at the Jenkins Reservoir POD on March 11, 2019. There does not appear to be a reason water would

Jenkins Creek Reservoir Diversion 3-11-2019
