## MEMORANDUM

**To:** Elizabeth A. Tellessen  
Winston & Cashatt, Lawyers  
601 W. Riverside Ave., Ste. 1900  
Spokane, WA 99201  
**From:** Eugene N.J. St.Godard, P.G., L.Hg., CWRE  
**Date:** October 12<sup>th</sup>, 2015  
**Subject:** Hydrologic Review, Scott Gardenhour Property, Oldtown, Idaho

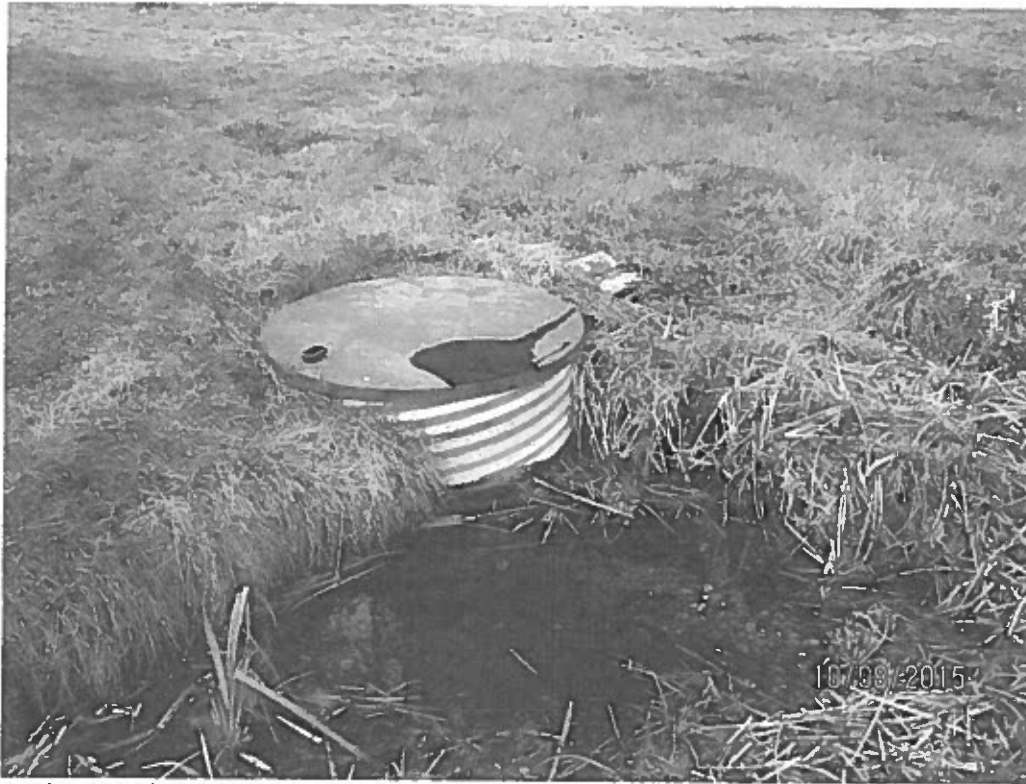
Photo 1: Picture of surface water diversion used for irrigation of lawn.

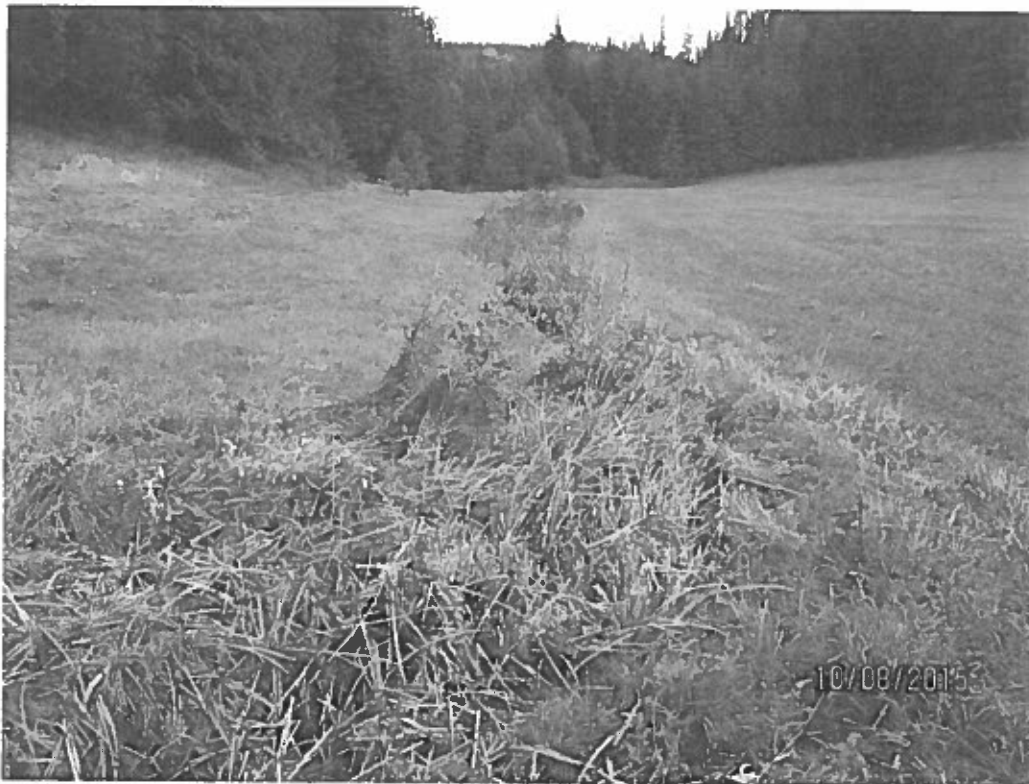
Flow in the creek was observed throughout Mr. Gardenhour's property. However, flow appeared to be obstructed beyond the diversion in the conveyance channel due to sloughing of sides and abundant vegetation. A good location to collect an additional flow in the constructed conveyance channel could not be conducted due to the poor conditions in the channel. But water was still present in the channel.

It should be noted that the measurement collected on October 8<sup>th</sup> is at a time when typically the hydrograph of creeks in this area are at annual low flow conditions. Also, it should be noted that the area is currently within a drought year. Therefore the flow which is currently observed can be inferred to be representative of the yearly low flow in a very low precipitation year. Essentially representative of the worst case scenario. Flow at the time of this site visit was recorded at 0.04 cfs. In my professional opinion, flows in higher precipitation years will most likely be greater than those observed at the current time. It should also be noted that flows within Albeni Creek are being restricted from the abundant vegetation within the creek (see Photo 2) and the sedimentation of the channel.

Photo 2: View looking upstream from diversion point showing existing condition of stream channel.
