Enclosed please find photos of the diversion on Eddy Creek at the IDWR GPS location A0002590 which is owned by Sidlo.

**The enclosed Photographs were taken in November – AFTER the close of the irrigation season.**

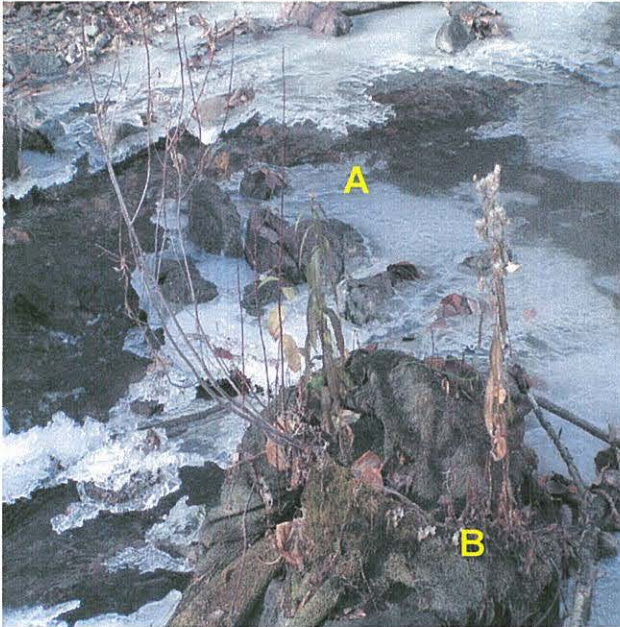
Photo 1

At position A Wall of rocks placed to divert flow in the creek. While not illegal, it does prevent the natural flow and delivery of other Water rights.

At Position B Pile of Rocks and Man made objects, including Carpet placed in the creek.

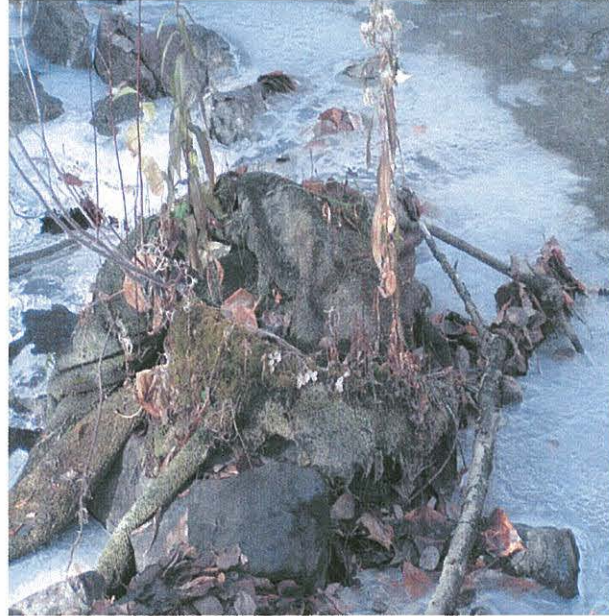
Photo 1 B

Clearly shows Carpeting which had been placed in the Creek.

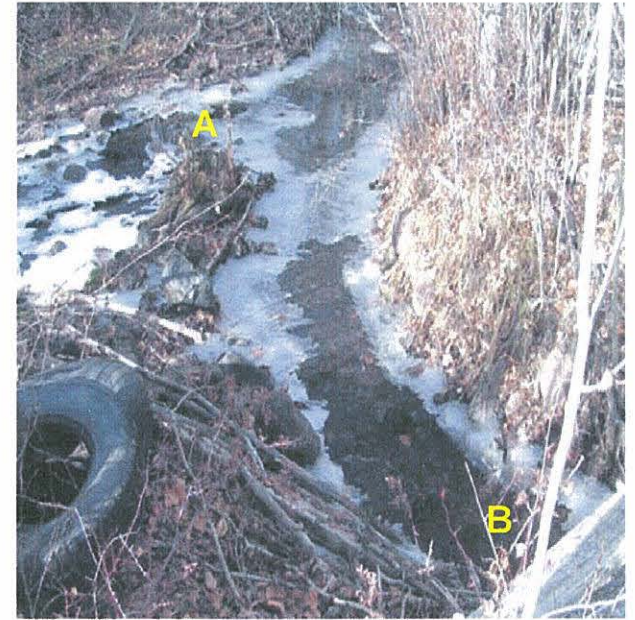
Photo 2

At Position A The man made dam is seen to divert a majority of the creek.

At Position B The piece of dimensional Lumber designates the end of the diversion area and the start of a ditch.

**Please Note** in Photos 2, 3, and 4 The Walls of the Diversion area and the walls of the Ditch can clearly be seen to be substantially Vertical and to have been cut with a mechanical means such as an excavator or a backhoe.

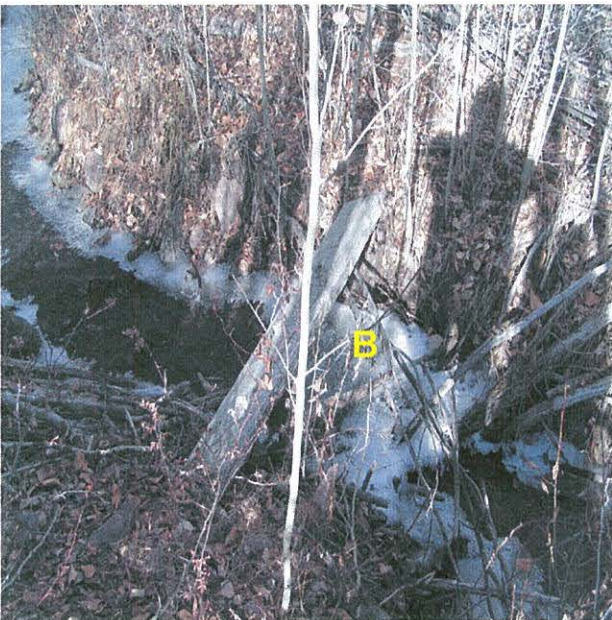
Photo 3

Again at Position B The piece of dimensional Lumber again designates the end of the diversion area and the start of a ditch.

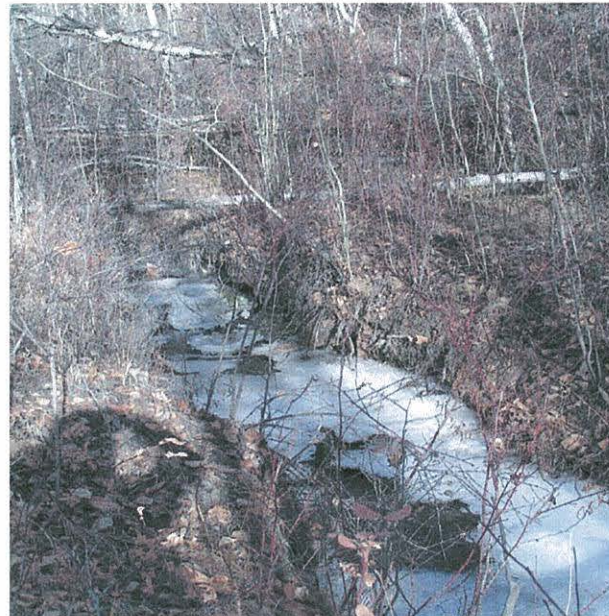
Photo 4

Shows the ditch as it travels the distance to the Headgate.

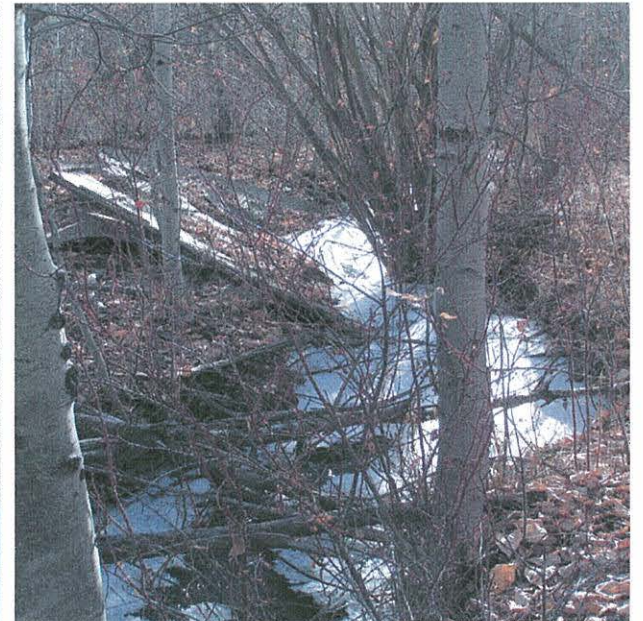
Photo 5

Shows the ditch as it travels a further distance to the Headgate. This also shows trash diverting the ditch flow.

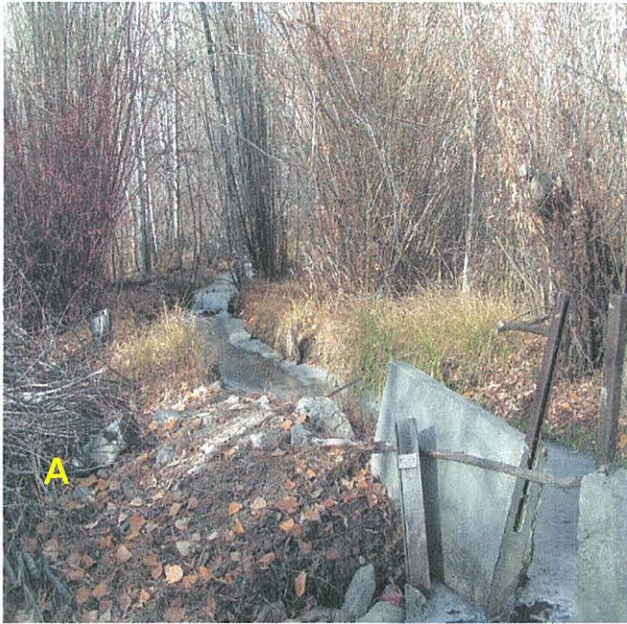
Photo 6

From the Headgate area, This again shows the ditch and another distance required to reach the Headgate. At A it shows that the bank had to be substantially built up to maintain the ditch flow.

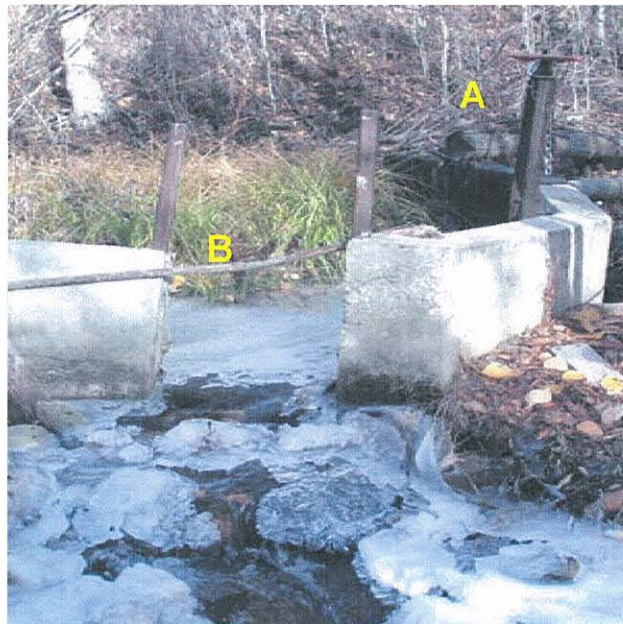
Photo 7

At position A The locked Headgate which is mandated by law to be secured.

At Position B The Flow can be seen to be Dumped onto the ground, instead of remaining in the Creek and Not diverted, especially since this is Not Irrigation Season.

If the headgate were to be placed on the creek, as are the other headgates in the district, only the correct water right amount would be diverted and the excess water would not be dumped onto the ground but would remain in the creek where it belongs.

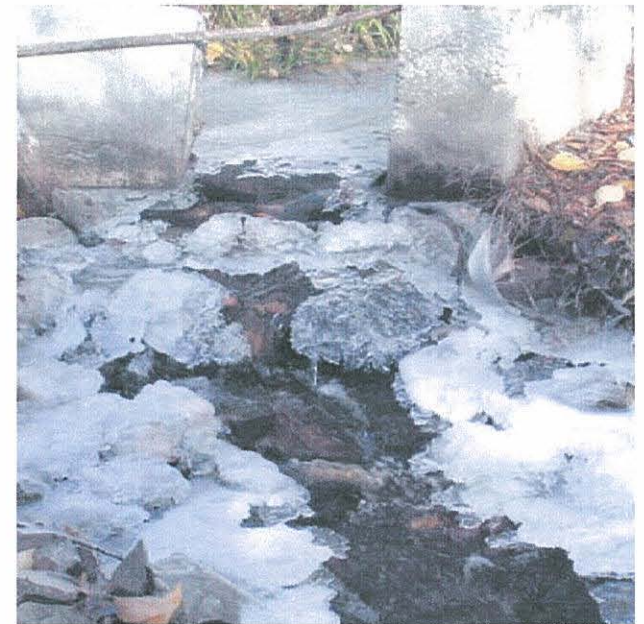
Photo 7B

Clearly shows the Quantity of the Flow improperly diverted.

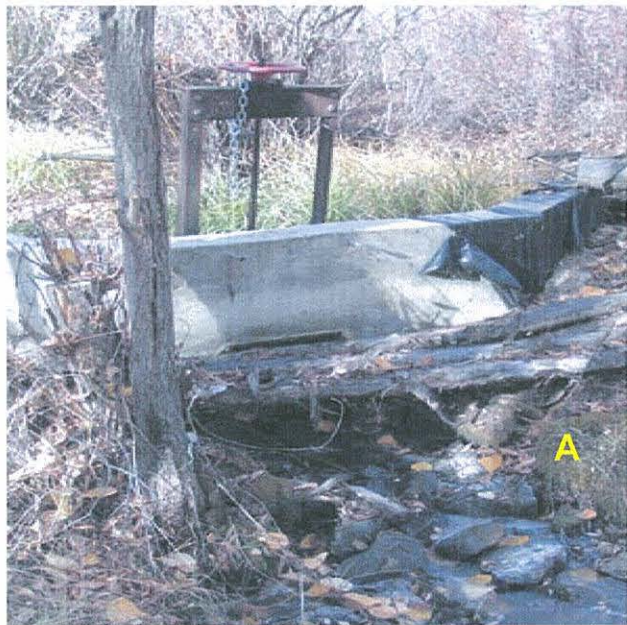
Photo 8

Clearly shows the Quantity of water which flows through the secured Headgate.

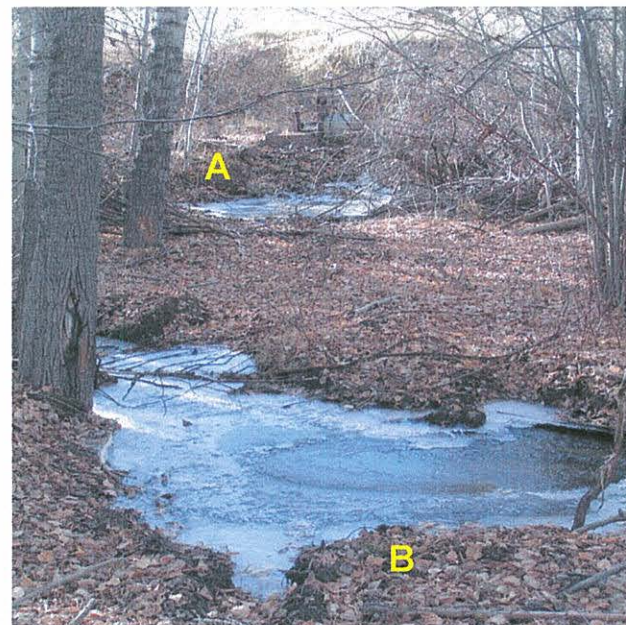
Photo 9

At position A The Next Diversion on the creek, secured, and the normal flow of the creek. This area is the access to that Diversion.

At Position B This clearly shows the Quantity of water which has been wrongfully diverted from the creek and dumped on the ground.

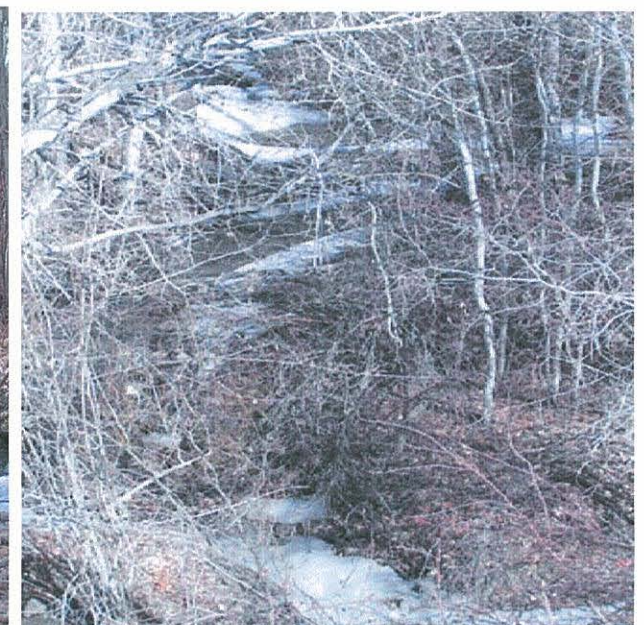
Photo 10

This shows the water which has been diverted and dumped on the ground as it is spread across the ground before it trickles back into the creek.
