**Field Exam Summary A25-12306 November 15, 2003**

Water Resources Field Services

**General Comments - All Maurice Robison Claims**

**General Comments - A25-12306**

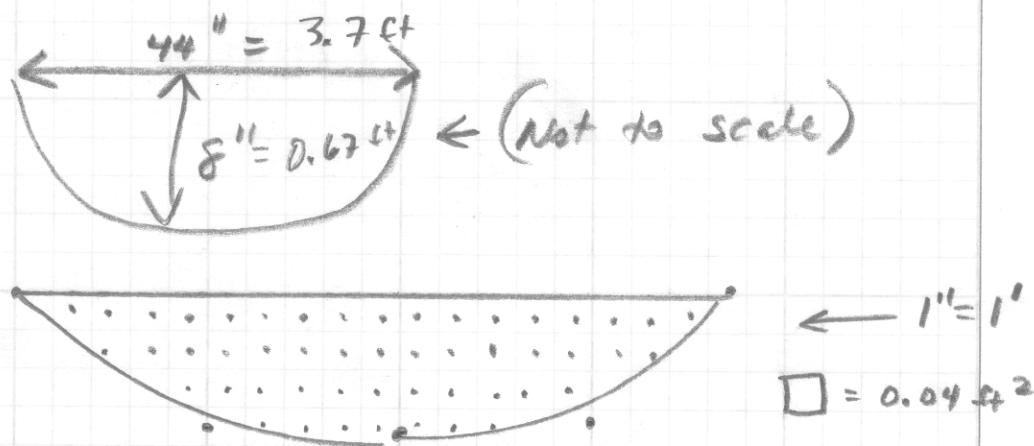
Cross-section (see A25-13582Notes-3.jpg):

I did not have my lazer level so I measured approx ditch dimensions w/ tape measure I planned to take slope from USGS map, plotting ditch locations w/ GPS. On a small scale the ditch appears to go uphill in places but over the length, the ditch about parallels the 6280 contour. Since the reservoir elevation is given at 6290 and the last waypoint <sup>(118)</sup> is much closer to the 6280 than the 6260, I suppose fall is about 10 ft in the mile length of the ditch.  $\frac{10}{5280} \approx 0.0019$ .

$$HR = \frac{A}{WP} = \frac{2.0 \text{ ft}^2}{4.38 \text{ ft}} = 0.46 \text{ ft}$$

$\approx 50 \text{ squares} \approx 2.0 \text{ ft}^2$   
WP measured w/ ruler =  $4\frac{3}{8} \text{ ft}$   
 $\approx 4.38 \text{ ft}$

Mannings' n from Perry Civil Engineering  
Handbook 1959

Earth, some weeds 0.025 0.030  
Earth, dense weeds 0.030 0.040

I select 0.030 as mid-range value.

$$Q = \frac{1.486}{n} A R^{2/3} S^{1/2} \quad (\text{Bureau Rec} \\ \text{Data Meas. Manual} \\ \text{p170})$$

$$Q = \frac{1.486}{0.030} (2.0) (0.46^{2/3}) (0.0019)^{1/2} = 2.6 \text{ ft}^3/\text{s}$$

The slope could be double what I estimated  
and n could be 0.025.

$$Q = \frac{1.486}{0.025} (2.0) (0.46^{2/3}) (0.0038)^{1/2} \approx 4.41 \text{ ft}^3/\text{s}$$

The slope could be half what I estimated  
and n would be 0.04

$$Q = \frac{1.486}{0.04} (2.0) (0.46^{2/3}) (0.00095)^{1/2} \approx 1.38$$

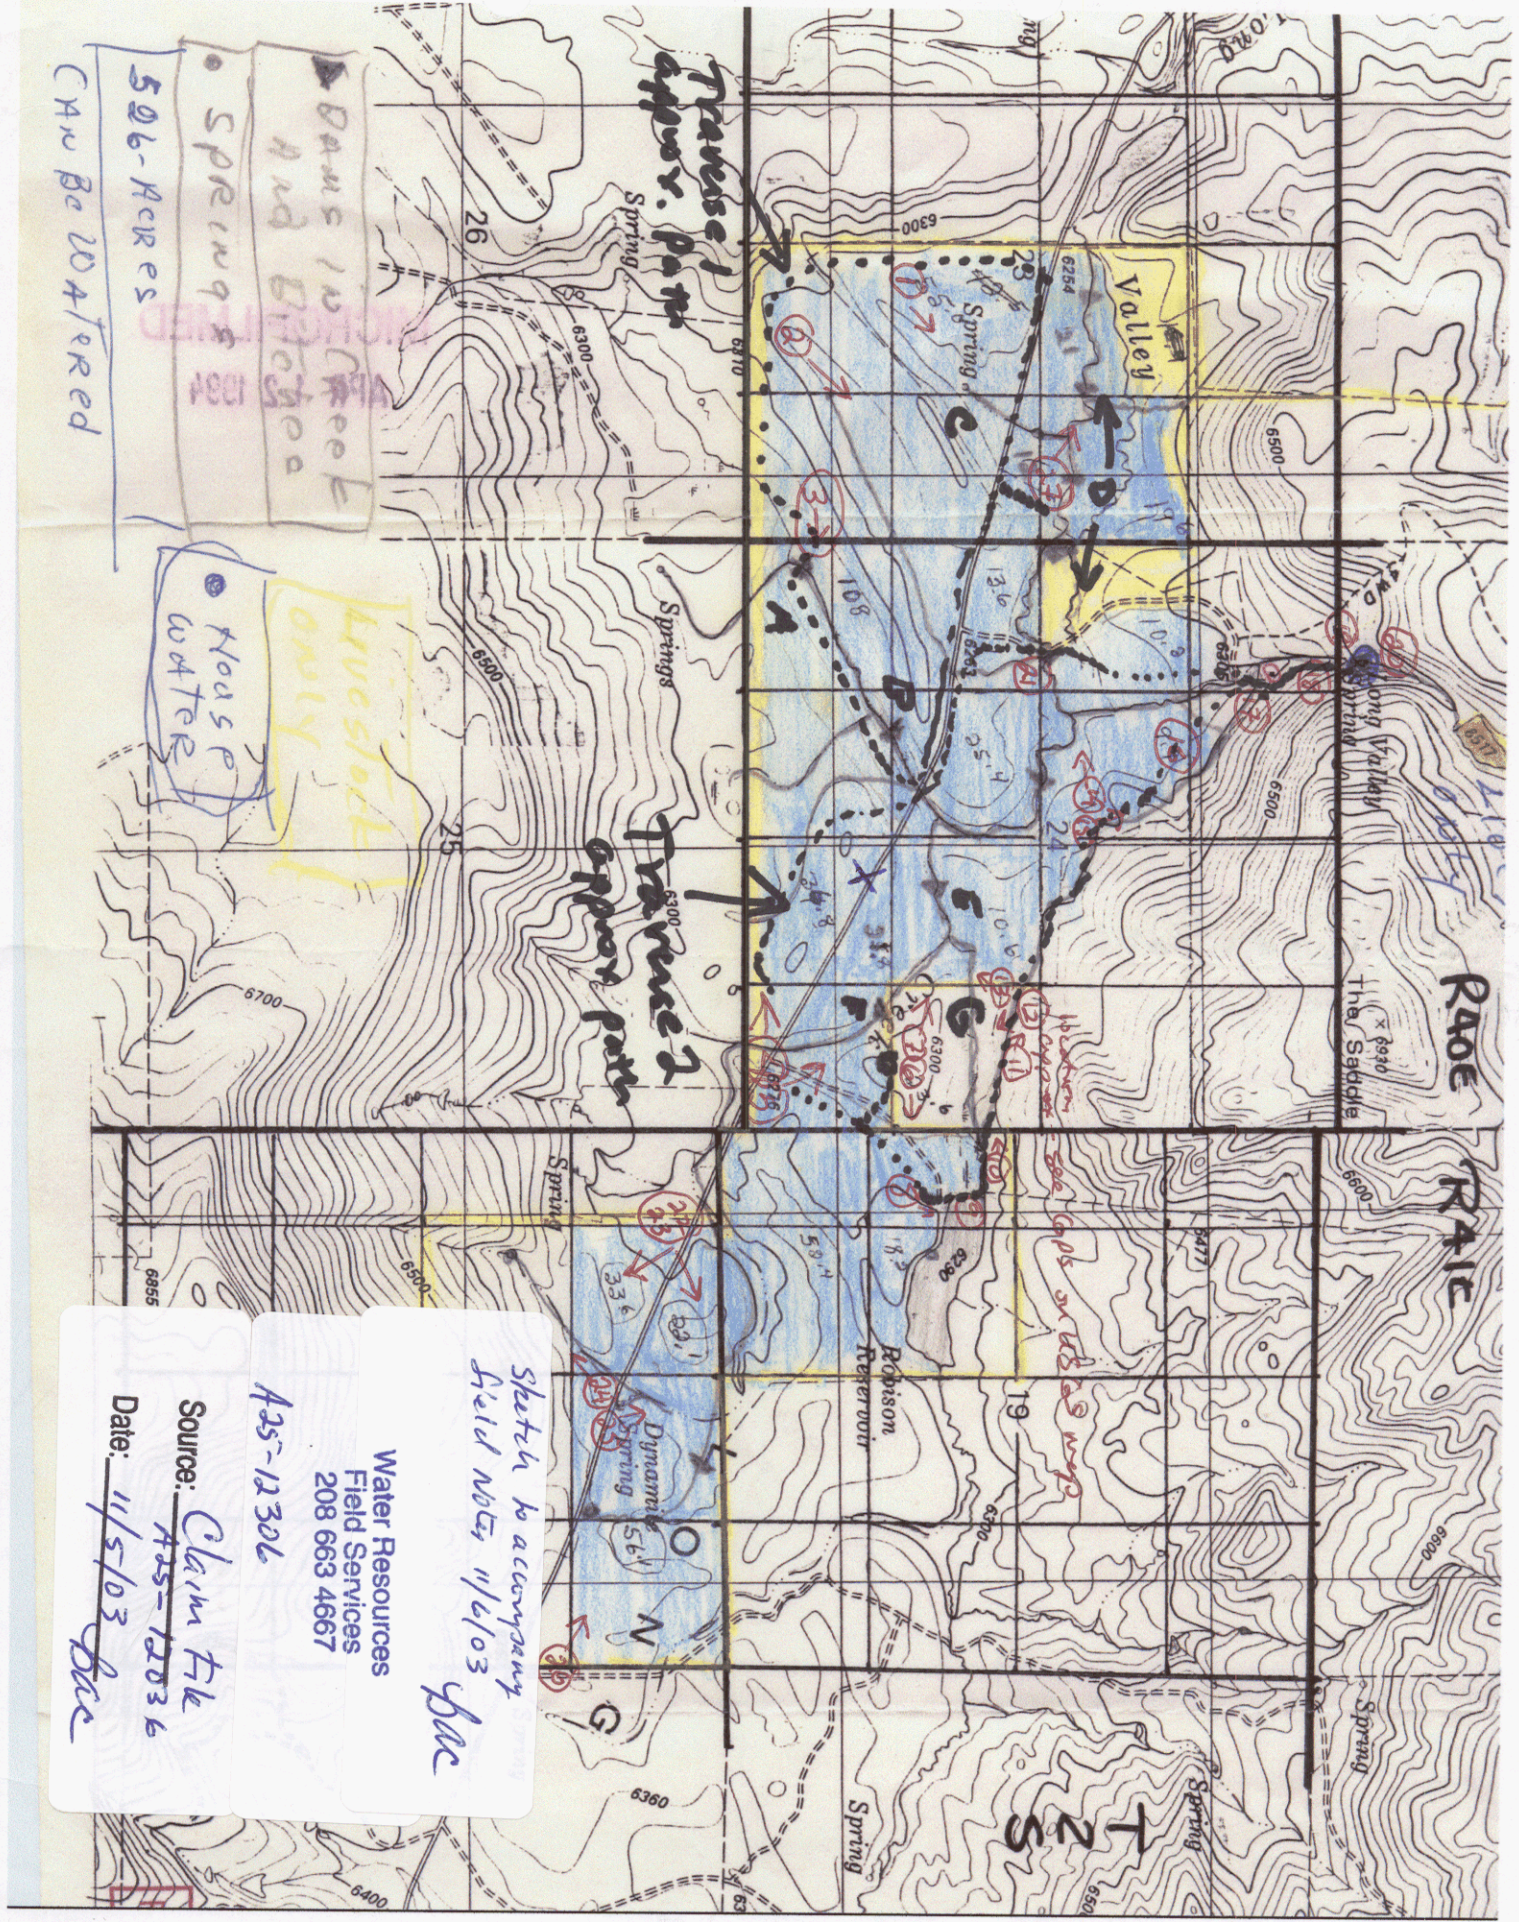
Sketch to accompany  
Field Notes 11/6/03  
Dac

On November 6 I returned and did a more thorough investigation. Field notes are in the photos directory as A25\_13582Notes\_X.jpg where "X" is the page number. GPS readings are in UTM and correspond to points sketched on a copy of a USGS map in paper file A25-12306. Photo numbers in the notes refer to the red circles on a copy of the claimant's map, also filed in paper file A25-12306. GPS readings for Points of Diversion are reported in the summary write up and the data file in IDTM coordinates. My GPS unit sometimes seems to "lose" data points when I change filenames so the GPS filenames are just the names assigned by the unit.

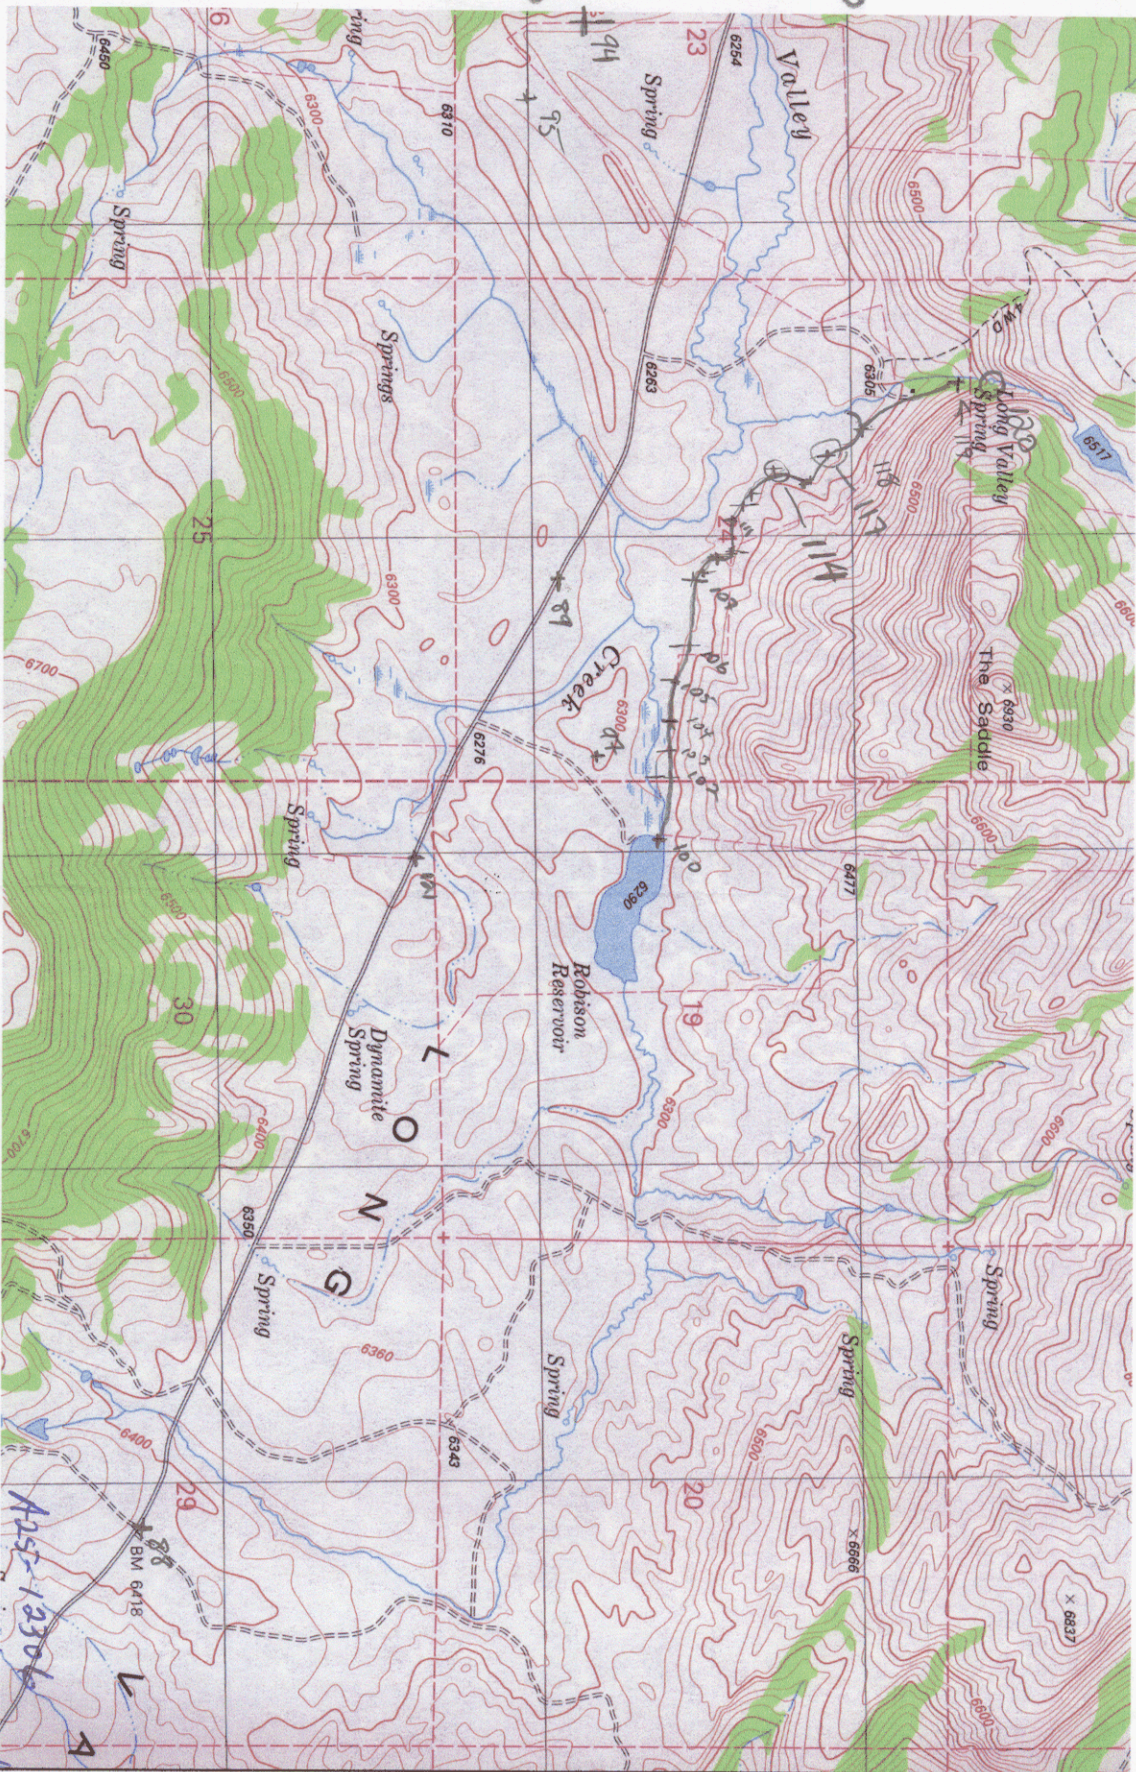
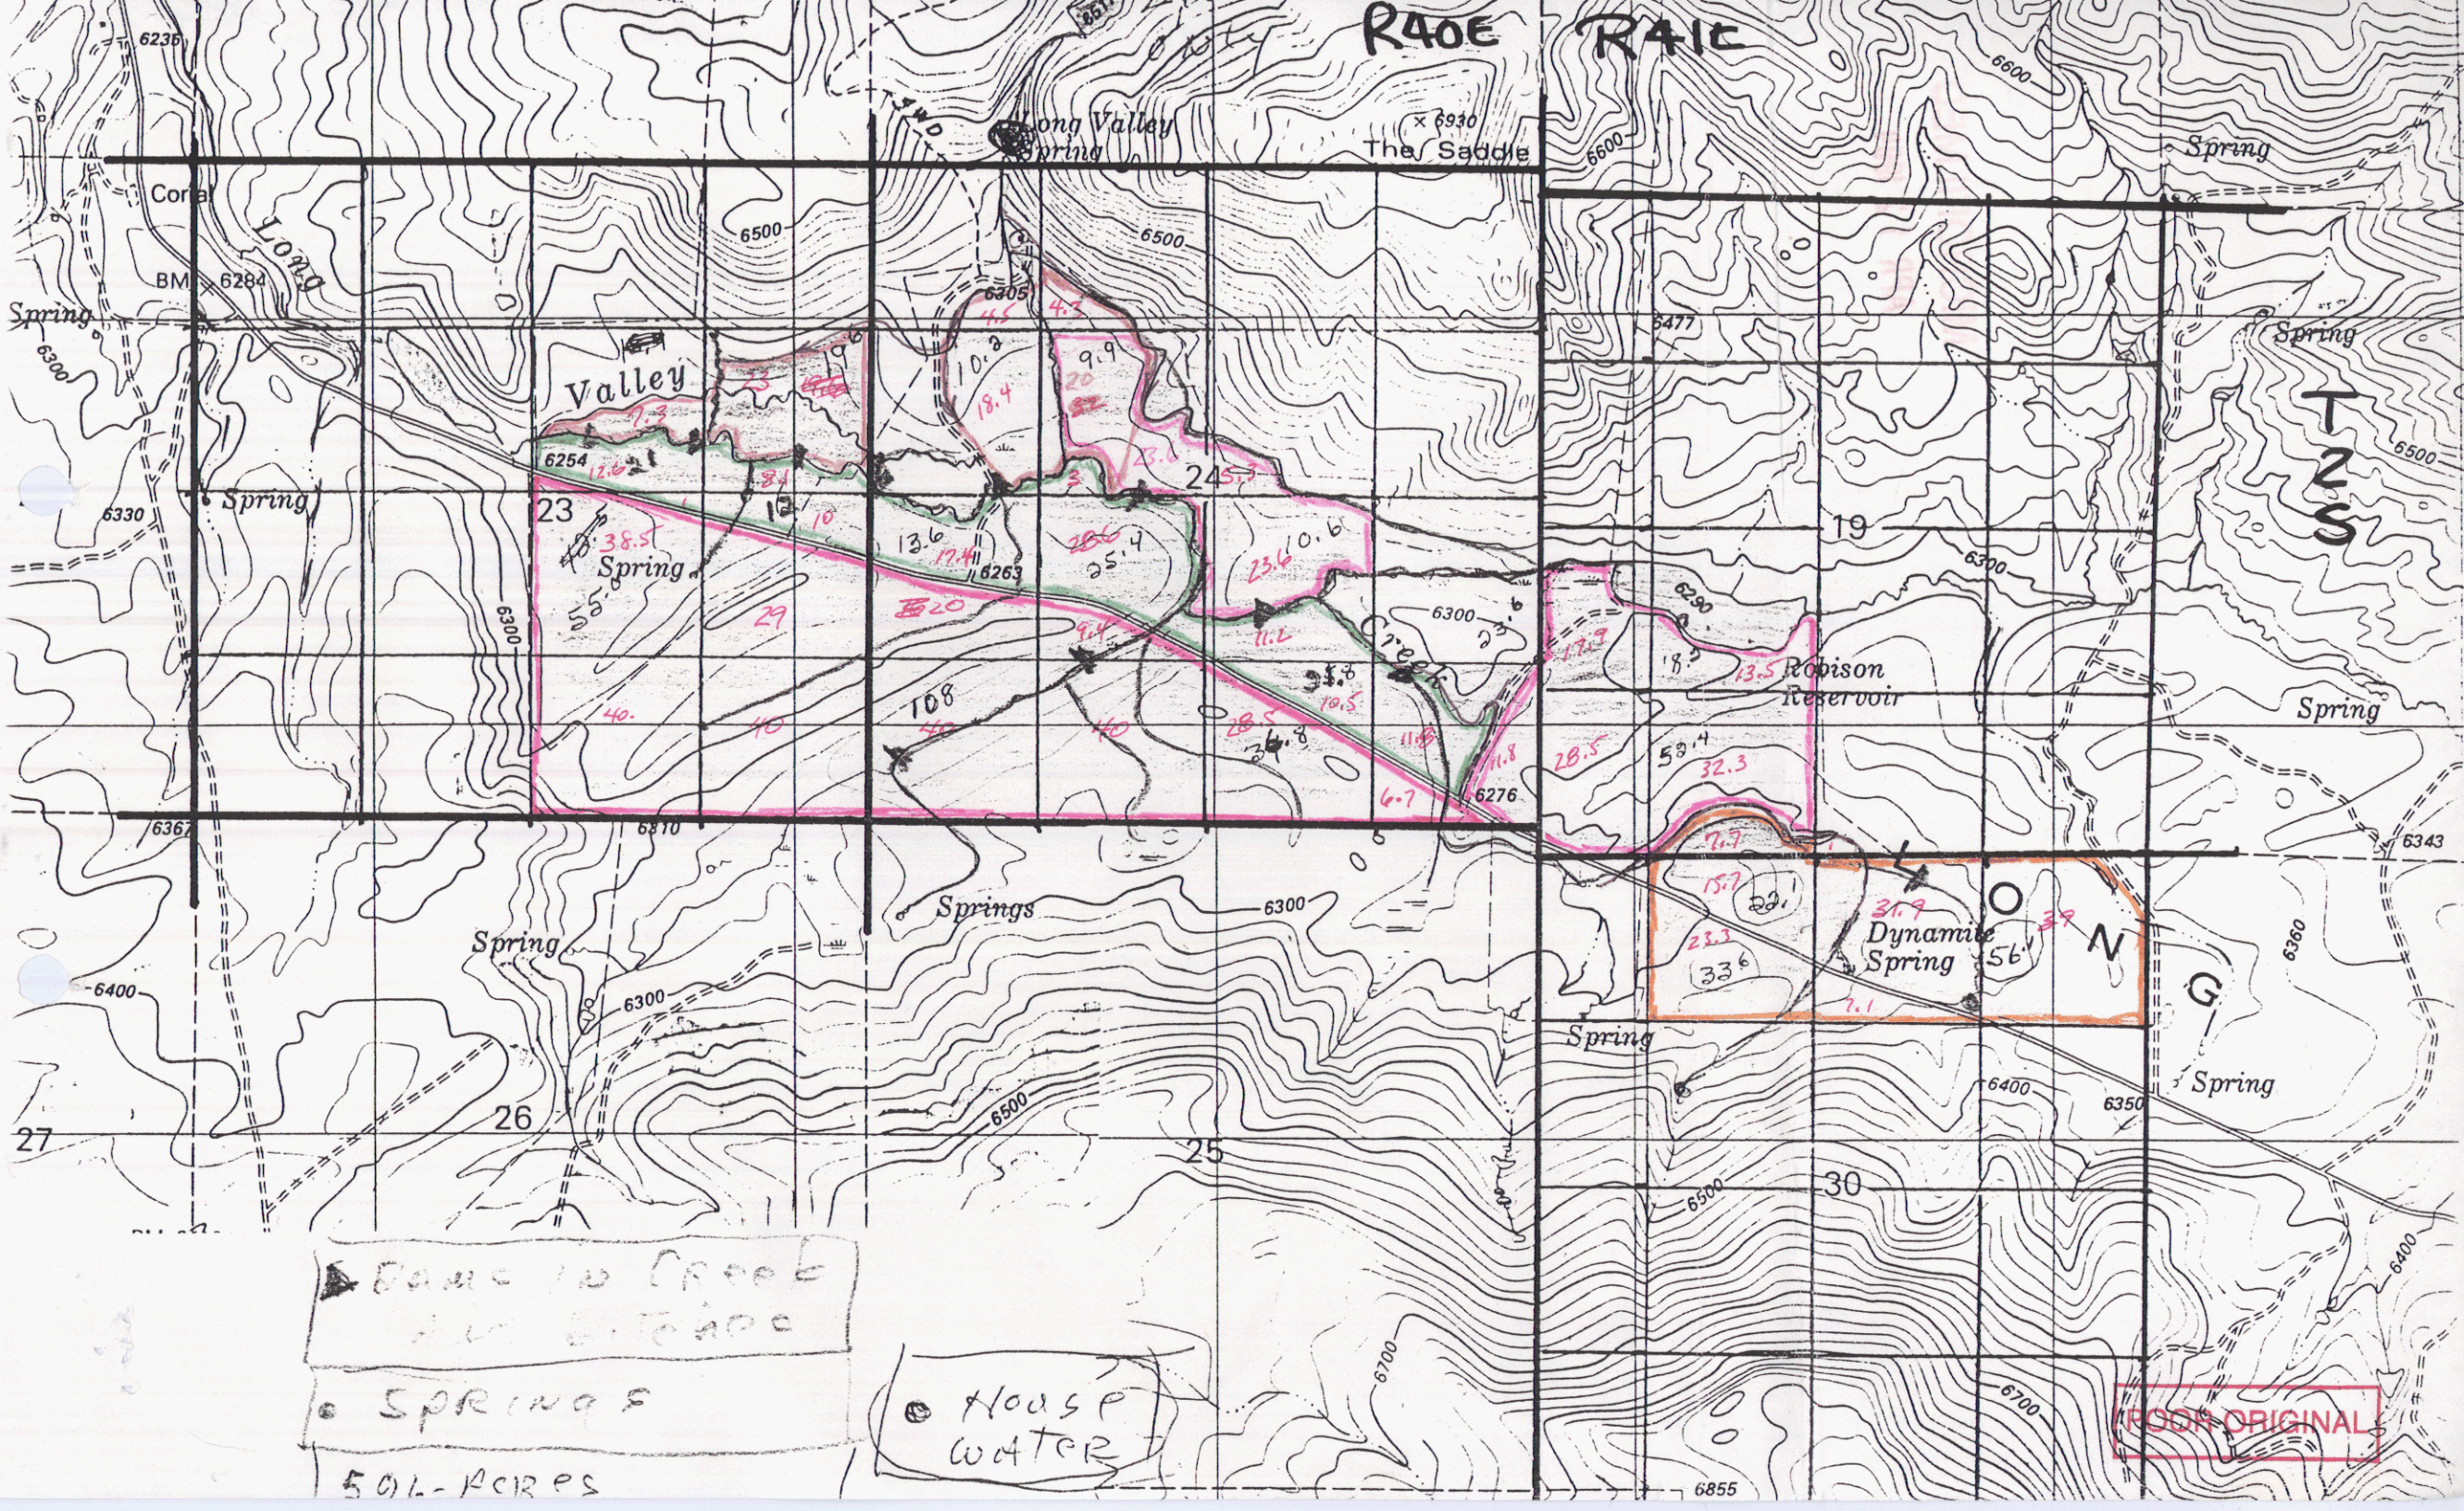
# T2N R40E Long Valley Quad 4565

G

▲ Dam to Creek  
for bitumens

• Springs

506-Acres

• House  
water
