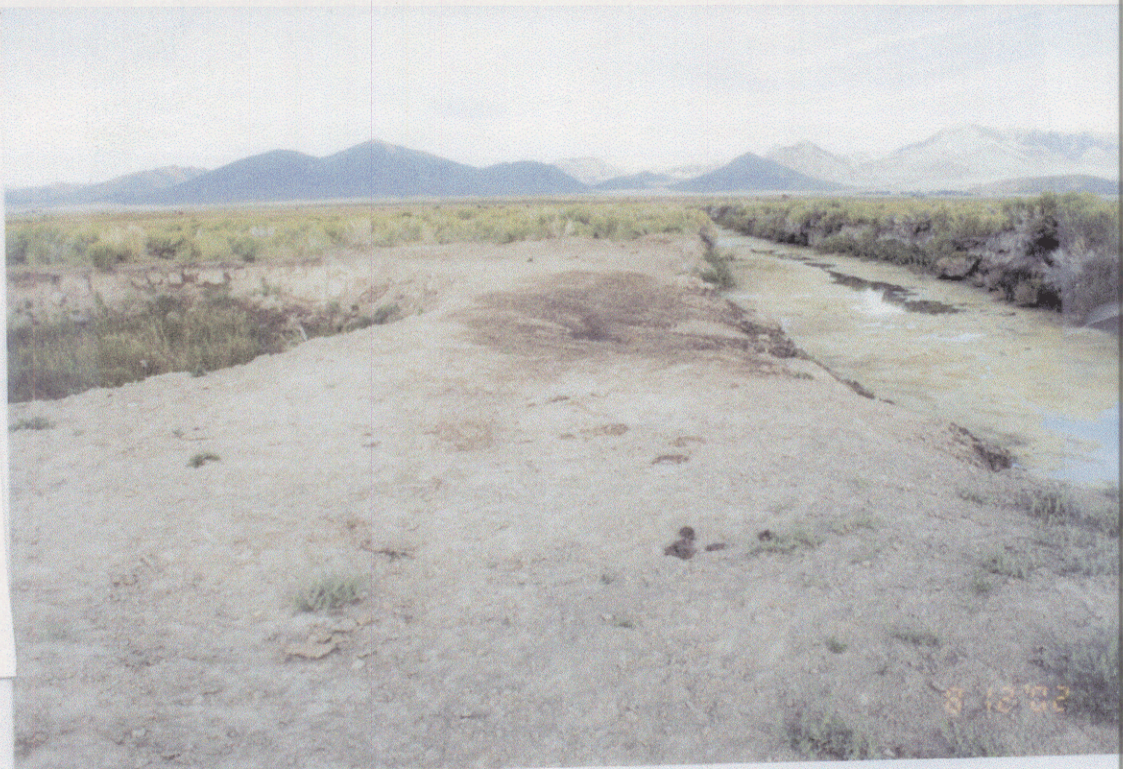
POINT #1  
EARTHEN DAM  
LOOKING WEST

20. As can be seen by the photographs of the earthen dam, there is no way to release the water except by removing the dam.

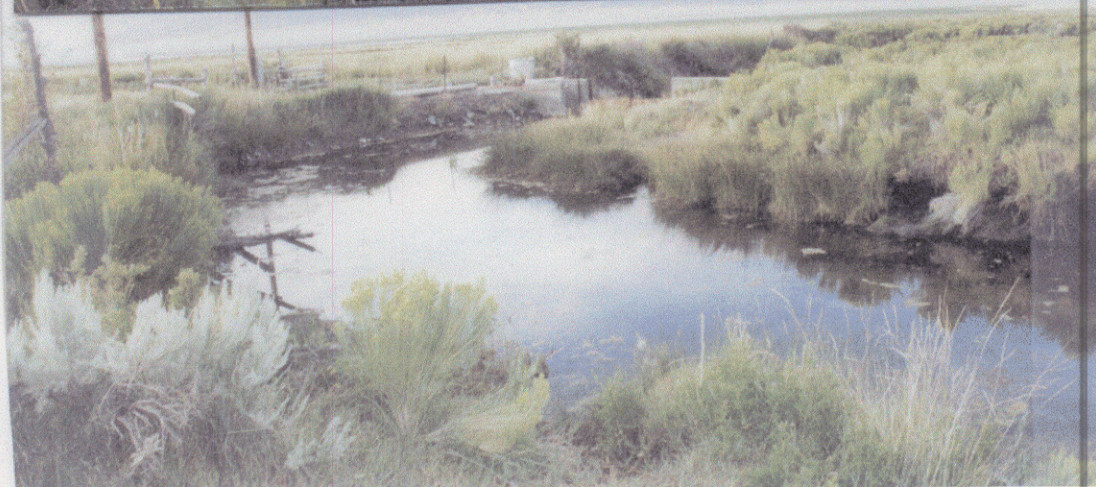
POINT #3  
CREEK BY  
PUMP, JUNCTION OF  
ALMO CREEK AND  
RAFT RIVER

8. #3 shows the concrete structure and pond at the pump site where the water was diverted into Jones'es sprinkler system. In August there was no water being diverted by the pump. It was merely being impounded so that it filled the channel towards the earthen dam and also the channel of Almo Creek, as shown in #2.

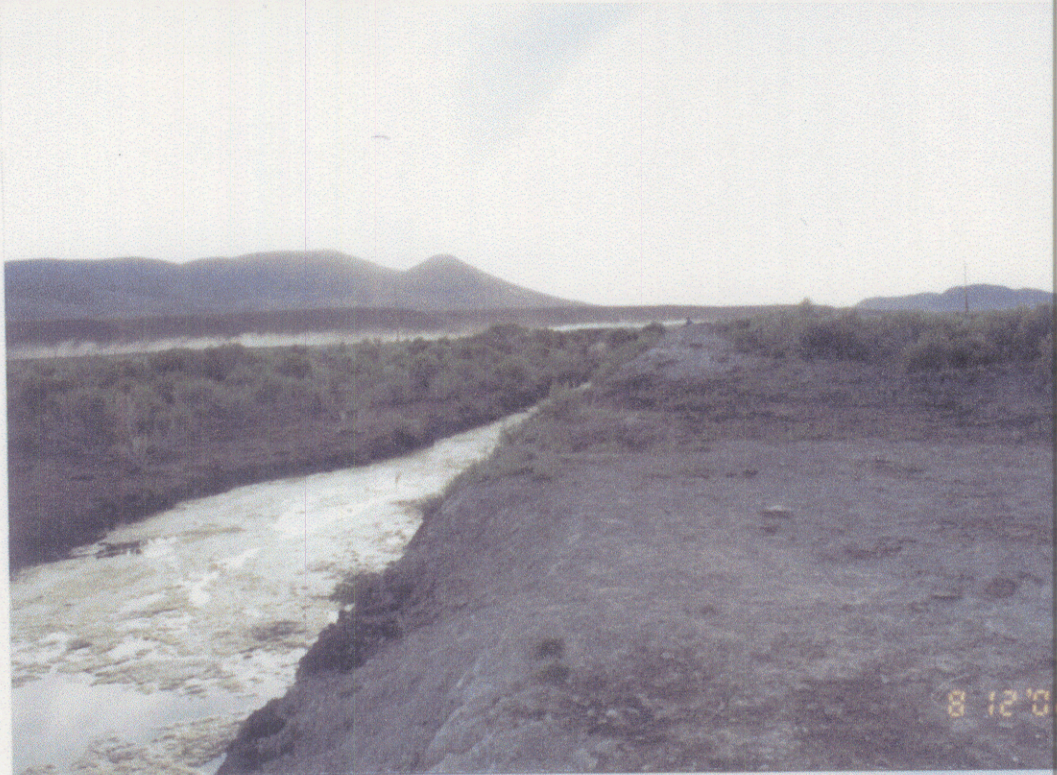
POINT #1  
EARTHEN DAM  
LOOKING ~~WEST~~  
*EAST*

9. The next photo was taken from Point #1, the earthen dam looking Eastward.

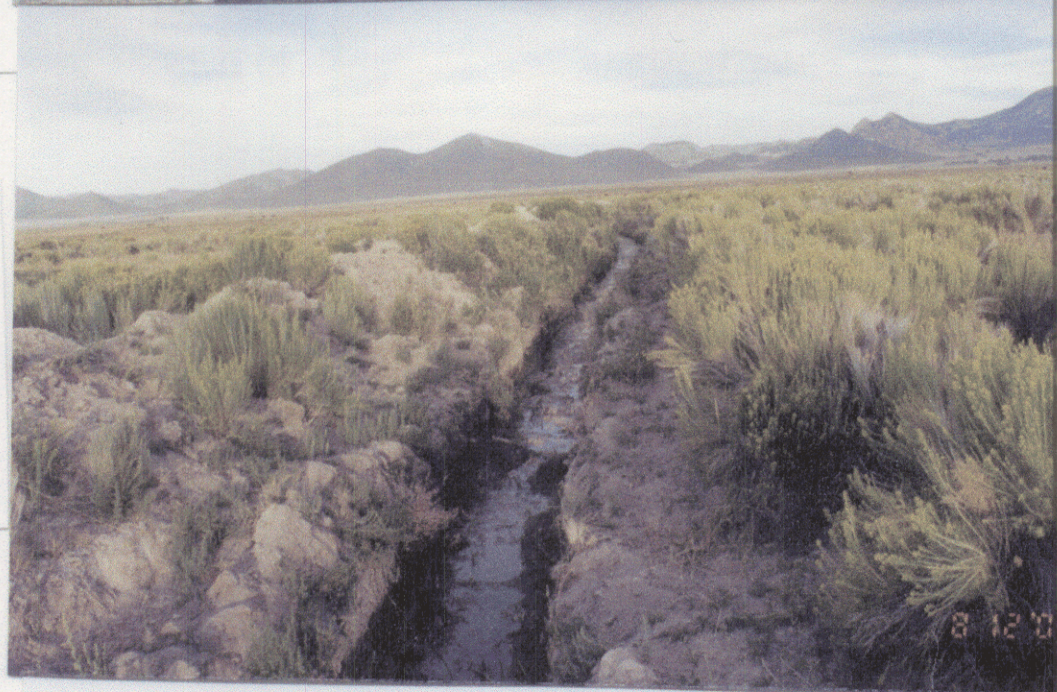
POINT #5  
RIPPLE IN DITCH  
WEST OF JONES

10. The next photo was taken from Point #5, near Jones'es fence, looking towards the Earthen Dam, showing that some water was reaching Jones'es fence. This water ran down the ditch part way to the pump site, to about Point #4, but all sank before it reached the pump site.

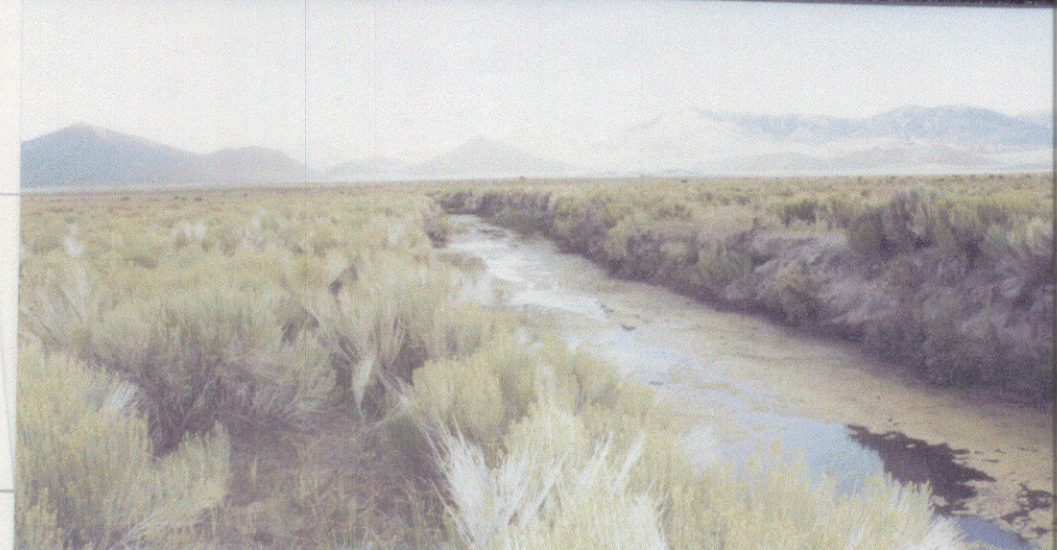
POINT #6  
WEST OF  
EARTHEN DAM

11. The next photo shows the pond created by the earthen dam, about 100 yards West of the Dam at point #6.

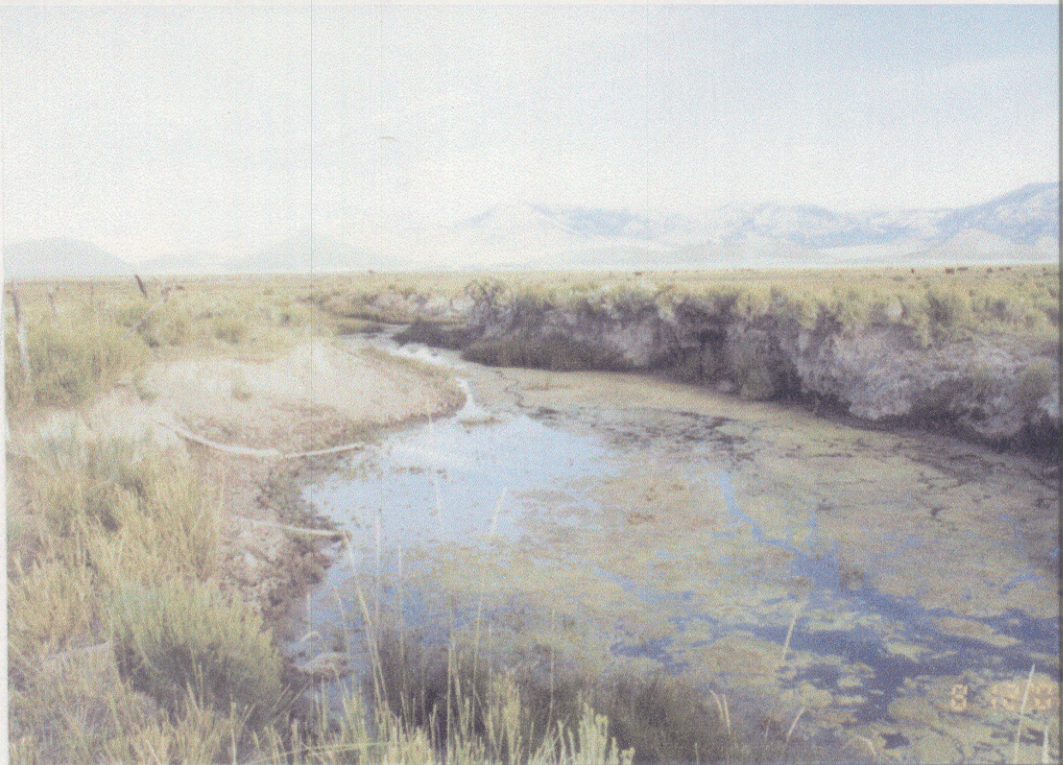
POINT #7  
WEST OF  
EARTHEN DAM

12. The next photo shows the pond about 220 yards West of the Earthen Dam . This Photo was taken from Point #7.

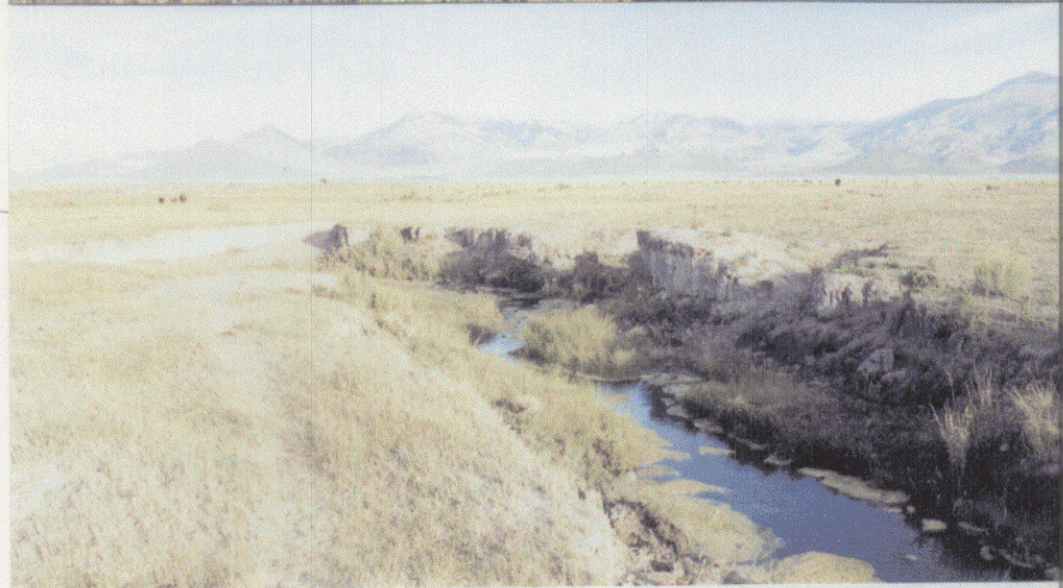
POINT #8  
WEST OF  
EARTHEN DAM

13. The next photo shows the pond about 3/16ths of a mile West of the Earthen Dam at Point #8, showing the Western end of the pond. Where the pond appears to turn toward the South is very near the measuring device at Point #9. Water springs up in potholes in the area near the measuring device slightly to the Northwest. There is another large spring about 1/2 mile North at the foot of Jim Sage Mountain and somewhat wet areas in between, which are possibly seepage from the mountain.

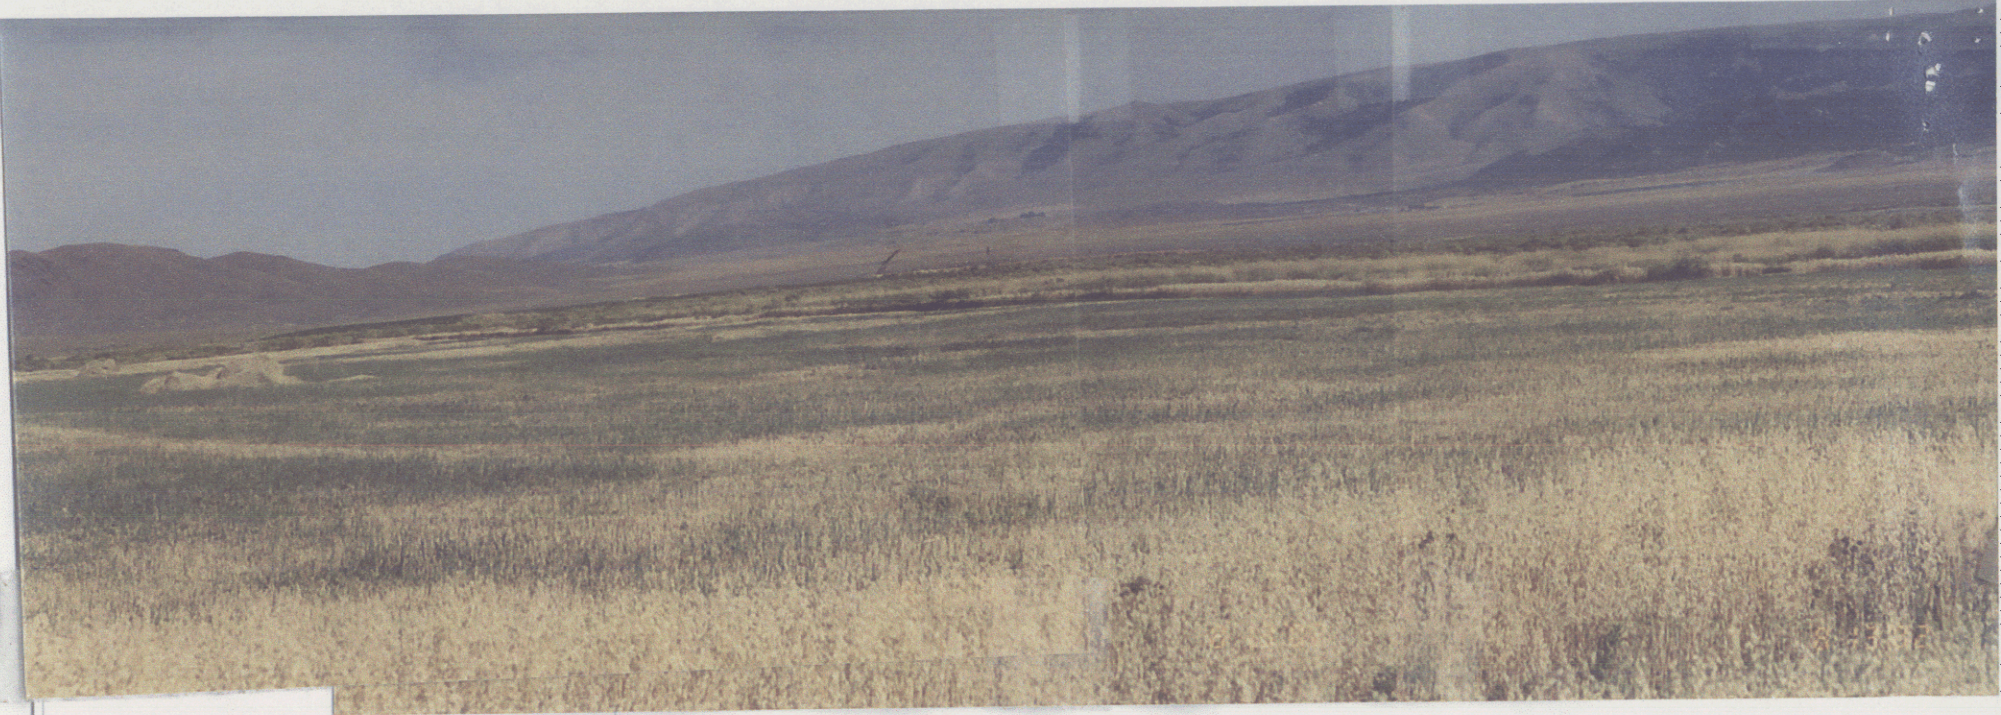
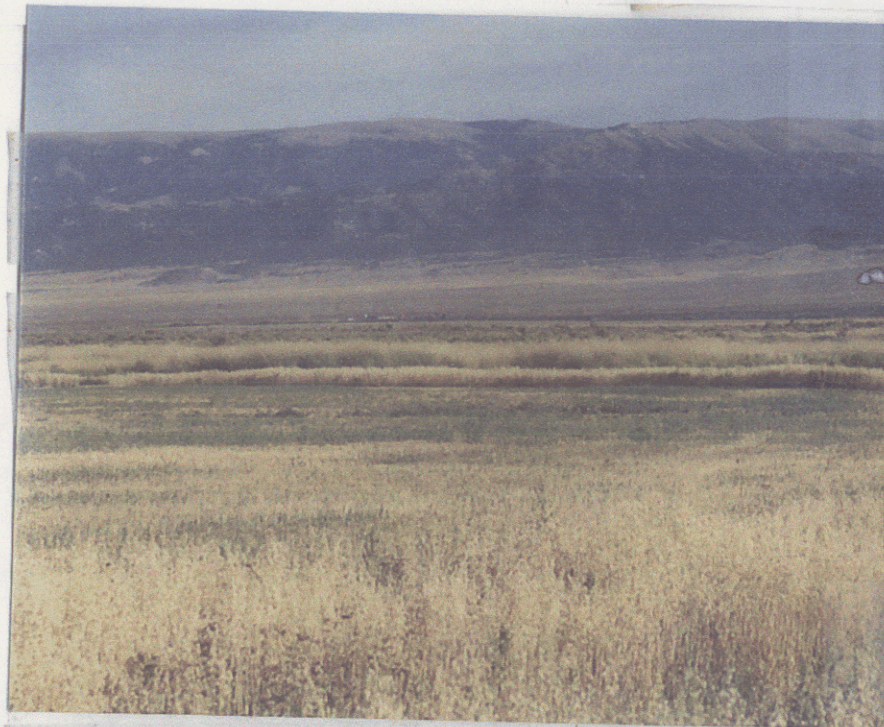
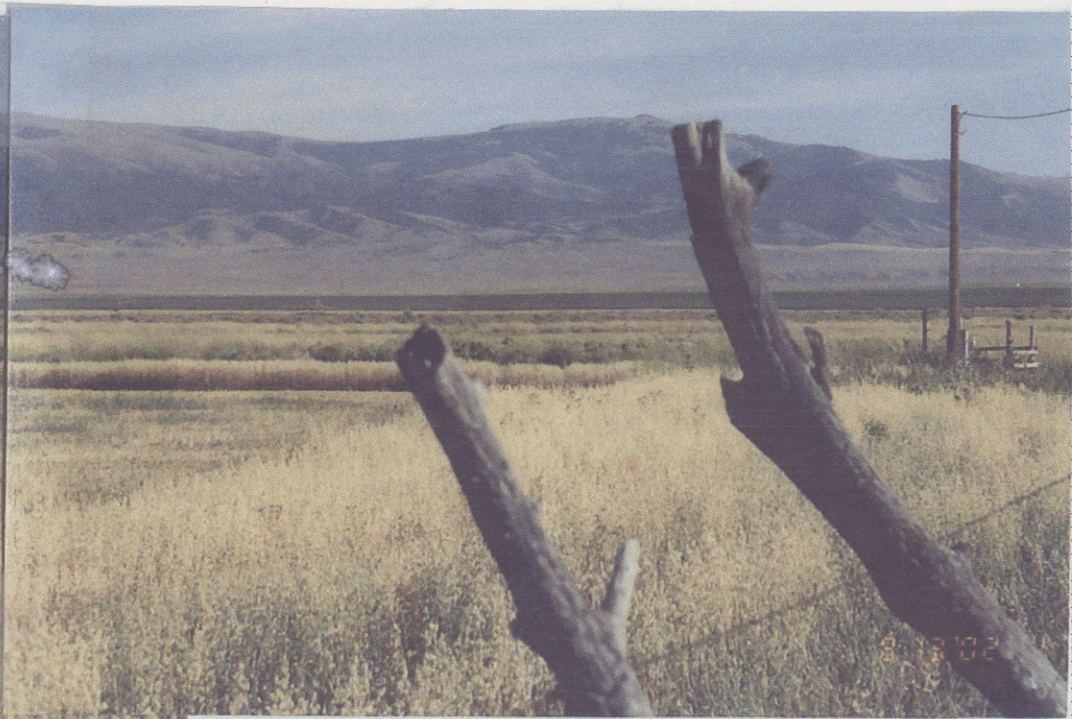
LOOKING ACROSS THE FIELD FROM POINT #4

14. The next group of photographs show the area in the Reccommended Place of Use which Joneses claim they have ceased to irrigate allong the South of the Place of Use. They are now

irrigating new ground on the North side of the Place of Use, up to the line which I have labeled "Fence" on the Aerial Photo. This group of photographs was taken from Point #4 on the West fence looking Southeastward across the field. The area which they claim they have ceased to irrigate is covered with tall rye grass and big sagebrush.
