## MEMORANDUM

Subject: Measurements for Colwell Applications & Adjudication Claims

On June 24, 2004, Cynthia Clark and I met with George Colwell, wateruser, and Harley Noe, consultant from Associated Earth Science, to measure discharge in the Johnson-Higby Ditch, a diversion from the Payette River located north of New Plymouth at 8N 4W 20 SWNENW. Measurements of the ditch were taken shortly below the headgate and also about 1.1 miles downstream. In addition, pumped discharge from the unnamed slough identified as a source in another application was also measured.

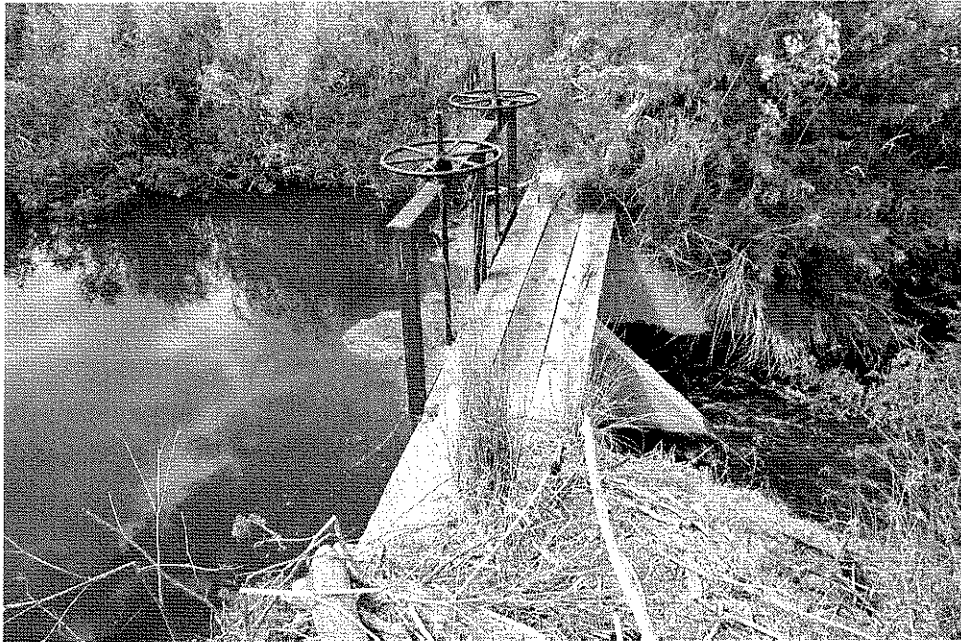
Photo 1. Johnson-Higby Ditch Headgate.

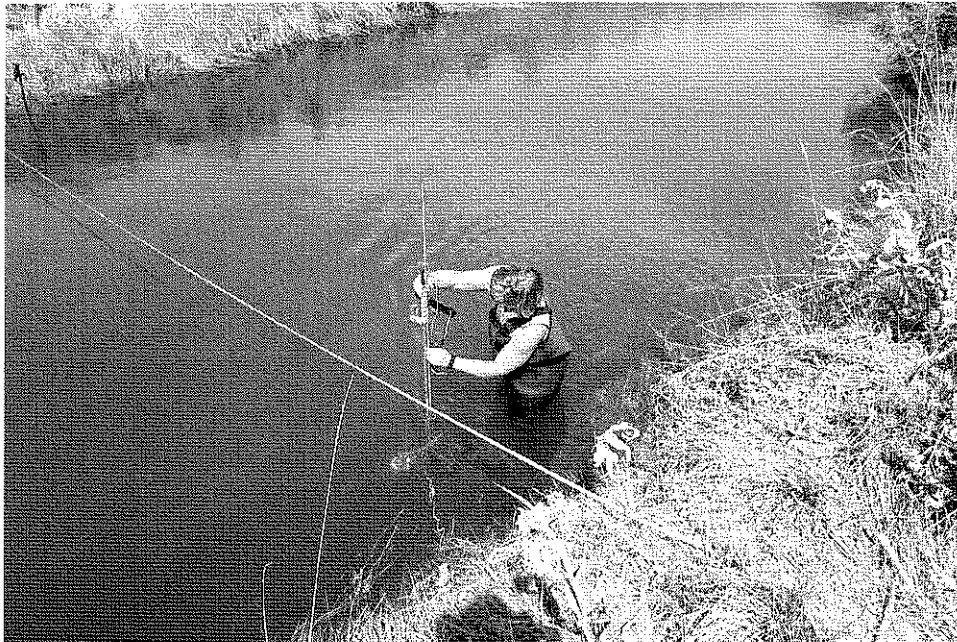
Photo 3. Measuring transect below headgate. Flow was fairly smooth and steady.

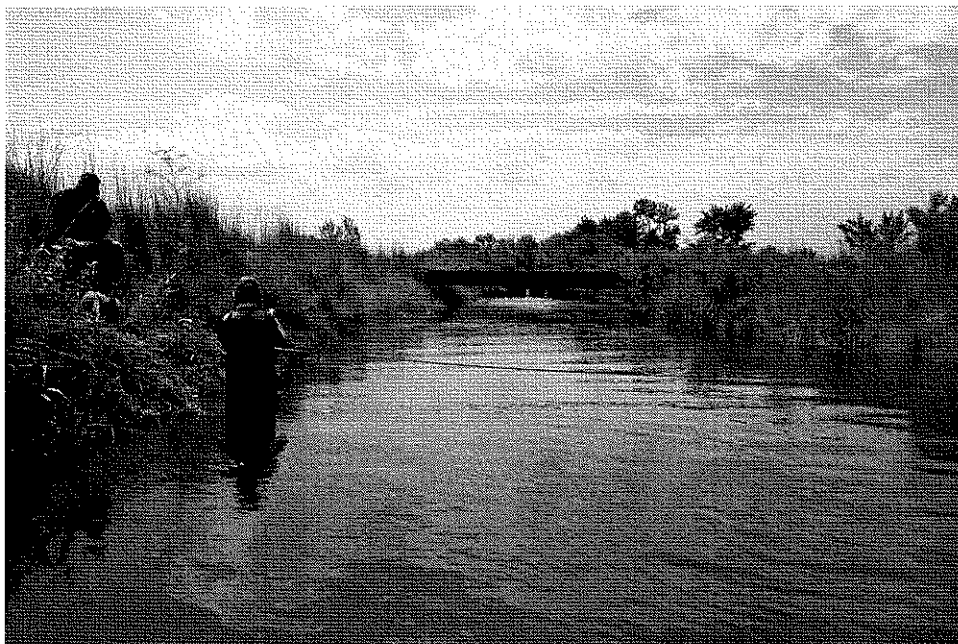
Johnson-Higby ditch 180 feet below headgate: 57.1 cfs

Photo 4. Measuring discharge in Johnson-Higby Ditch about 180 feet below headgate.

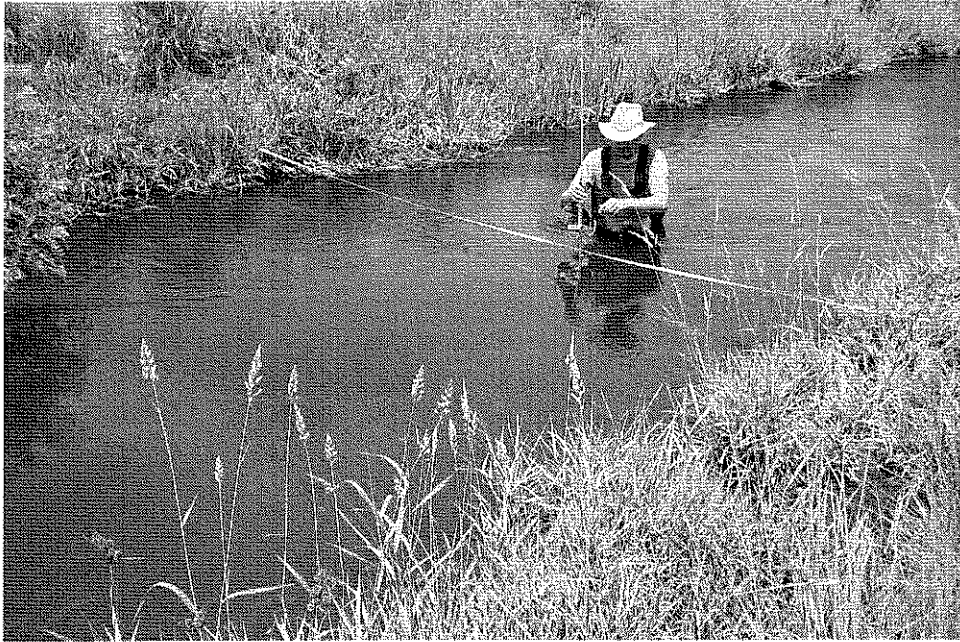
Johnson-Higby ditch 1.1 miles below headgate: 51.4 cfs

Photo 7. Measuring discharge in Johnson-Higby Ditch about 1.1 miles below headgate, above small private bridge.

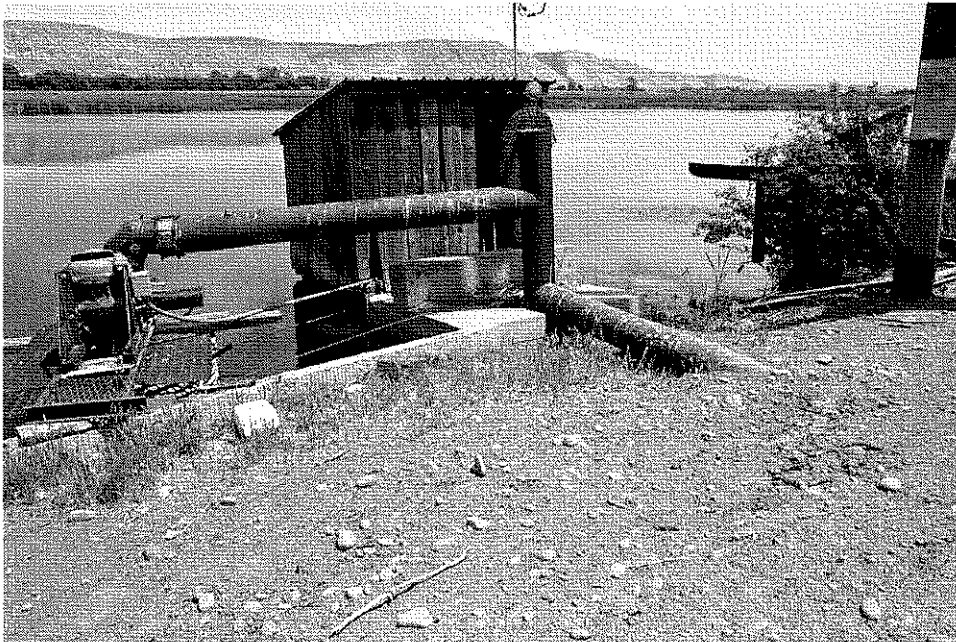
Photo 8. Unnamed slough diversion system includes 25-hp pump into earthen ditch and/or concrete slip-form ditch.

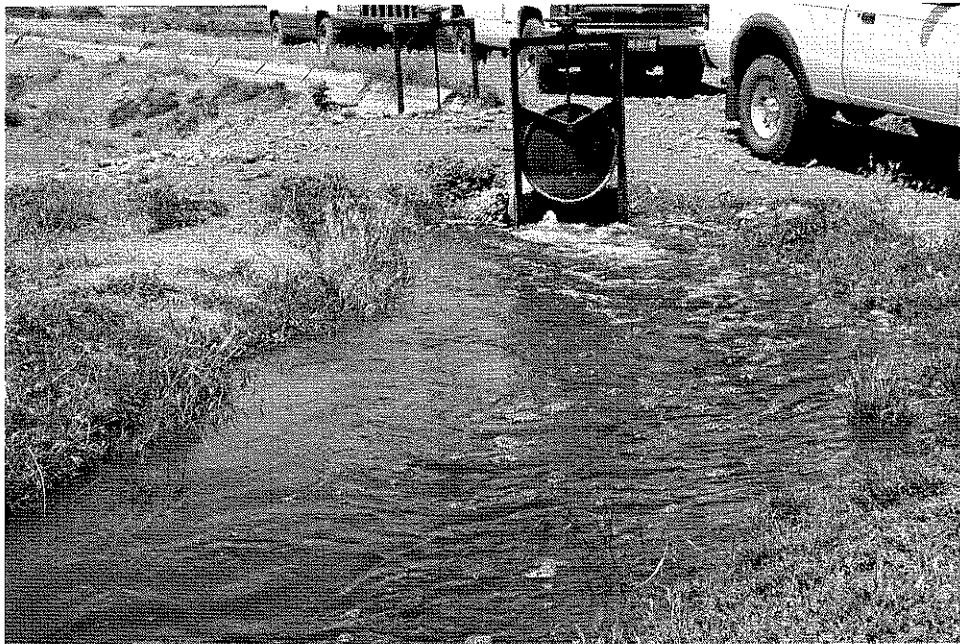
Photo 9. Discharge from pump into earthen ditch. Flow can also be turned into the concrete slip-form ditch in the background (which was dry today).
