**United States' Investigation of  
Idaho Department of Water Resources'  
Recommended Irrigated Lands  
on Riddle Ranches**

**The Bureau of Indian Affairs, Pacific Regional Office and  
The United States Department of Justice**

Niel Allen, Ph.D., P.E.

July 8, 2005

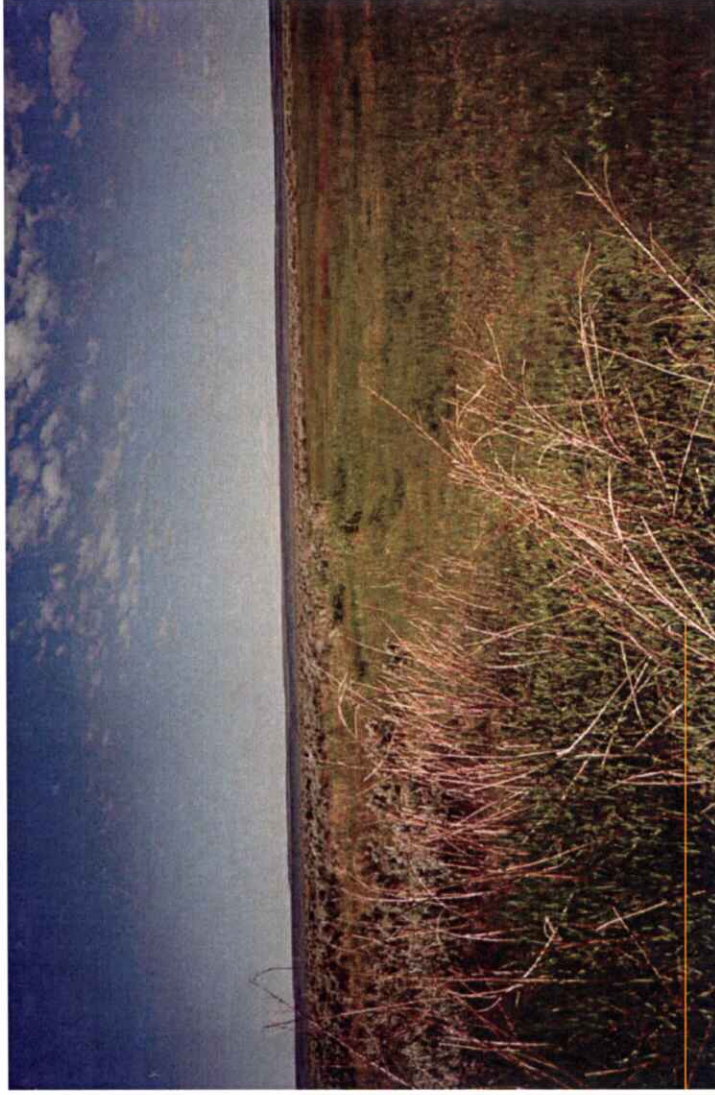
Figure C-32. Picture 3-22. IDWR recommended irrigated area -- T14S, R3E, S29 (June 10, 1999).

The picture taken at this area is contained in Appendix C, Figure C-32. IDWR delineated area within Section 29 was determined to be irrigated as shown in Appendix B, Plate 1. However, there are areas of sagebrush within IDWR's recommended irrigated areas that are not irrigated (see Figure C-32). These areas were not delineated and appear to be only a couple of acres.

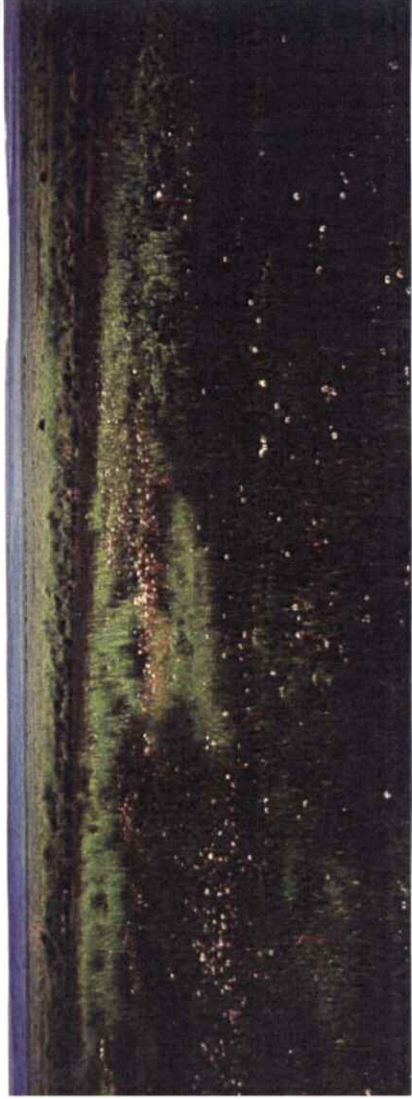
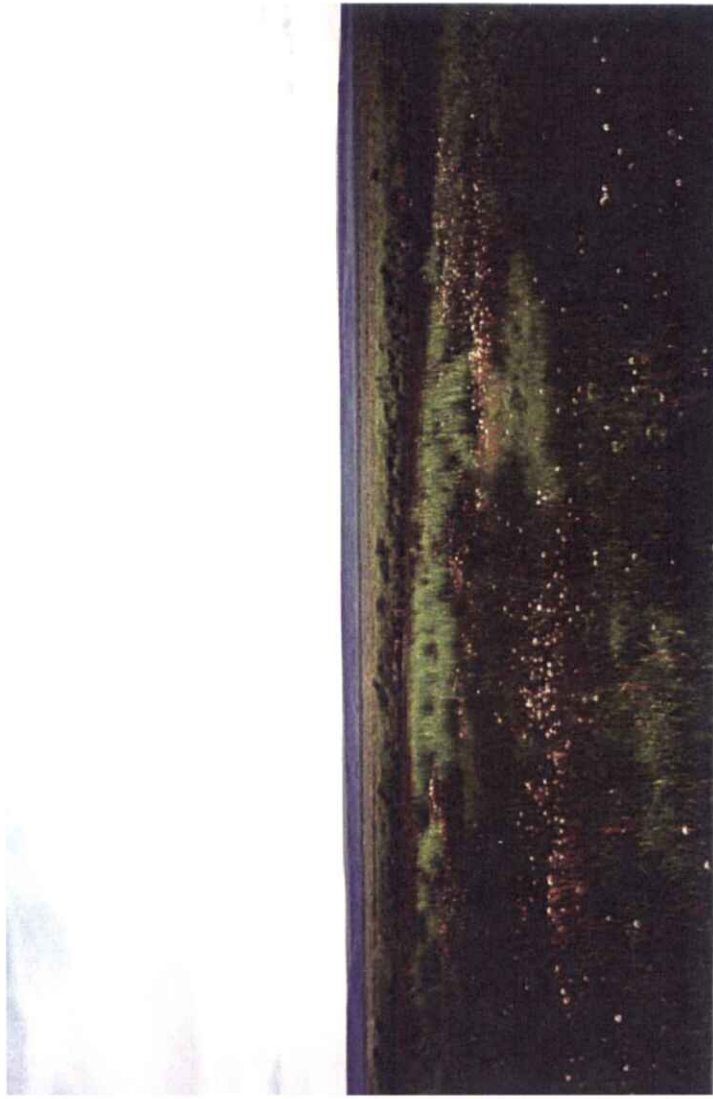
The pictures taken at this area are contained in Appendix C, Figures C-27 and C-28. The area was determined to include both non-irrigated and irrigated areas as shown in Appendix B, Plate 1. The boundary between the non-irrigated and irrigated areas is a distinct dike and channel that is visible on the aerial near infrared photography and maps. The division between the areas is based on vegetation and irrigation facilities. The areas on the south end of the Riddle Ranches occasionally may not be irrigated during a year because of inadequate water supply.

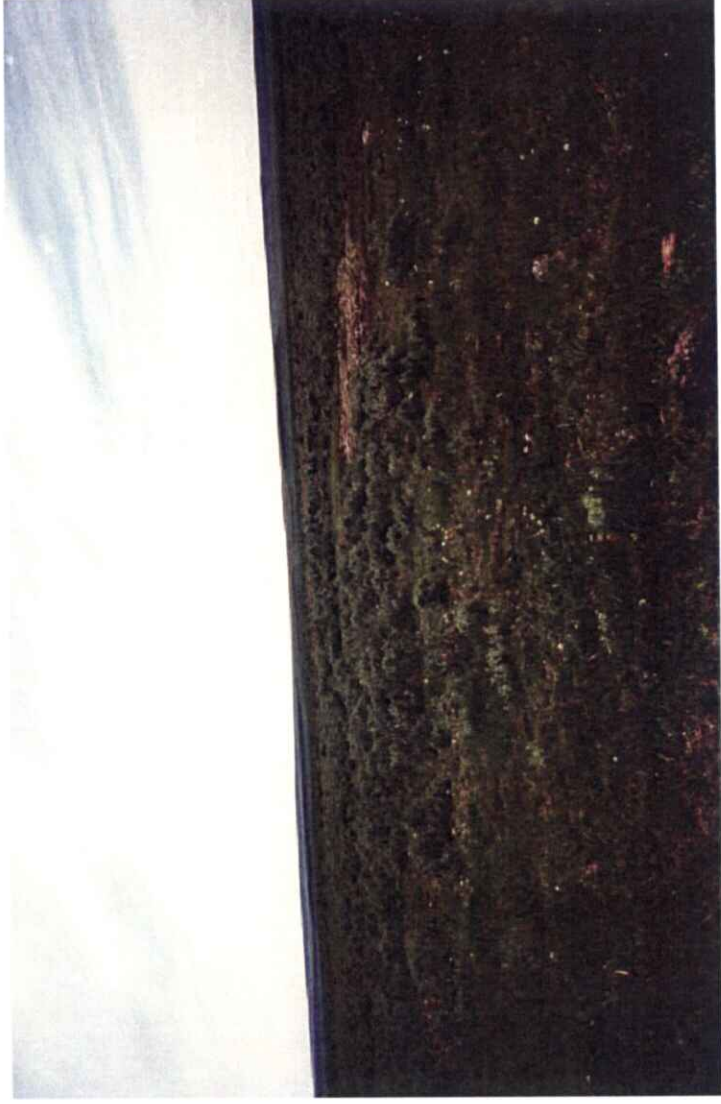
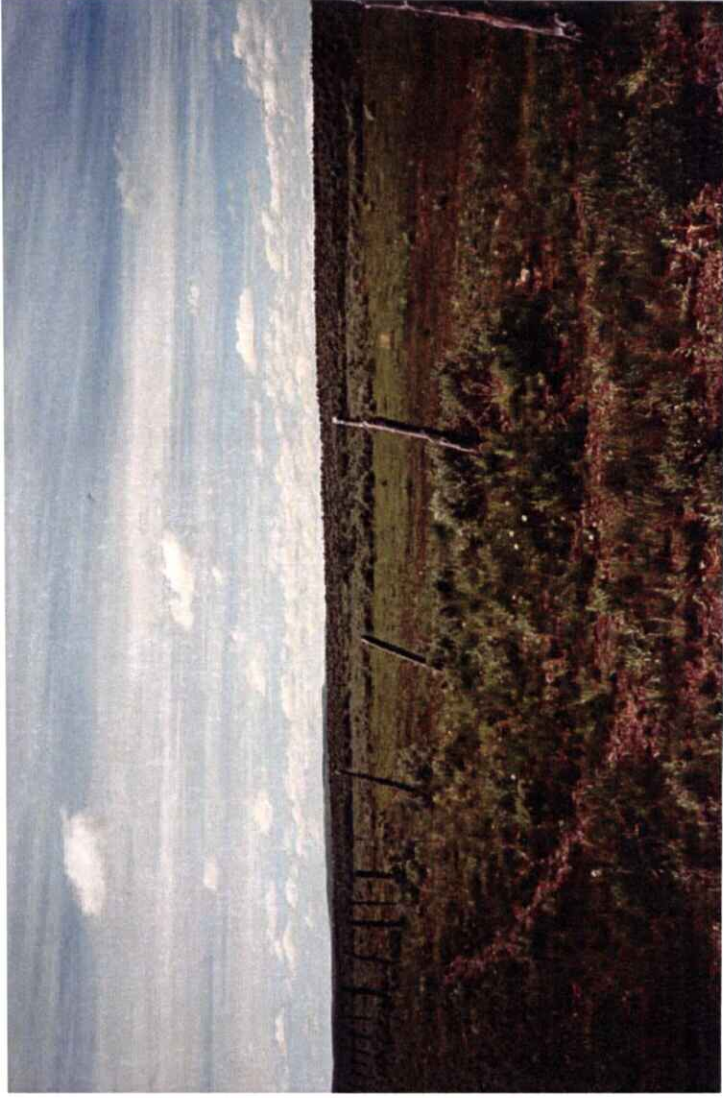
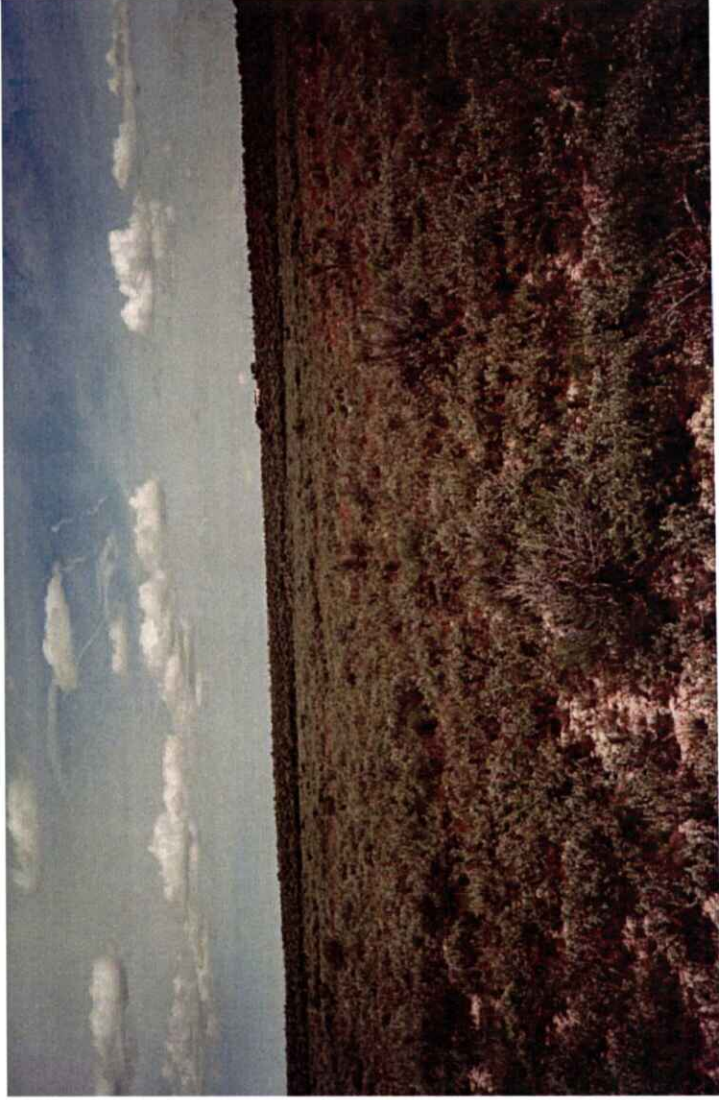
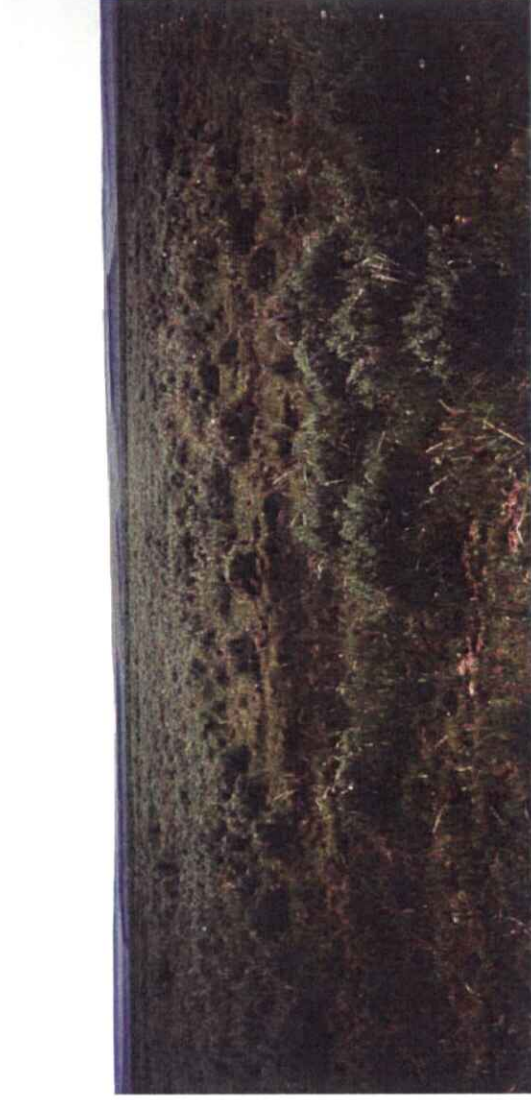
The pictures taken of the west edge of the south half of Section 14 are contained in Appendix C (Pictures Taken During United States' Field Investigation of Riddle Ranches Reservoirs and IDWR Recommended Irrigated Areas), Figures C-22 through C-26. This area was determined to be non-irrigated as shown in Appendix B, Plate 1. The area was once cleared of sagebrush, but now a lot of sagebrush has returned. There is no evidence of recent (during the last 5 years) irrigation and this portion of the area was determined to be non-irrigated.

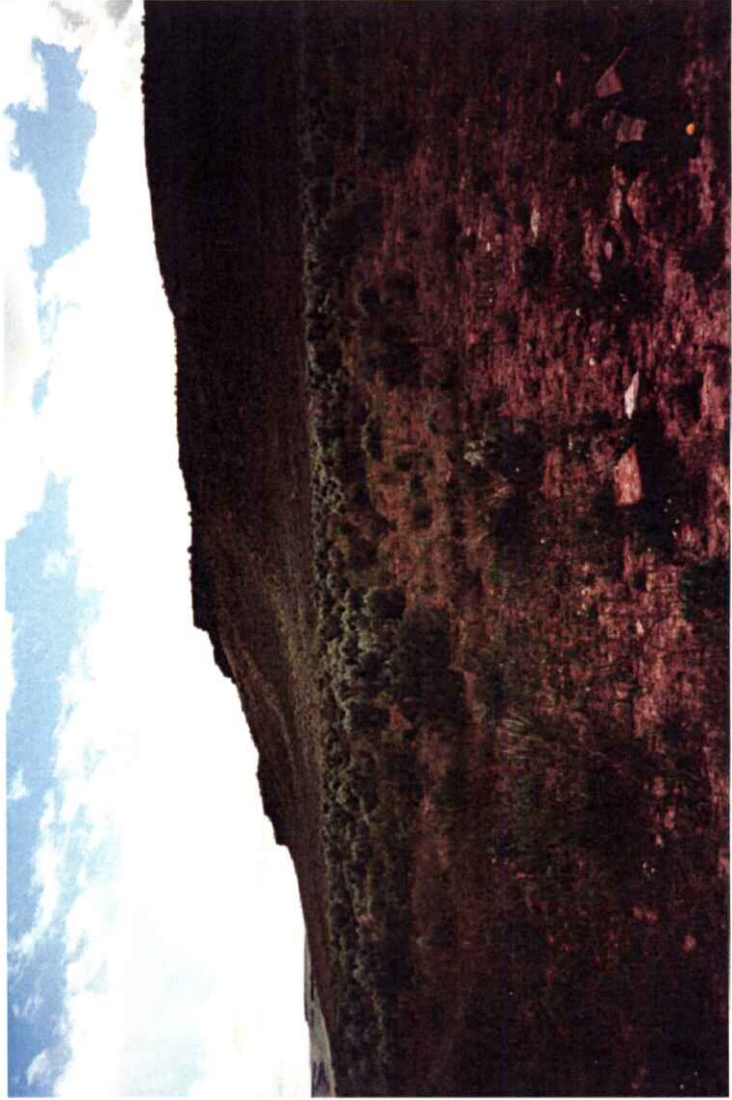
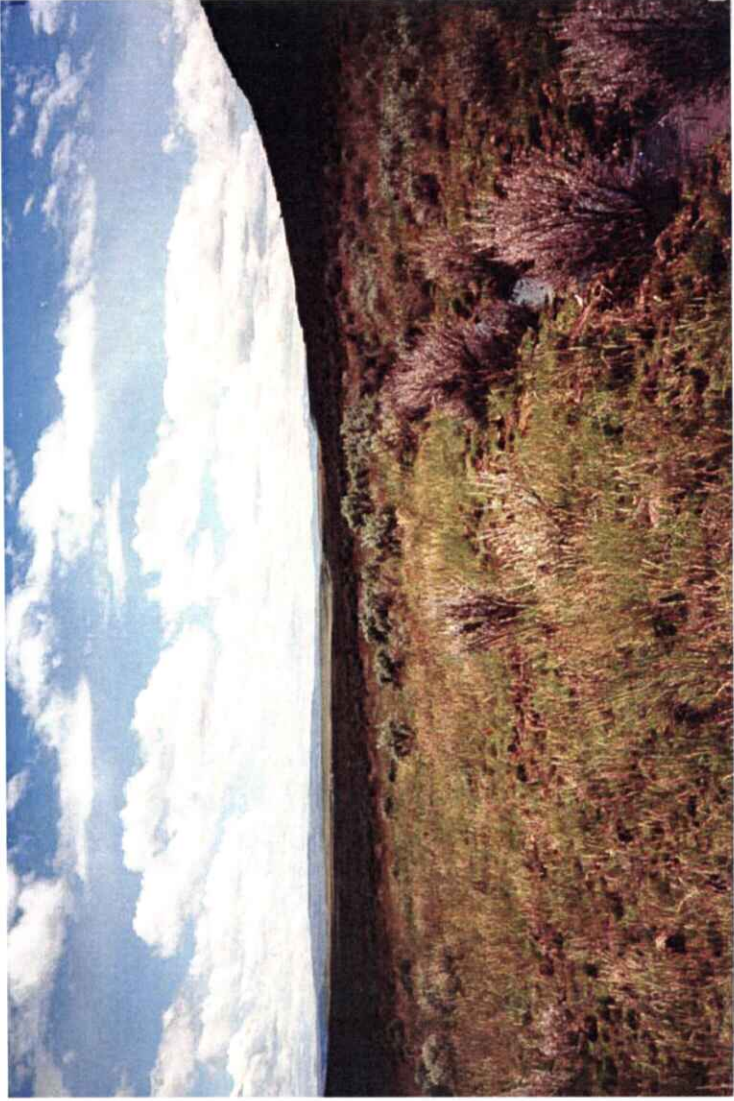
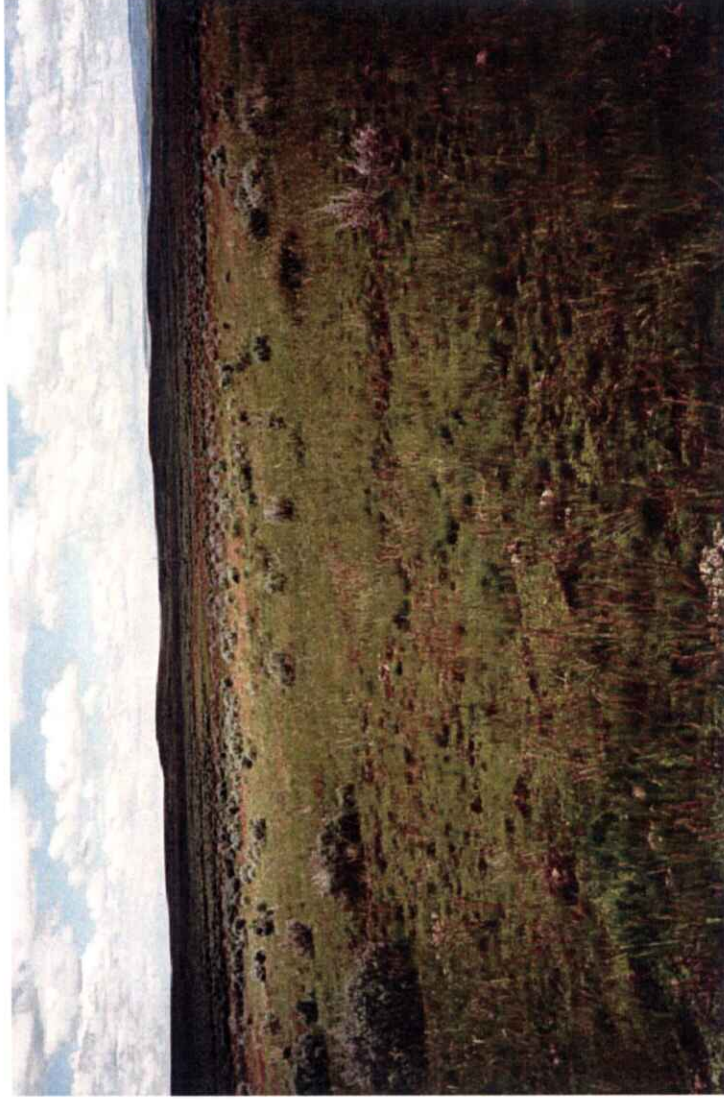
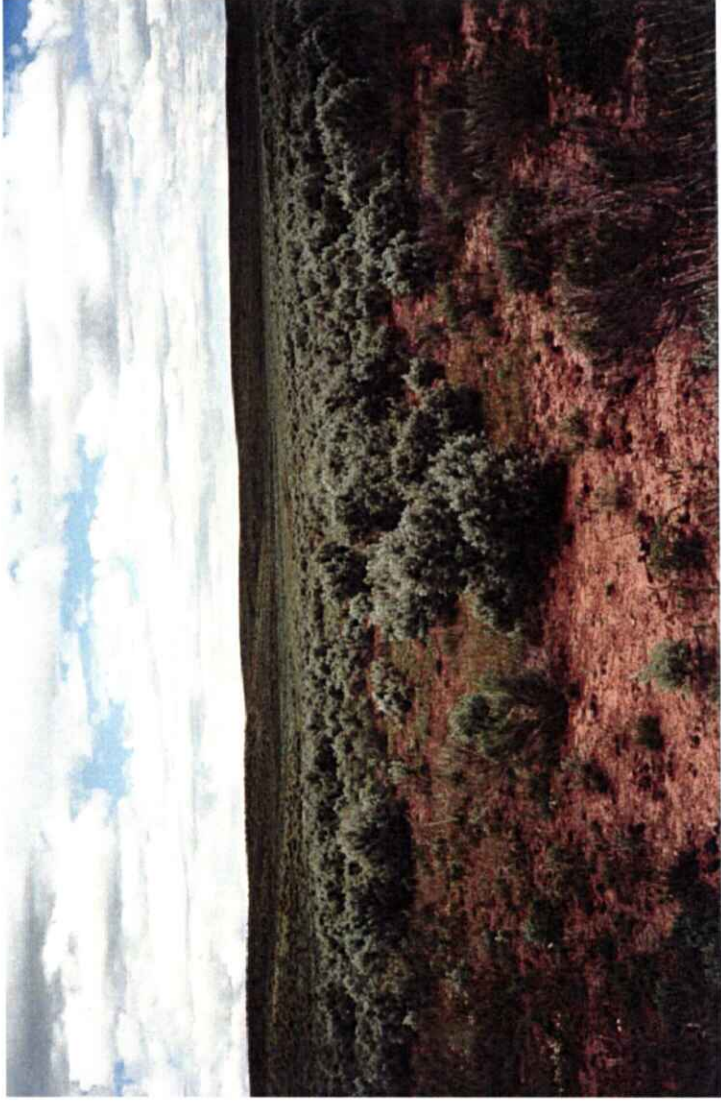
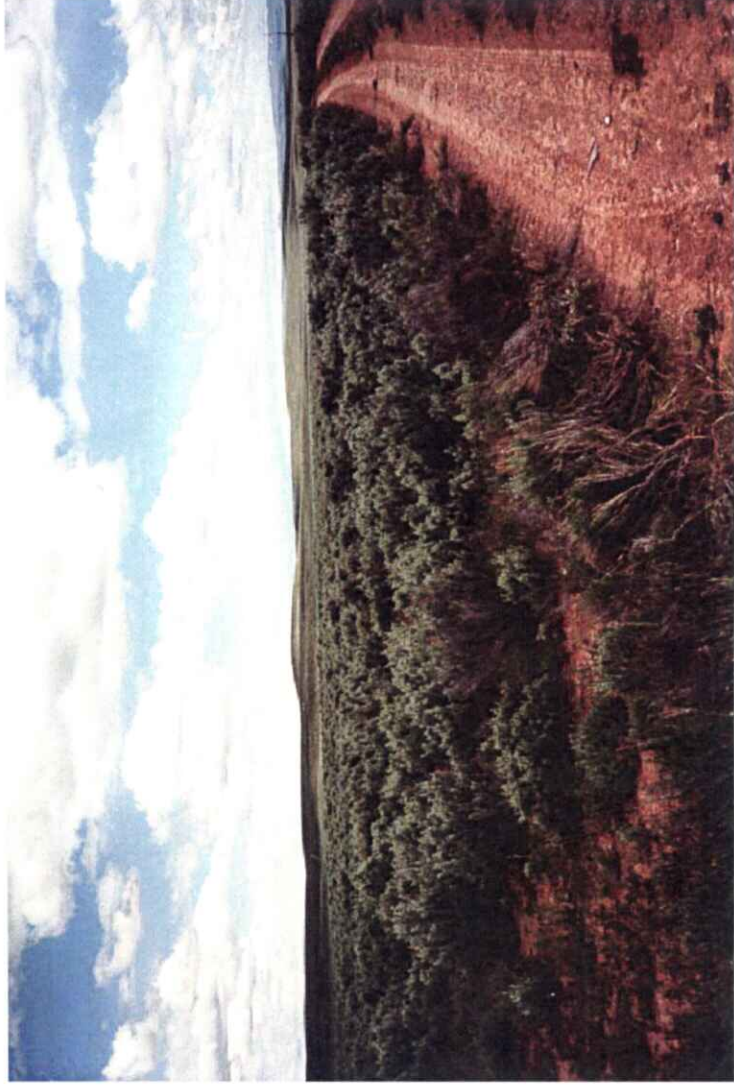
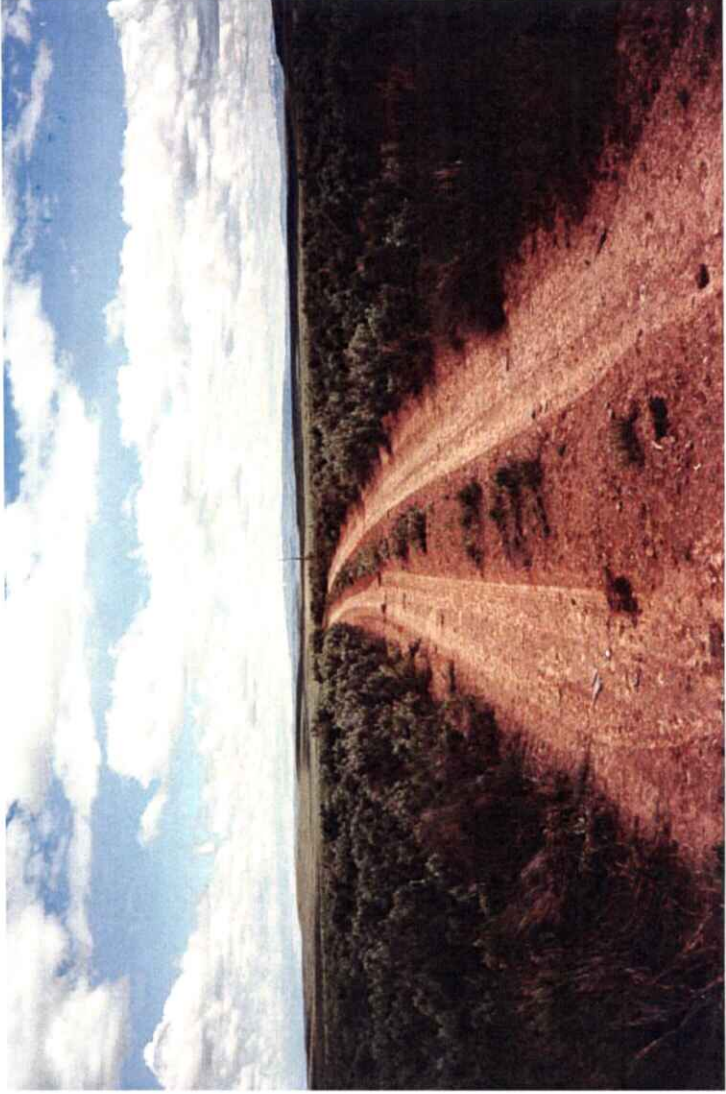
Pictures taken at this area are contained in Appendix C, Figures C-1 through C-7. The delineation of the area is shown in Appendix B, Plate 4. The area was determined to be non-irrigated based on forfeiture. Old ditches indicate historical irrigation, but the vegetation and the statement of Mr. Jackson indicate that the land has not been irrigated during the recent 5 years. The diversion to this area washed out years ago (prior to April 1969) when the old Shoofly Dam (upstream of West Fork Shoofly Reservoir) failed, which has not been reconstructed since that time.

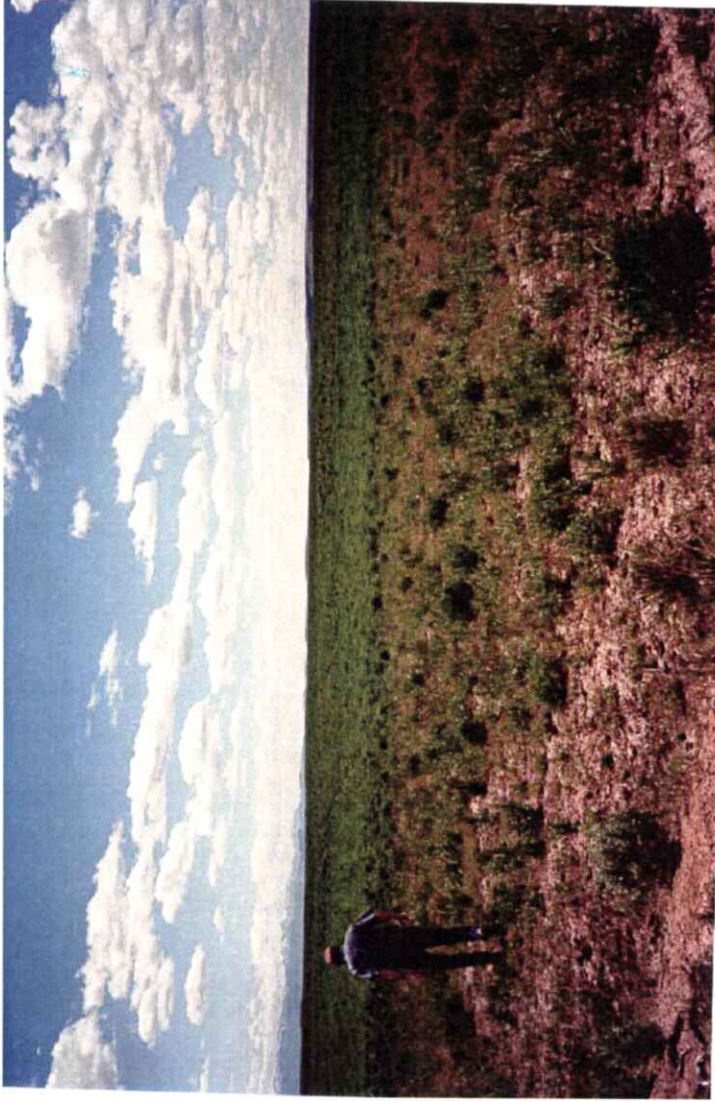
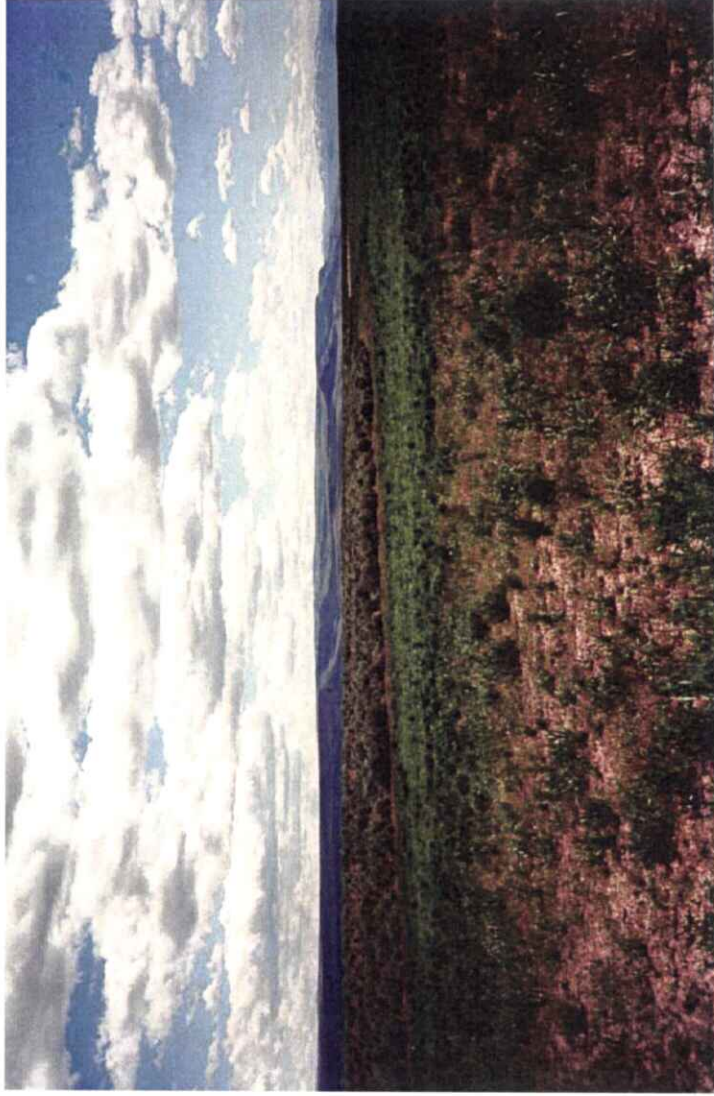
The pictures taken at this area are contained in Appendix C, Figures C-43 and C-44. The delineation of the area is shown in Appendix B, Plate 1. Based on the 1987 aerial photographs, most of Section 25 appeared non-irrigated. At the time of the field visit almost all of Section 25 was cropped, including the portion of the area that is outside of IDWR’s recommended irrigated area. The portion of the area that is outside of IDWR’s recommended irrigated area is producing dry-land alfalfa. The year that the area was cleared of sagebrush and planted to alfalfa and grass is not known. The irrigation ditch that provides water to this area had recently (during 1999) been cleaned to increase its capacity and function. The ditch was dry and there was no indication that irrigation had recently occurred. Based on the fact that an irrigation ditch was in place and the area was cropped it was determined irrigated. However, based on the 1987 aerial photo, some the area could be non-irrigated based on forfeiture. More information would be needed to determine if the area has not been irrigated for 5 consecutive years. •
