**29-00443M**

**POD**

**Field Exam 9/24/01**

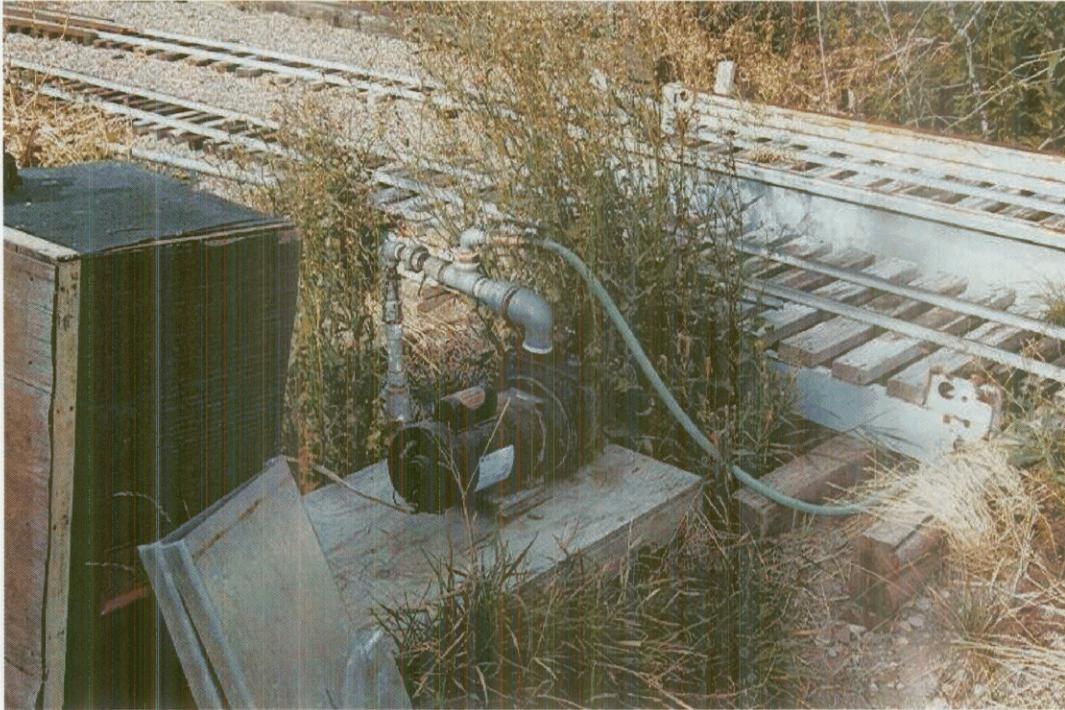
Looking NW. Pocatello creek on the other side of the RR tracks. Pump outflows to a 2 in underground PVC to sprinkler system. Pump is a Magnetek – Centurion. 1.5 hp; # 7-164300-24; AMPS SF 9.2/18.4. (CSAXTON 9-25-01)

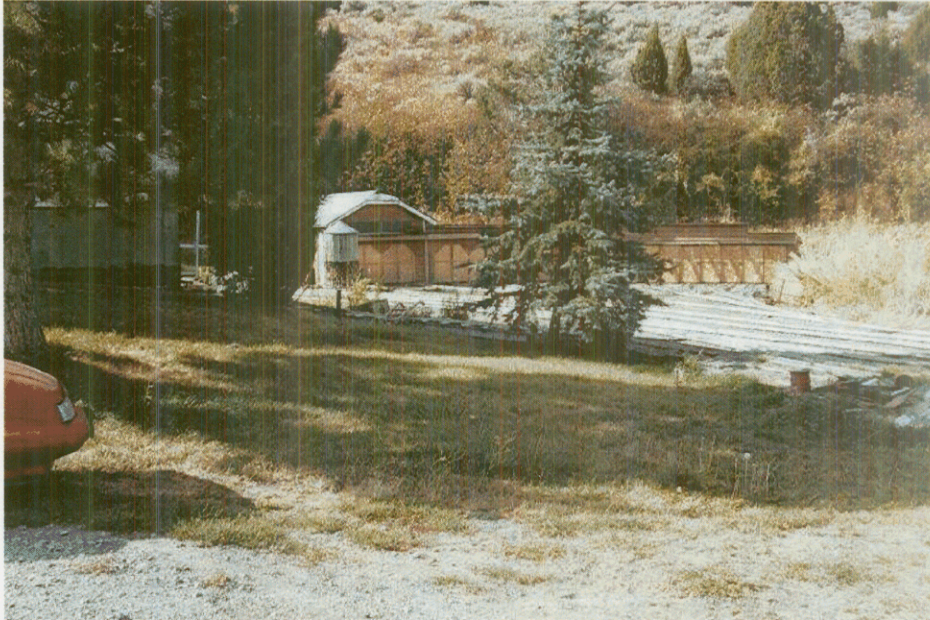
Looking S. Pocatello Creek behind me in picture. Home is to the left in picture.

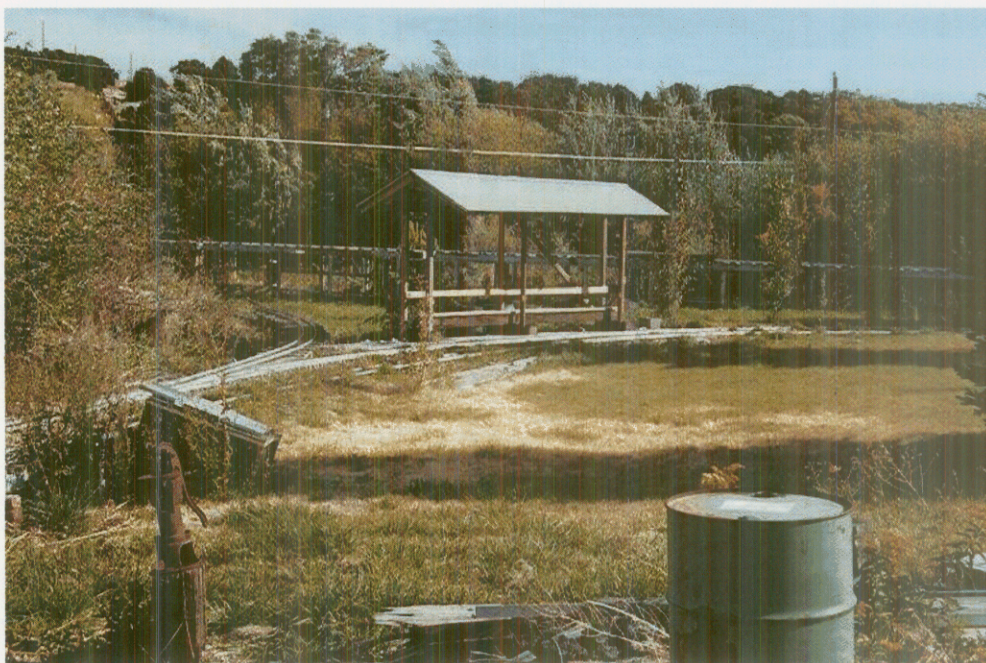
Looking South. Irrigated Place of use around the home and the RR tracks consists mostly of lawn. Diesel

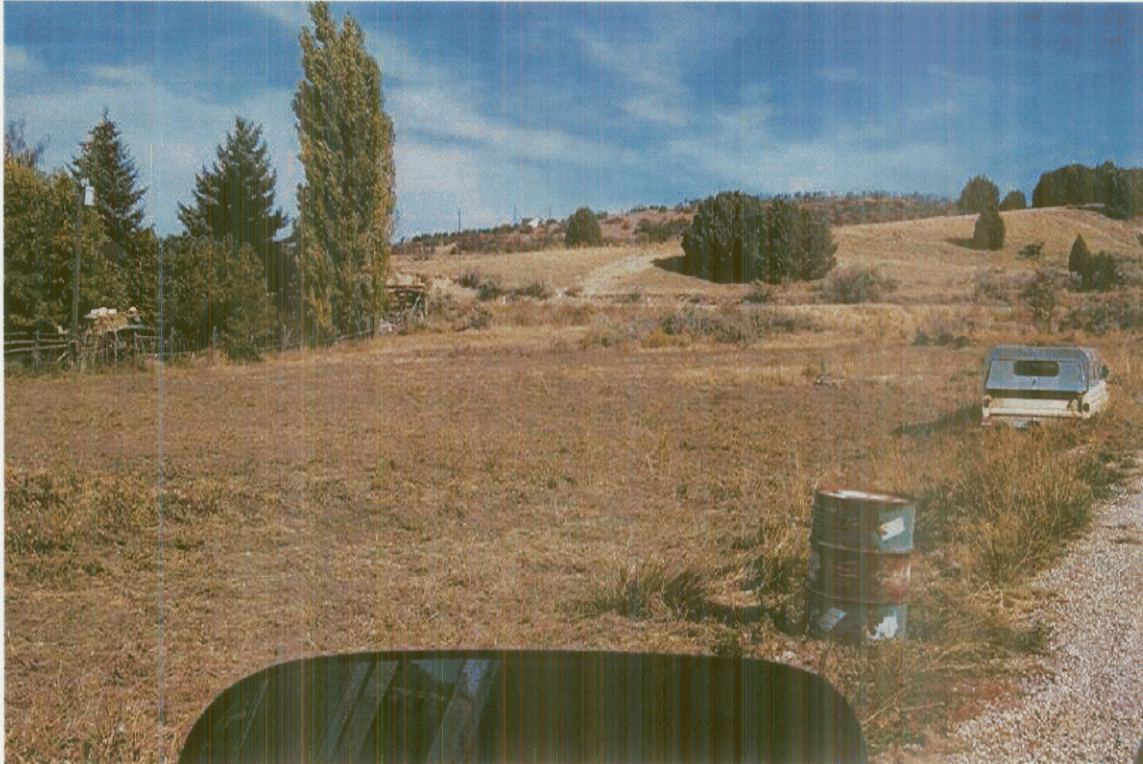
**Field Exam 9/25/01**

Looking NE. POD home and lawn behind me in picture. POU shown here is on the West side of driveway. This property bought by the Griggs on July 29, 1994. In phone conversation with Ethel Griggs she said that the previous owner didn't irrigate. Not irrigated this year. NAPP photography indicates it could have been irrigated in 1987, but not recommending it as irrigated POU based on conversation with Mrs. Griggs.

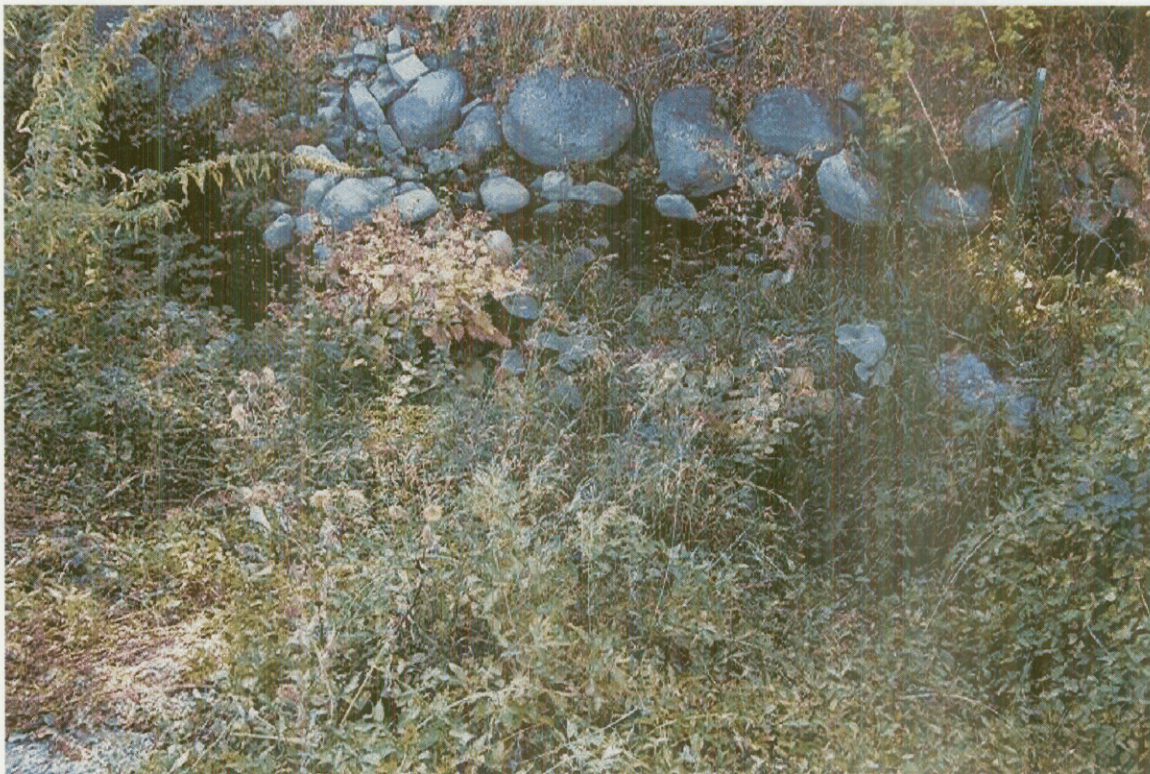
**Taken 10/3/01**

Historical Point of diversion that diverted water to the ditch that carried water to the north side of the North Fork of Pocatello Creek.

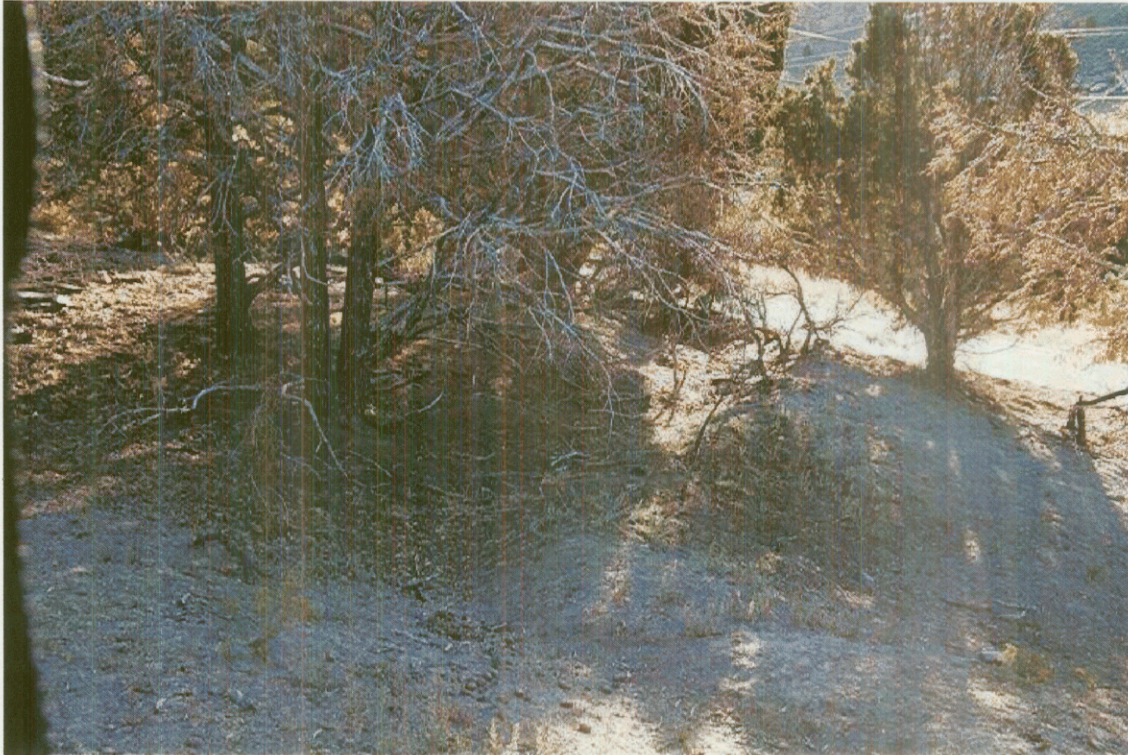
Taken 10/3/01

Looking East. Signs of the old historical Ditch that carried water to the north side of Pocatello creek to flood irrigate down to as far as Angelo Trayis' place.
