**29-02342A**

**POU**

**Field Exam: 8/13/02**

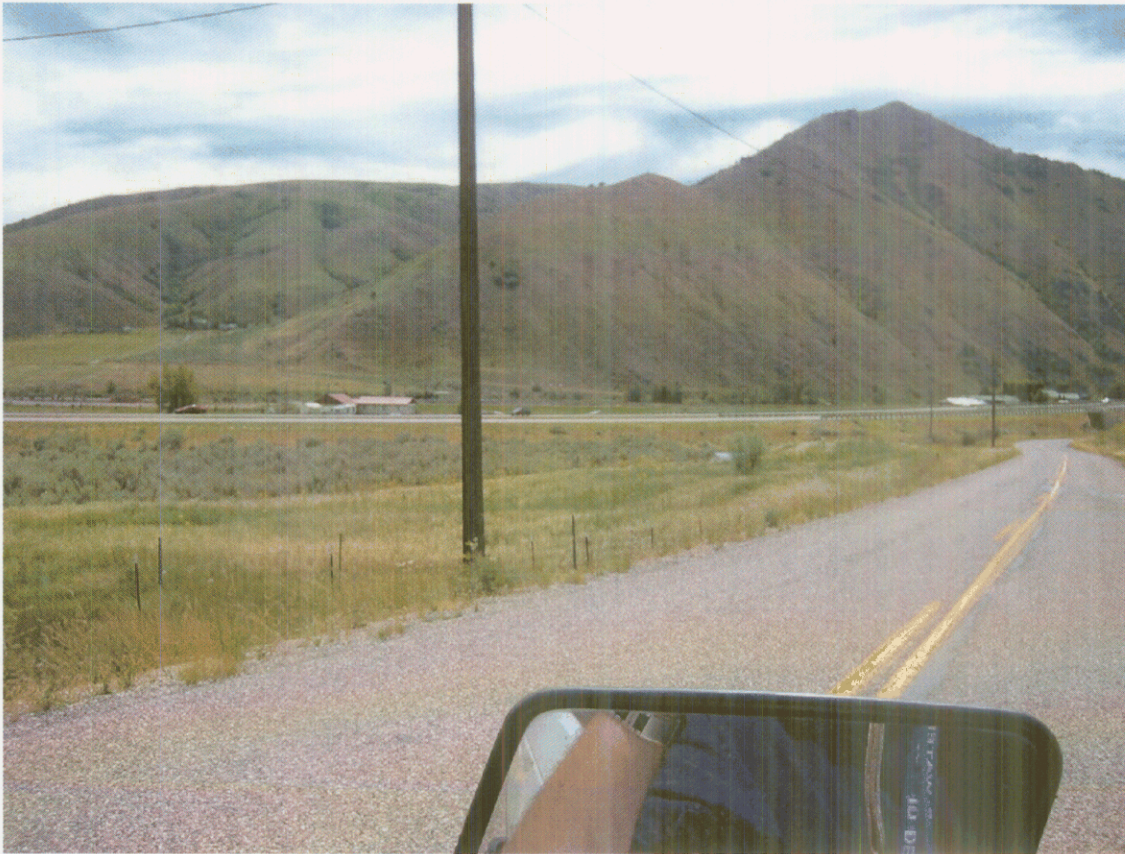
Looking South. A portion of the claimed POU was resumed during the irrigation season of 2002. Picture shows the irrigated POU. Boundary between sagebrush and pasture ground shows the line between irrigated/cultivated ground and what is not irrigated (csaxton).
