**29-04442**

**POD**

**Field Exam 8/22/01**

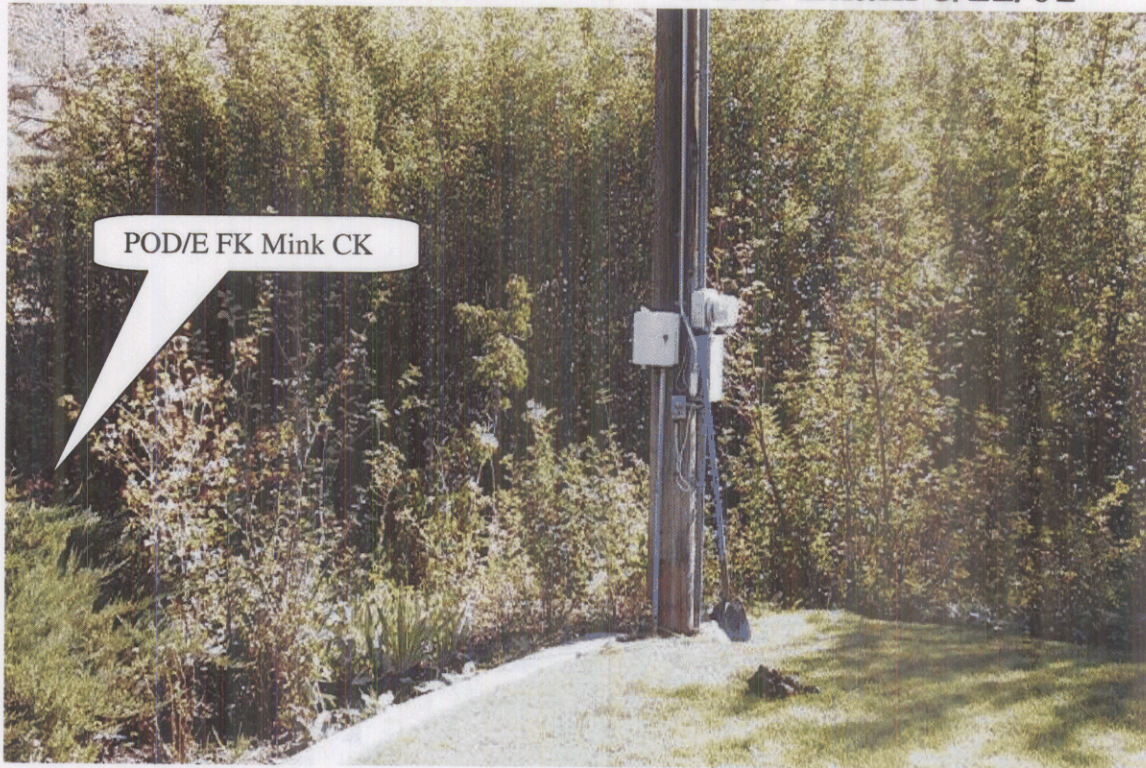
Looking North East. Claimant aquired the property November 2000. He said that when he purchased the property through HUD there was structures in the creek where a pump would have been set up. Picture shows power pole that ran power to pump. East FK of Mink Creek Road is in background behind the trees (csaxton 8/30/01).

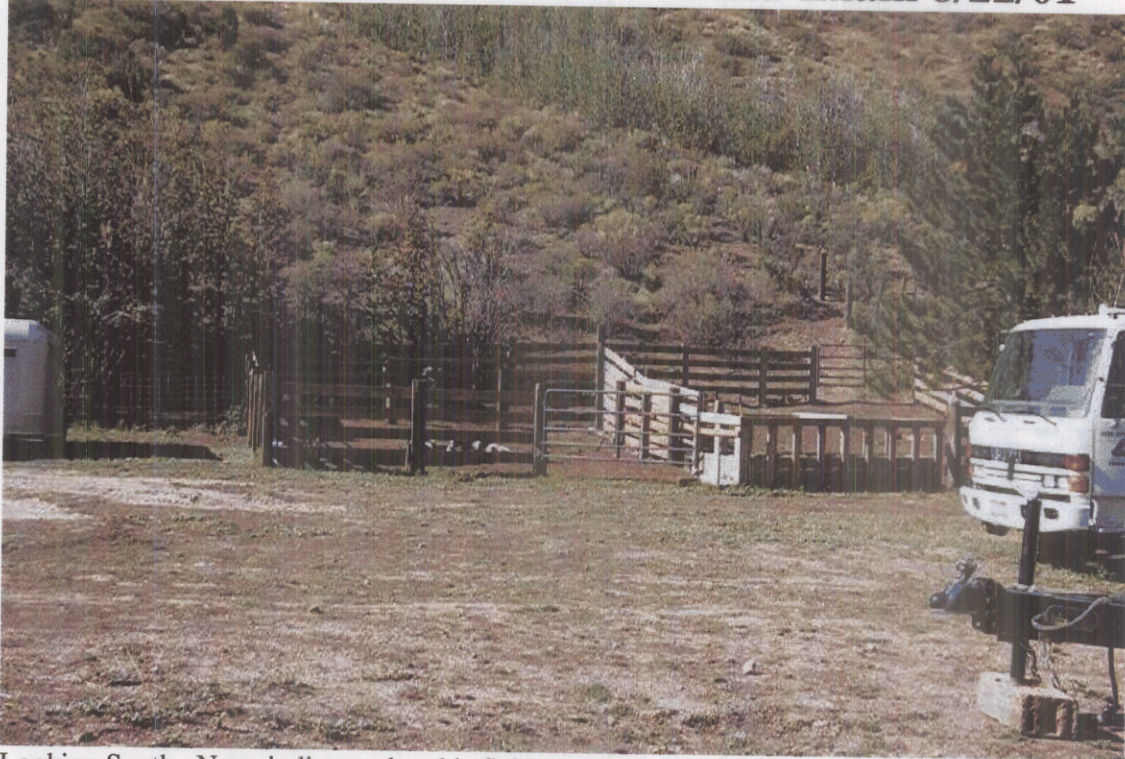
**POU**

Looking South. Napp indicates that this field could have been irrigated in 1987. Statement from neighbor Mrs. Norwood, said the land had been historically irrigated by original claimant James Marshall. Marshall sold the property in 1997. Even if no irrigation took place after Mr. Marshall sold the property, that is only 4 years of non-use. Recommend irrigation as seen on Napp photography (csaxton 8/30/01).

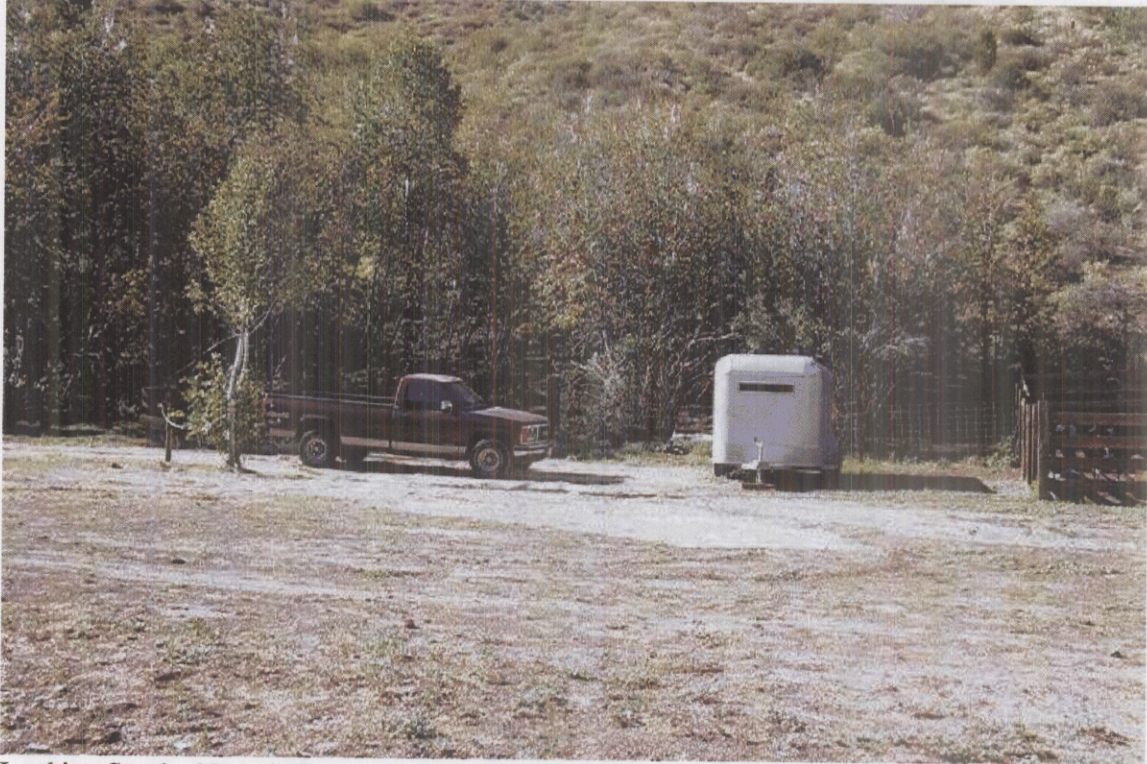
**POU**

Looking South. Napp indicates that this field could have been irrigated in 1987. Statement from neighbor Mrs. Norwood, said the land had been historically irrigated by original claimant James Marshall. Marshall sold the property in 1997. Even if no irrigation took place after Mr. Marshall sold the property, that is only 4 years of non-use. Recommend irrigation as seen on Napp photography (csaxton 8/30/01).
