24-2005A

## JR SIMPLOT

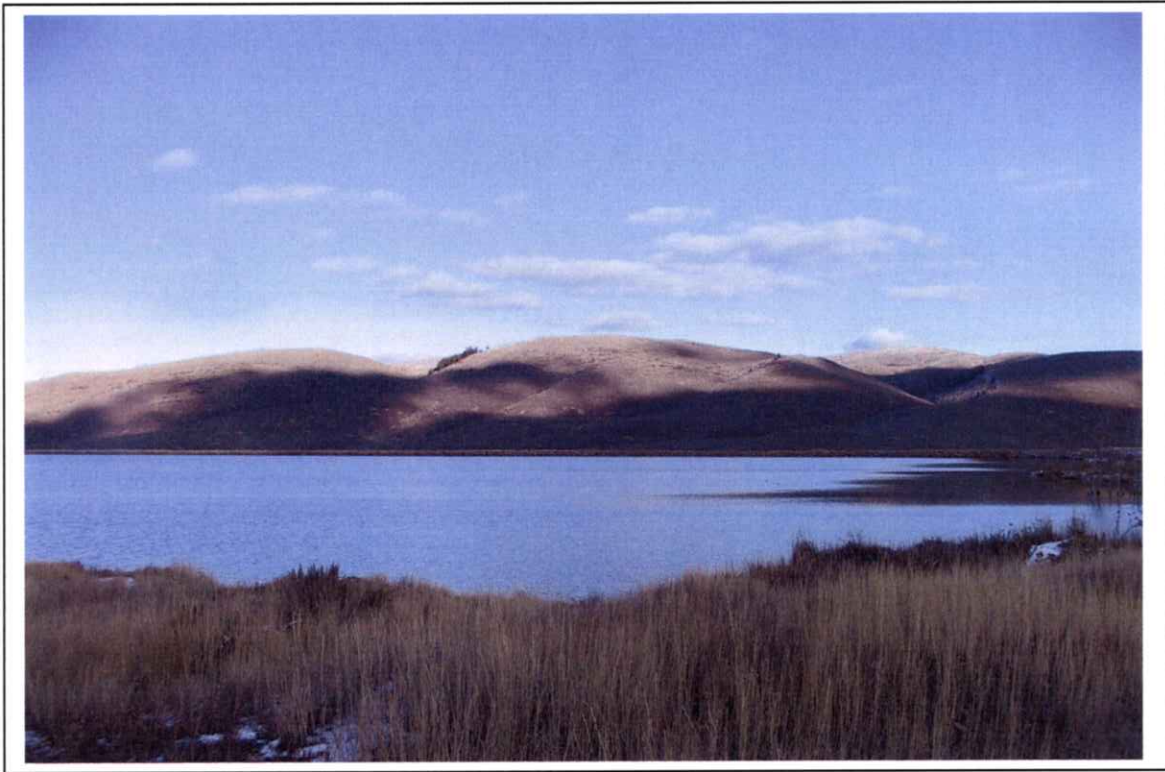
IMG\_1499

Looking North easterly at phase I  
settling pond. The slurry is pumped  
to the phase II pond to settle out. Then  
it gets pumped to the phase I pond  
to settle out again. Then the water  
is pumped back to the plant to be  
reused again. Then it's pumped back  
again from the plant to the phase II  
pond. Closed loop system, no water  
leaves the system. CS

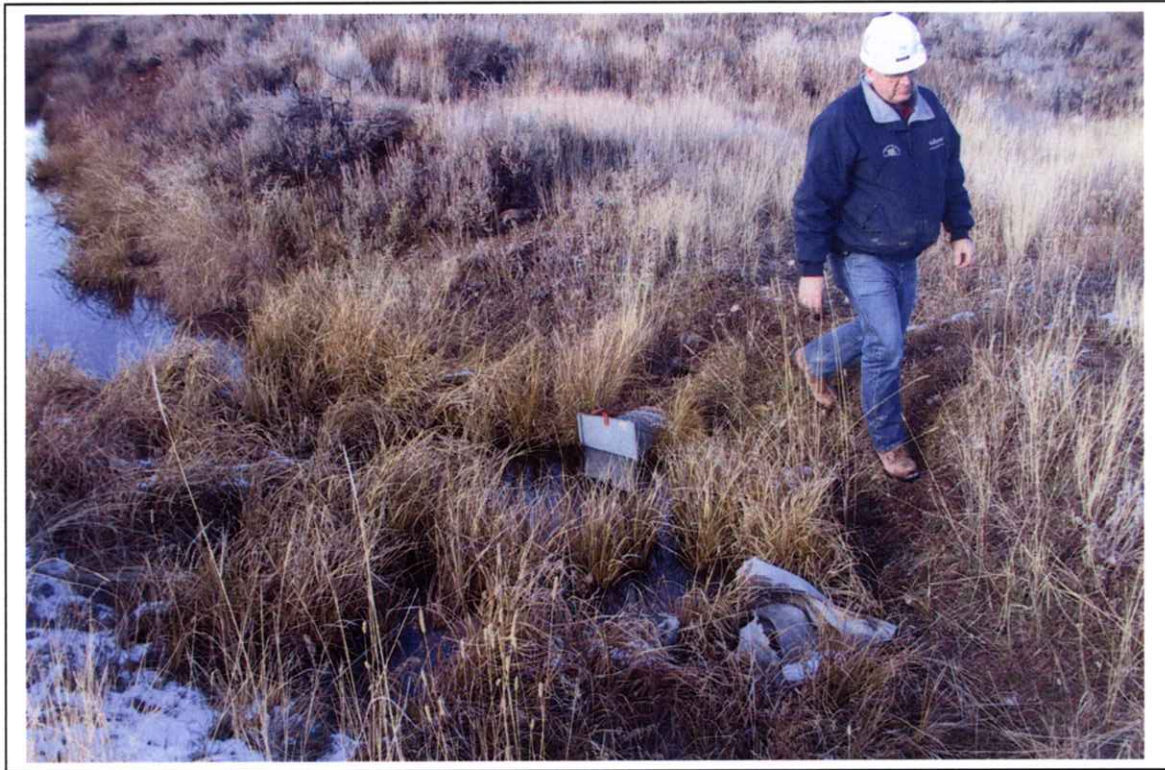
IMG\_1497

Verlin Andrews shut the headgate from  
Roberts Creek to the ditch to phase II  
pond.  
this ditch is on south side of phase I.

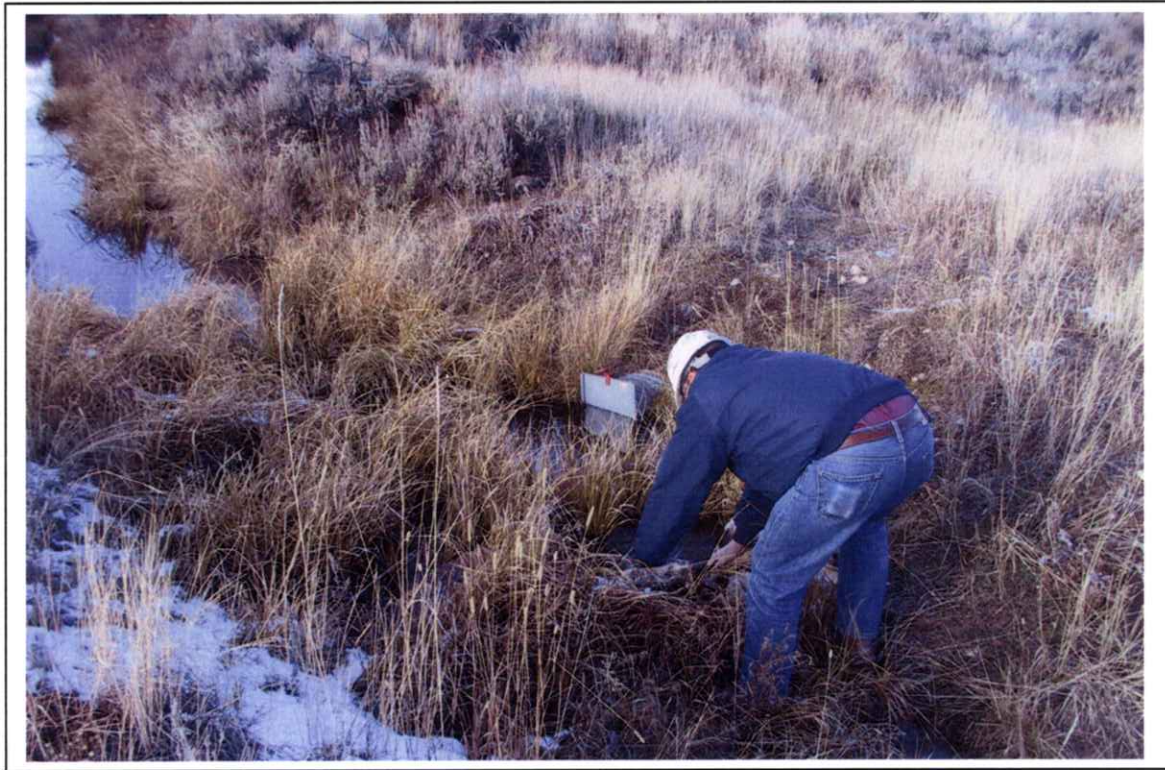
IMG\_1498

Verlin is attempting to pull out the  
canvas dam from Roberts creek.  
but it is already frozen to the soil.
