Friday, April 13, 2007

Field exam for Claim No. 35-2019

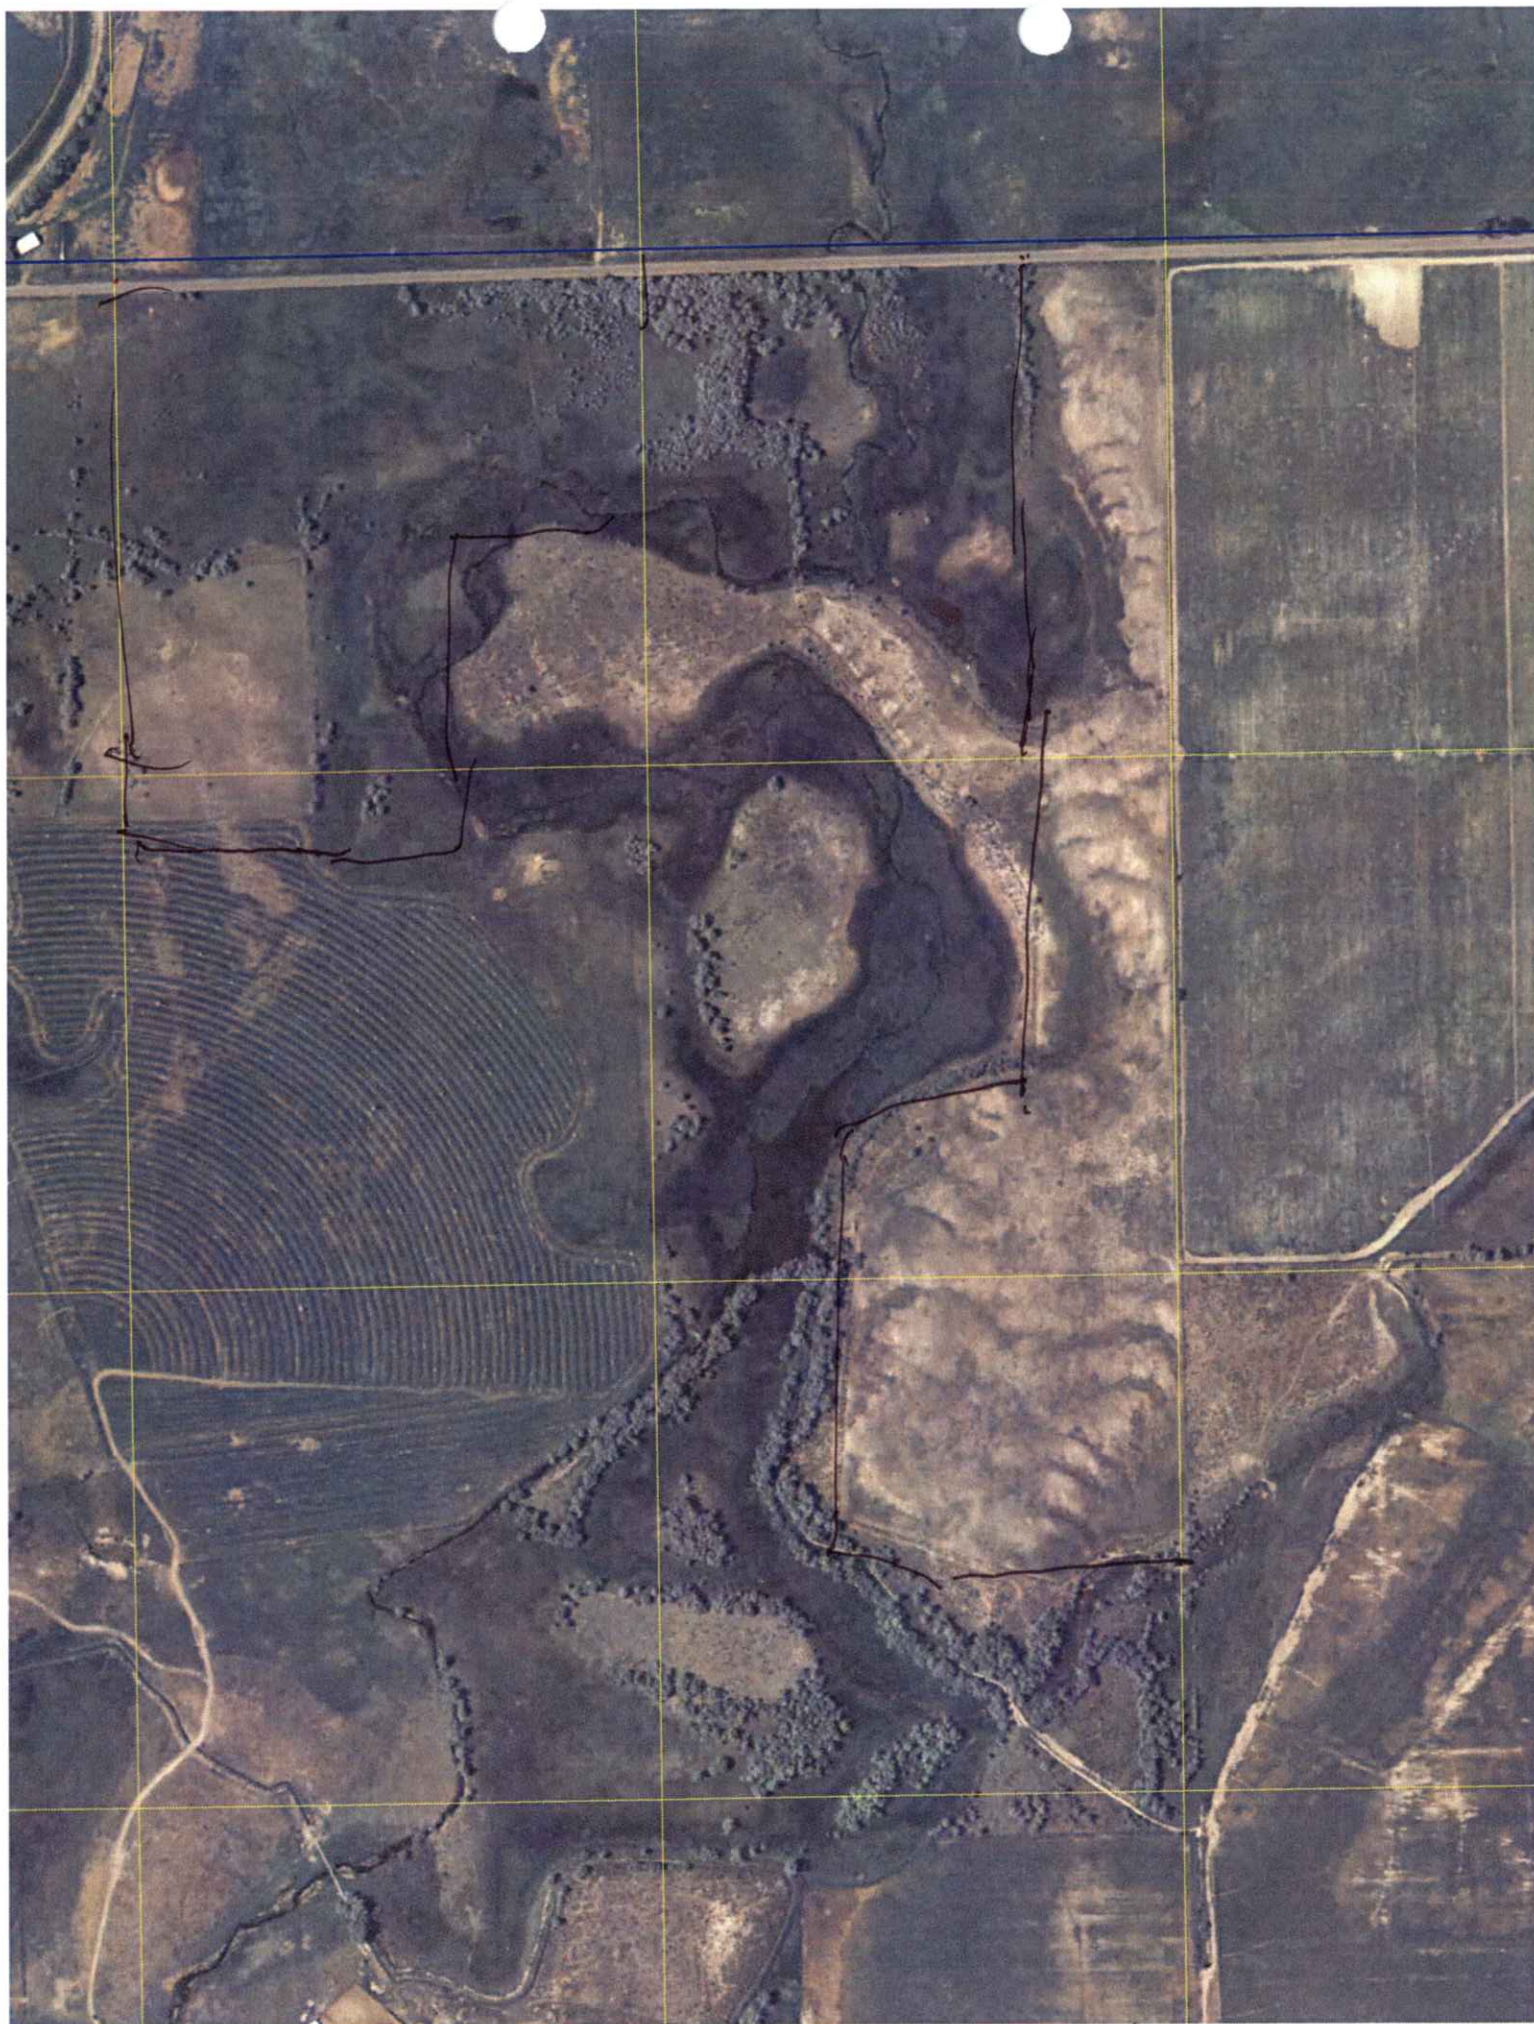
CLAIMANT'S DRAWING OF POU

POU: Claimant had not yet irrigated the property himself. However he identified the place of use based on conversations he had with Mrs. Nelson, the previous owner. Claimant marked up an aerial photo to show what he believed was the irrigated ground. Nate and I observed existing ditches and portable irrigation mainline, although much of it had been stolen per claimant. Much of the licensed POU appeared previously irrigated, although not as much as was licensed. Some of the ground identified by Jeff on the map did not appear irrigable.
