In Re SRBA ) A. Subcase 37-4151  
(Insert water right number)  
)  
Case No. 39576 )  
STANDARD FORM 1  
OBJECTION

Wood River - Ketchum  
Environmental Reconnaissance

December 1991

Wood River - Ketchum Environmental Reconnaissance  
by  
Karl Gebhardt, Hydrologist  
Joyce Gebhardt, Wildlife Biologist

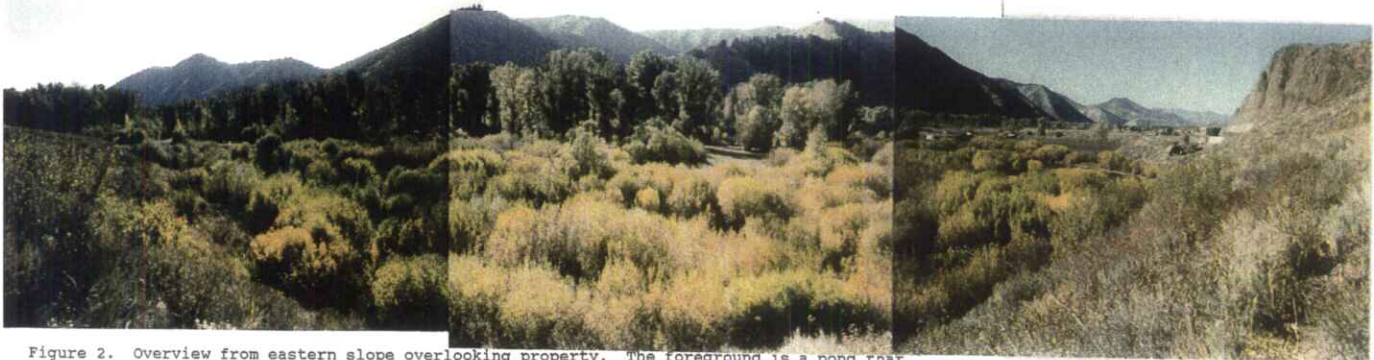
Figure 2. Overview from eastern slope overlooking property. The foreground is a pond that functions and was formed as an overflow flood channel. A control device located in the center of the left-hand photograph controls the water level in the pond. This pond is quite large compared to overflow flood channel ponds along most rivers of this size. The pond also has a very limited inflow which, with the poor shading, probably leads to water quality problems in the summer.

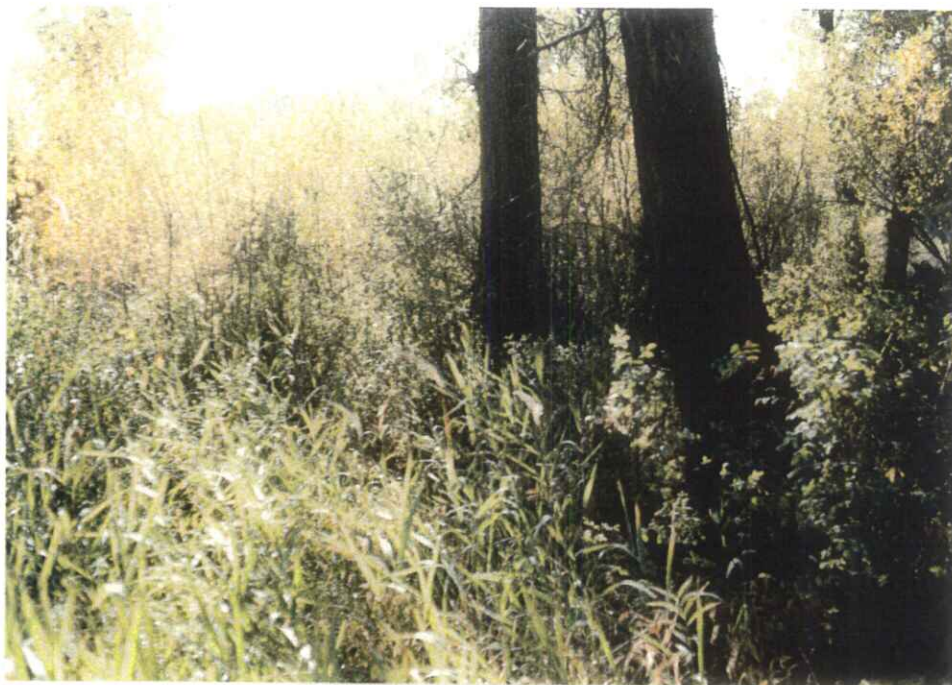
Figure 3. Margin of cottonwood forest and willow community. The understory is quite heavy throughout and is indicative of this type of riparian community. In many urbanized areas, cottonwood forests do not regenerate because flood control does not provide the disturbance required for cottonwood reproduction. This is not the case at this property and there are lots of younger age cottonwoods that will replace the older trees.

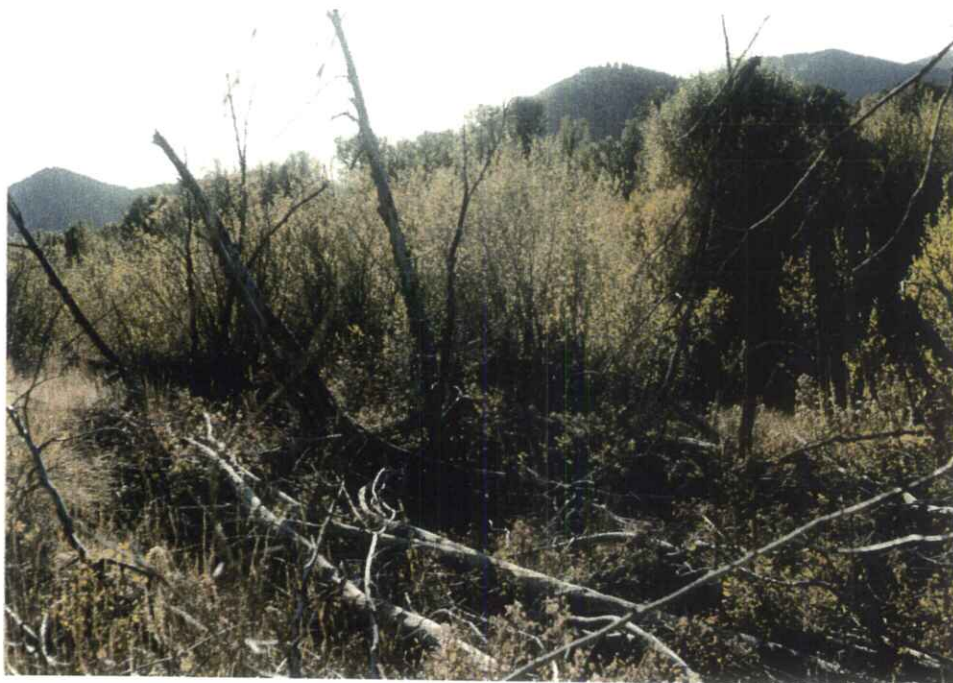
Figure 4. This location is at the base of the slope and shows some dead juvenile cottonwoods. This is a normal scene, particularly with the amount of beaver activity that is going on.

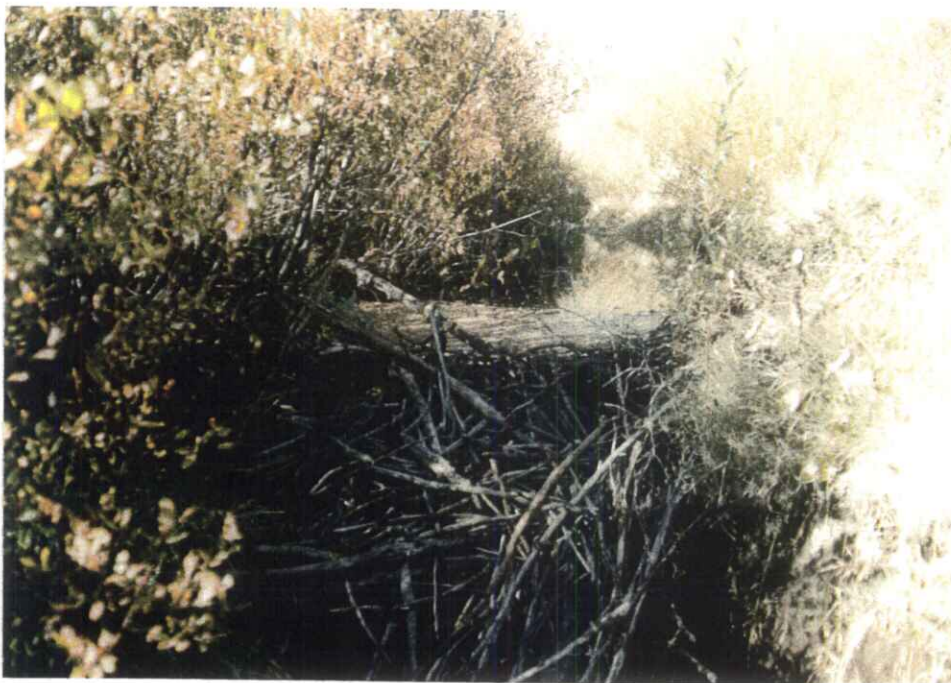
Figure 5. This photograph shows a beaver dam along one of the smaller flood channels. This is considered a fairly typical situation on the Wood River. The narrow channel provides ideal conditions for beaver and the heavy vegetation supplies abundant food, cover and shading. This type of situation would tend to provide positive lowering of water temperatures in the summer.

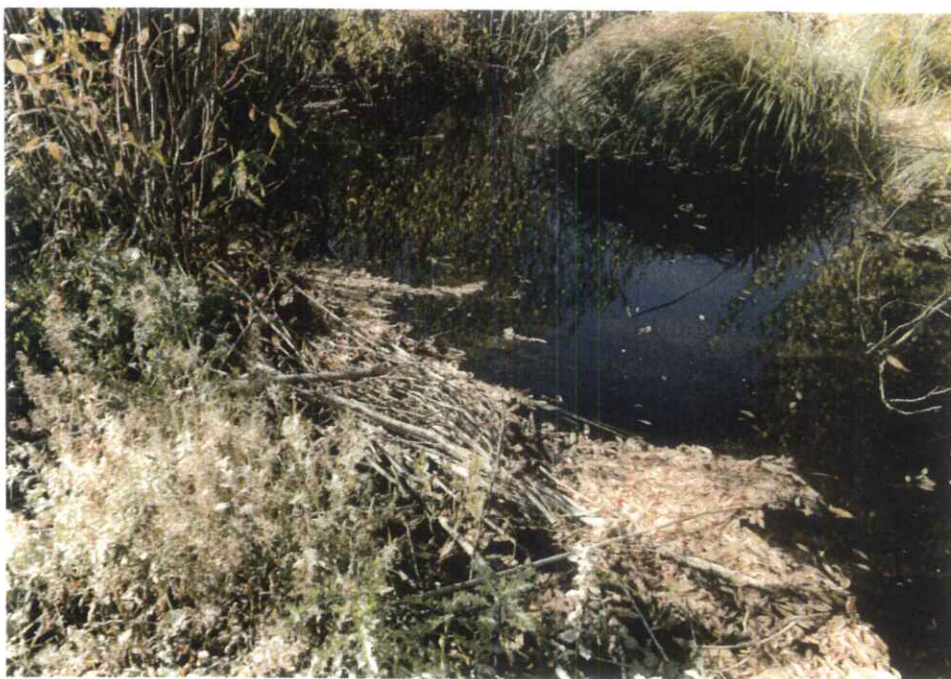
Figure 6. Backwater from another beaver dam. Note the clarity of the water. The floating material are leaves. This site contained numerous small fish (< 3 inches).

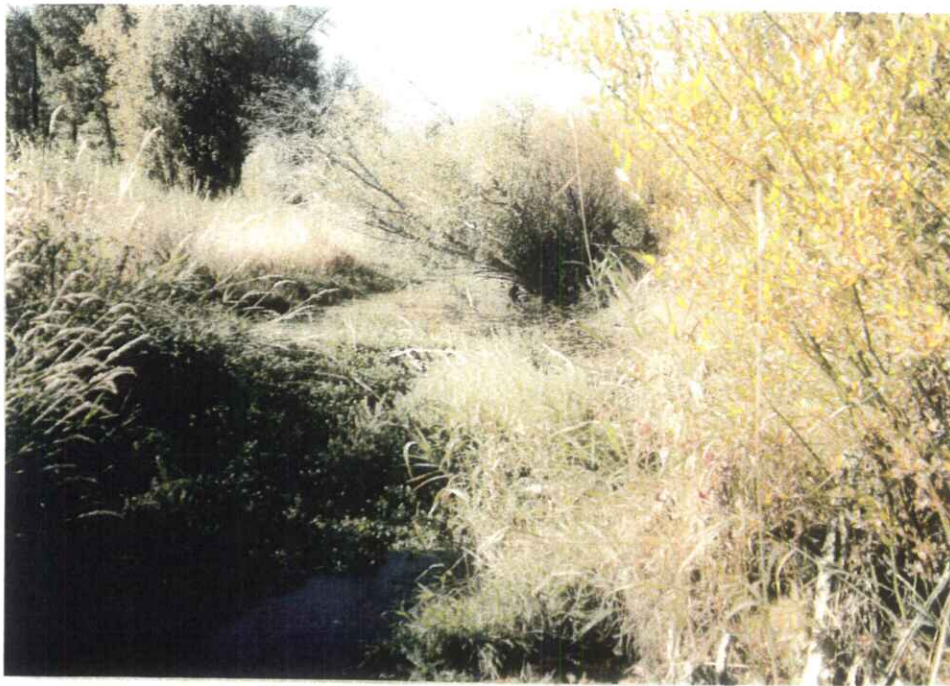
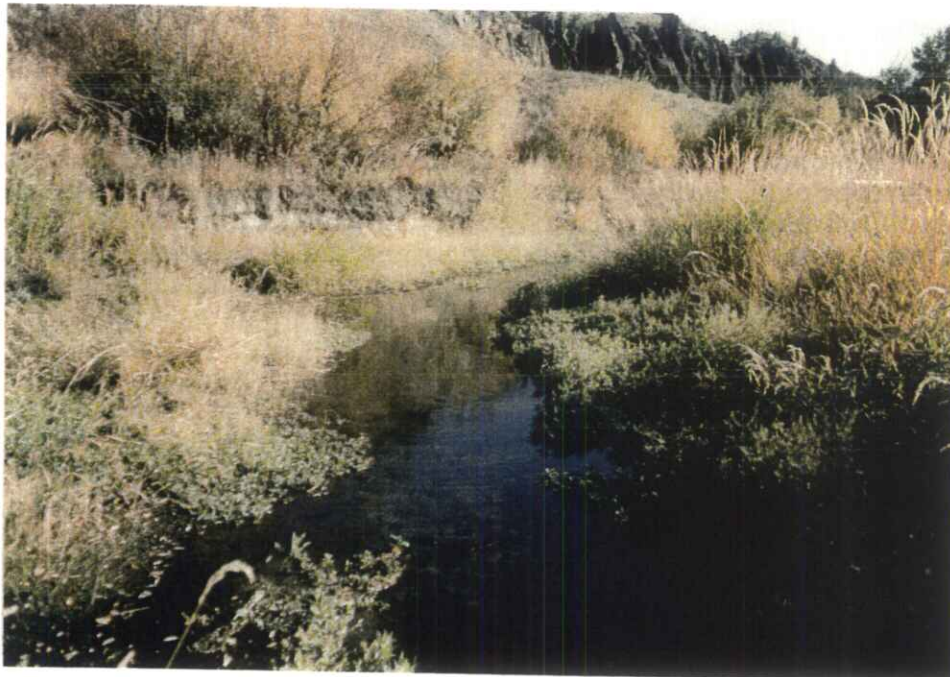
Figures 7 and 8. This is a overflow flood channel flowing at low flow. It has generally good stability and is growing lots of young vegetation and a variety of riparian and aquatic species. The main Wood River is only a few hundred feet below this point and provides good escape and rearing habitat for fisheries. The vegetation has significantly narrowed the channel (see Figure 8) since the floods of 1983 and 1984. There is a large deposit of fine sediments at the mouth which will provide sites for aquatic and obligate wetland vegetation. During a major flood, this area is expected to be scoured, widened and changed significantly where there is no woody vegetation. The vegetation should reestablish to what is shown in the photographs provided that flooding is not significant.

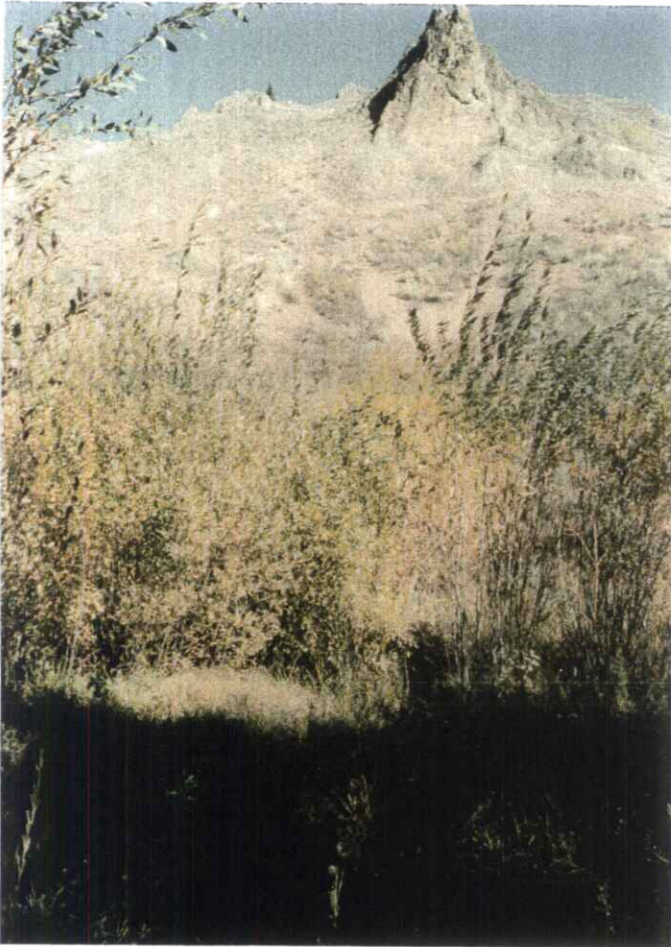
Figures 9 and 10 show the typical dense herbaceous and shrub vegetation. The steep slope to the east provides additional diversity of habitat and extended shading in the morning.

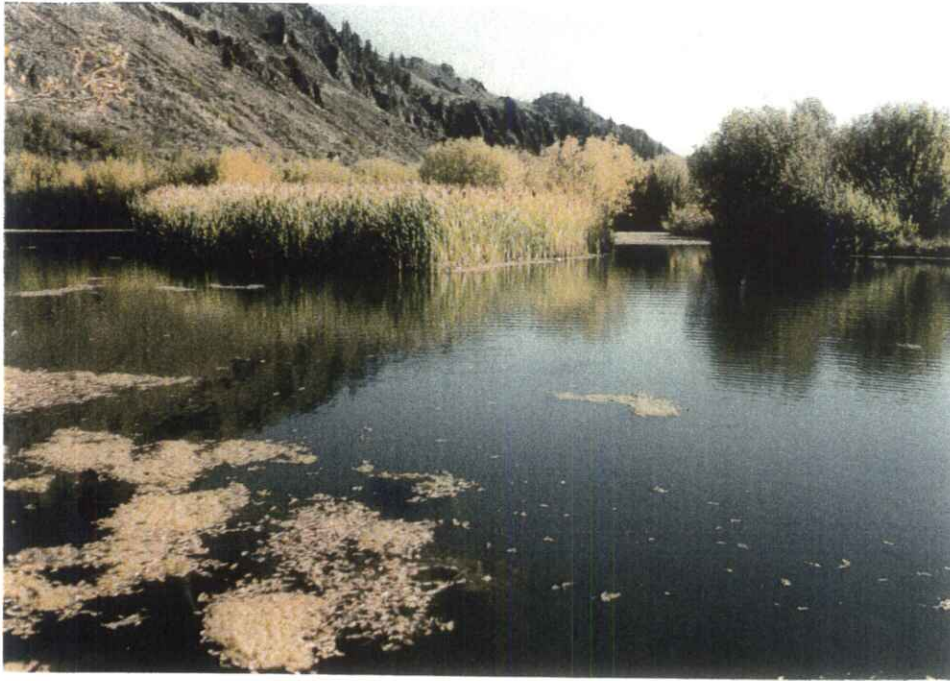
Figure 13. The open water area provides unique habitat to typical Wood River riparian ecosystem. This pond has been artificially enlarged and the water level is controlled with a head gate. The pond probably can be adjusted to provide maximum habitat for waterfowl. Its value as a fishery is uncertain at this time.

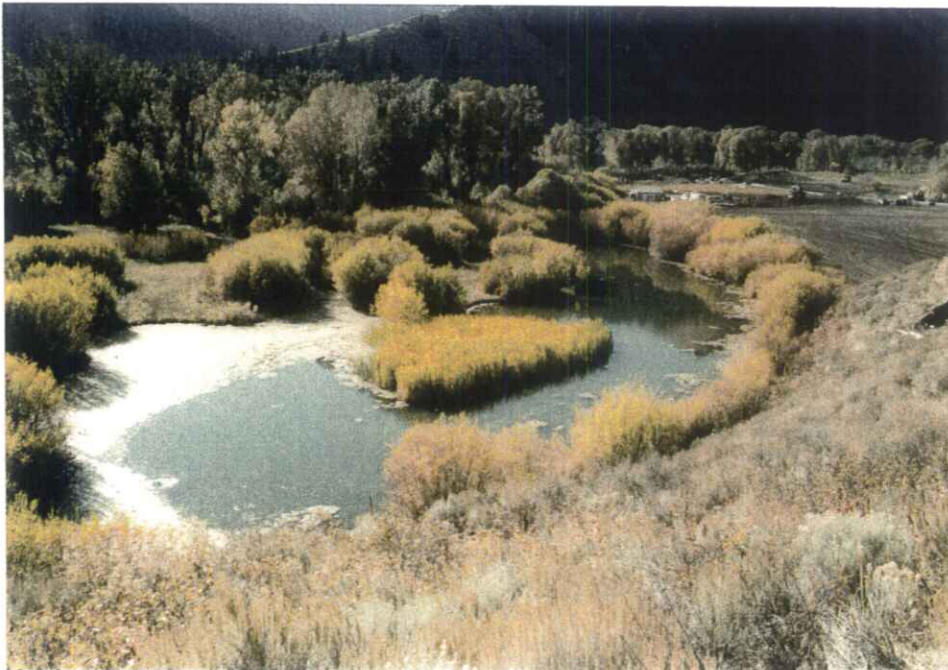
Figure 15. A view from near the Hormel residence. The appearance of the pond may not be pleasing in the summer because of algae. This will be a typical fall scene because of floating leaves.

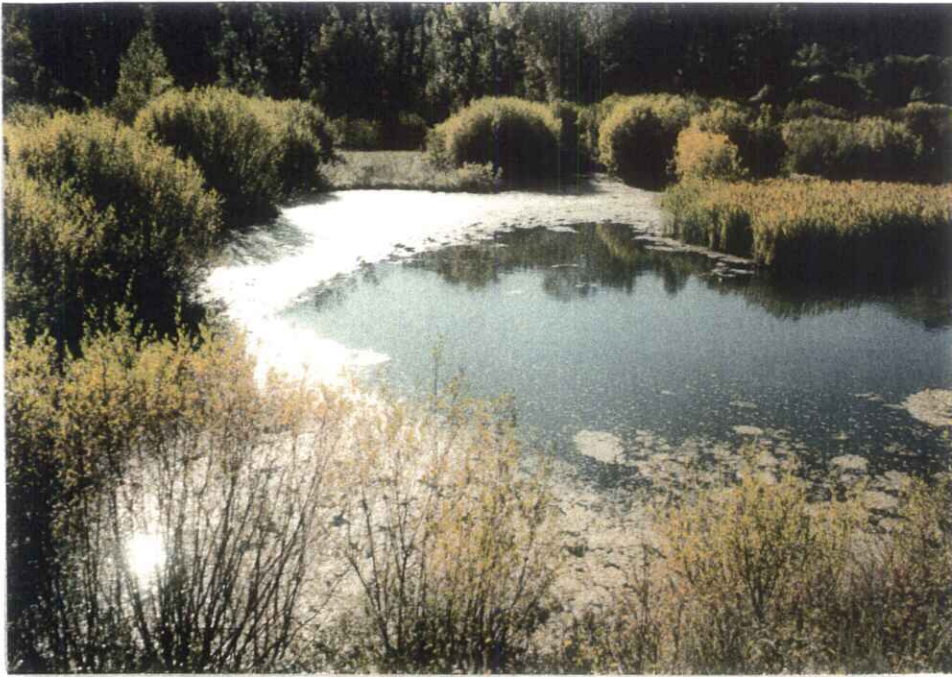
Figure 16. The pond accumulates quite a lot of floating material composed of leaves and algae.

The only water quality concern on the property has to do with the ponded water. There may be an over production of algae and aquatic vegetation in the pond due to a number of factors. The major concerns in summer conditions are elevated temperatures and creation of biochemical oxygen demand and depletion of oxygen in the pond, particularly at night. Both of these conditions could affect the fishery in the Wood River downstream from the confluence but are more likely to affect the usage of the flood channel and pond by native fishes.

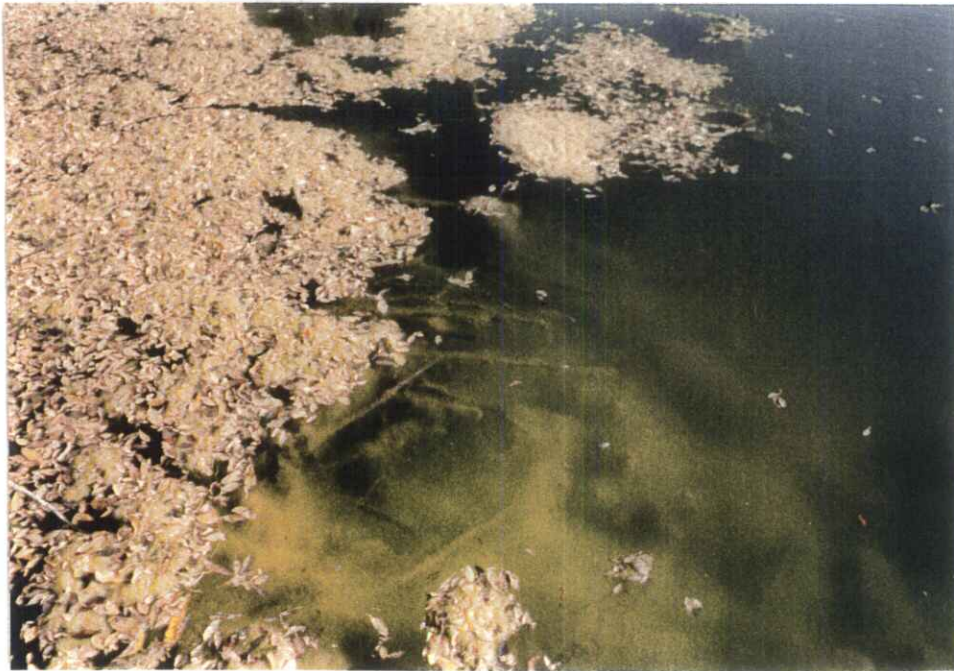
Figure 16. A closer look at the pond reveals lots of algae and aquatic vegetation. This situation may be detrimental to the native fish in the Wood River because of diurnal dissolved oxygen deficits.

At this point in time, the only area that requires further study is the open water area in the northern portion of the property. There needs to be some water quality sampling and hydrologic measurements. The study would determine the amount of temperature and/or dissolved oxygen problem caused by the pond and would recommend mitigation to correct the problems.
