To: File A34-00832A  
Fr: Bryce A. Contor  
Date: August 30, 1999

Re: Field Inspection

Today I inspected the point of diversion, diverting works, and place of use of claim A34-00832A, in the company of Mr. James Bauer, claimant.

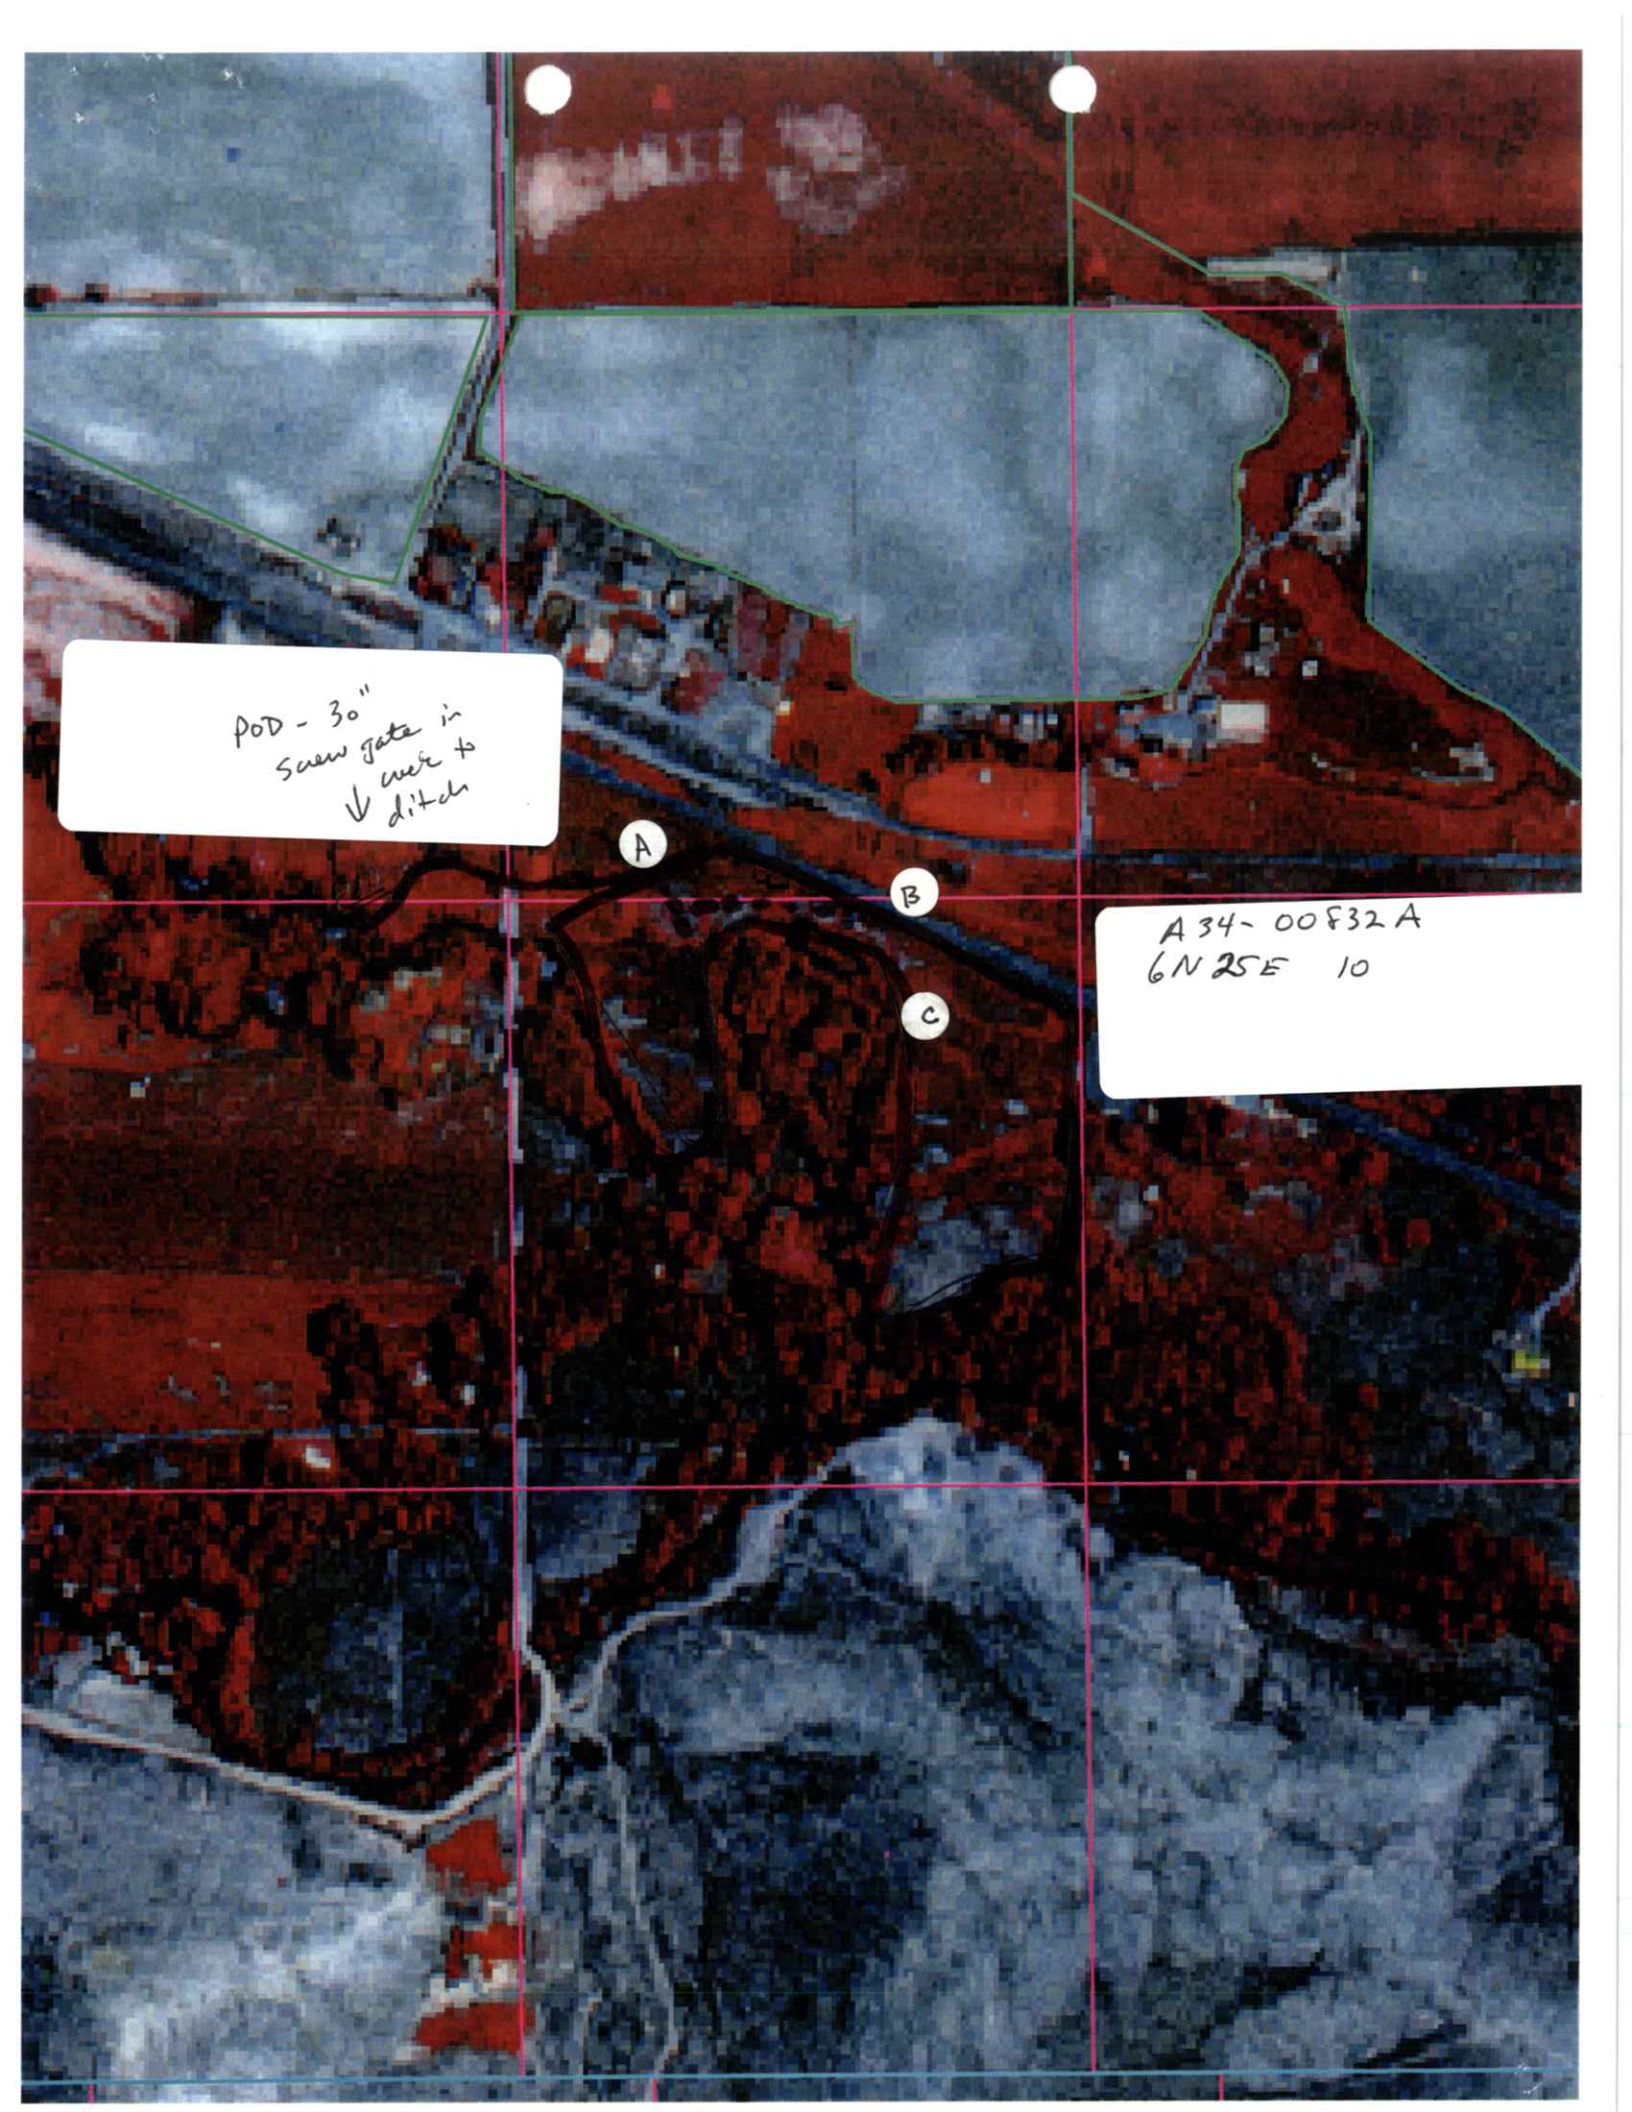
A34-00F32A  
6N25E 10

POD - 30"  
Sewer gate in  
weir to  
ditch

30" Screw gate - spring the river water  
late - spring fed only.

Share ditch w/ George Gilbert

≈ 500' ? N of road.

≈ 6" fall in 100' @ ditch by hand level -  
see map.

- 1) Map on claim matches what I found in the field – see attached GIS with sketched details. Mr. Bauer more or less concurs with my sketch.
- 2) Location “A” shows concrete check structure (see photos) indicating historical ability to divert water onto property.

- 5) Newly constructed ditch (dotted line) south from location “A” has adequate fall – approximately 6 inches per 100 feet by hand-level sighting – to convey water to place of use. It appears that this ditch would work if structure “A” were checked up.

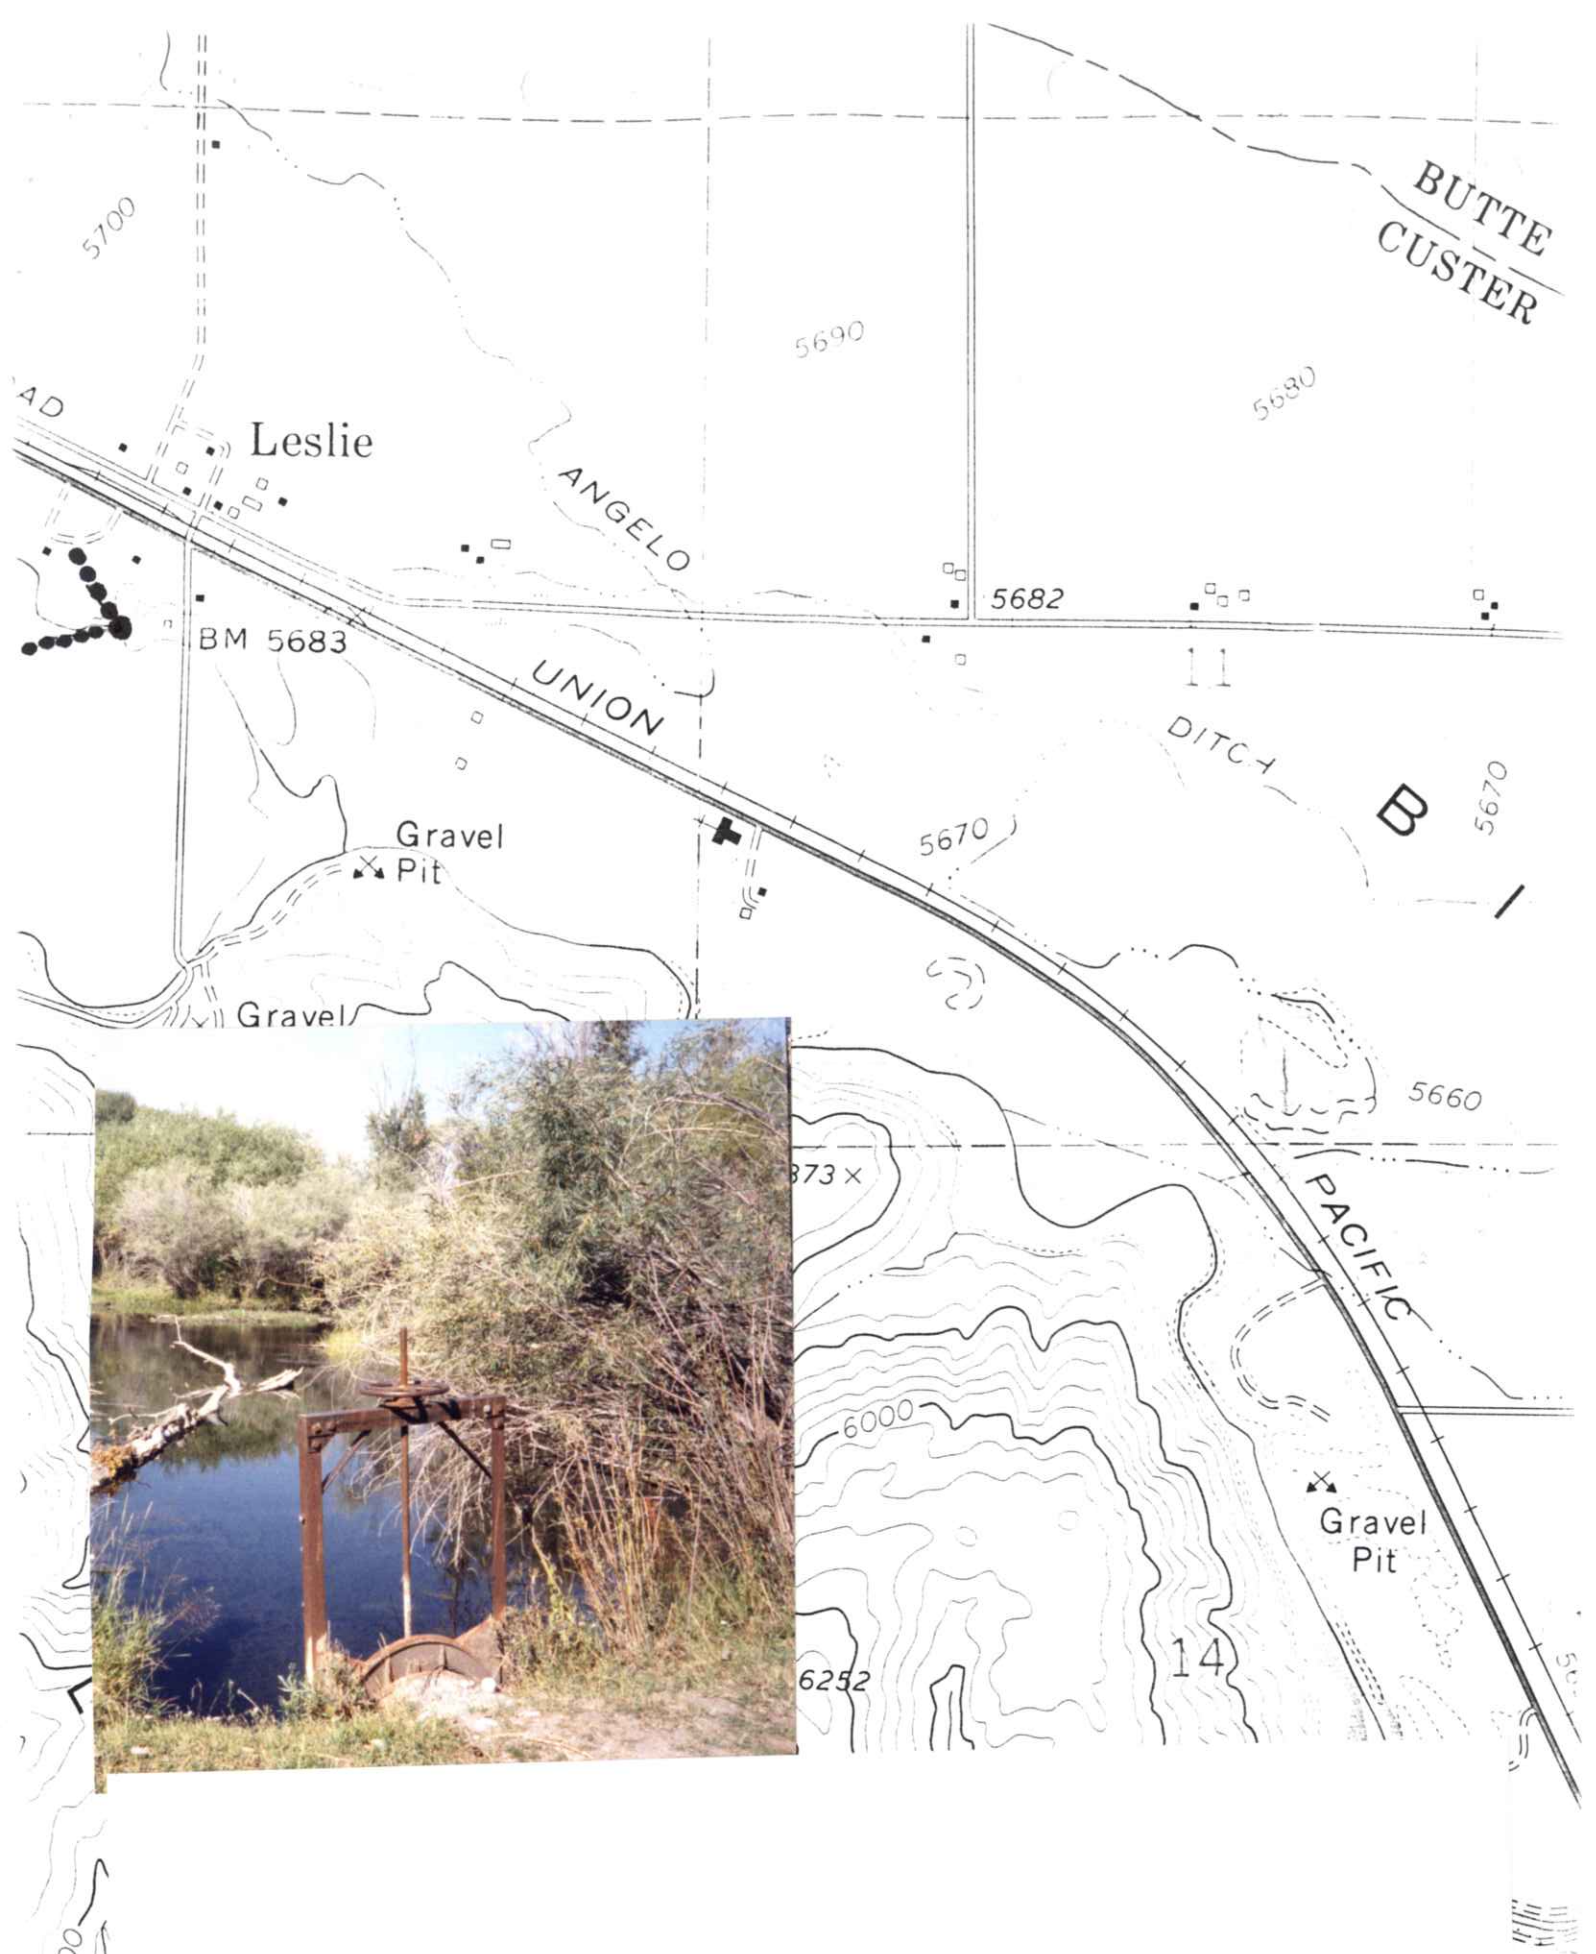
**A34-00832A Photo taken 8/30/1999 by Bryce A. Contor**

30 inch screwgate on Spring Creek. Looking west (upstream) across top of screwgate.

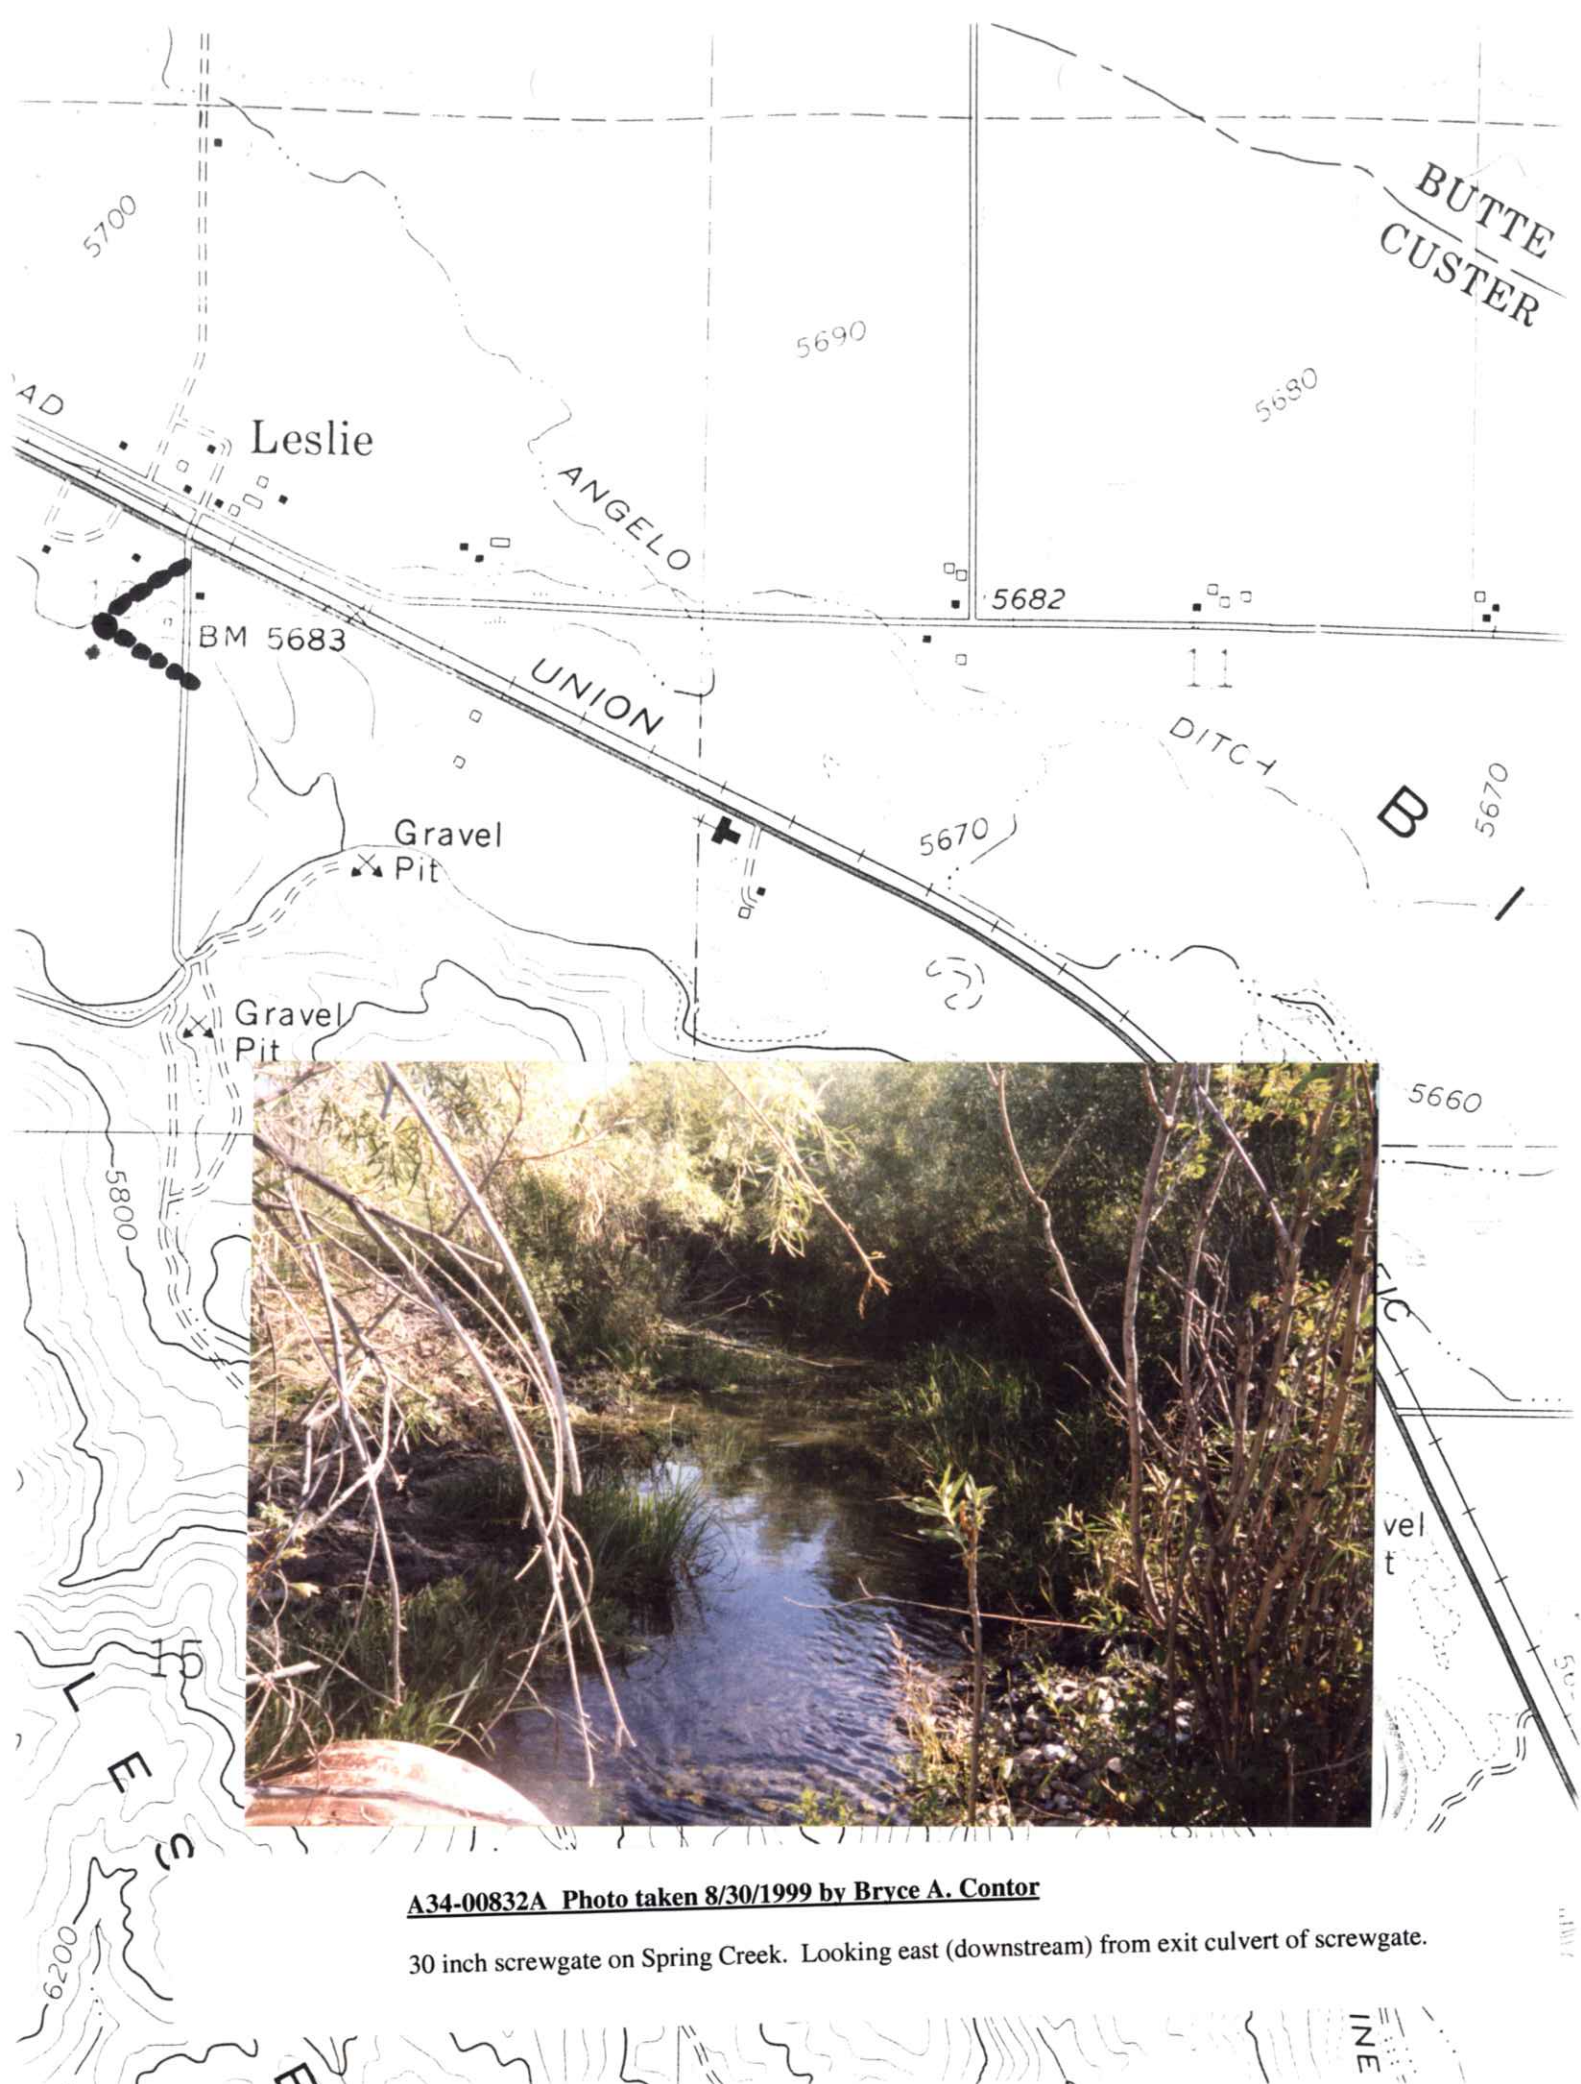
**A34-00832A Photo taken 8/30/1999 by Bryce A. Contor**

30 inch screwgate on Spring Creek. Looking east (downstream) from exit culvert of screwgate.

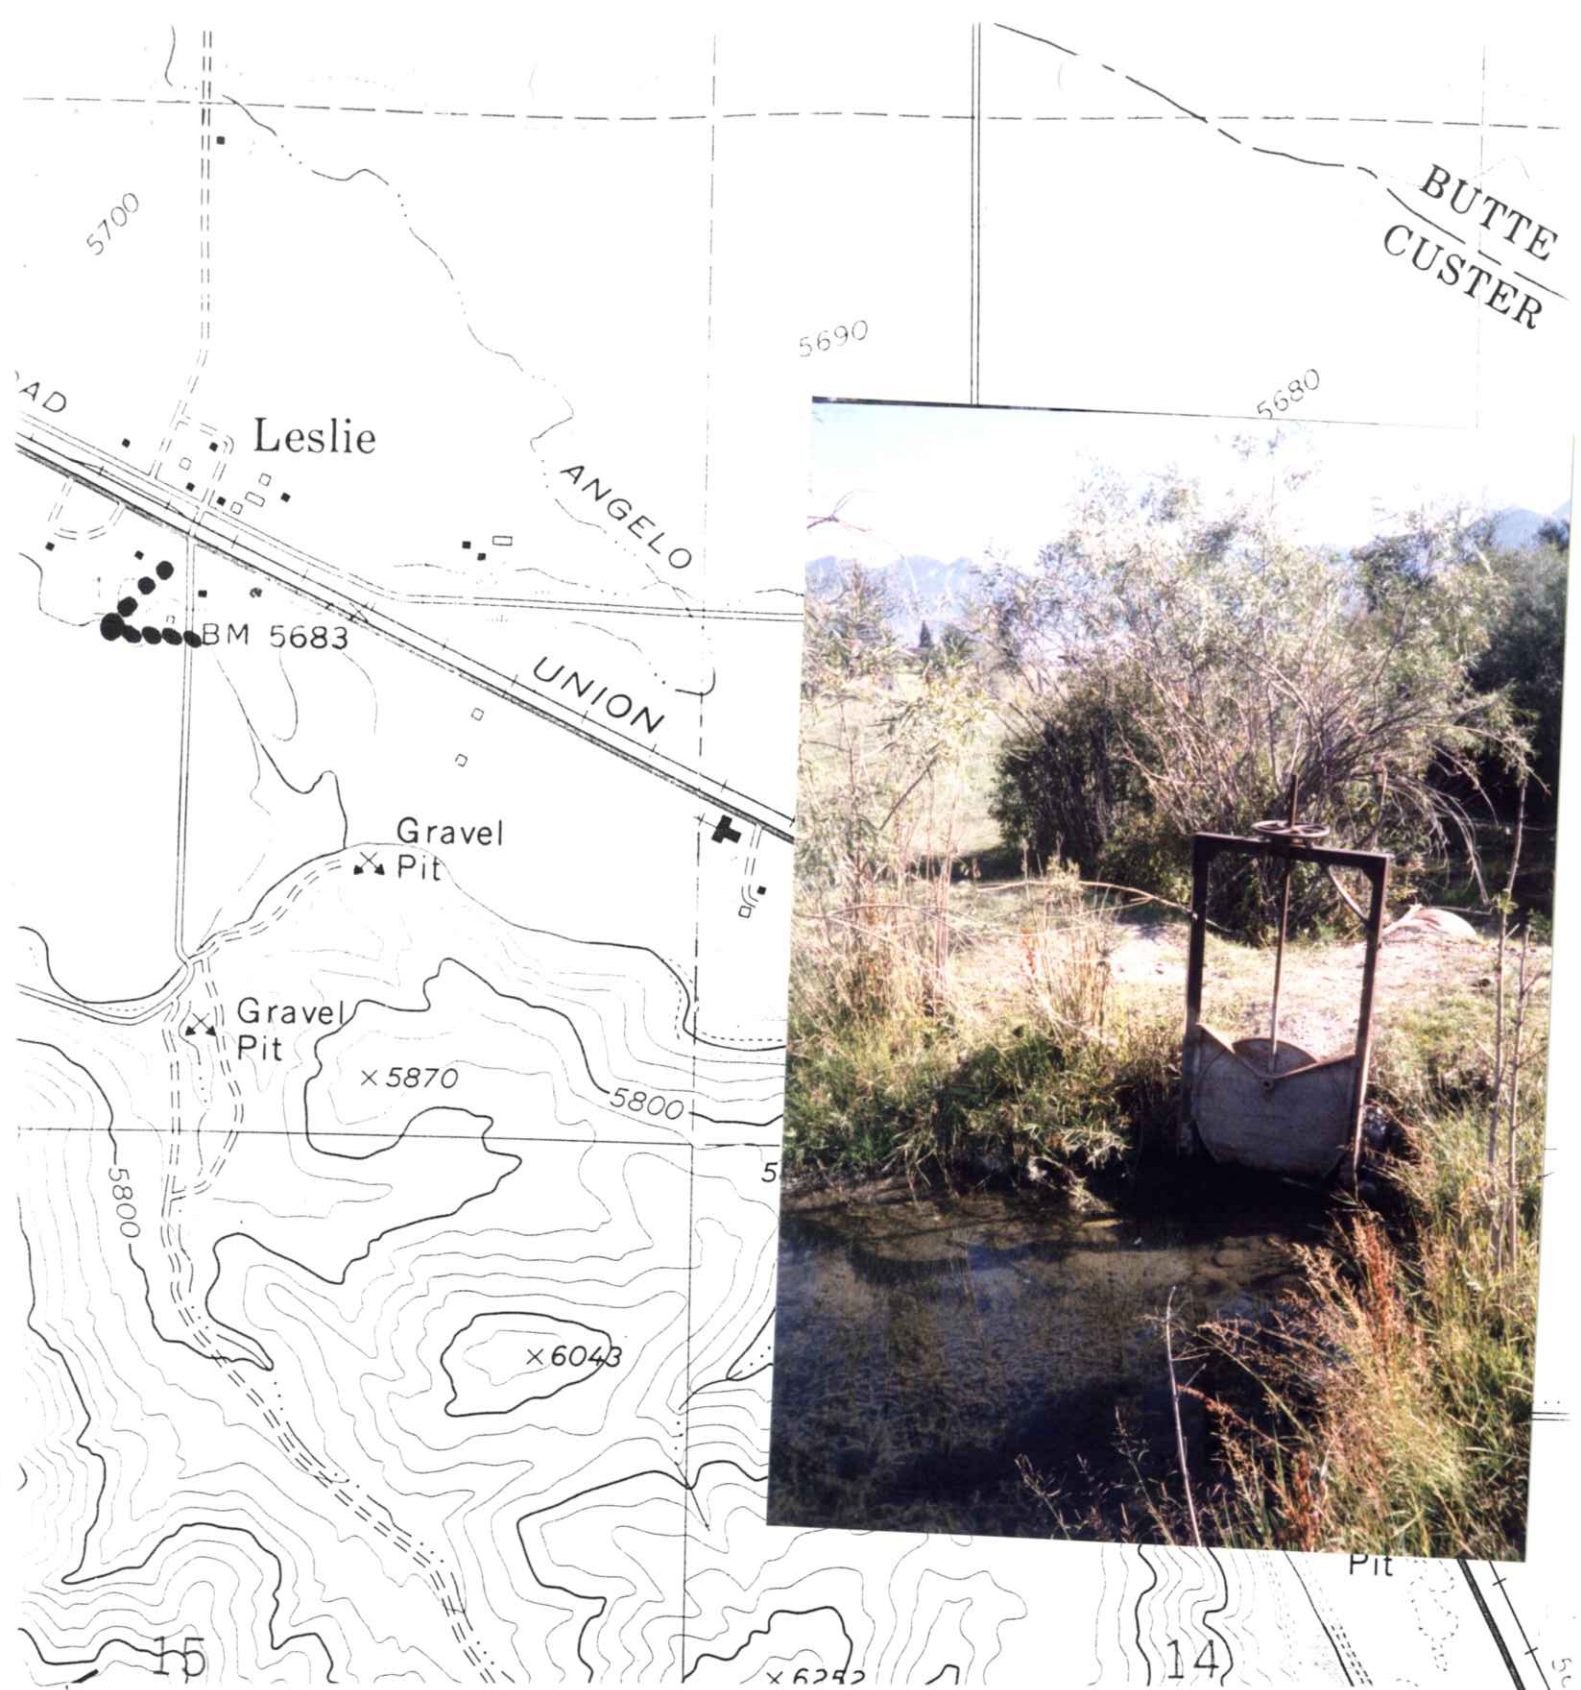
**A34-00832A Photo taken 8/30/1999 by Bryce A. Contor**

30 inch screwgate on Spring Creek. Looking east (downstream) across top of screwgate.

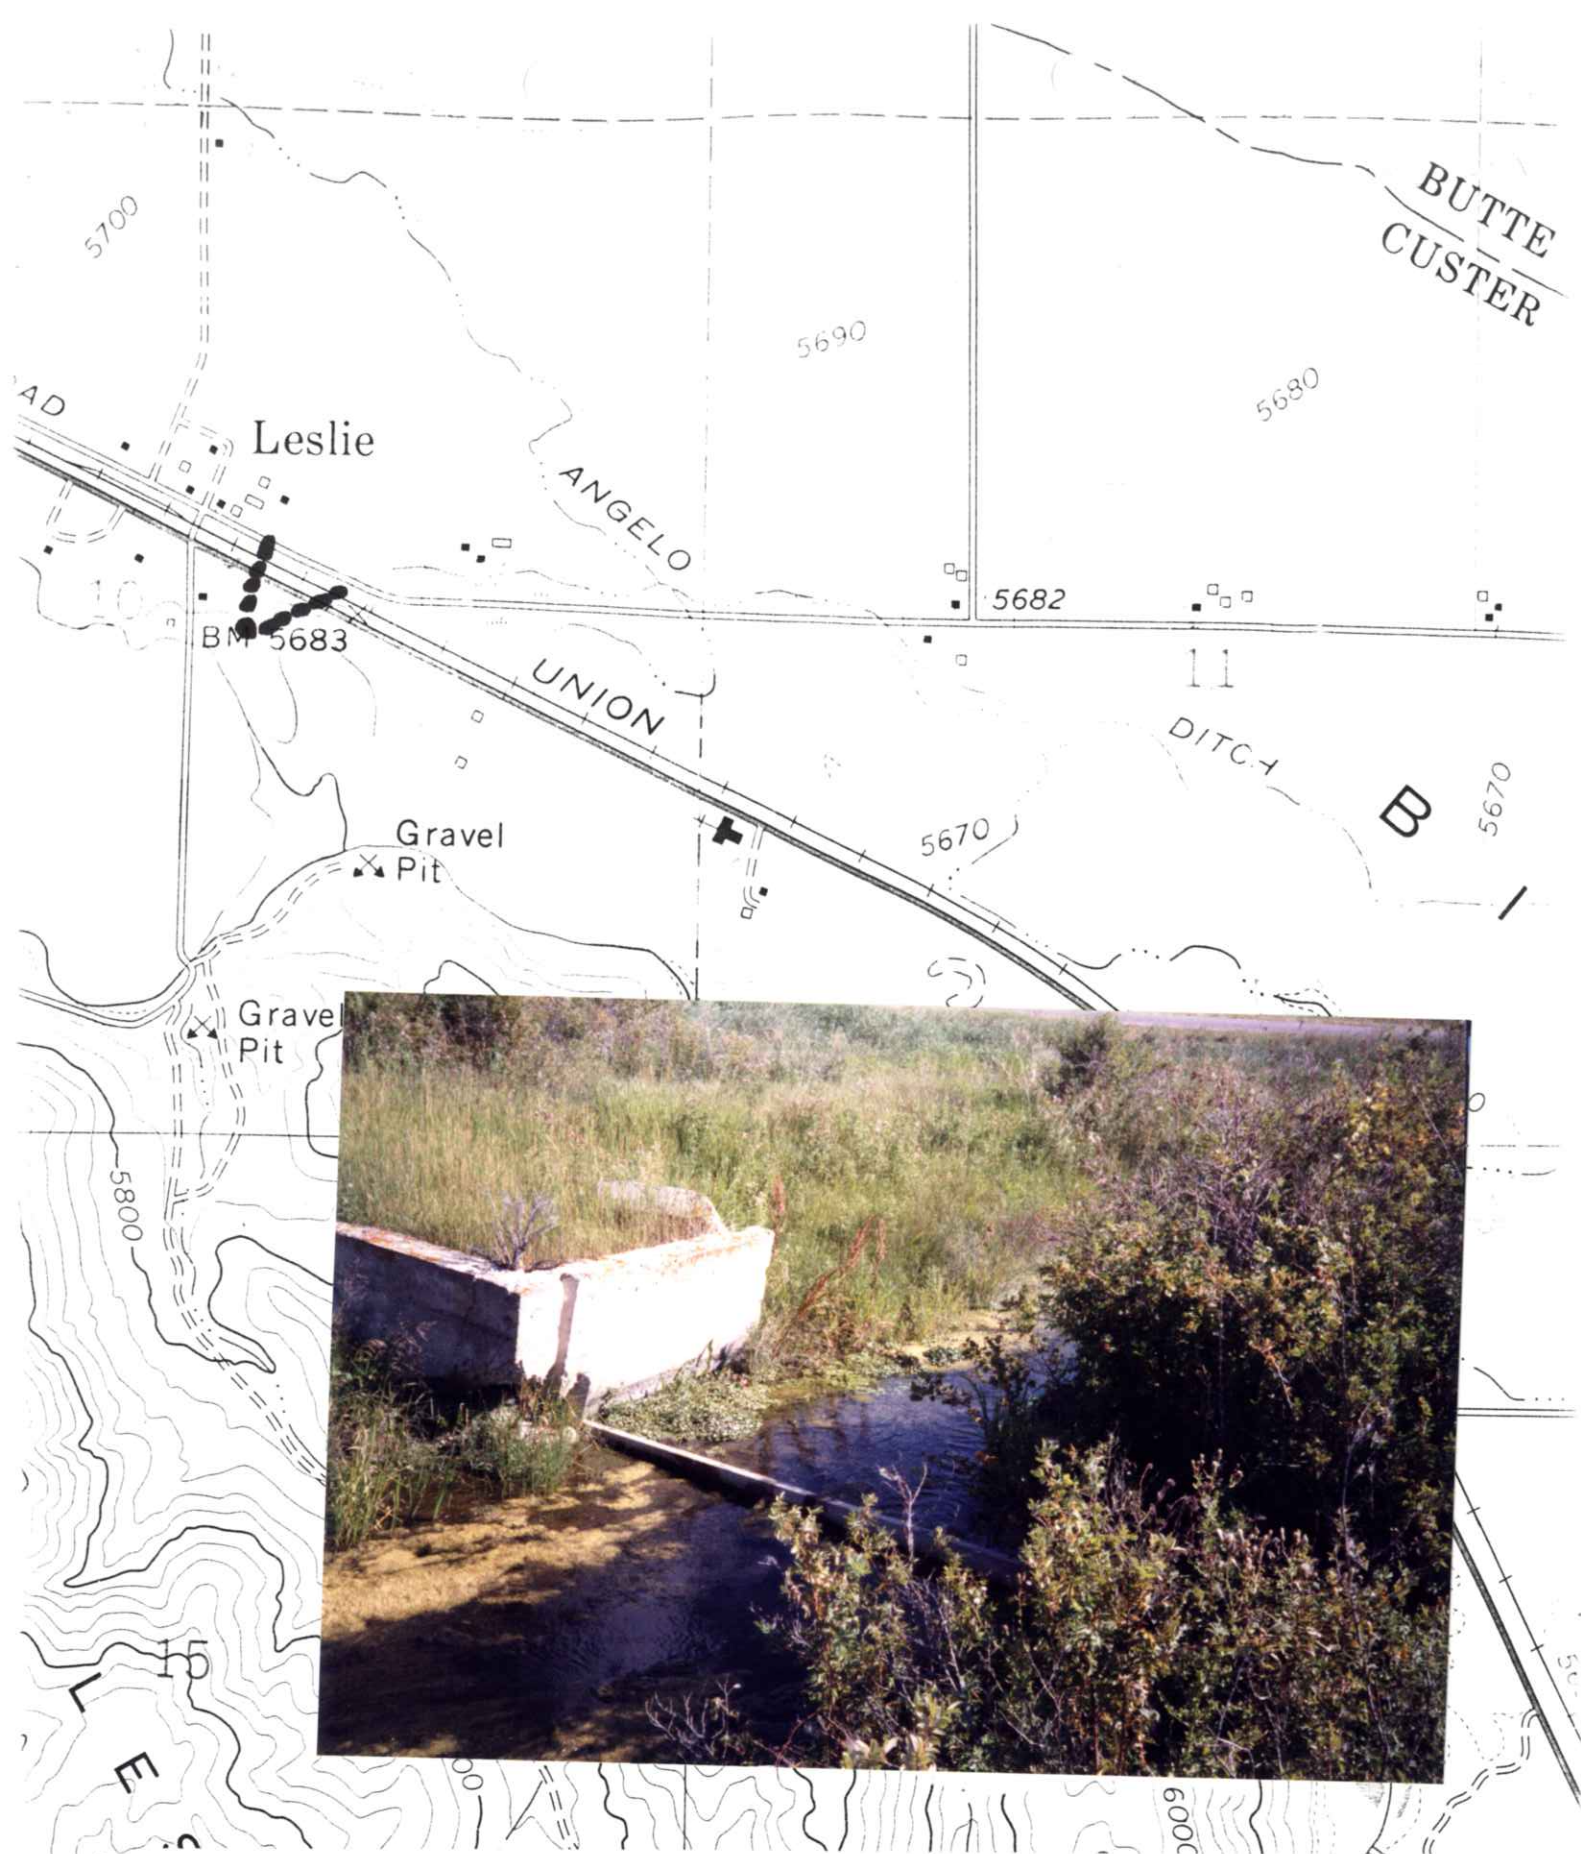
**A34-00832A Photo taken 8/30/1999 by Bryce A. Contor**

Check structure on ditch, location "A" on GIS photo. Looking east northeast from south side of ditch.

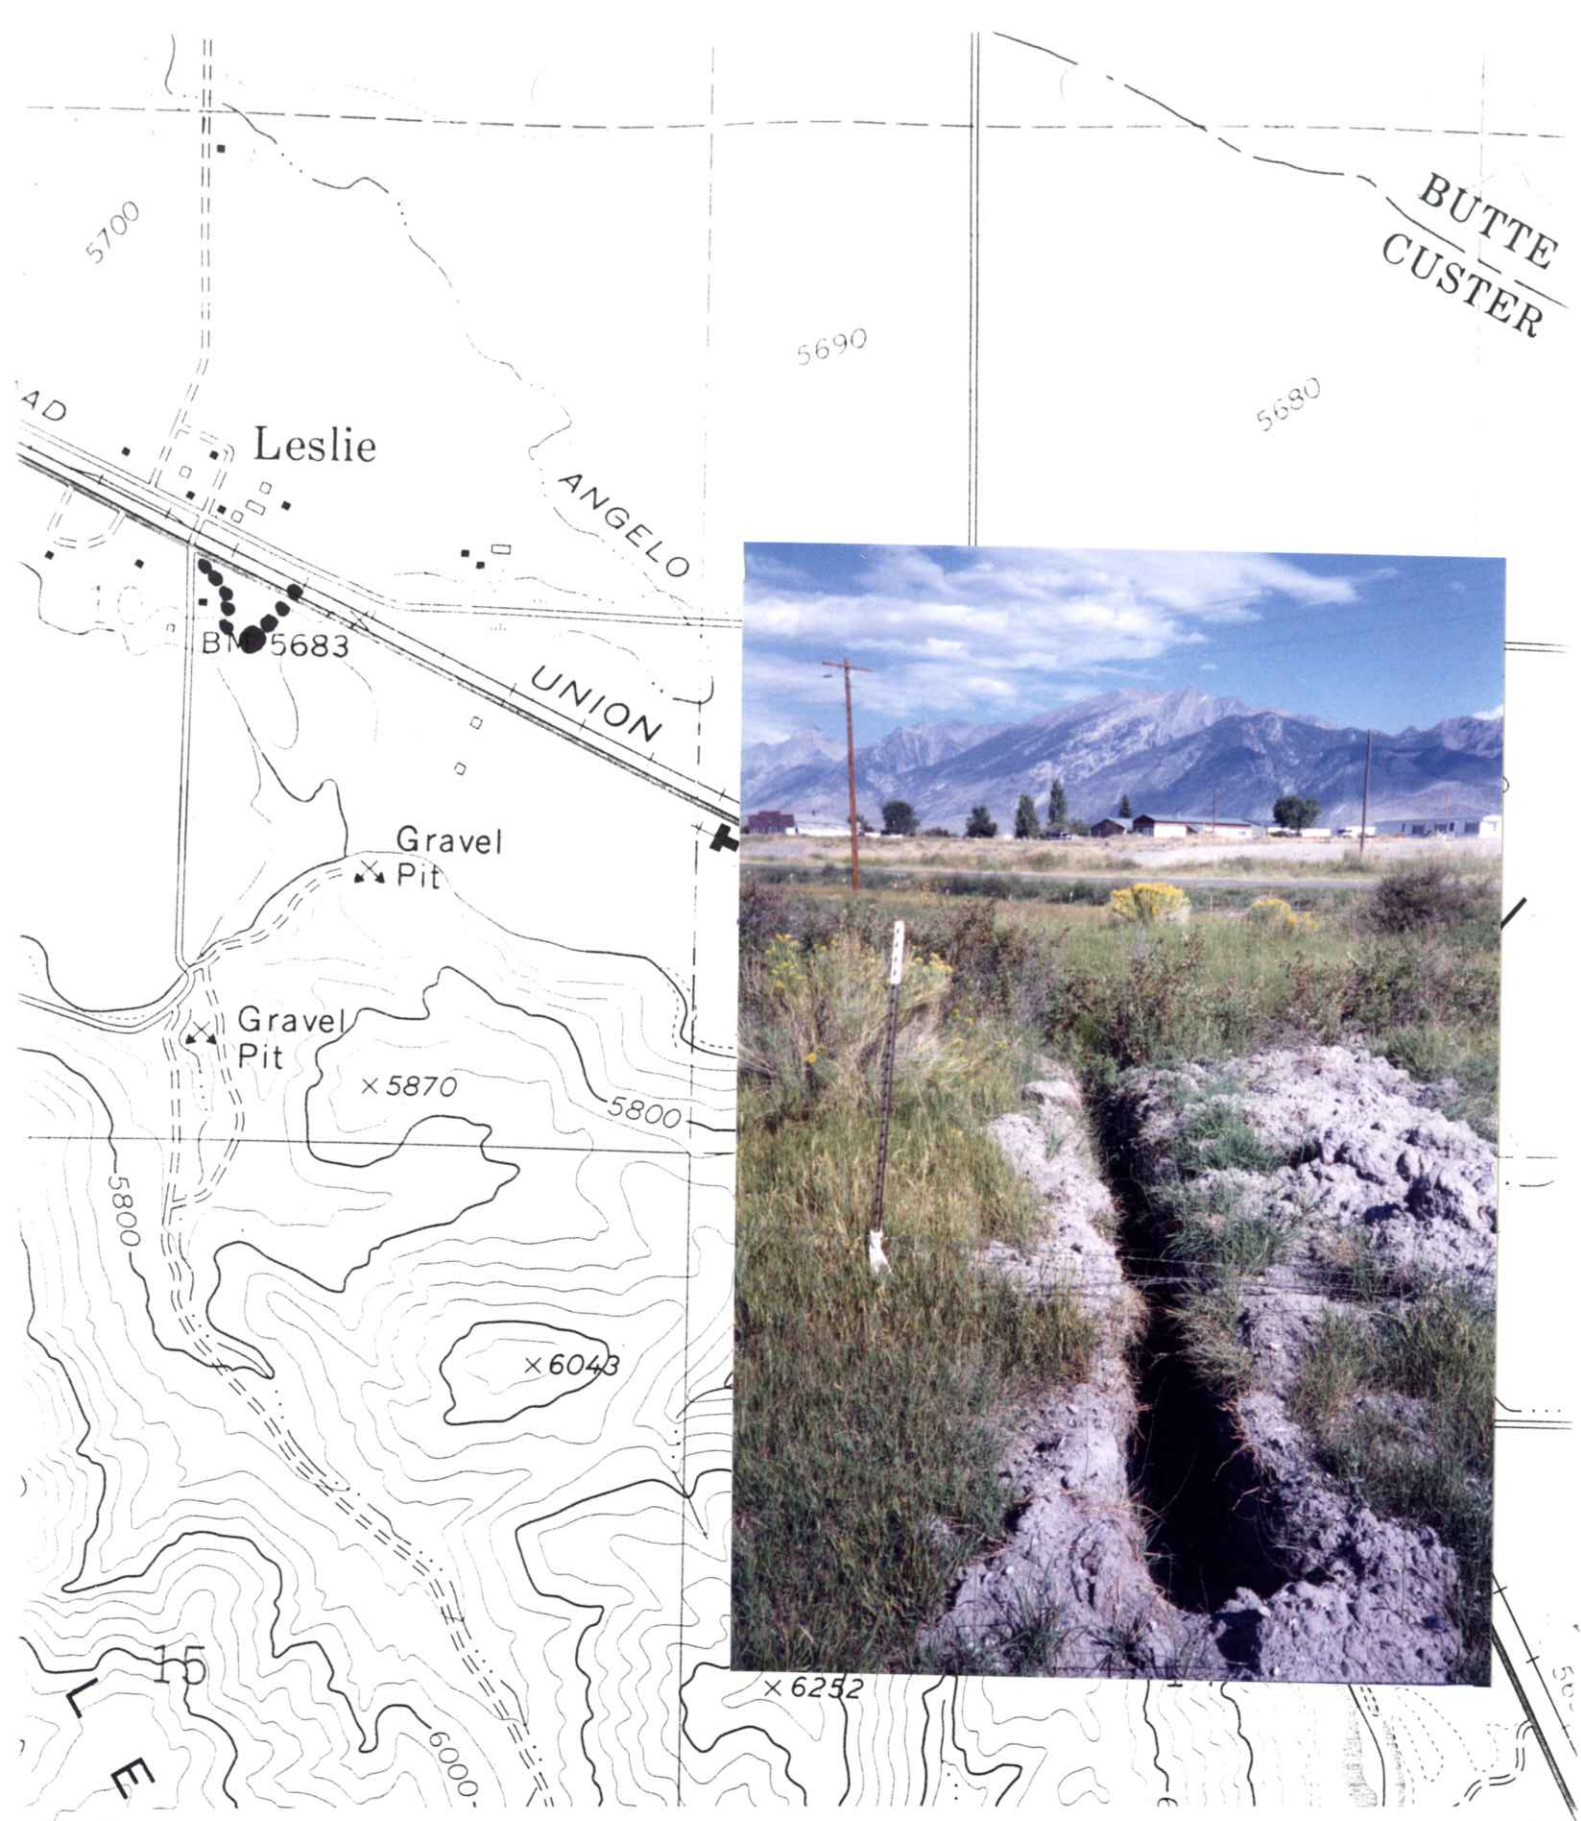
**A34-00832A Photo taken 8/30/1999 by Bryce A. Contor**

New ditch to check structure "A." Looking north from north edge of POU.

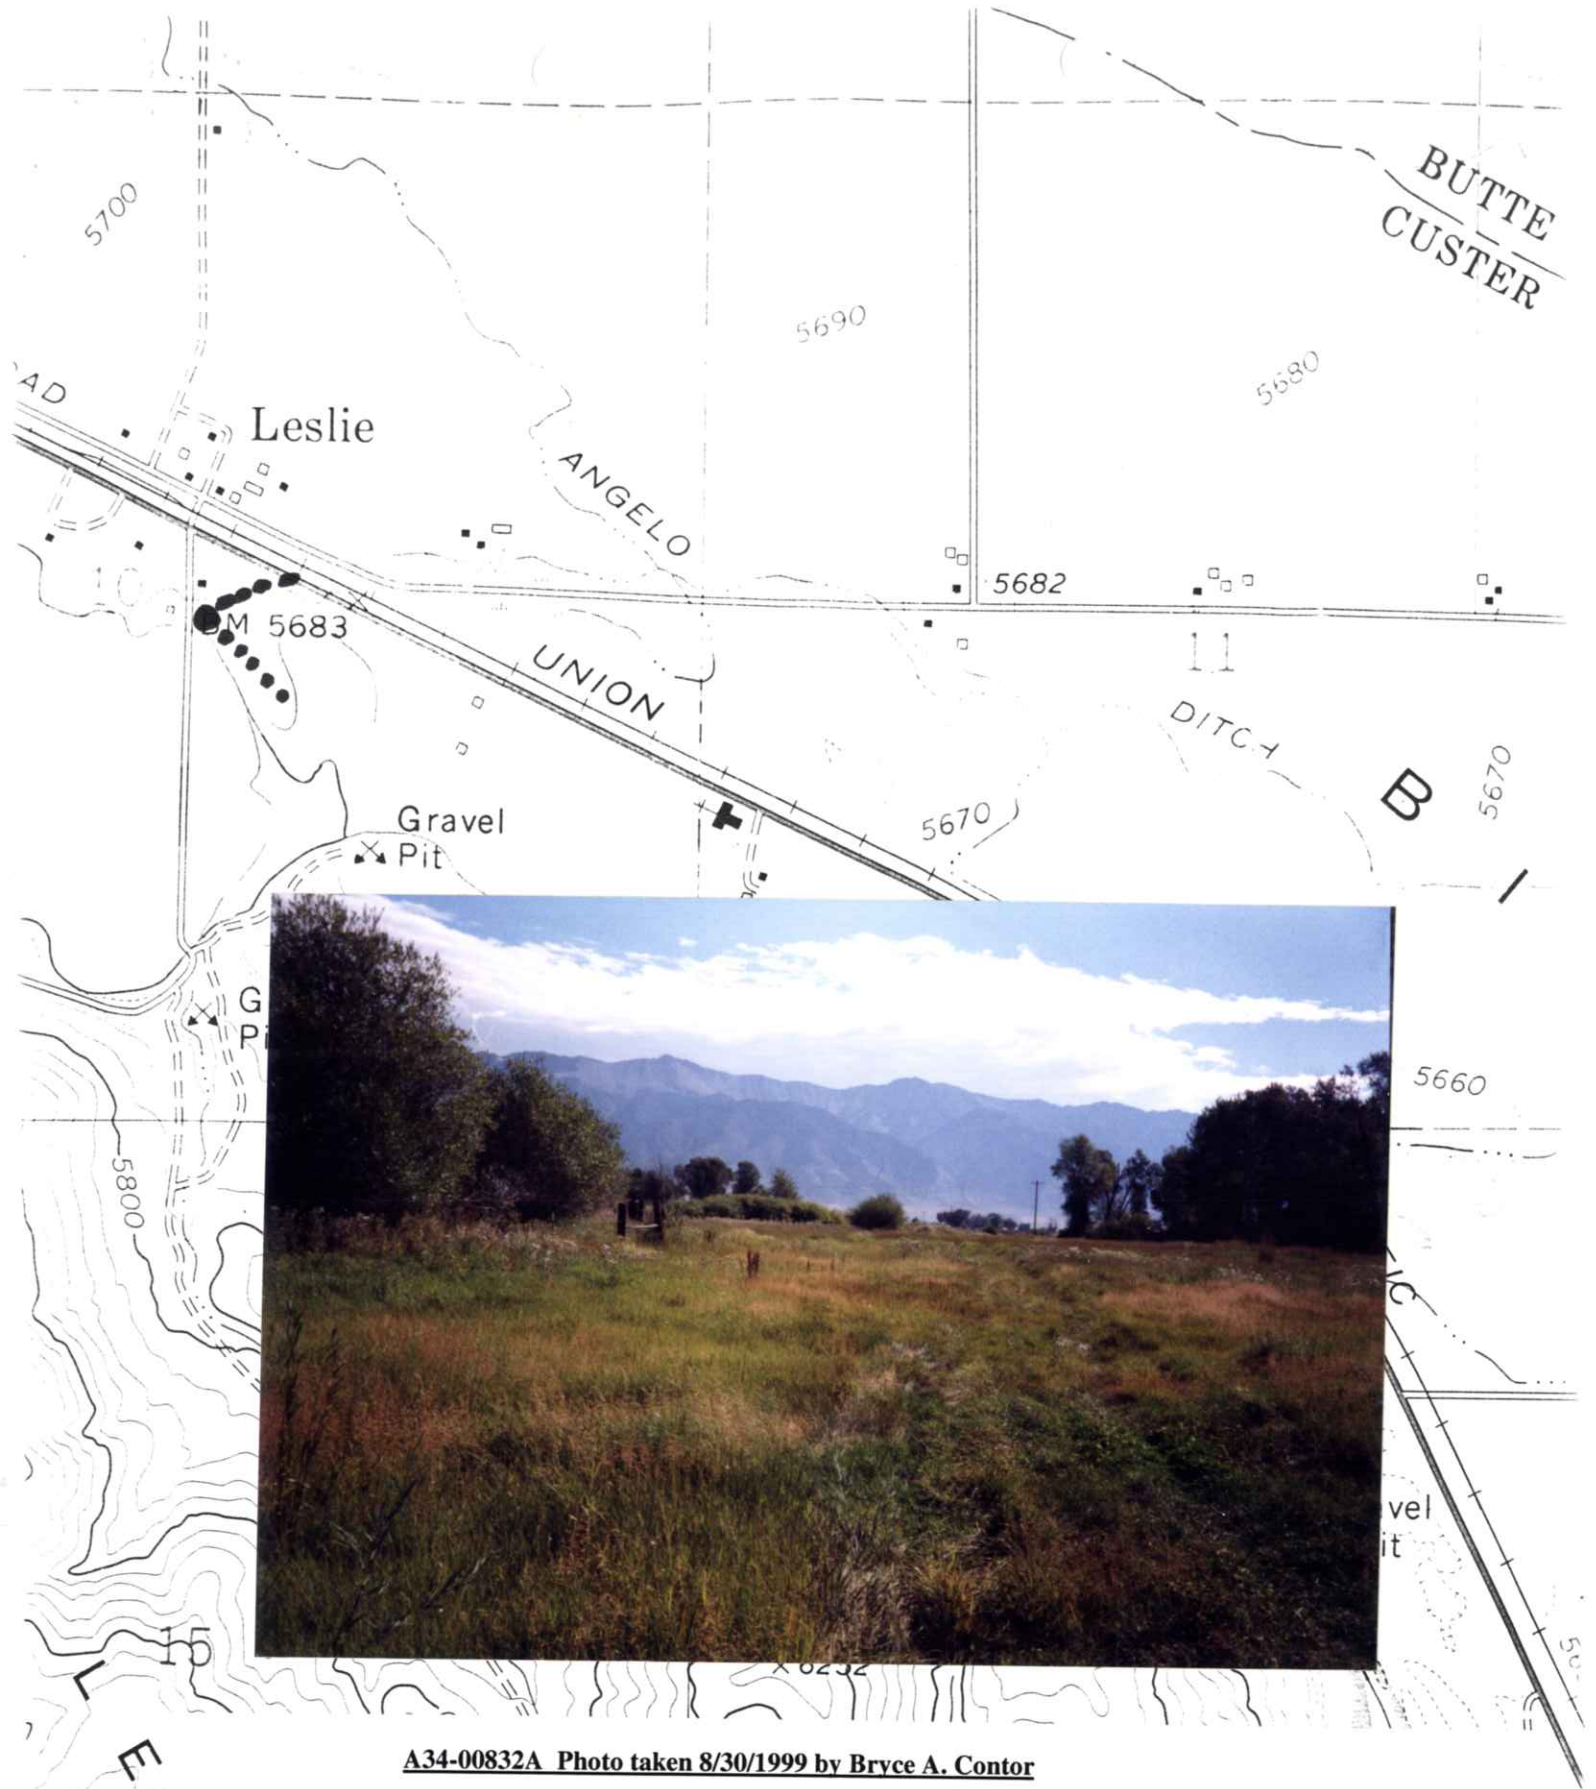
**A34-00832A Photo taken 8/30/1999 by Bryce A. Contor**

- 3) I did not see any remnants of old cross ditches or corrugations, indicating it has been some time since property was irrigated. Mr. Bauer indicates property has not been irrigated since he bought it about 1974.

Entry to POU. Looking southeast. Per claimant, no irrigation has occurred this season.

- 9) Based on the acknowledged lack of beneficial use, it appears that this claim should be recommended for disallowal.
