To: File A34-00832A  
Fr: Bryce A. Contor  
Date: August 30, 1999

Re: Field Inspection

Today I inspected the point of diversion, diverting works, and place of use of claim A34-00832A, in the company of Mr. James Bauer, claimant.

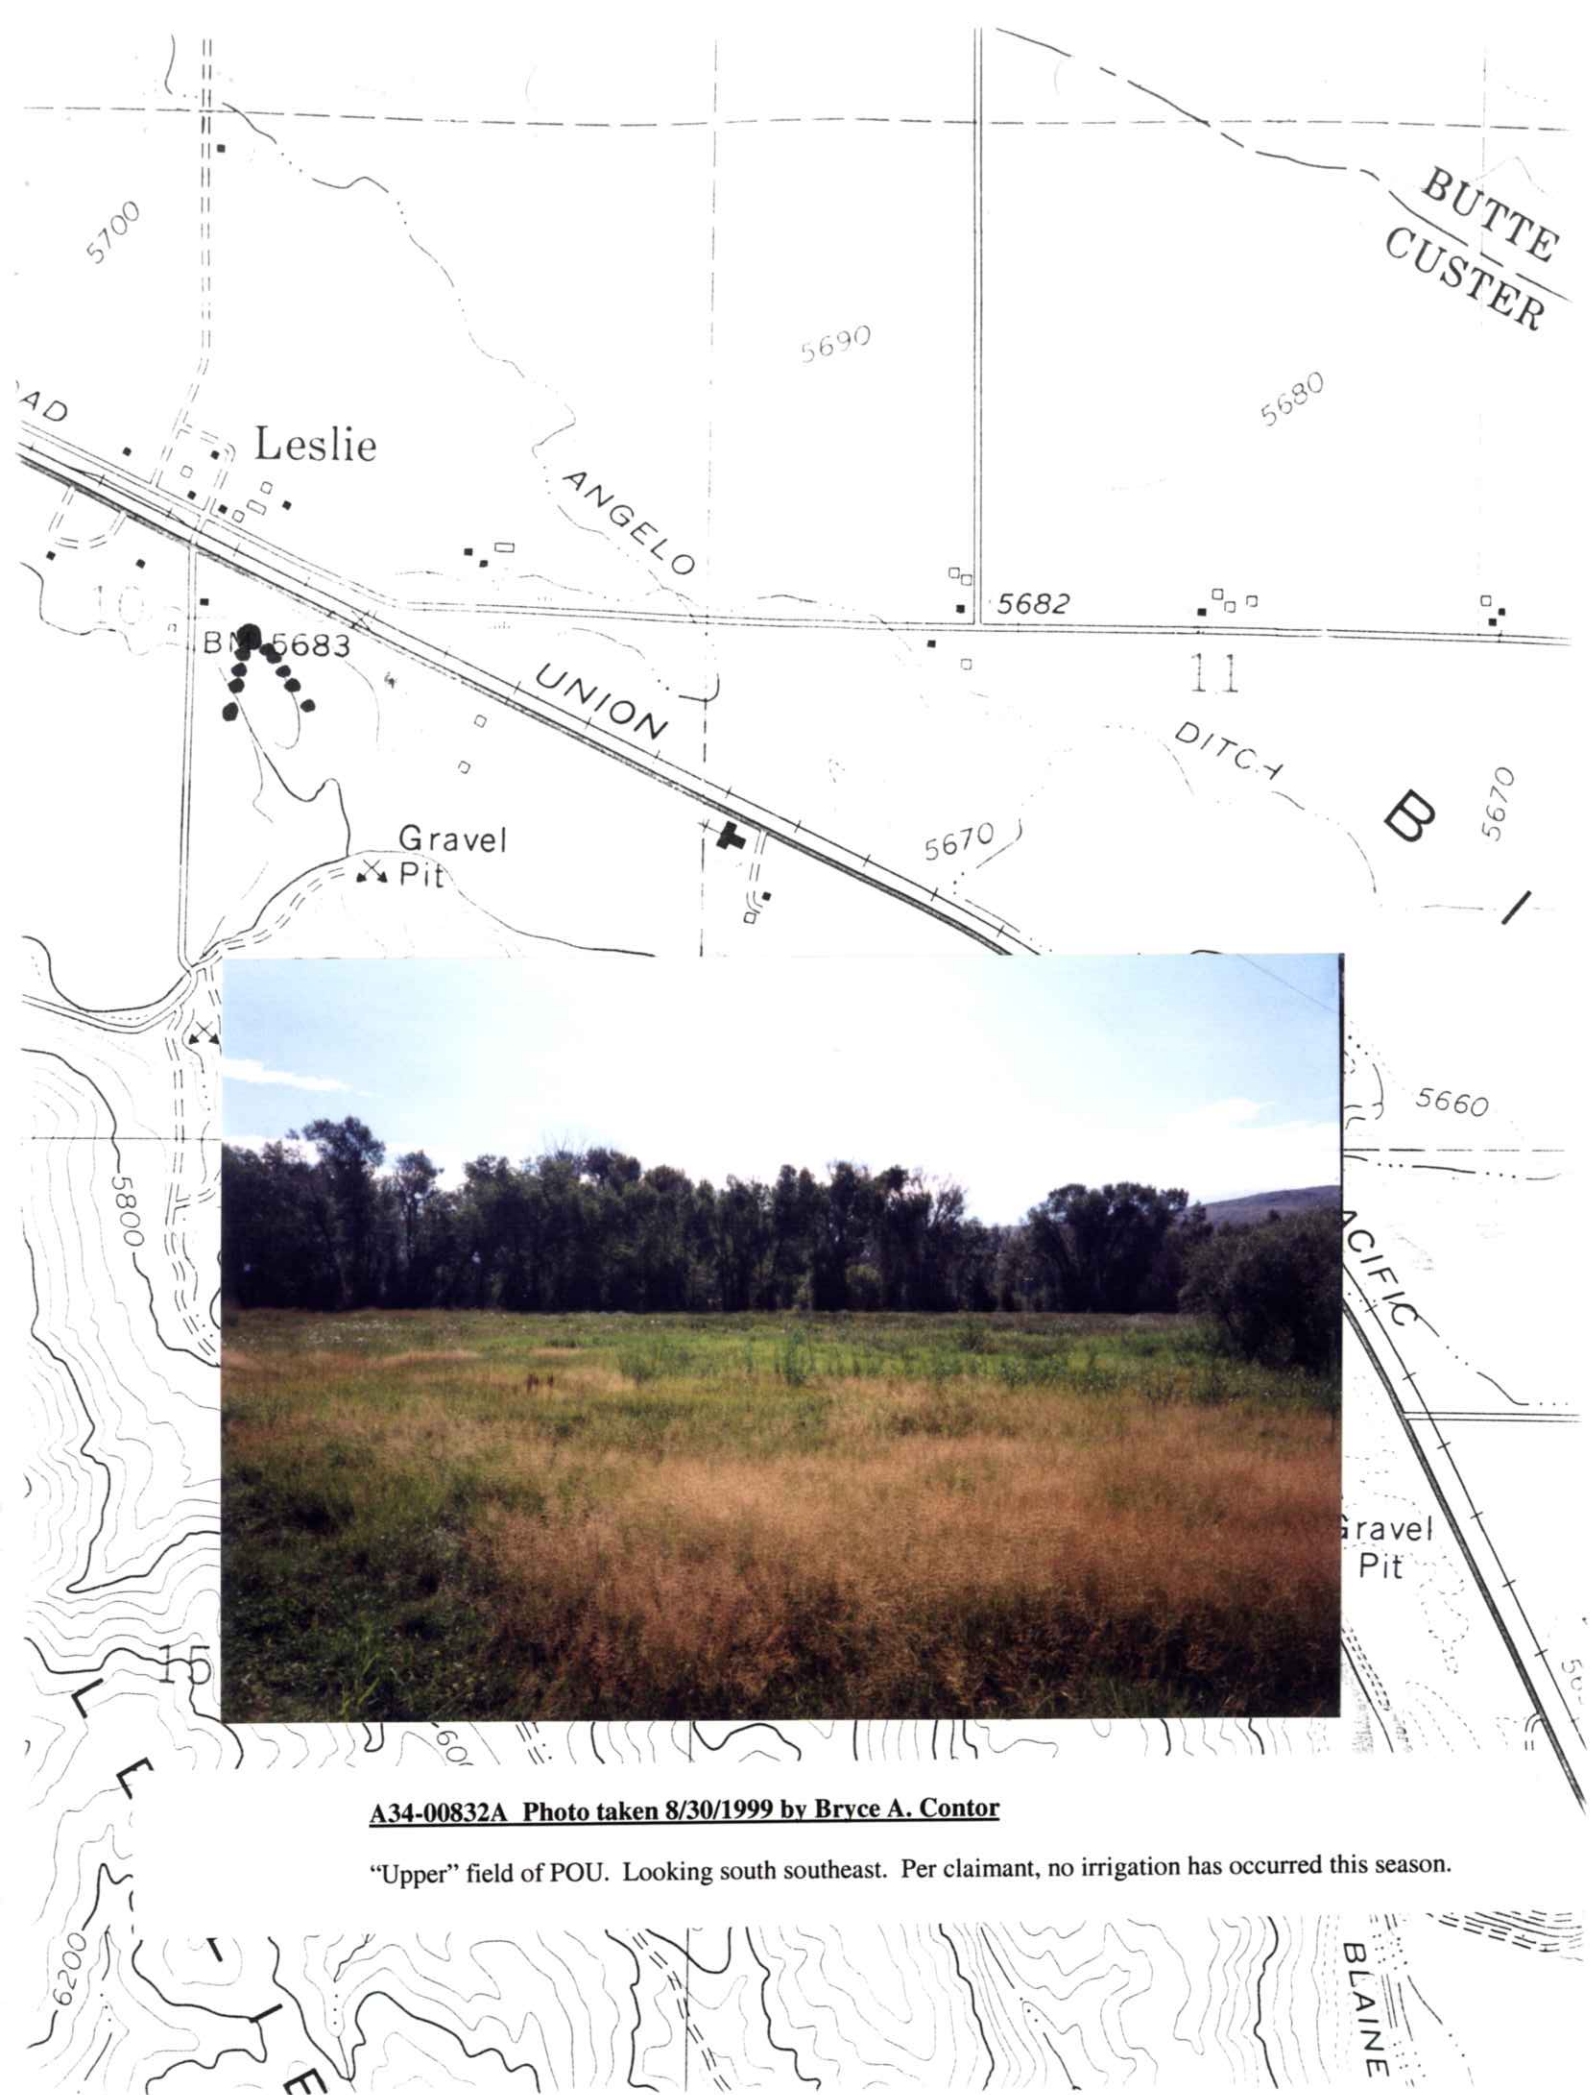
**A34-00832A Photo taken 8/30/1999 by Bryce A. Contor**

"Upper" field of POU. Looking south southeast. Per claimant, no irrigation has occurred this season.

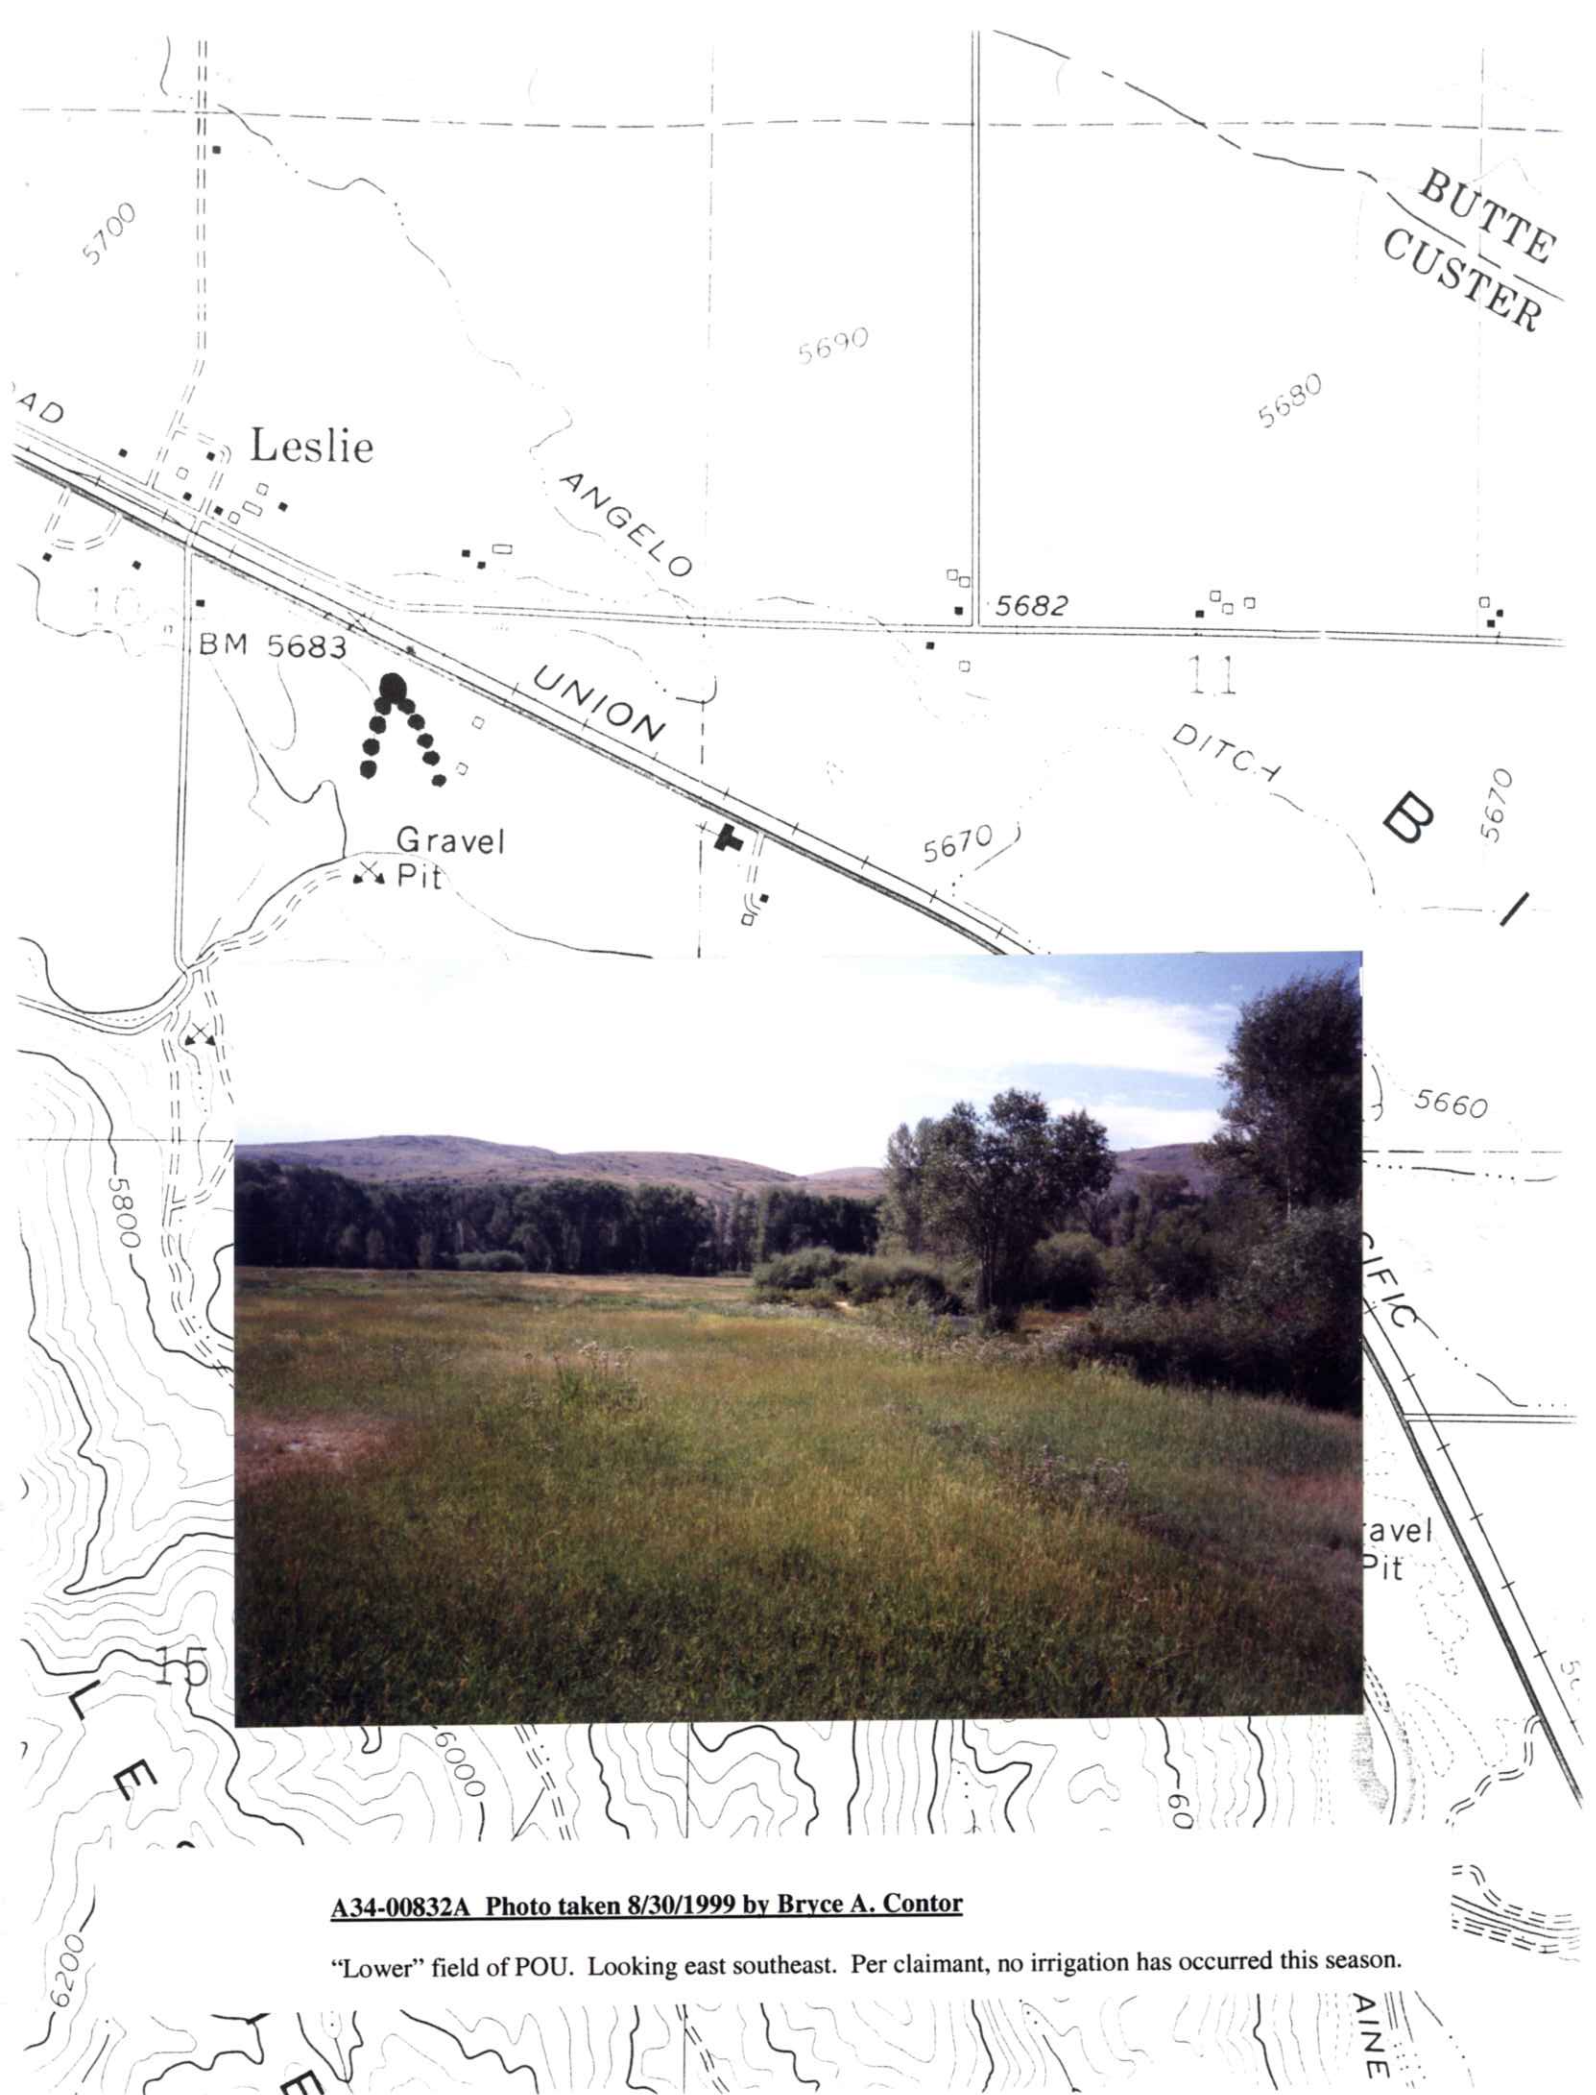
**A34-00832A Photo taken 8/30/1999 by Bryce A. Contor**

"Lower" field of POU. Looking east southeast. Per claimant, no irrigation has occurred this season.

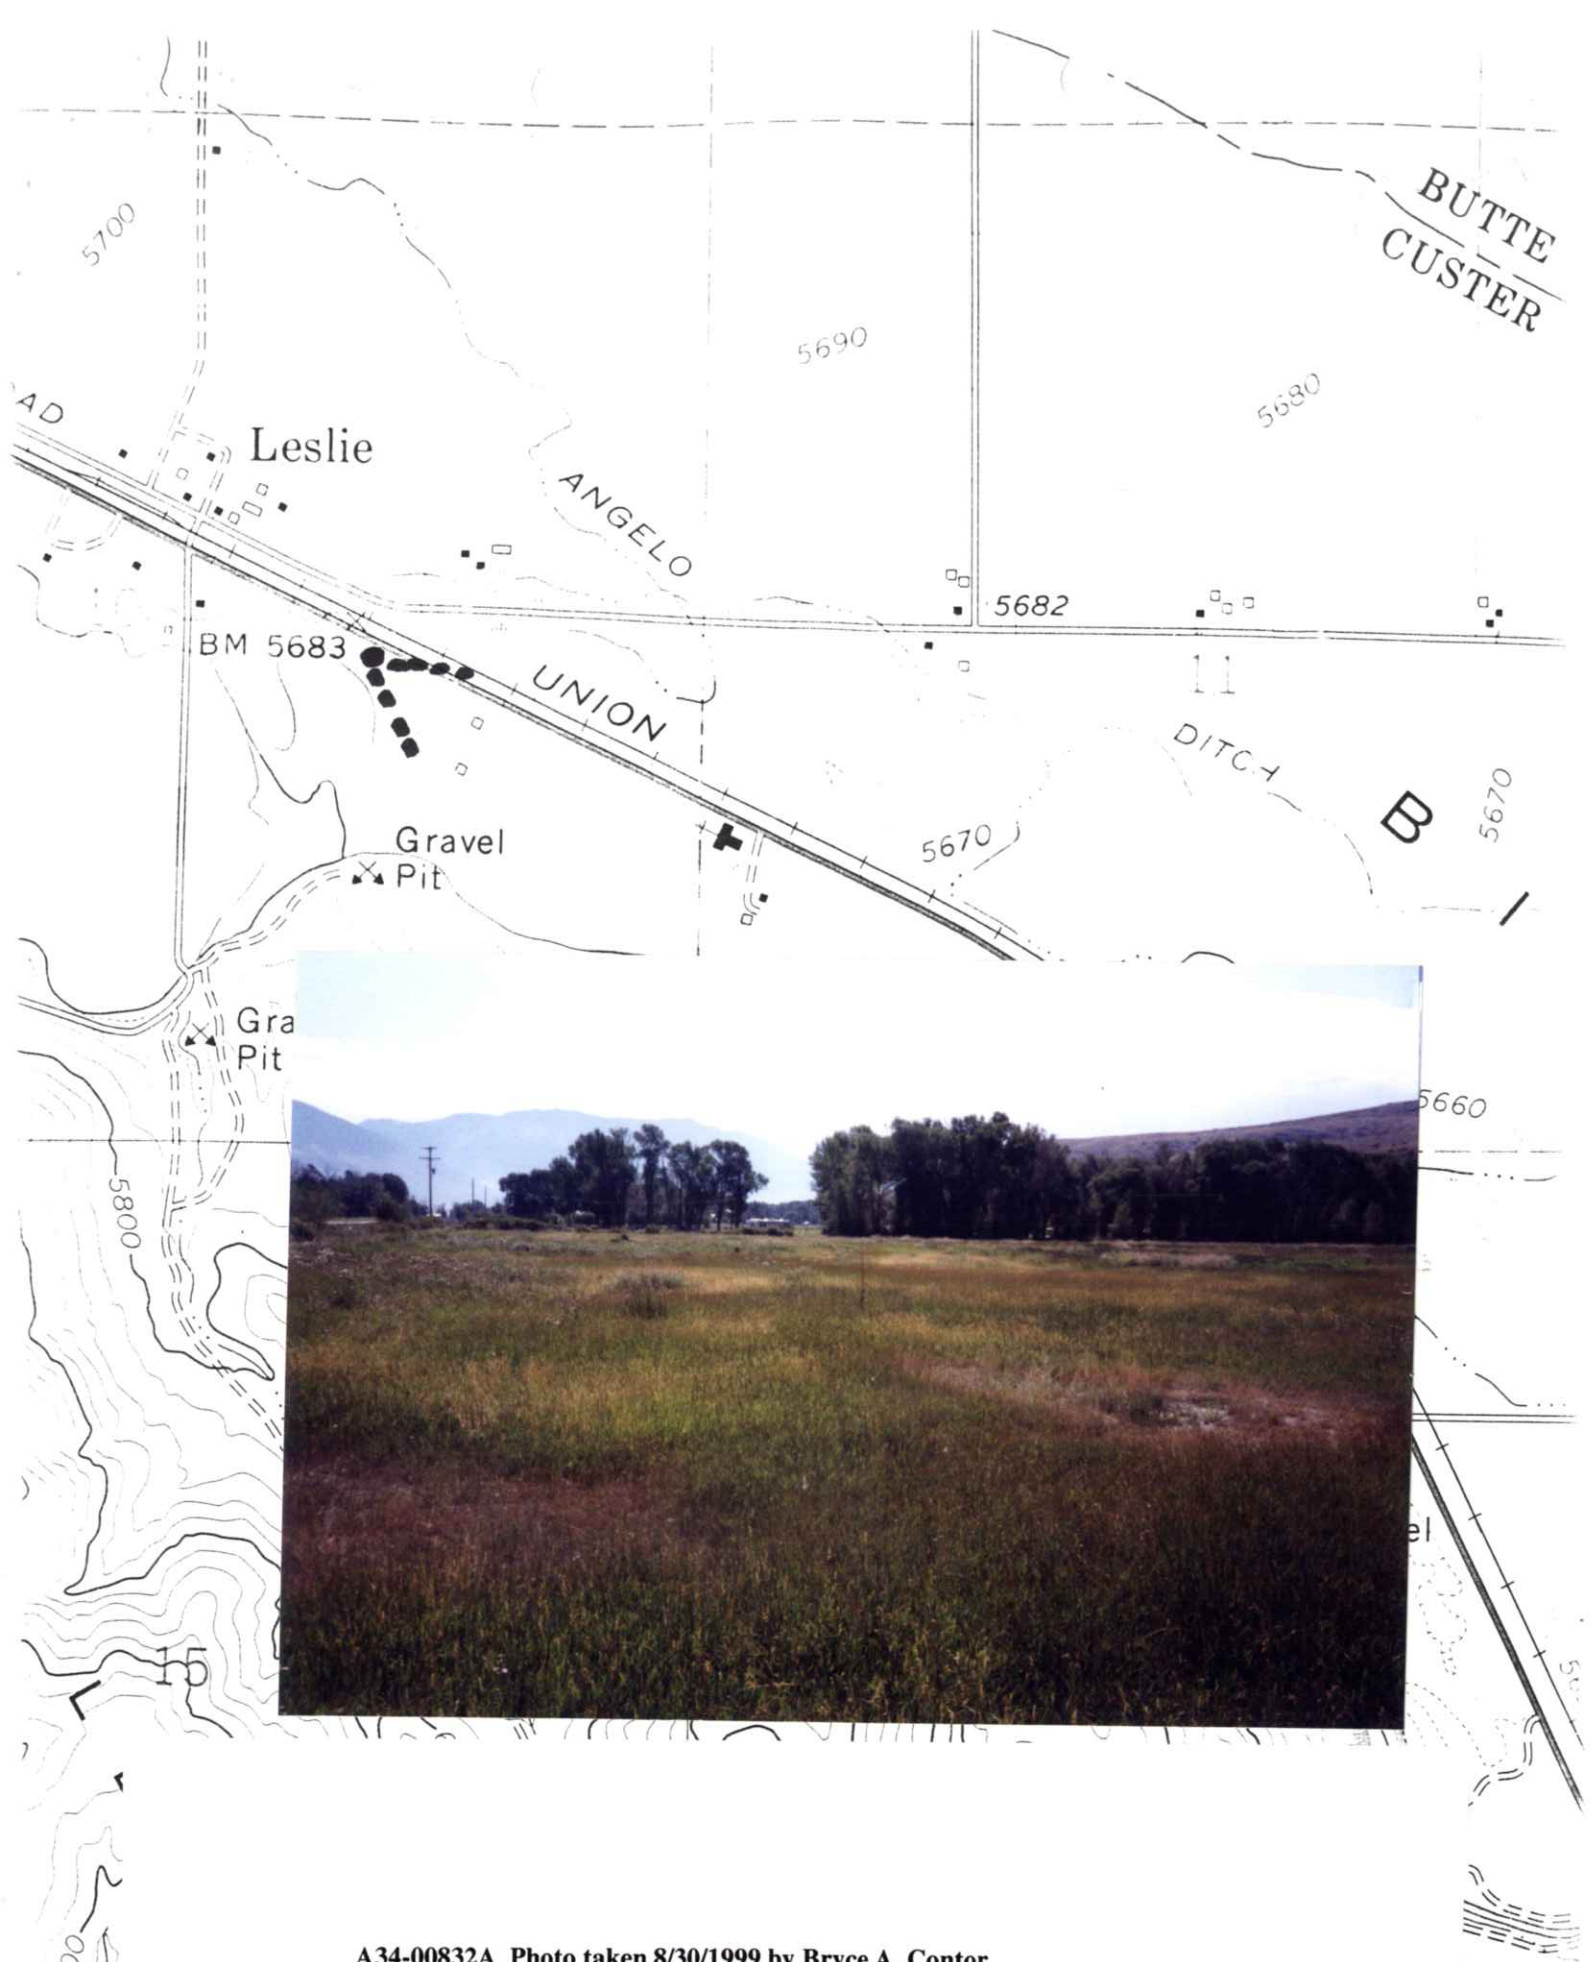
**A34-00832A Photo taken 8/30/1999 by Bryce A. Contor**

"Lower" field of POU. Looking east along highway. Per claimant, no irrigation has occurred this season.

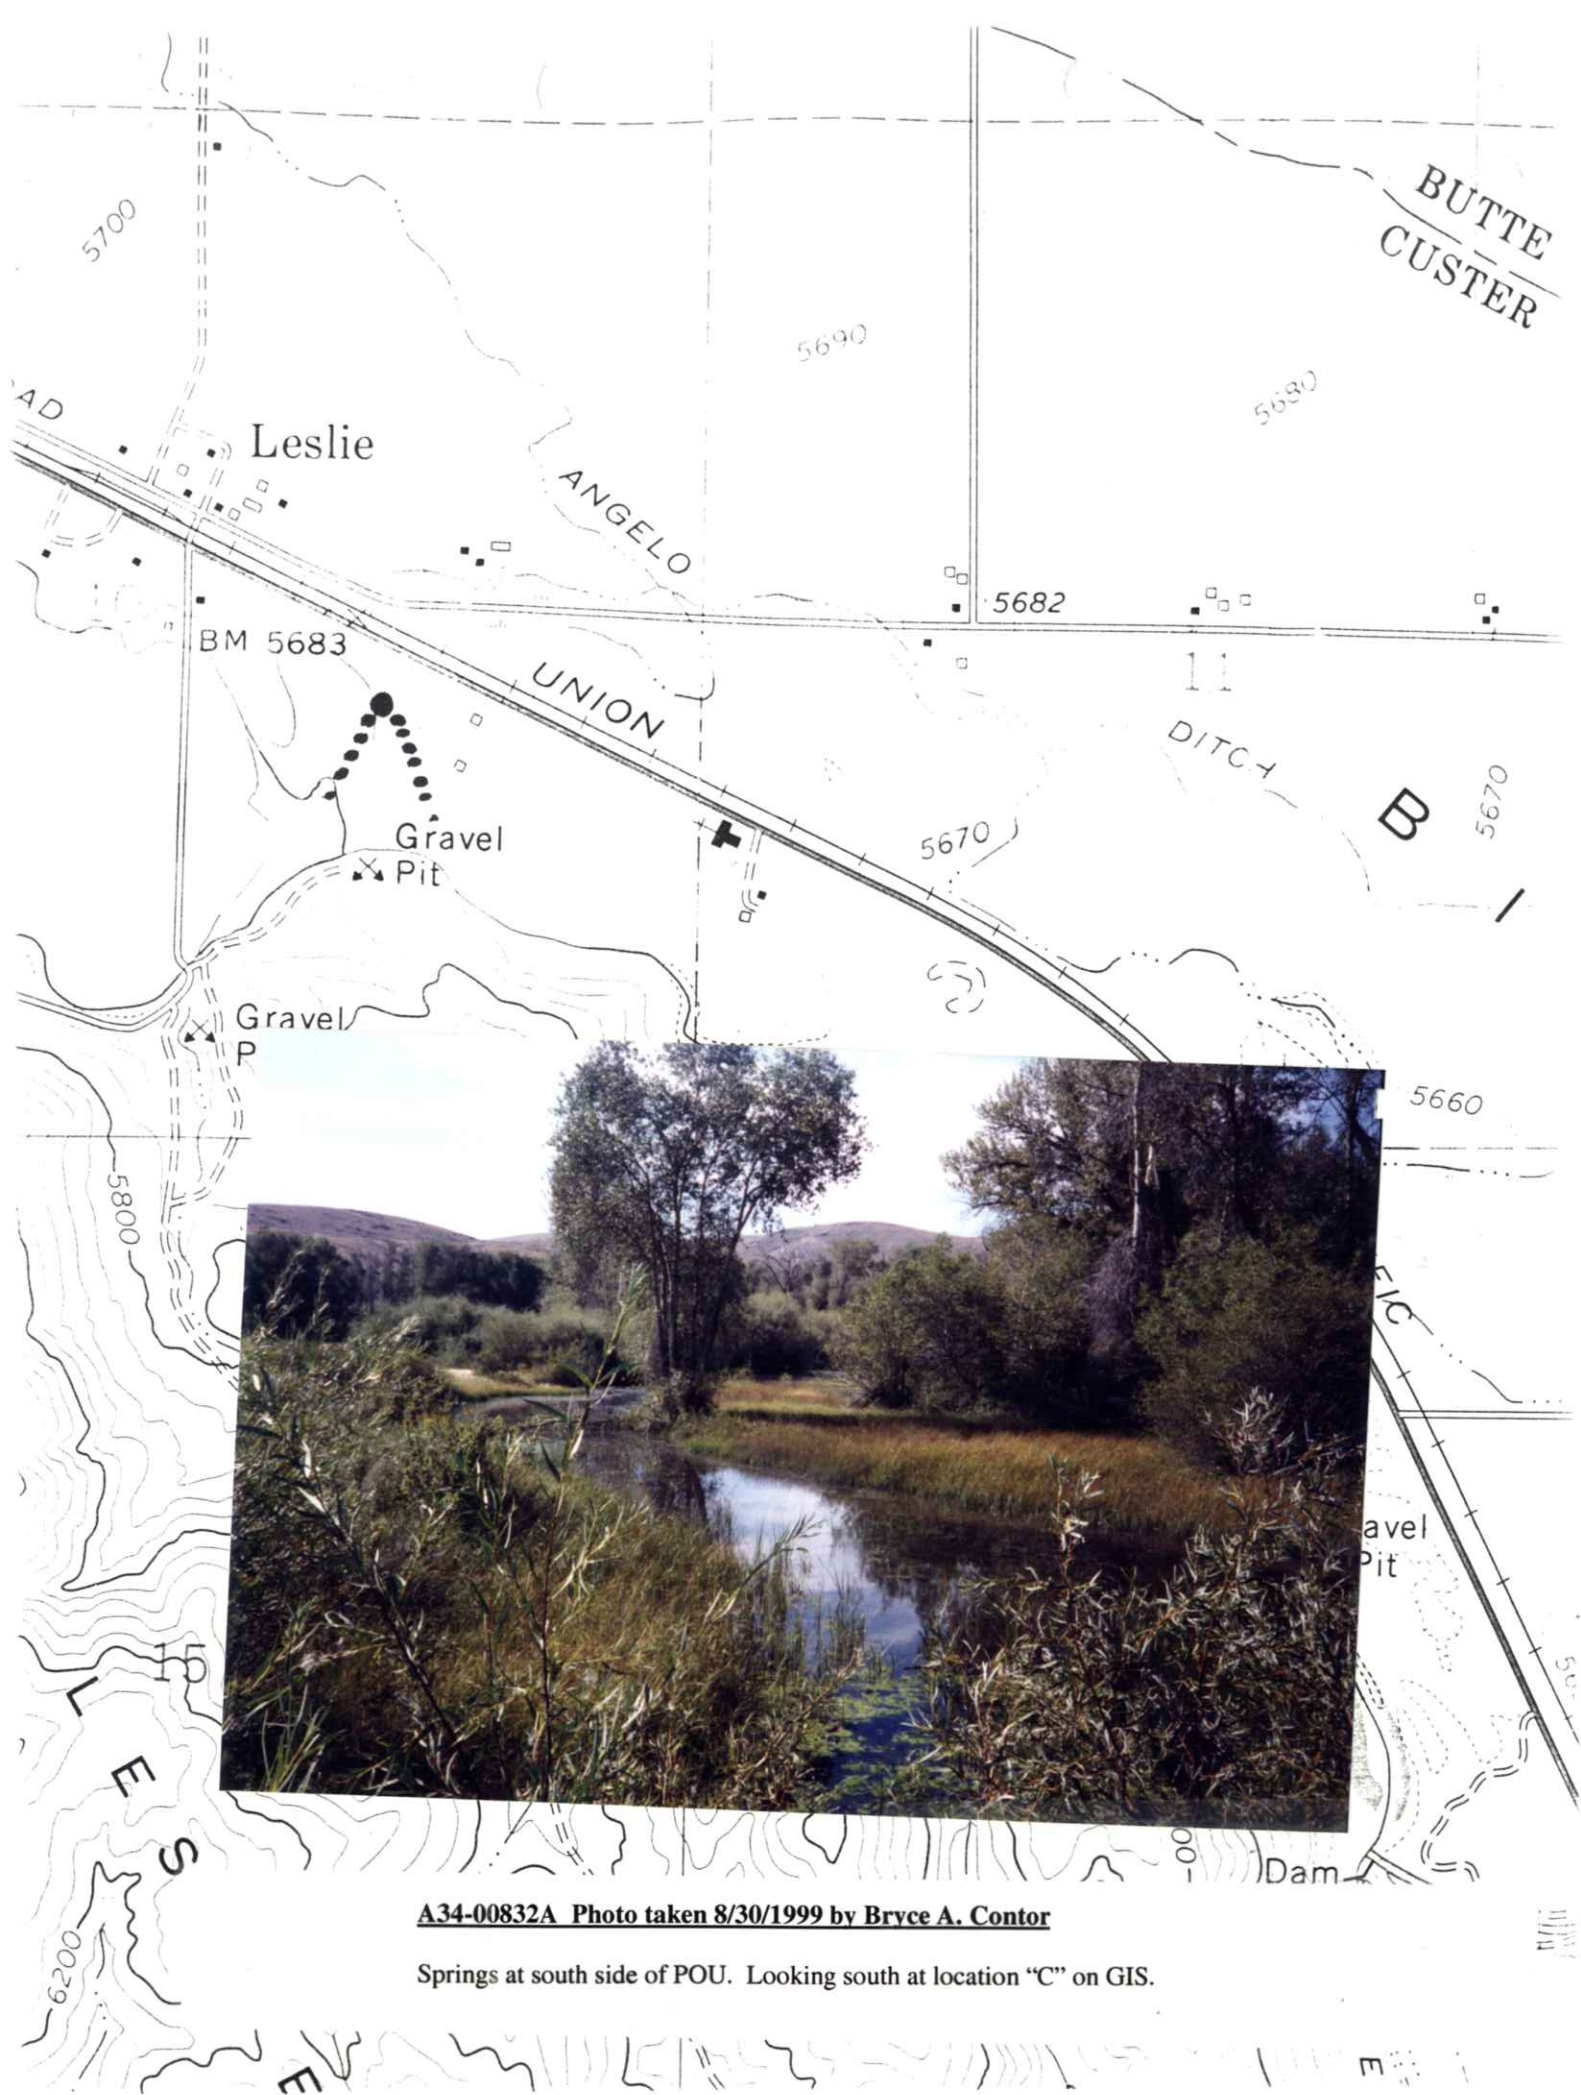
**A34-00832A Photo taken 8/30/1999 by Bryce A. Contor**

- 6) Photo “C” shows springs which rise on the property but which are too low in elevation to provide irrigation to place of use without pumps. Apparently not historically used on this POU.

Springs at south side of POU. Looking south at location "C" on GIS.
