Notes from field exam to review 75-14436 (Robert Tacke)  
Meeting date: 10/01/2008  
Agent: Monica Van Bussum

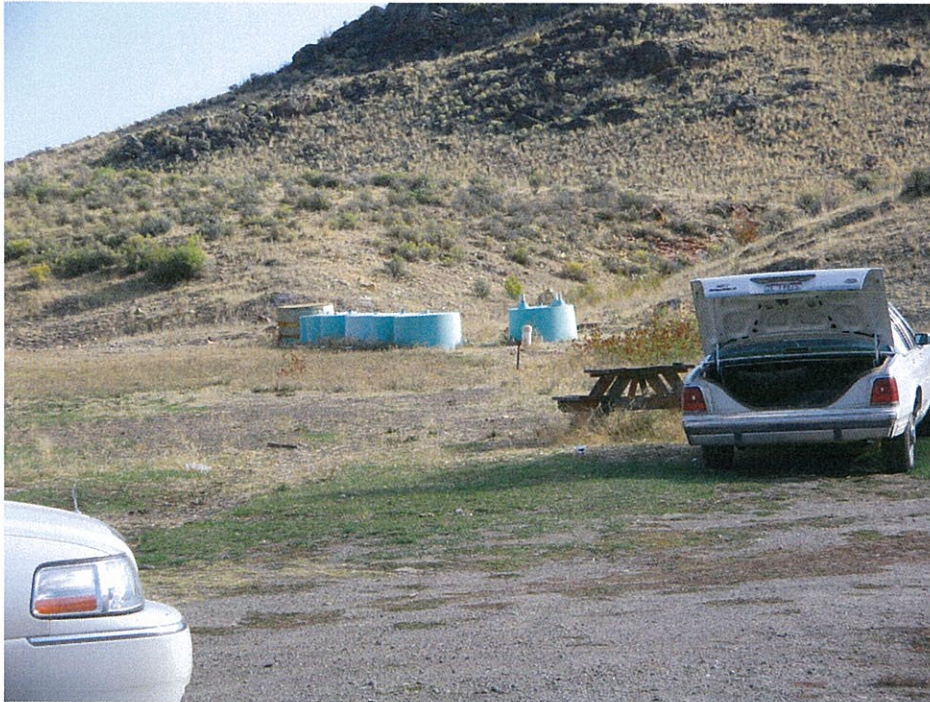
View of springs that form points of diversion for 75-14436. Because of the nature of water use (bottling spring water, in part), the spring water can not be exposed to the air and the entire spring and diversion works are buried underground. The water is piped from this location down below to the bottling plant. The irrigation water is also piped to the ground below and then gravity-fed ditches irrigate the property. Small springs and seepages dot the property and are used by stock and naturally irrigate the ground. As can clearly be seen in this picture, there was nothing to attached a department tag to, so I did not tag the points of diversion but did take a GPS point.

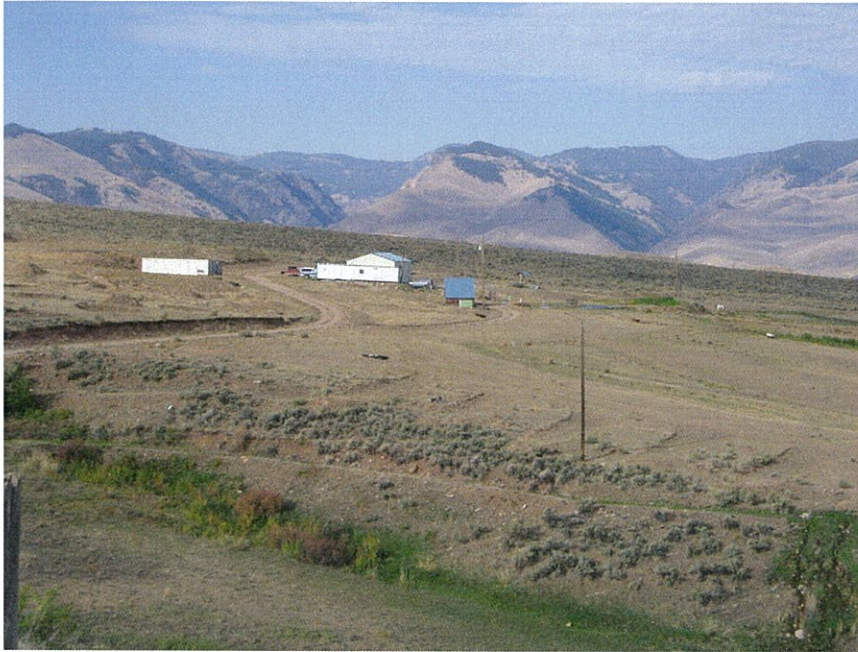
View looking west across the valley towards the bottling plant, which is the largest of the buildings seen here. Mr. Tacke has plans to build a larger bottling plant on the site. To the right in the photograph (north in compass direction), some of the irrigation ponds are visible. These small ponds take less than one day to fill, so no storage component is needed. There are 5 ponds in total that can be used for irrigation.

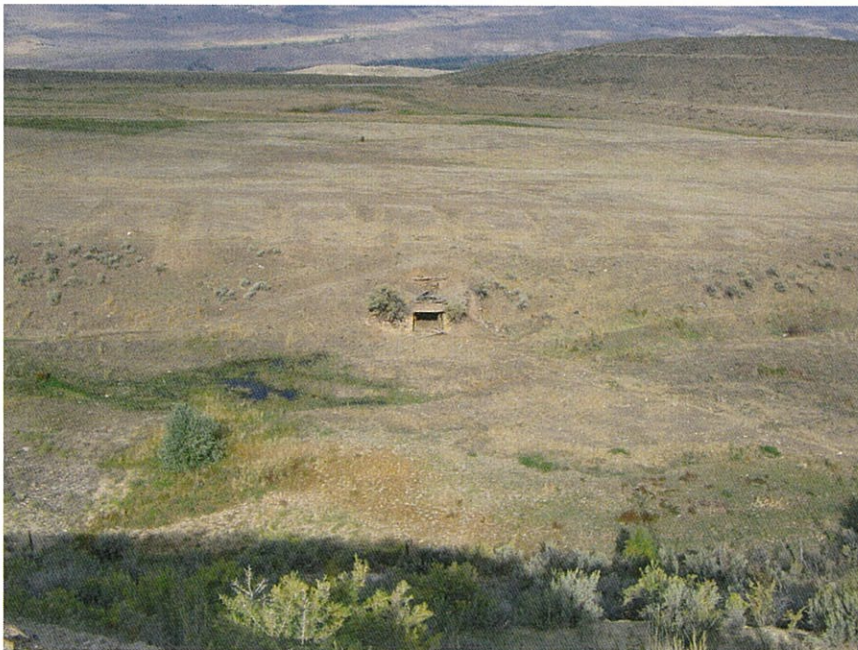
A second picture looking northwest from above the irrigated ground. A small seepage can be seen to the left. Irrigation can be seen in the background, as well as one of the small ponds. The small rock building seen in the center was apparently used as cold storage during the early ranching years.

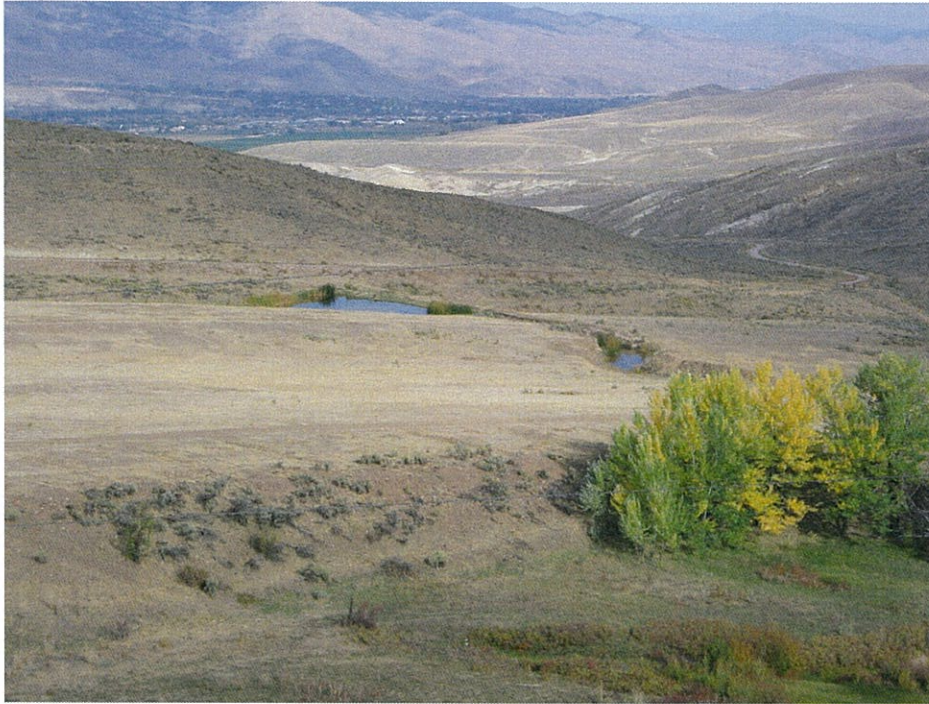
An alternative view of some of the small ponds on the property that hold water for irrigation. The City of Salmon can be seen in the background.

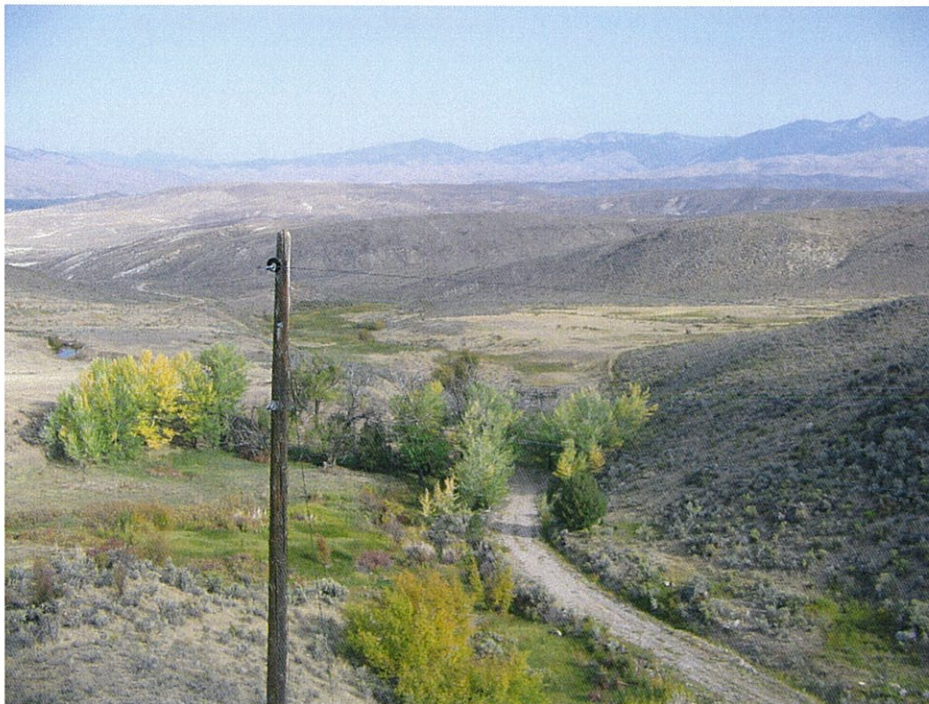
One of the gravity flow ditches is seen in this photograph. In the foreground, it parallels the ditch until approximately the center of the photograph where it diverges from the road to the left, as indicated by tree growth. A pond can be seen in the background to the left. Picture taking facing north from the road to the spring.

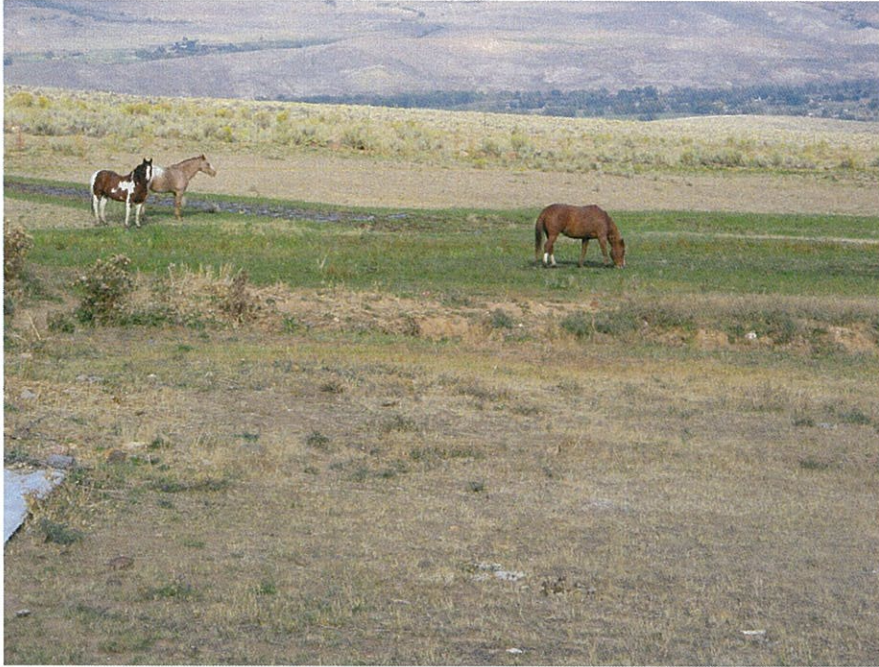
Photo taken looking west over the valley. This picture shows stock use as well as some standing water in the property indicating numerous small seeps.

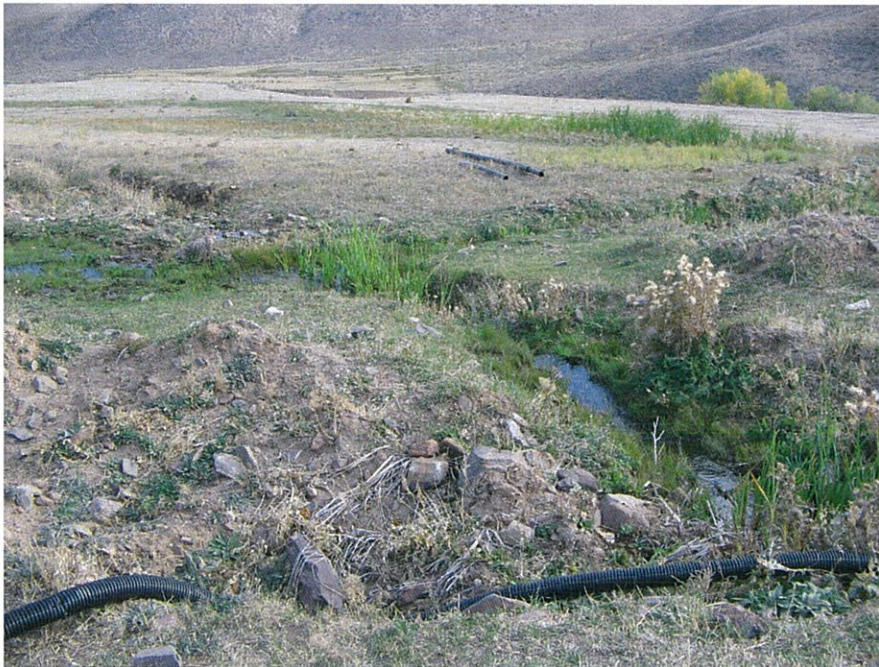
Picture taken from near the bottling plant looking north. A gravity flow ditch can easily be seen. There are small seeps in this area that supplement the water from the springs up above.

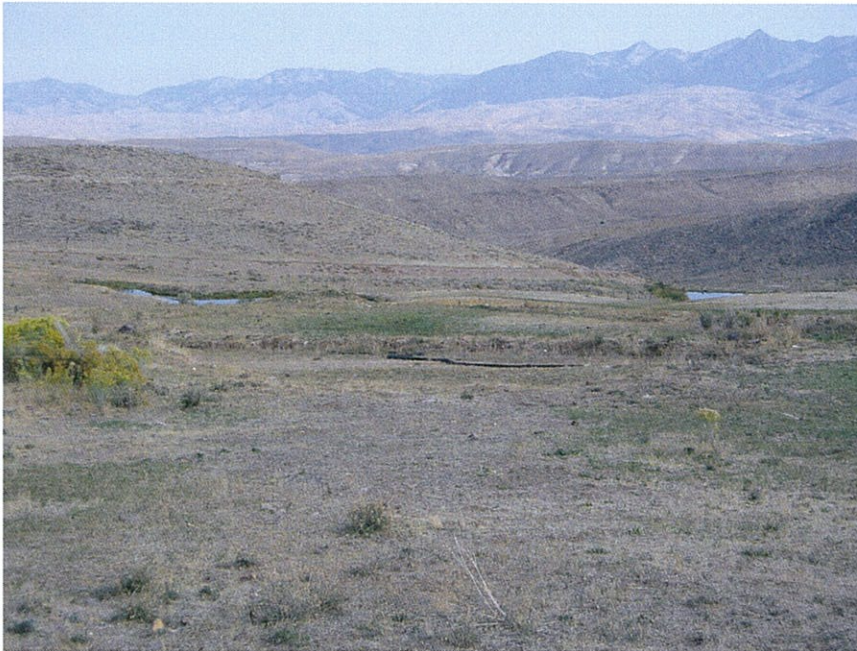
Photo taken looking north/northeast from in front of the bottling plant. A couple of small ponds can be seen to the left and right. There was not a lot of active irrigation at the time of the field exam (early October), but signs of past irrigation were quite evident, including the black pipe seen in the center of this picture.

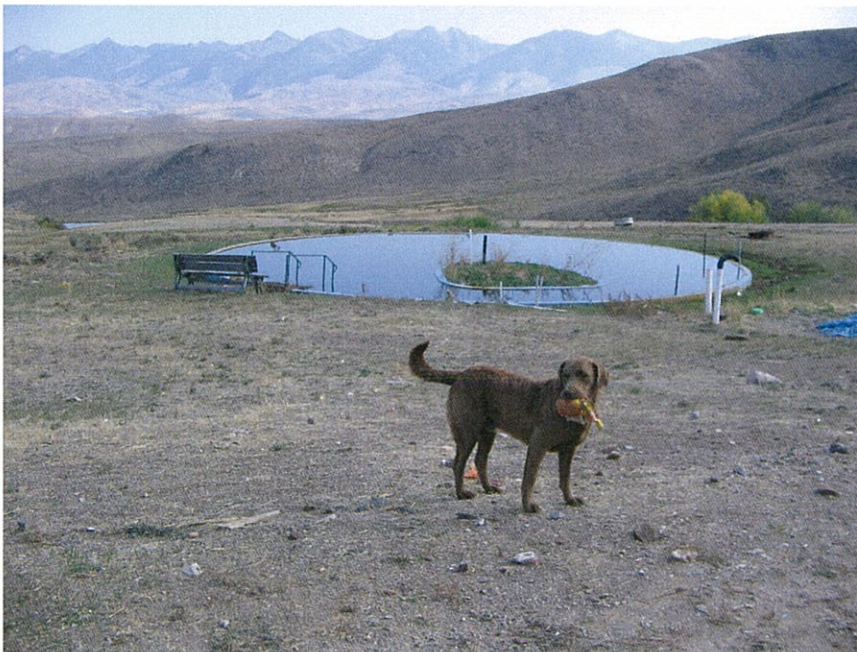
Photo taken looking north/northeast of one of the irrigation ponds. Mr. Tacke also uses bumper boats in this pond, as it was his intention at one time to return Salmon Hot Springs to its resort status. Also, Ivan the watchdog.

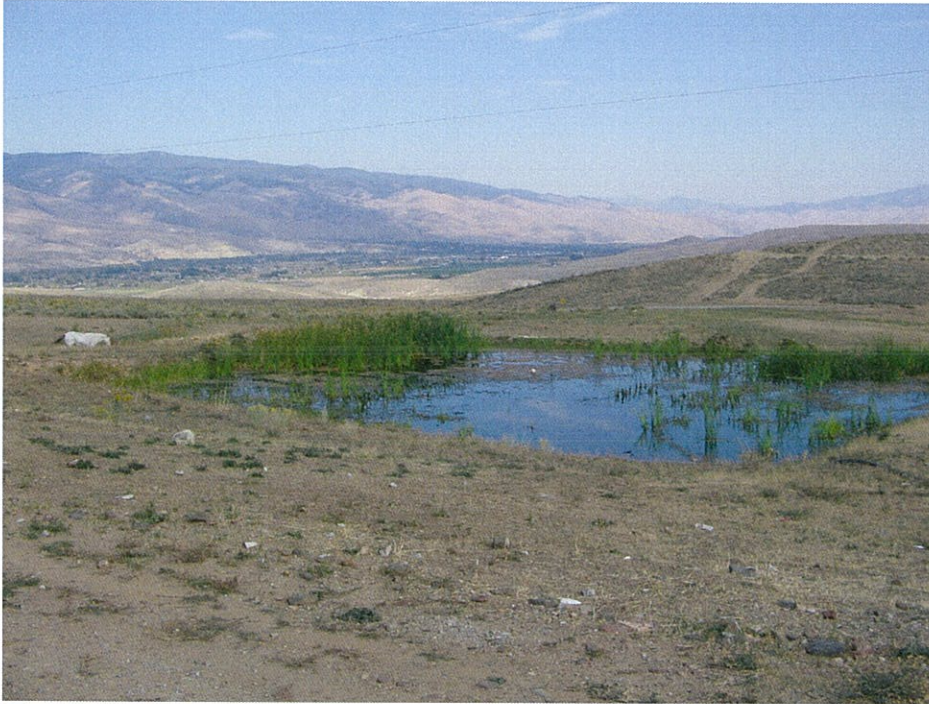
Photo taken looking north, City of Salmon visible in the background. A small pond used for irrigation.

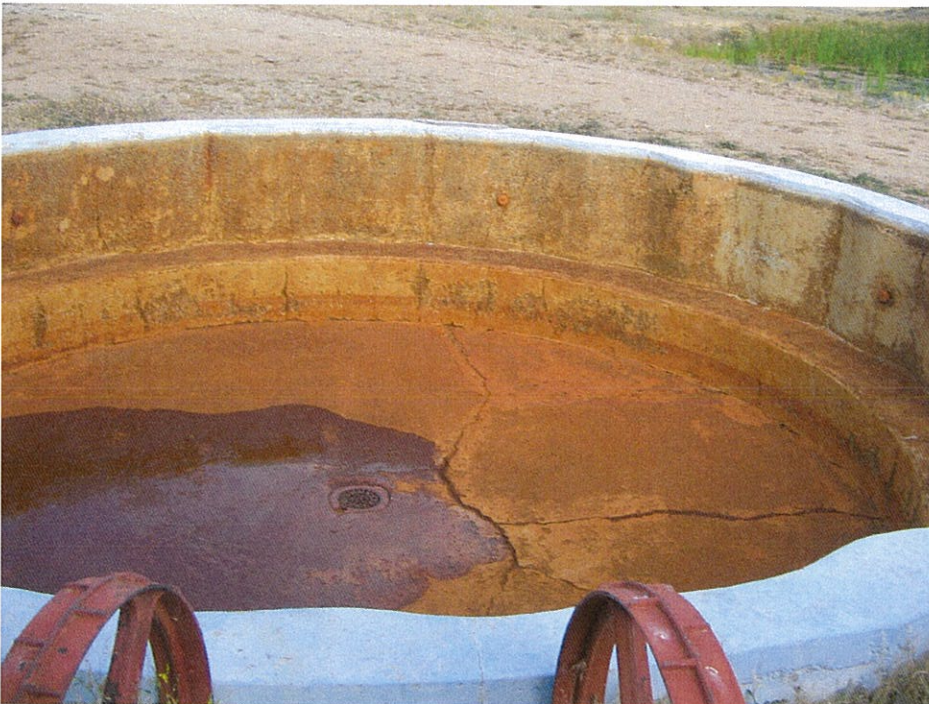
One of the small irrigation ponds, this one immediately in front of the bottling plant. Pond was approximately 8 to 10 feet wide and 3 to 4 feet deep.

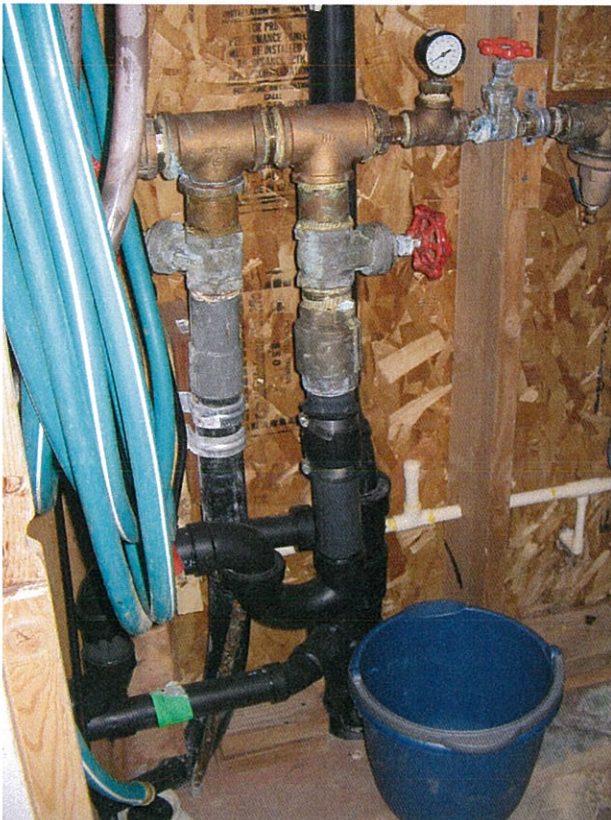
Entry point for water to the current bottling plant. According to Mr. Tacke, the gauge will read 100 psi during operation and has a reducer on it (extreme right) because of the extreme pressure in the system. The springs are approximately 200 feet in elevation above the level of the bottling plant.

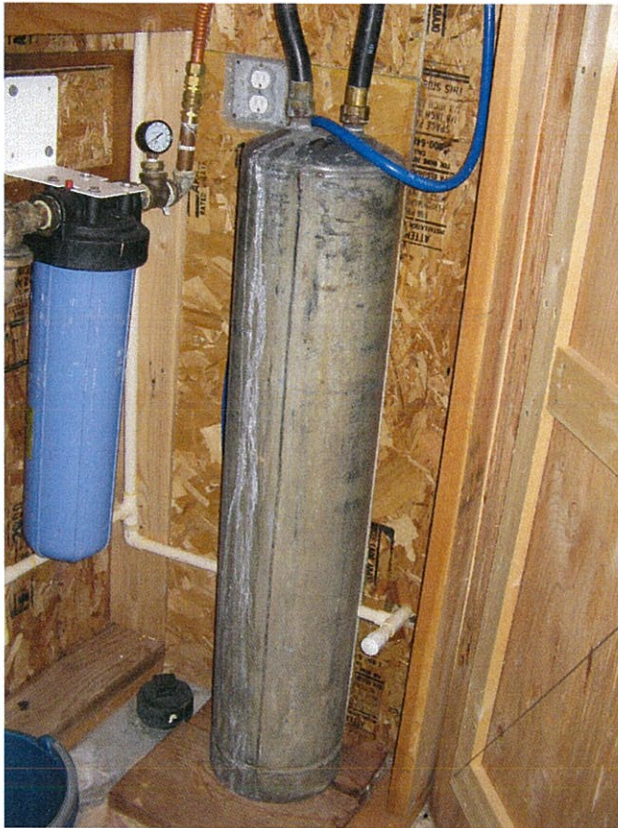
Filter for water entering the bottling plant.

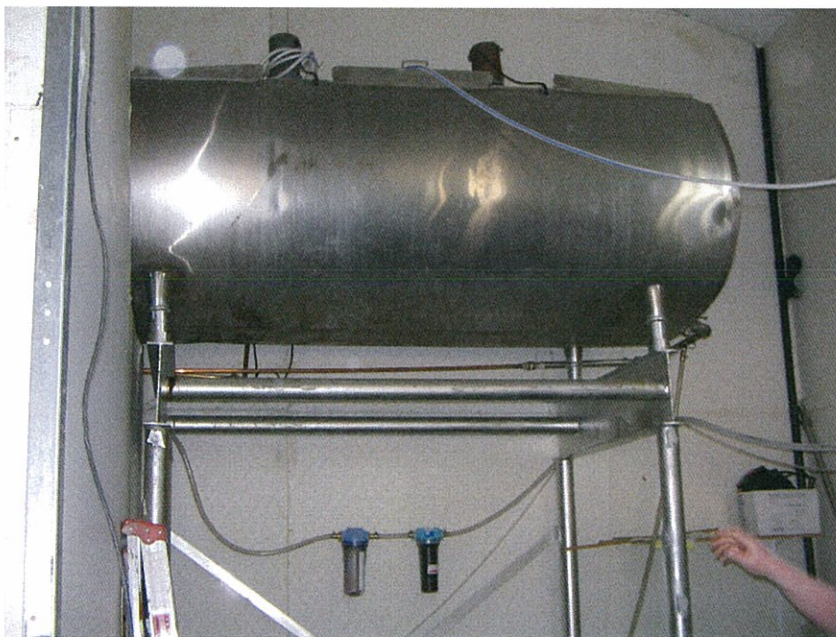
1200 gallon milk storage container used to store water and to send to bottling apparatus. The water from the spring is a constant 113 degrees F and, to be bottled, must be kept below 90 degrees. The milk storage container is double-walled and can be used to cool the water.

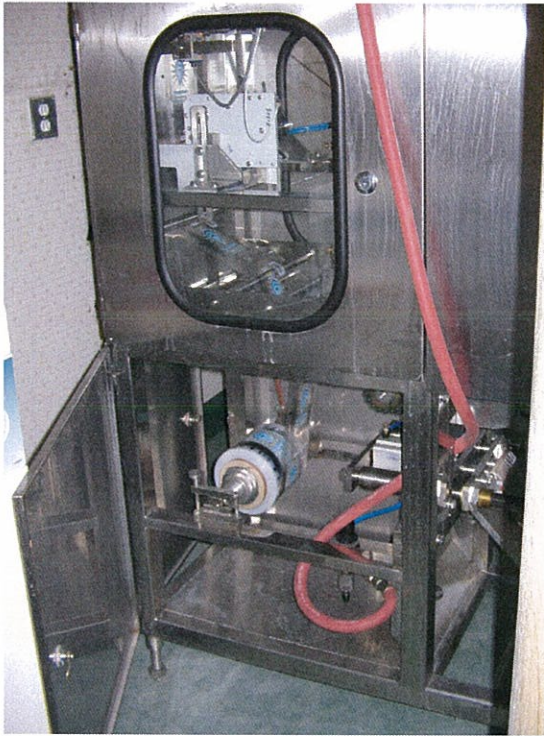
Part of the bottling apparatus. Technically, the plant does not use bottles, but plastic pouches. I use the term bottling here for convenience.

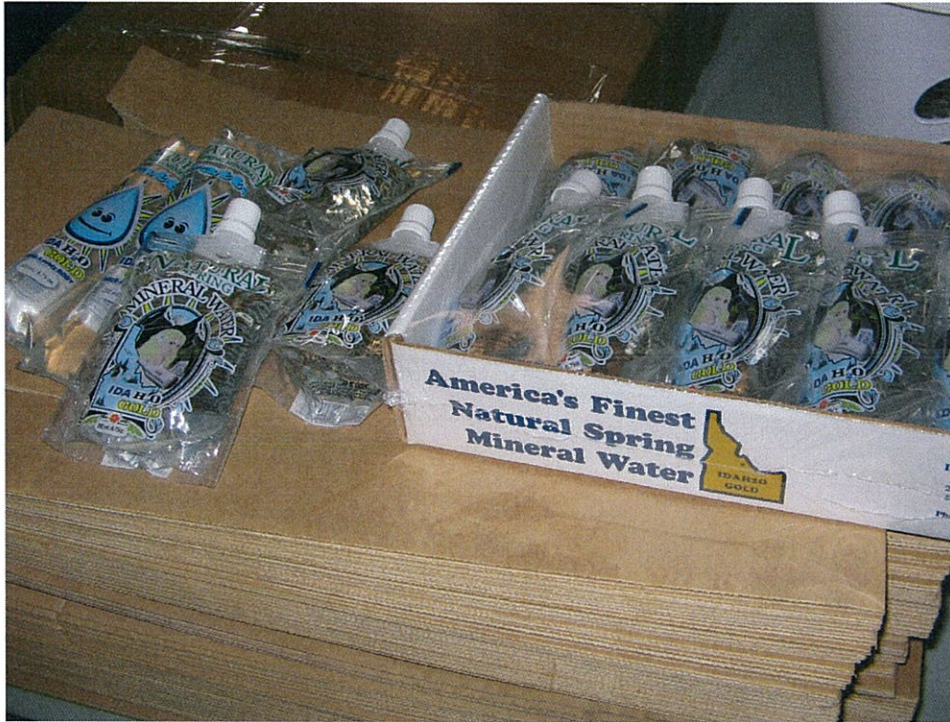
The end product of the bottling operation. Both types of pouches are shown. Two of the standard pouches are shown at left and the rest are pouches with drinking spouts.
