Re: Water Rights - Irrigation 24-4006 Caribou G. Id.

SRBA CLAIM 24-4006: LOU SCARLETT

IRRIGATION CLAIM

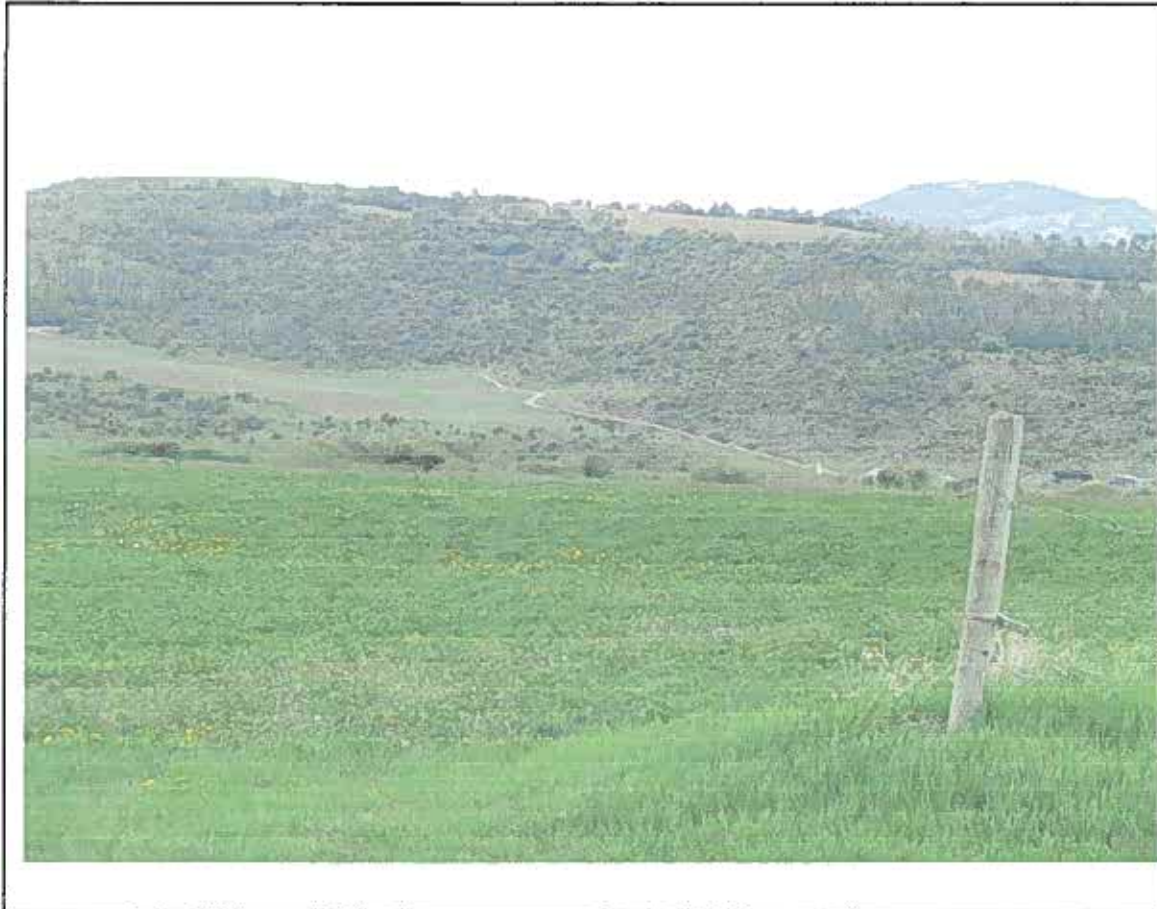
IMG\_1593

This photo was taken from the southeast corner of Fredrick Louis Scarlett's property.  
This corner is a low spot and you can see that there are several high spots in the field.  
The row of trees in the center of the photo is Tincup Creek. This would make it difficult  
to flood irrigate the field from Tincup Creek. I'm looking in a northerly direction.

No irrigation was being done on the day of my visit.

Photo taken from the SE corner of  
Fredrick Louis Scarlett's farm  
The ground is higher along east fence

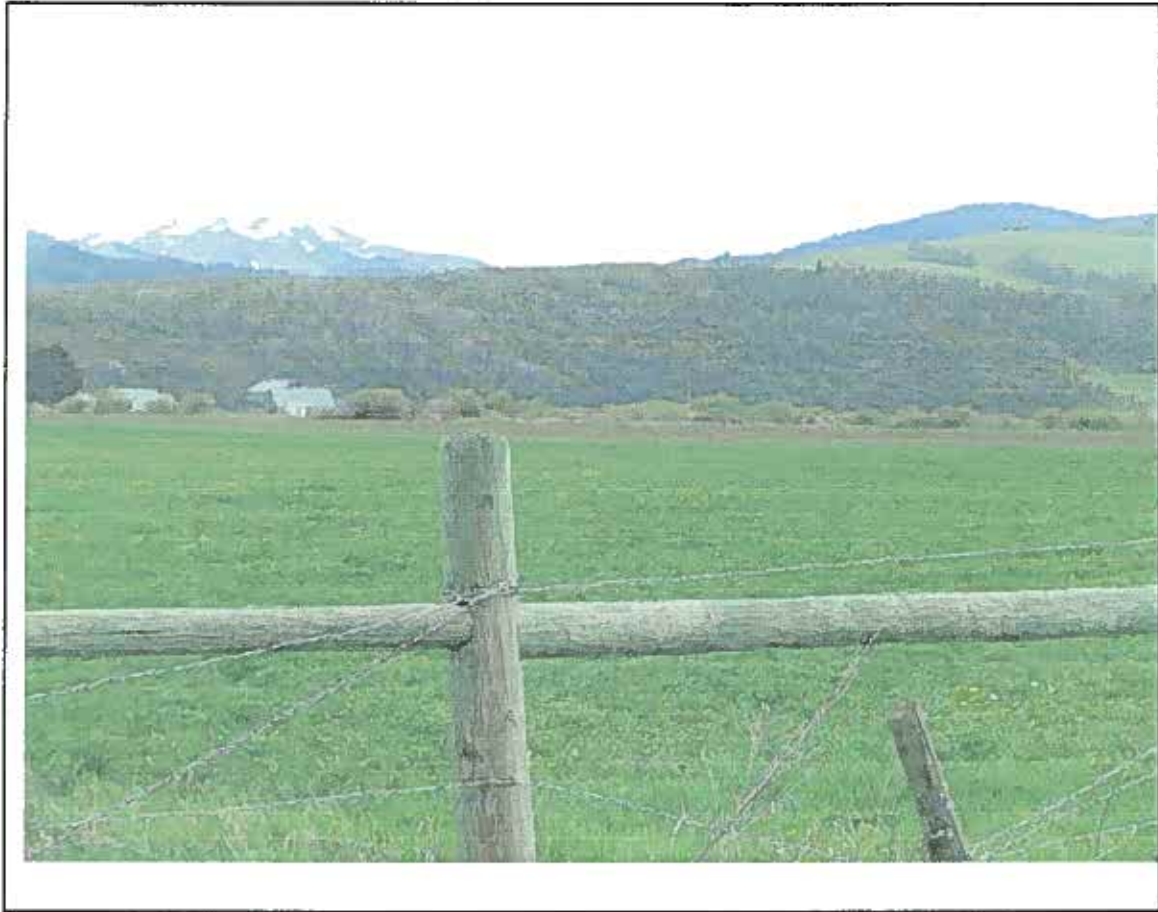
IMG\_1594

This photo was taken from the southeast corner of Fredrick Louis Scarlett's property. In this photo I'm looking in a northwesterly direction at the claimed place of use under his amended claim. The corner is a low spot and you can see that there are several high spots in the field. The row of trees in the center of the photo is Tincup Creek. This would make it difficult to flood irrigate the field from Tincup Creek. No irrigation was being done on the day of my visit. No one was home at the time of my visit so I did not look at any claimed points of diversion.

Photo 1594 17:48 Looking N.W. Hwy  
at POA. This corner is low.

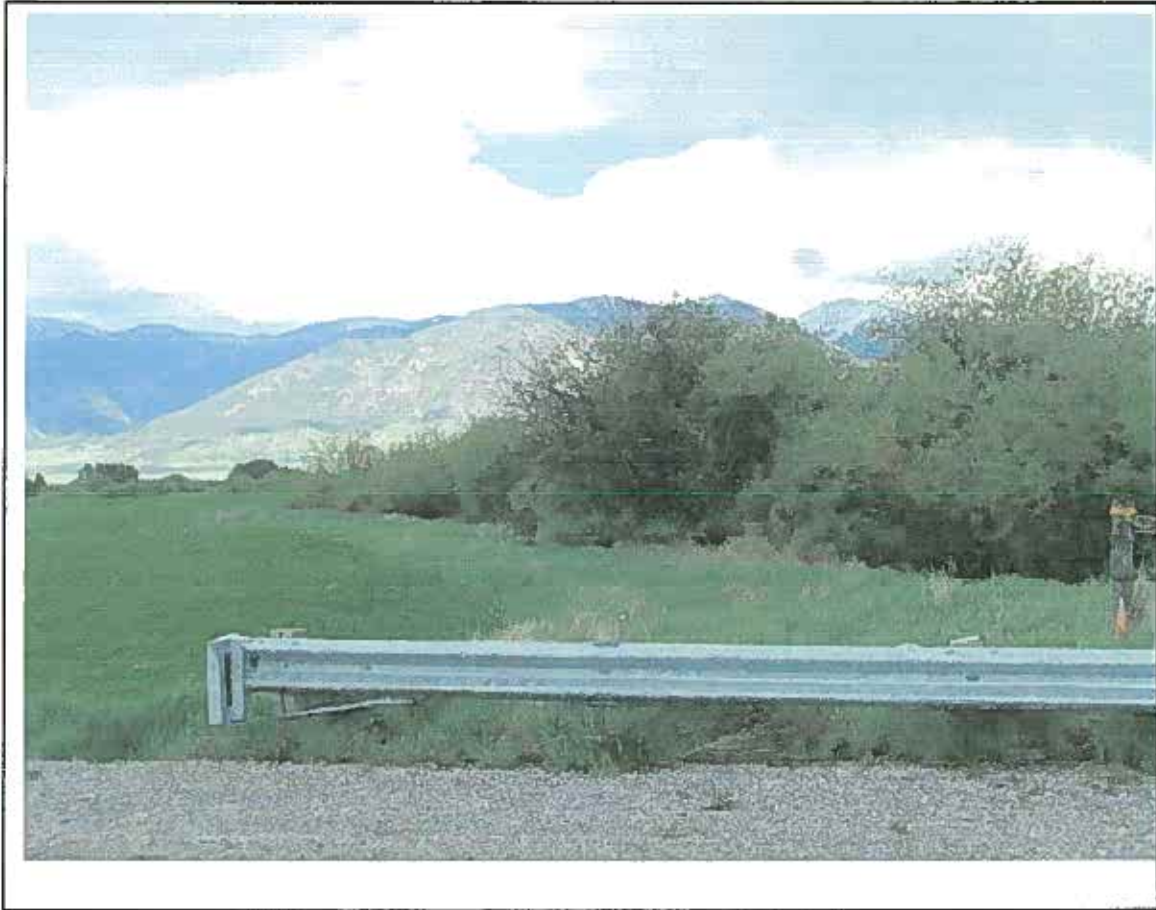
IMG\_1595

This photo was taken from Tincup junction road. I'm looking east on the north side of Tincup Creek. The claimed place of use under the amended claim claims the land clear up to the creek banks. As you can see from this photo the place of use should be cut back. No irrigation was being done on the day of my visit. No one was home at the time of my visit so I did not look at any claimed points of diversion.

photo 1595 17:55 Looking in a NE'ly  
direction at the ground. North of Tin Cup  
Creek. The POA should be pulled back  
away from the creek. because the ground  
is uphill.

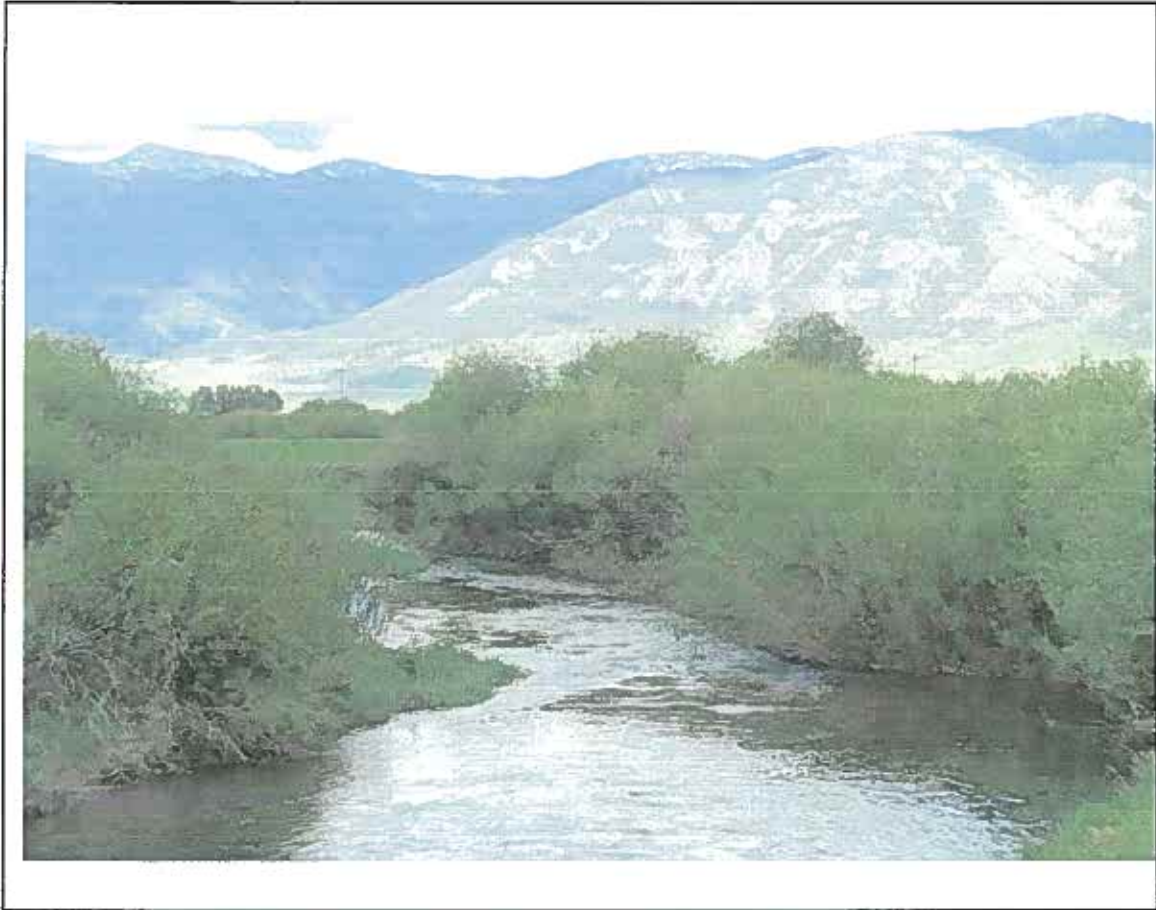
IMG\_1596

This photo was taken from Tincup junction road. I'm looking east at Tincup Creek. As you can see in the photo the creek was very low and the banks very high. Unless someone was pumping out of the creek I don't think they could flood irrigate from this source. No irrigation was being done on the day of my visit. No one was home at the time of my visit so I did not look at any claimed points of diversion.

photo 1596 17:55 looking east at  
Tin Cup creek. The banks are  
high, creek low, it would be  
difficult to flood migrate from  
creek.

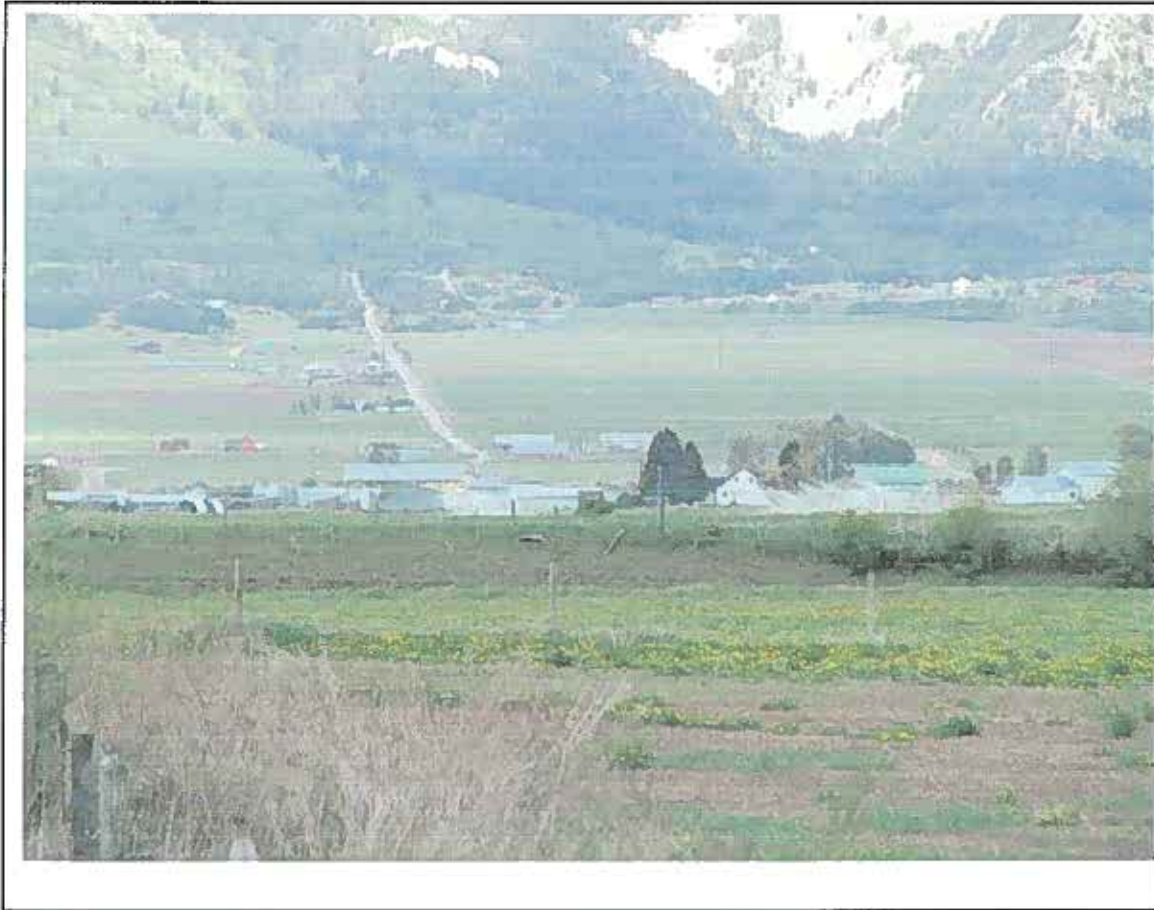
IMG\_1597

This photo was taken from Tincup junction road. I'm looking east at the south side of Tincup Creek. This dirt area in the foreground was recommended but is not owned by Lou Scarlett. Beyond the fence is a dirt/grassy area that is claimed as irrigated. It appears from the imagery to have a ditch on the east side of it. That ditch appears to be higher than the land claimed as irrigated. The creek was very low and the banks very high on the day of my visit. No irrigation was being done on the day of my visit. No one was home at the time of my visit so I did not look at any claimed points of diversion.

photo 1597 17:56 looking east at the  
land behind the house. White house I  
believe belongs to Lou Scarlett. The ground  
on the corner of Hwy 34 and Tin Cup junction. Red  
creek is in the background.
