Alfred Clark Nolan, Water Rights, 47NO3W117600

Item 5, Description of existing diversion works, continued:

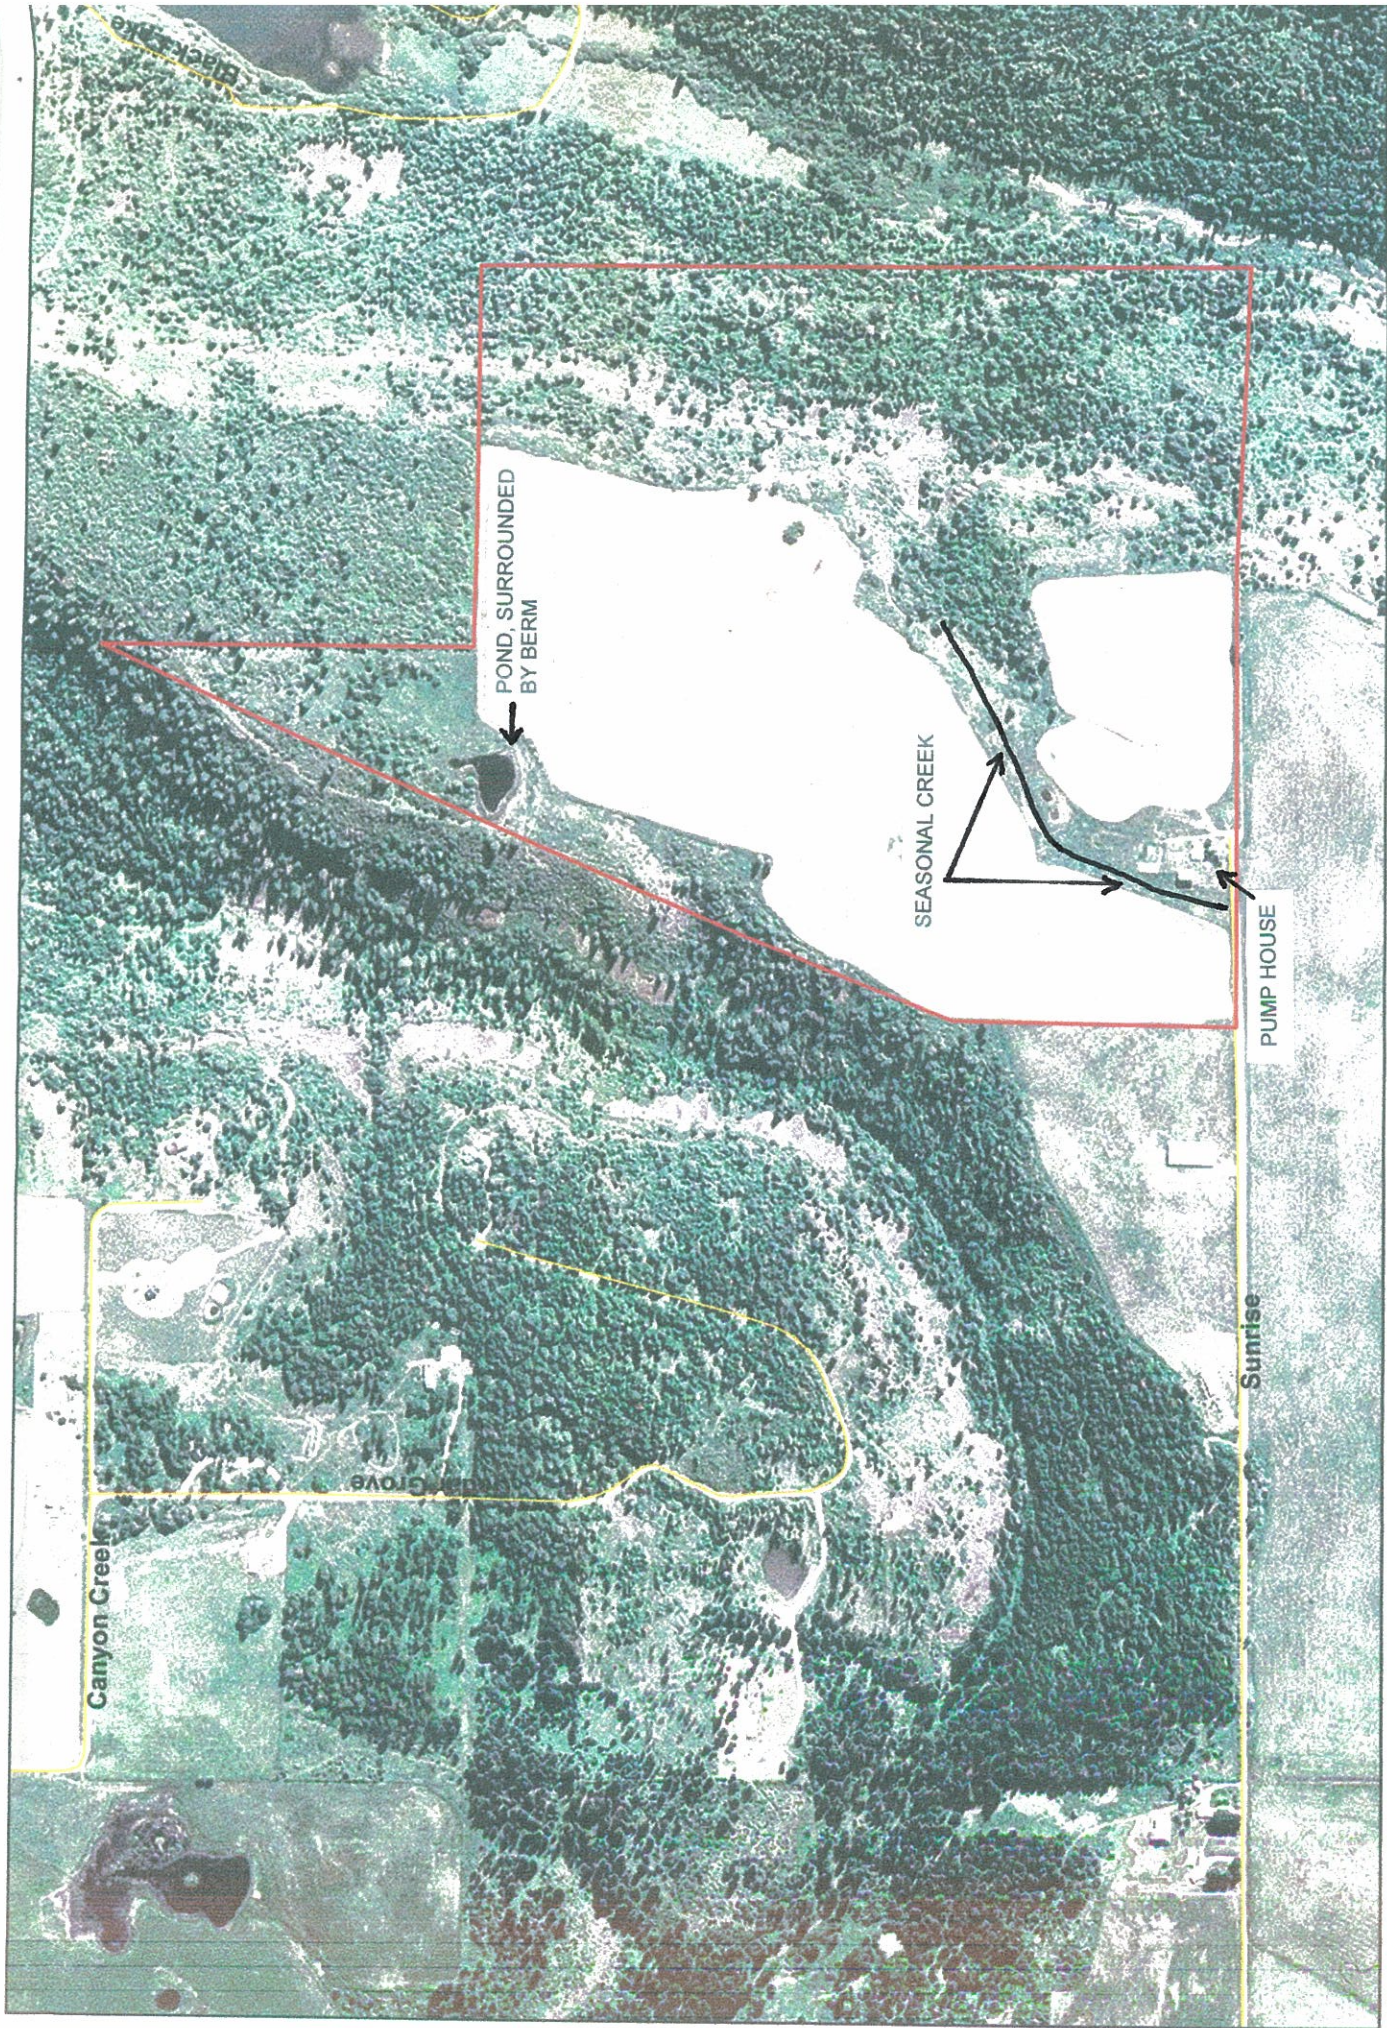
NOLAN  
47NO3W117600  
property in Sec 11 outlined in red

1 in = 660 ft  
2006 Photo

4. The seasonal creek (please see attached map). This creek runs diagonally through pastures to the north and east to fall over basalt rock on its way down my property to the canyon to the east and ultimately sinks there. The source of water for this creek is runoff from the surrounding fields. The creek reaches widths of 9 feet and depths of more than 1 foot.
