**CLAIM OR WATER RIGHT NUMBER:** A43-00080, A43-11142 and A43-00192

**Tns 13S; Rng 24E; Sec 21; SW¼ NE¼ SW¼ B.M.  
06-29-95**

**KELLY K CHRISTENSEN**

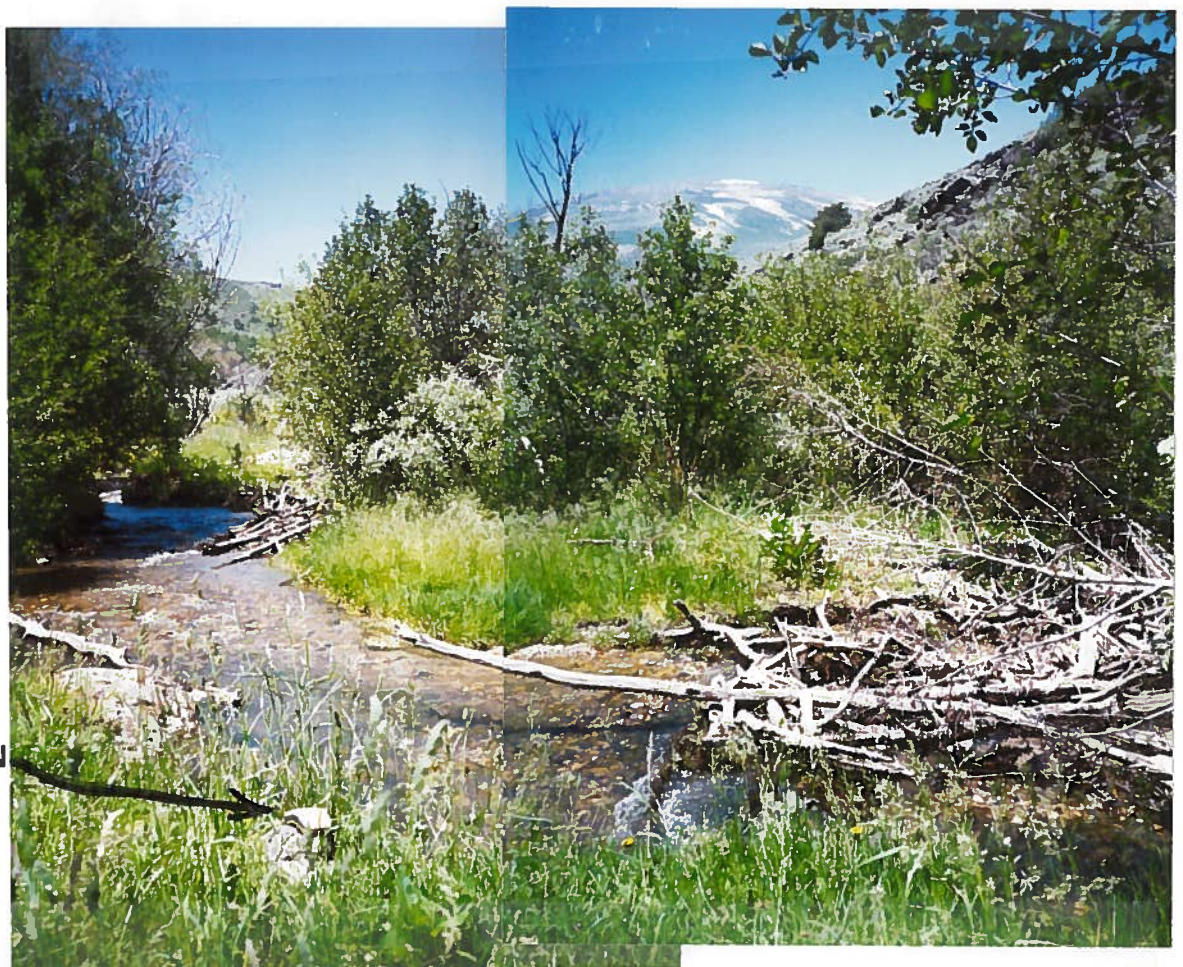
**GPS  
LOCATION**

This photo set shows the same location as picture set # 1 for A43-00192 and picture set # 5 for A43-00080 but is looking north northwest. This shows the GPS reading location for the point of diversion for these rights. The ditch is just out of the picture frame on the right.

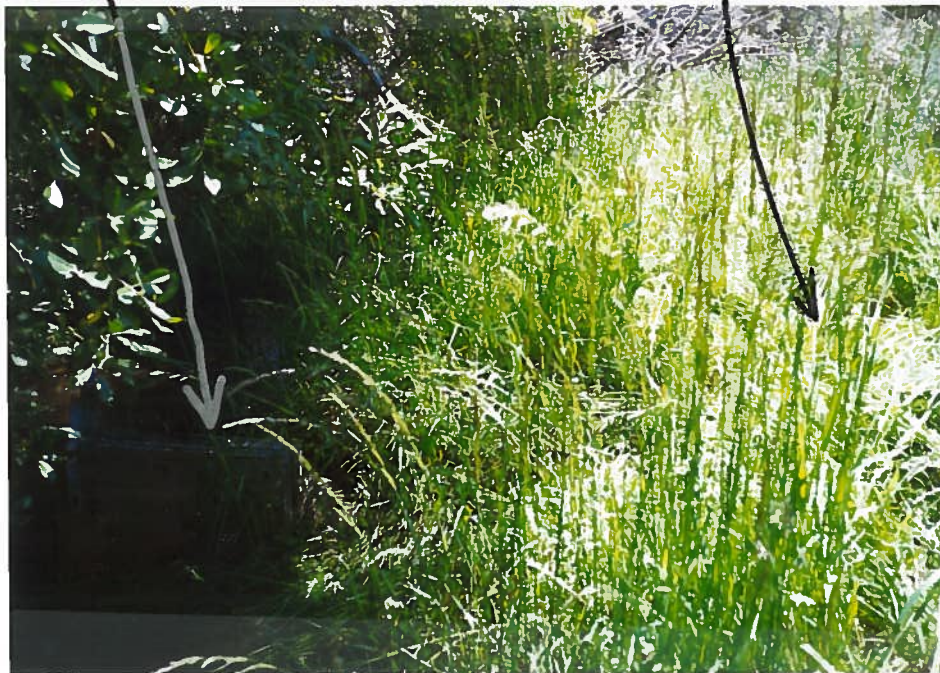
**HEADGATE**

This photo shows the headgate on the left and includes the GPS measurement site approximately six feet south of the headgate. The GPS unit is not visible in the grass. You are looking southeast in this photo. This diversion was not site tagged when measured.

**MEASUREMENT POINT**

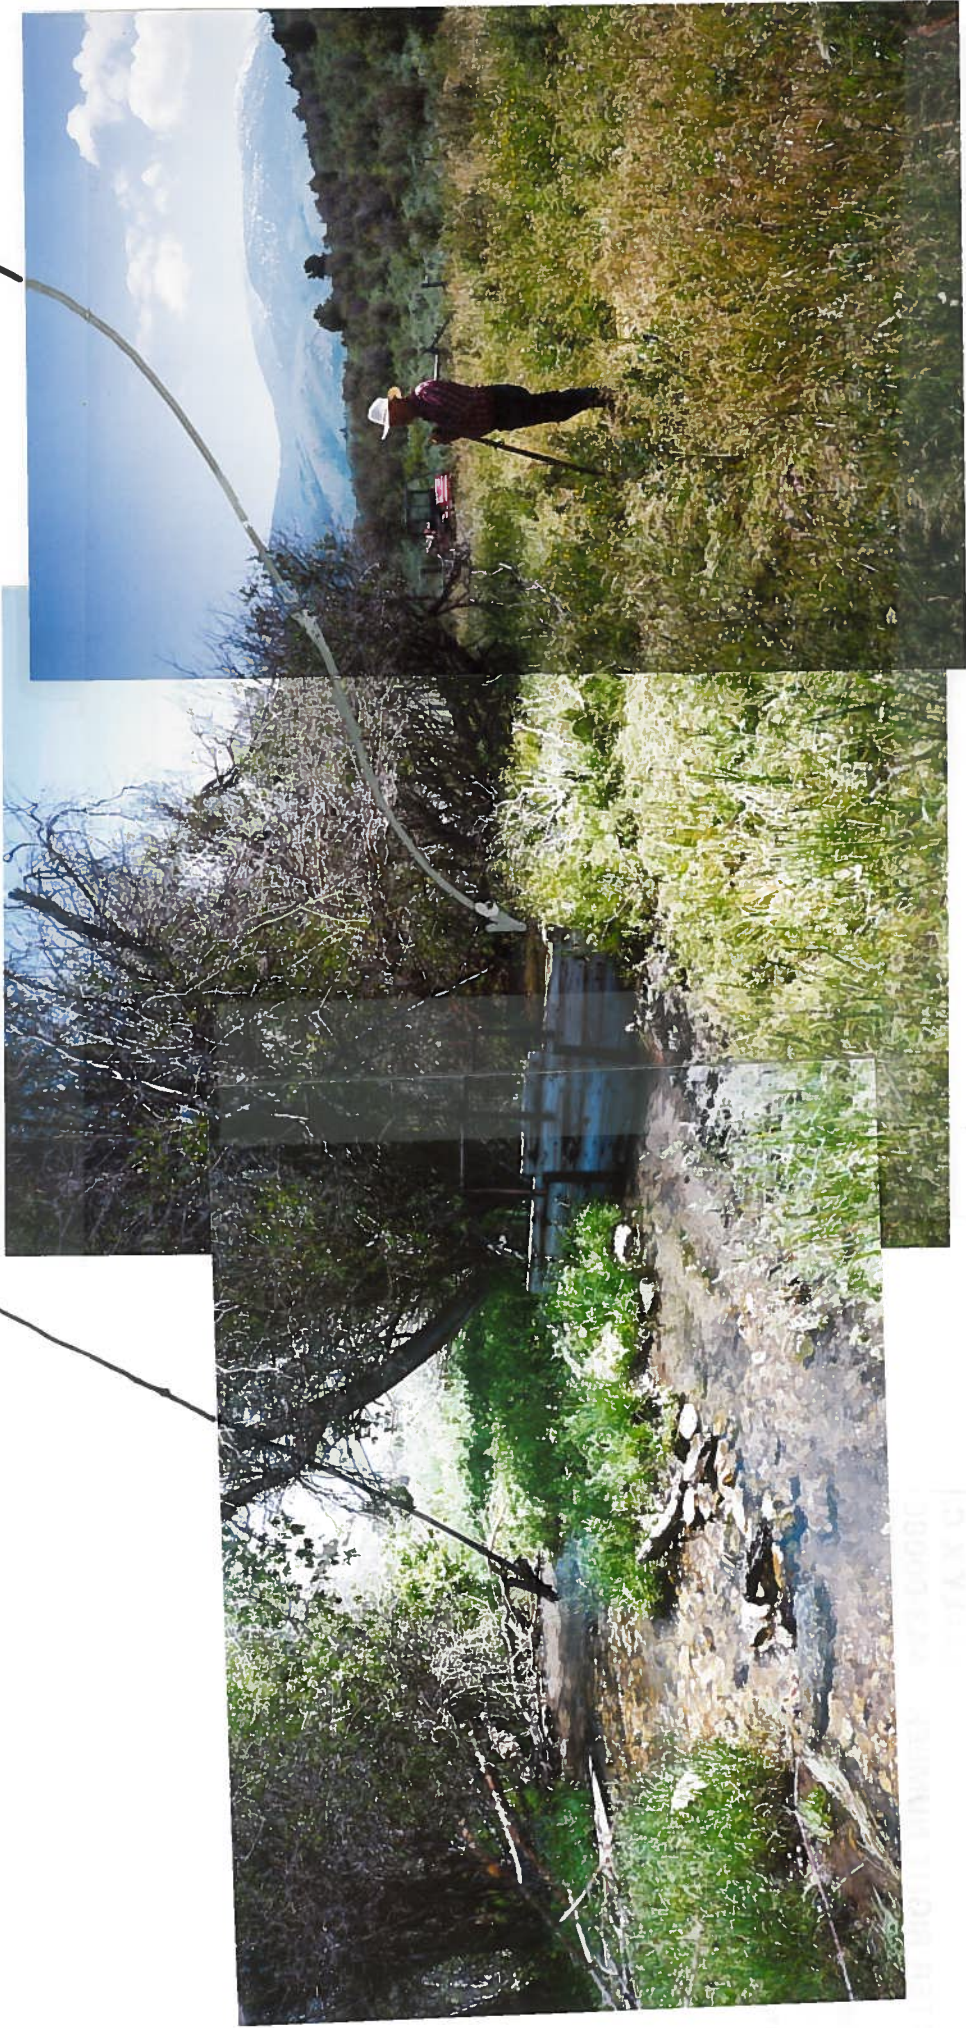
GPS LOCATION

This picture set shows the point of control for the northern diversion from Clyde Creek. Excess Clyde Creek water is diverted upstream approximately 300 northwest of this point. The excess is allowed to go back into Clyde Creek through the channel on the left. Clyde Creek is somewhat braided at this location. I took a GPS reading at this point. You are looking southeast on the left to south on the right. This ditch is shared with A43-00190. The GPS rover file is R062920A.

CHANNEL GOING BACK TO CLYDE CREEK
