**CLAIM OR WATER RIGHT NUMBER:**

**A43-00370**

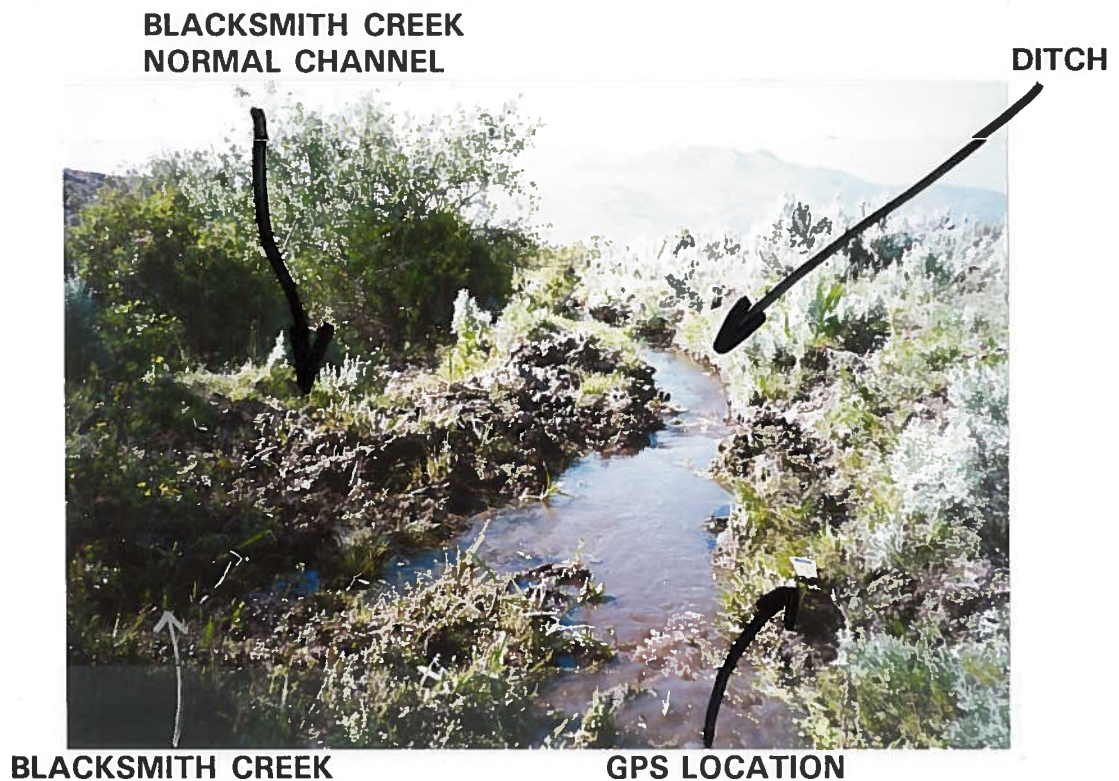
This photo is looking south across Blacksmith Creek and the point where an unnamed stream joins Blacksmith Creek. That stream roughly parallels Highway 77 from near Connor Summit to this point. The normal channel swings through and to the left of the brush on the left. A GPS reading was taken at this point but no site tag was placed at this location as there was no permanent structure to attach the tag to.

This is the northern most point of diversion of three from Blacksmith Creek.

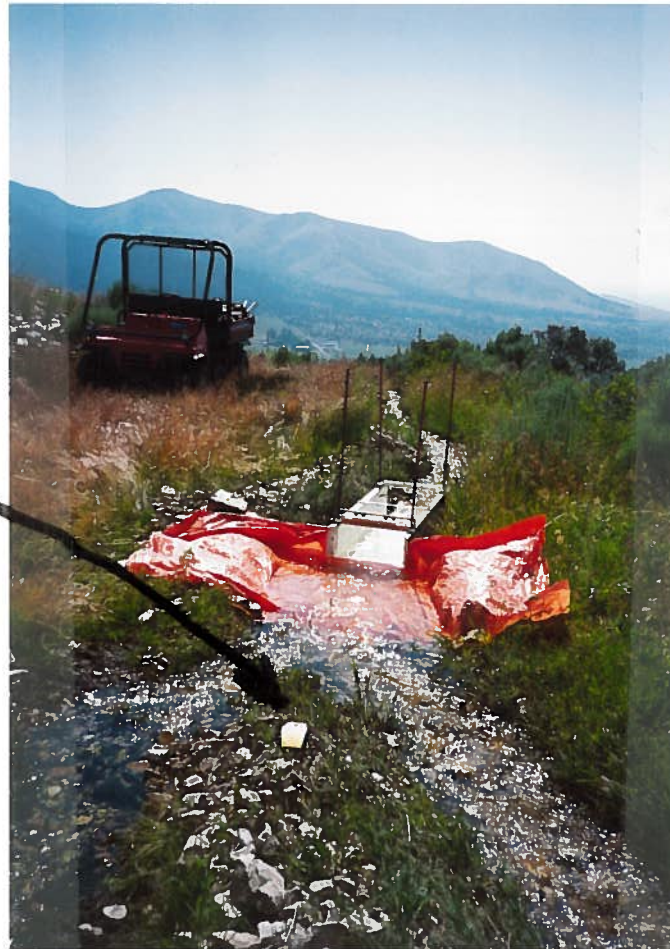
GPS SITE

This photo shows the eastern most spring of the Mahogany Springs System. You are looking east across the ditch and spring water. The spring is coming in from the left and the ditch runs along the right. I measured 0.50 cfs at this point which includes the output of all three springs.
