IDAHO DEPARTMENT OF WATER RESOURCES  
RECOMMENDATION OF WATER RIGHTS ACQUIRED UNDER STATE LAW

RIGHT NUMBER: 63-9591

### **Post-review follow up issues for IDL claims in basins 61 and 63.**

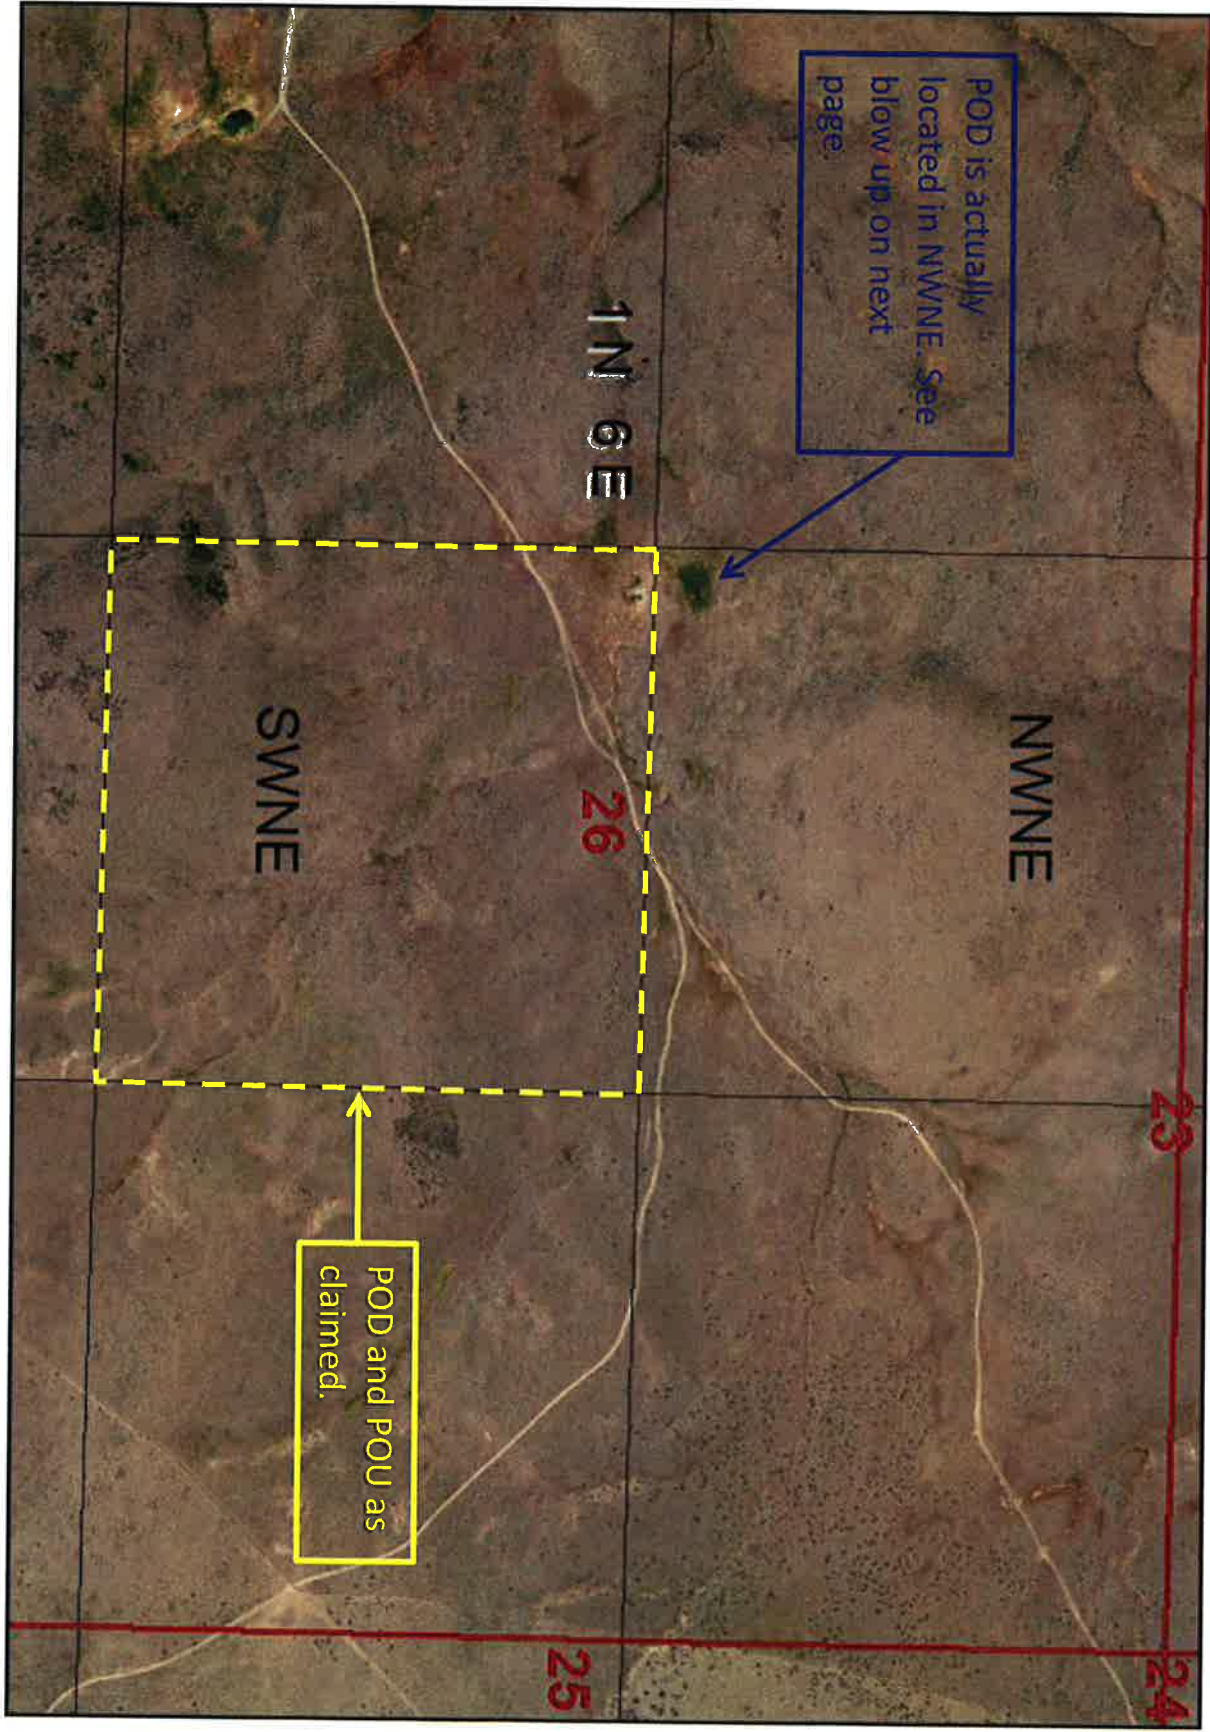
63-09591

Claimed

POD: T01N, R06E, S26, SWNE  
POU: T01N, R06E, S26, SWNE

The application for permit, license, and SF-4 all describe the POD and POU in T01N, R06E, S26, SWNE. However, aerial photography shows the POD actually being located within T01N, R06E, S26, NWNE.

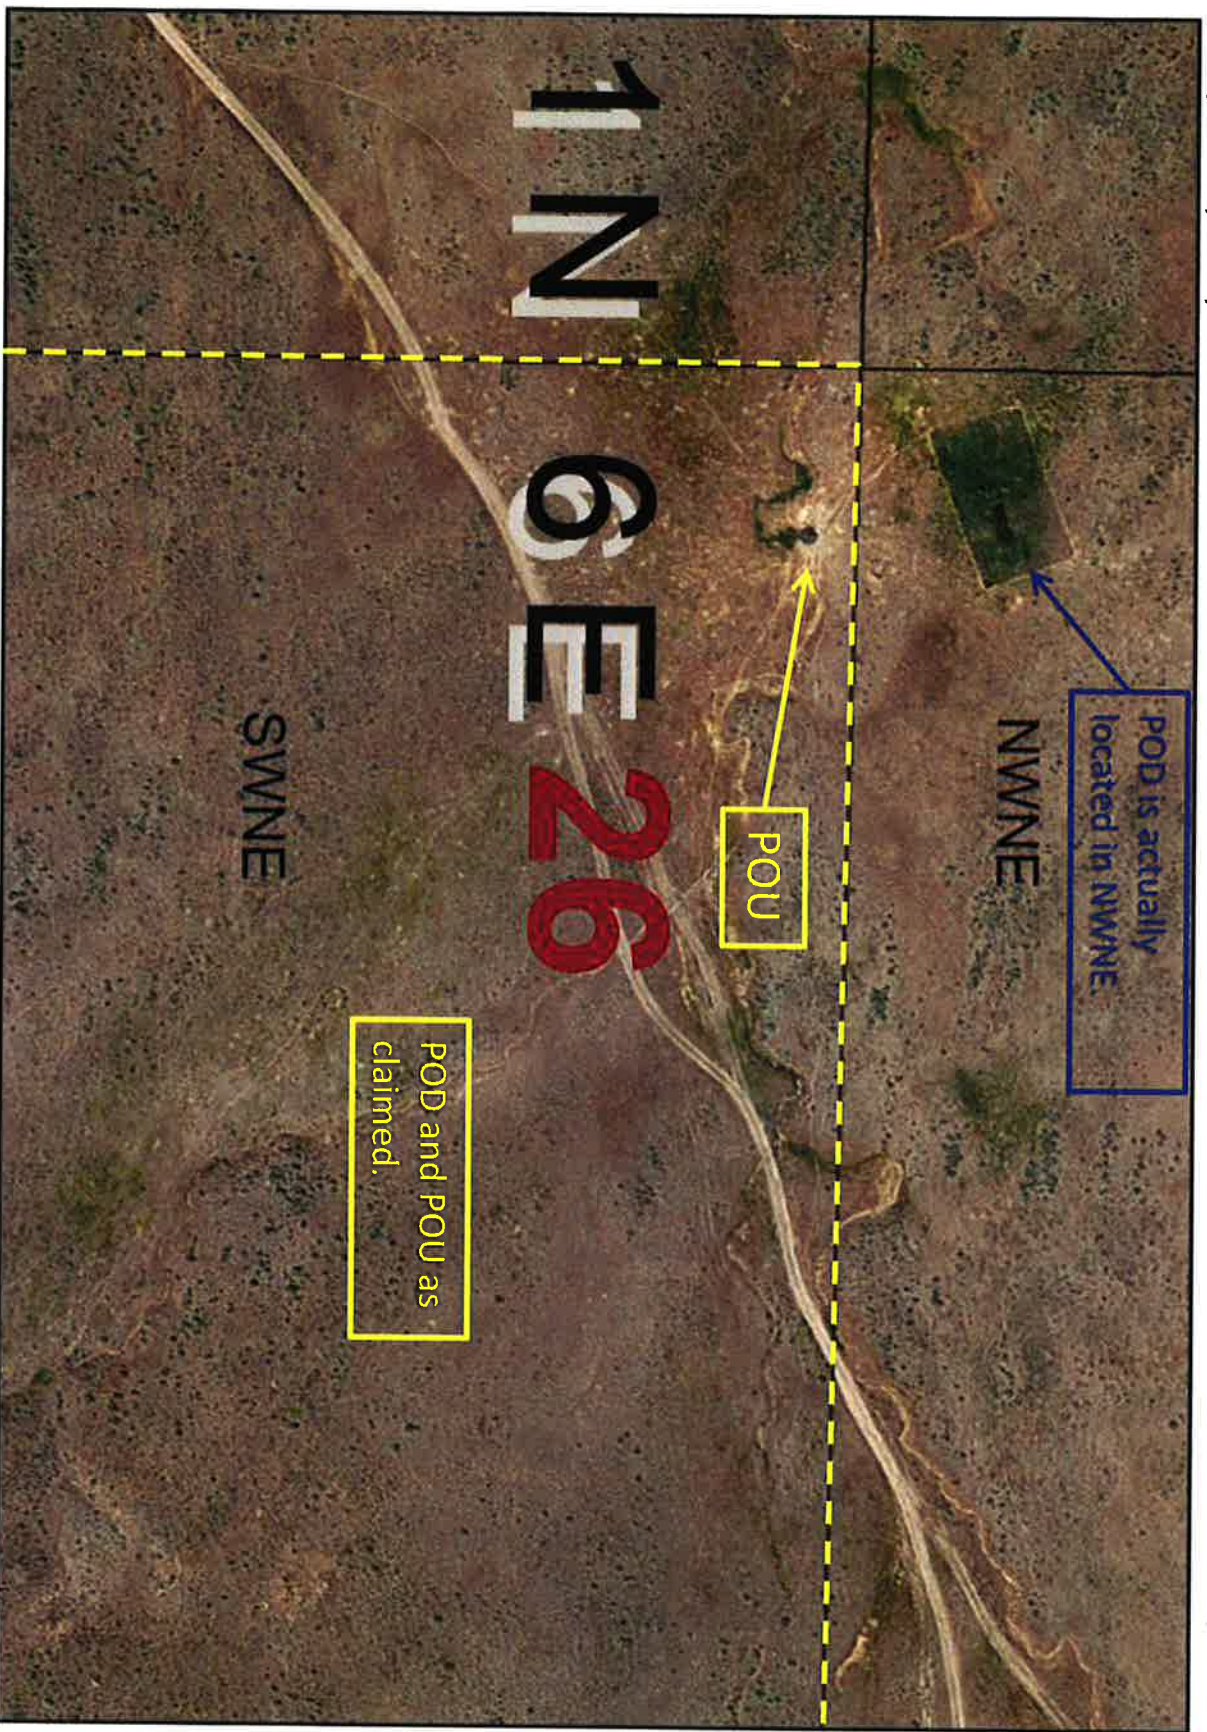
63-09591

Claimed

POD: T01N, R06E, S26, SWNE

POU: T01N, R06E, S26, SWNE

This hic/claim appears to have  
incorrectly described the QQ locations  
due to mapping techniques of the day.

I think the spring is in a fenced off area  
in (SW) NWNE and the trough is  
across the line in (NW) SWNE.

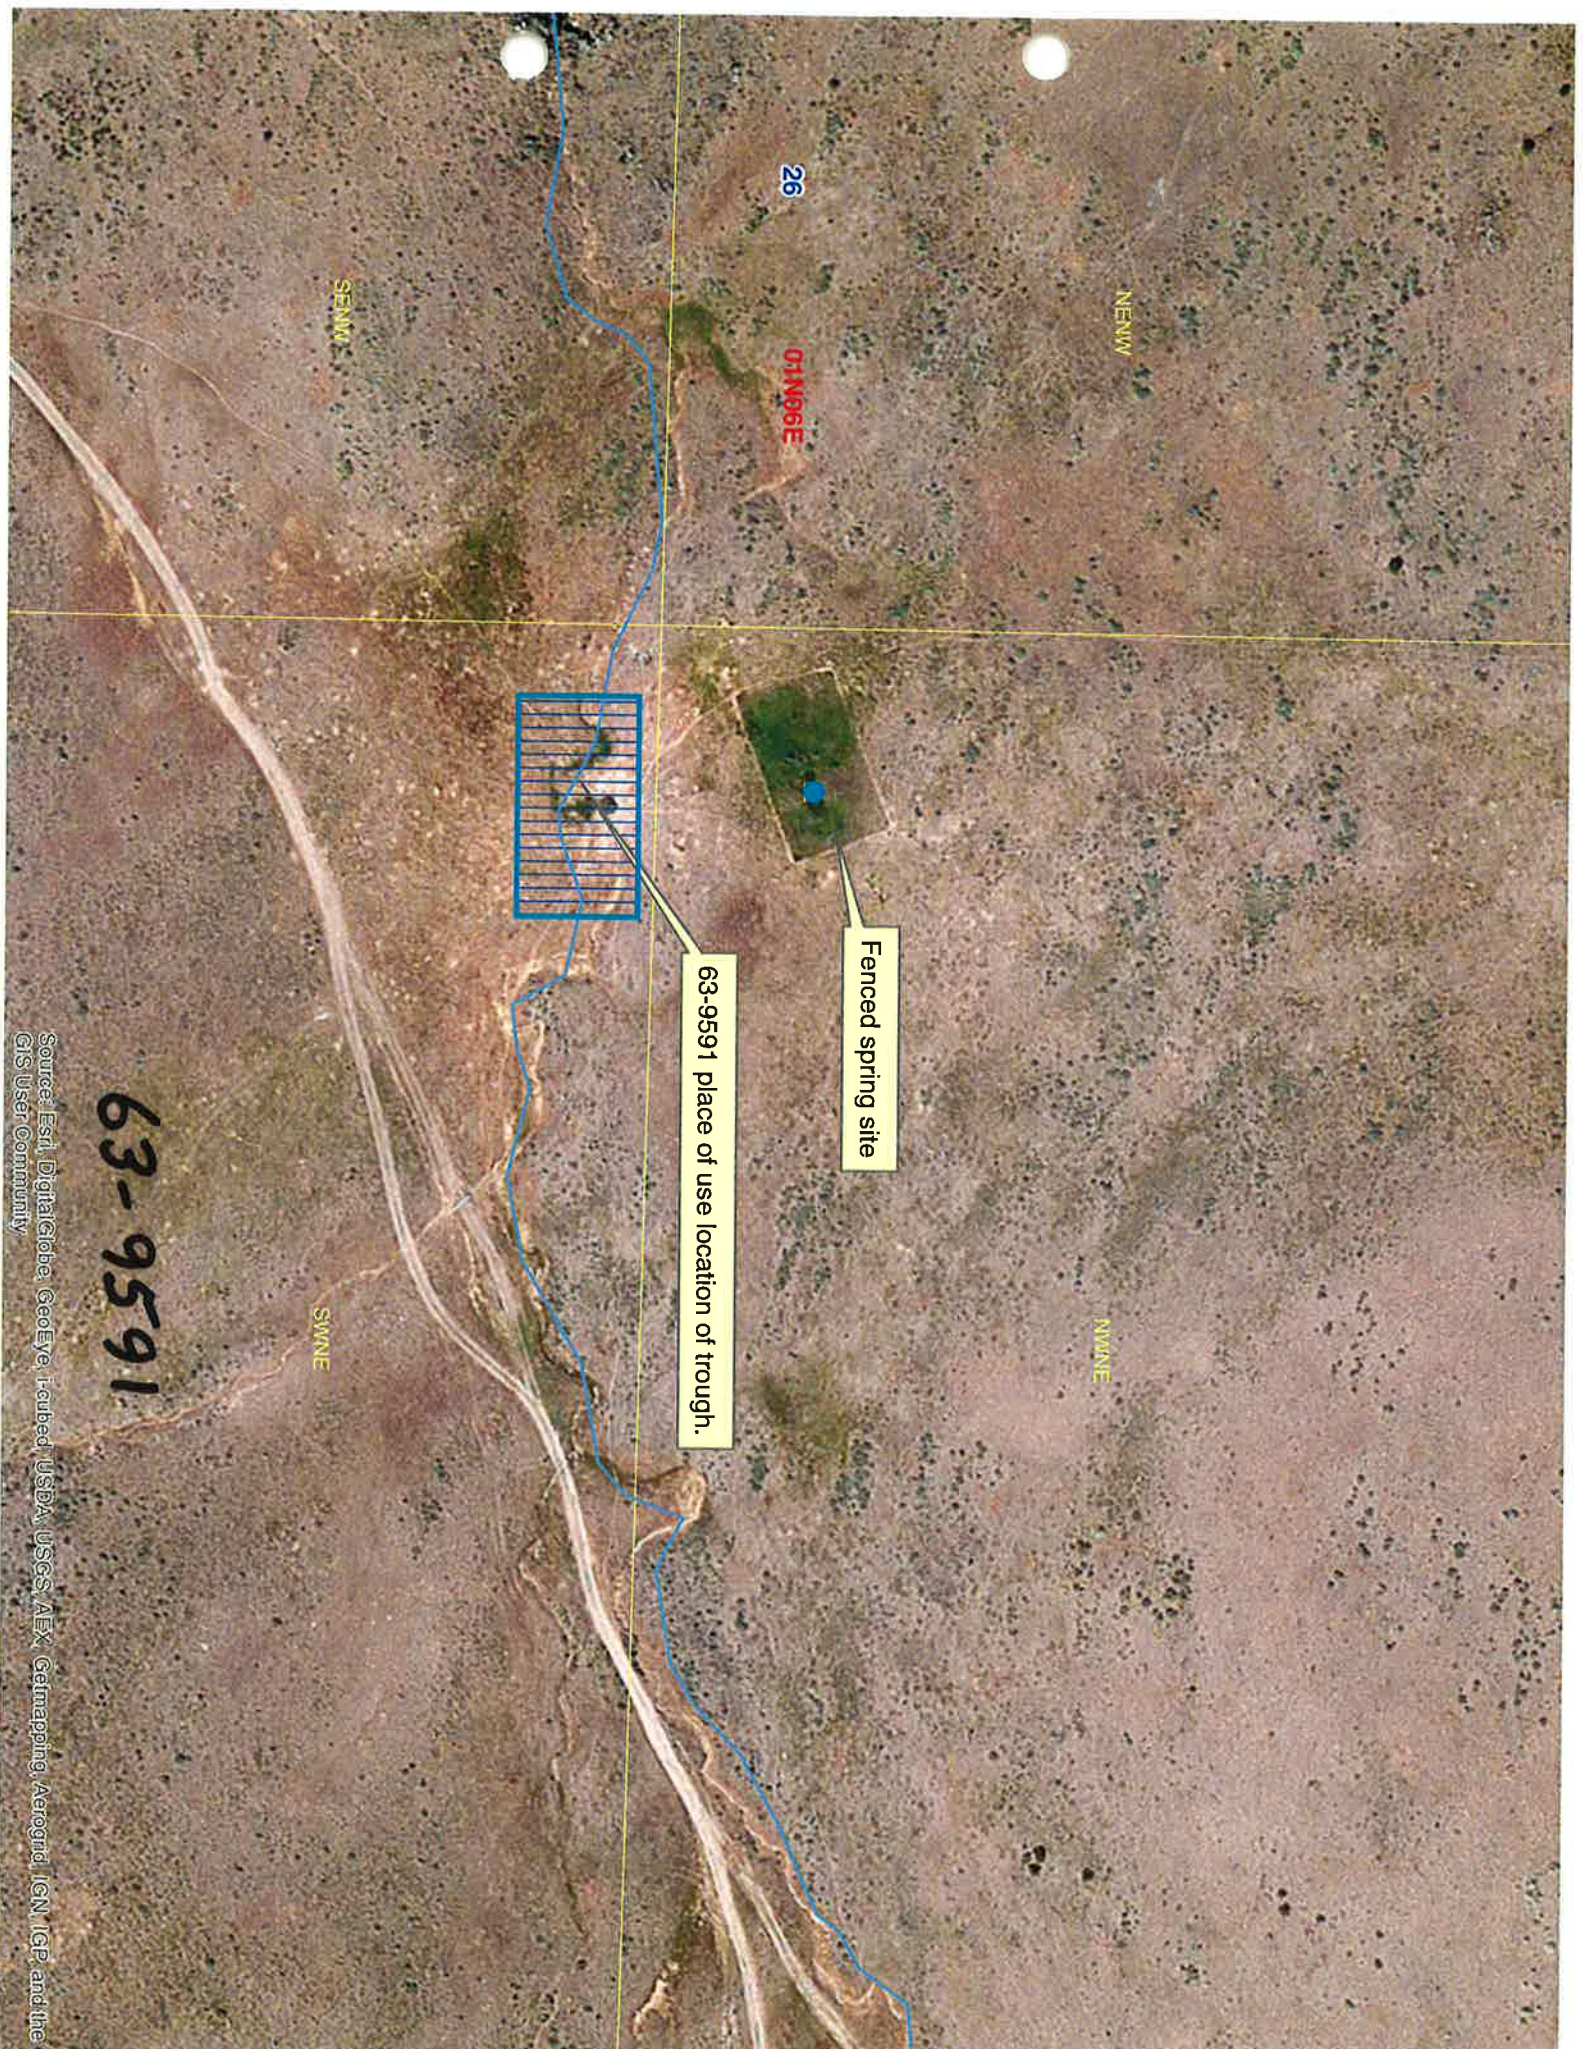
This claim/license appears to have been incorrectly described in the QQ locations. It appears the spring might be located in a fenced off area in (SW)NWNE while the trough is across the quarter line in the (NW)SWNE. The claim has been recommended based on the photos and that assumption. I would like confirmation from IDL that this is correct or an explanation of the actual system in place here. <See photo and rec'd>

Fenced spring site

63-9591 place of use location of trough.

| WR Number | Field Work Notes |
|---|---|
| 63-9591 | The head box is located in the fenced enclosure |
