## **FIELD EXAMINATION OF CSRBA WATER RIGHT CLAIM**

**Claim Identification Number:** 94-7165

**Date of Examination:** 06/20/2019

**Purpose of Visit:** Determine water source and POD location

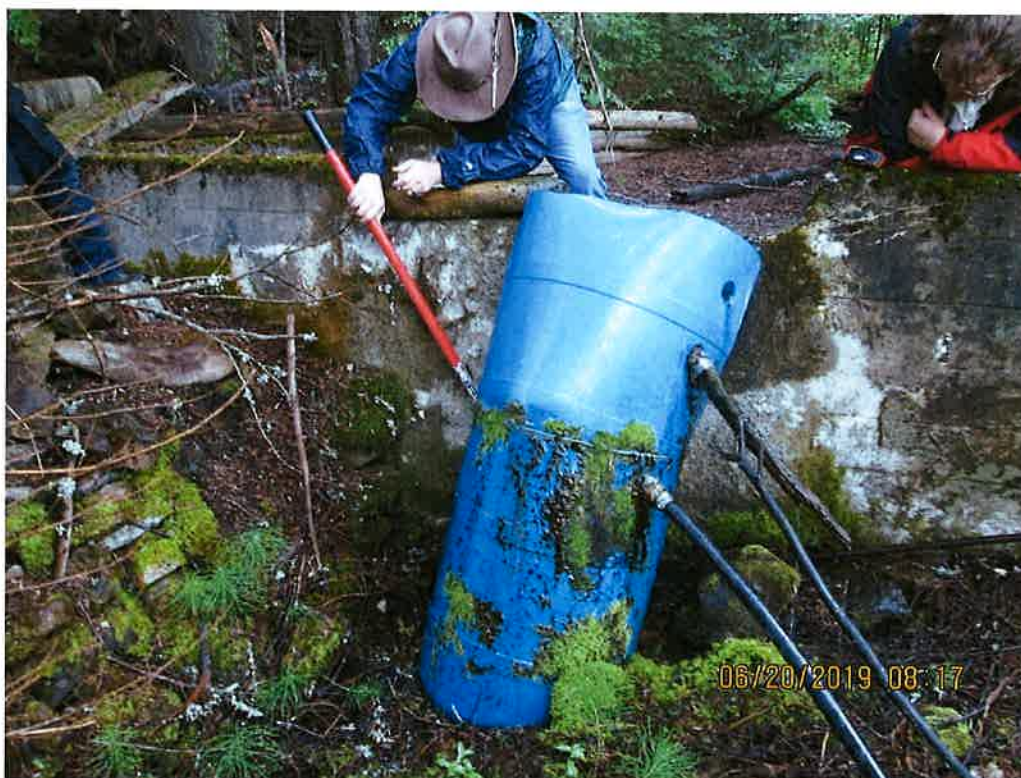
1) Fred Price inspecting construction of water delivery system (Time stamp is PST)

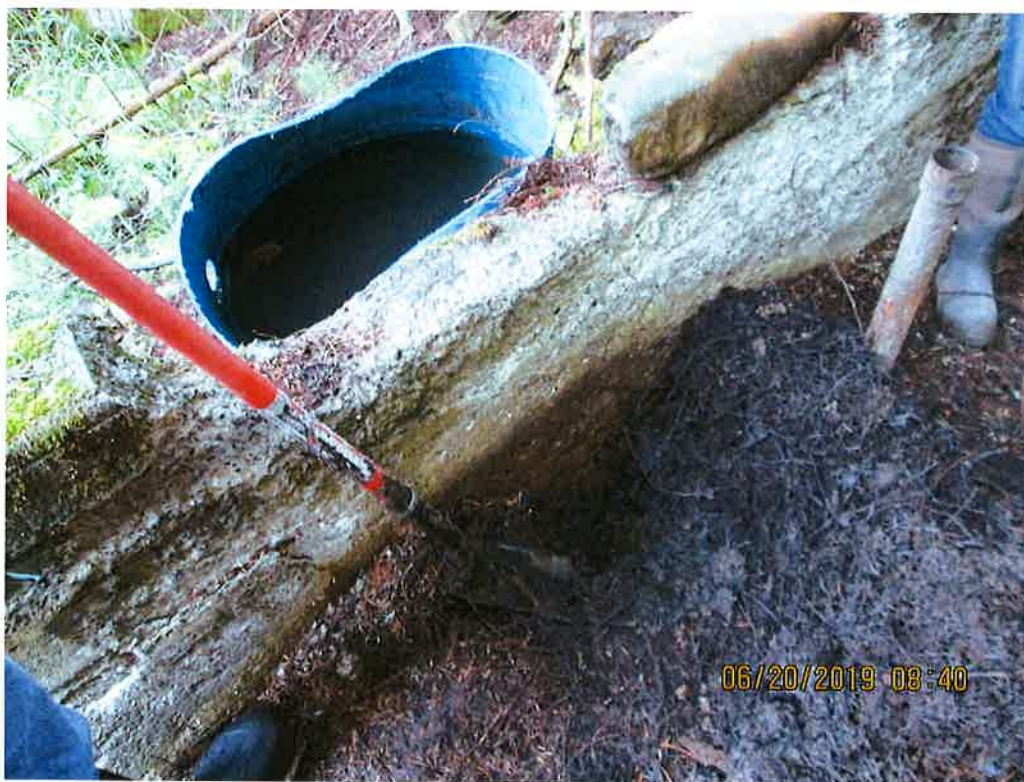
Based upon the observations made on site, it was determined that the source of water in the blue barrel is hydraulically connected to Gentle Annie Gulch Creek, but due to its brief subsurface flow could best be described as "Groundwater, Tributary to Gentle Annie Gulch Creek."

2) Hole dug in substrate above barrel quickly filled with water

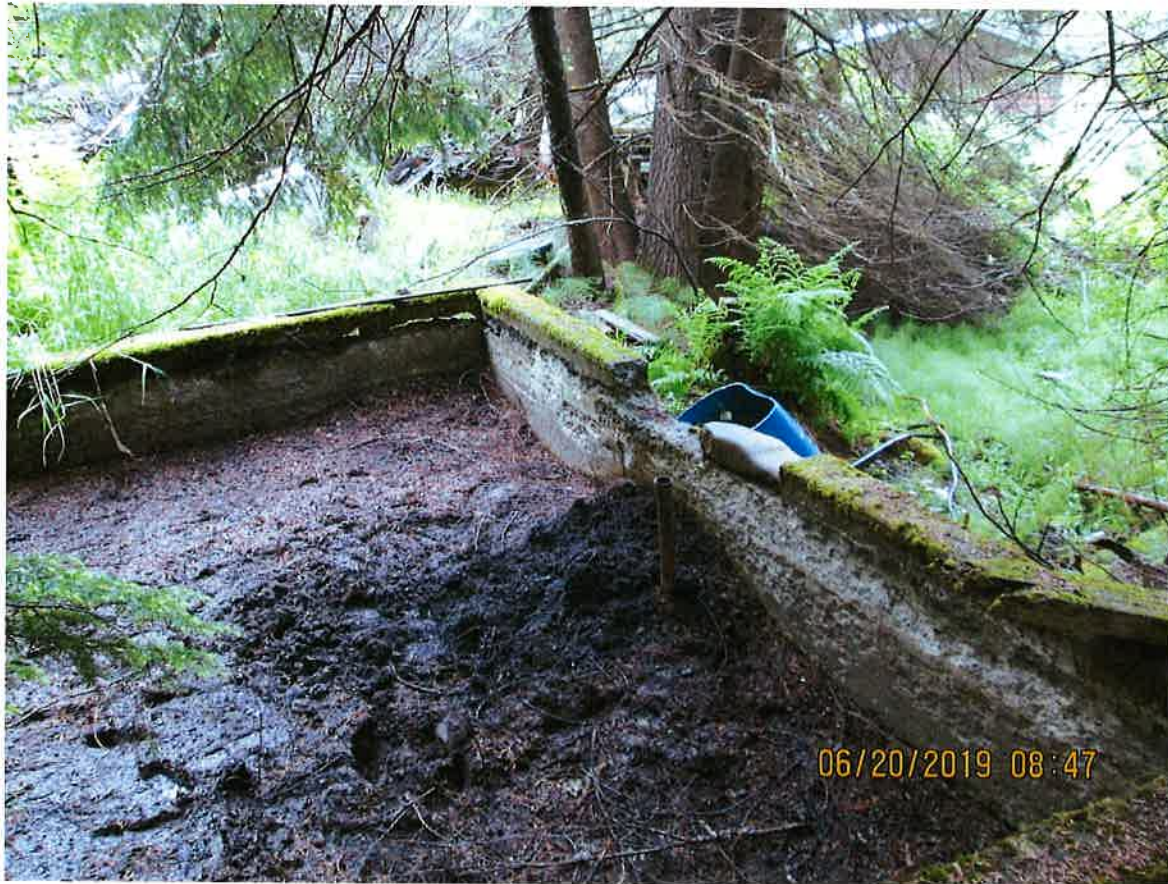
The source of water was difficult to determine, but was ultimately decided to be coming from a side channel that splits off of Gentle Annie Gulch Creek, goes sub-surface beneath the ground, and is funneled through the old concrete basin before resurfacing through perforations in the bottom of the blue barrel. The old concrete base of the basin appears to be acting as a confining layer, allowing the water to collect and build pressure. The hydraulic pressure is sufficient enough to fill the barrel, with a slow overflow trickling out. When the mud and silt substrate within that concrete basin was disturbed by our foot traffic, it quickly became saturated with moisture and liquefied, much like quicksand. A hole was dug in that mud near the downstream edge of the basin and it rapidly filled with water. When water was swept out of the barrel, it was steadily replenished. Water flows by gravity pipeline from the barrel down into a window of the house. The overflow from the barrel slowly trickles out and sinks back into ground and down a marshy draw that reconnects with Gentle Annie Gulch Creek.

- 3) Mud in basin above barrel became very soft and heavily saturated after being disturbed by our foot traffic
