## **FIELD EXAMINATION OF PRBA WATER RIGHT CLAIM**

**Claim Identification Number:** 87-11847

**Examination Location:** 1311 Marshall Rd, Viola ID 83872

**Purpose of Visit:** Determine if the source exists on claimant's property.

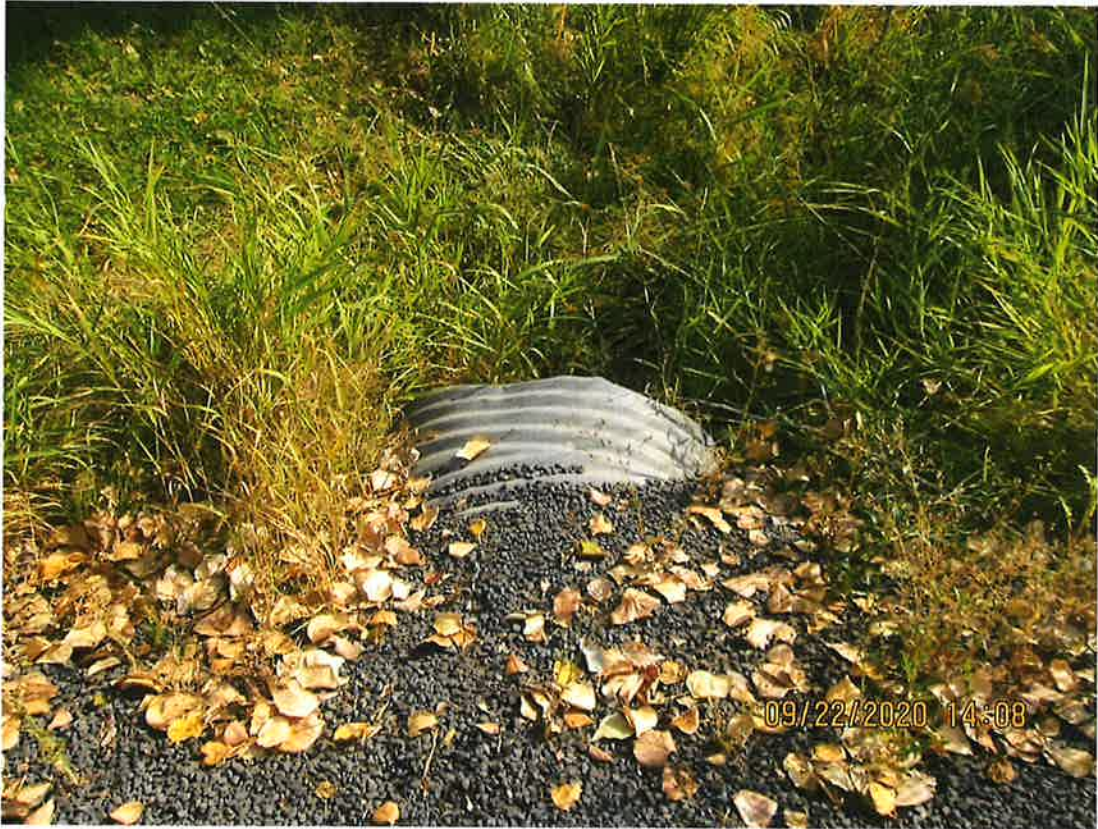
*Figure 1*

The claimant did not return my phone call requesting them to give me a call back. I was in the area for a separate field exam, and decided to see what information I could gather on the roadside by the claimant's parcel. I stayed on the roadside and did not enter onto private property. From the roadside, I could visibly see a channel that still had water located where the claimant claimed, figures 2-4. There is a culvert that allows the water to flow north under the road, figure 1 on the south side of the road and figure 5 on the north side.

After conducting the field exam, and in conjunction with ArcMap DRG and NHDPlus\_HR mapping, I recommend that the source is unnamed stream, tributary to West Fork Flannigan Creek.
