Research on priority date for claim 87-10301, requested priority date of 1/1/1949.  
By Glen Gardiner

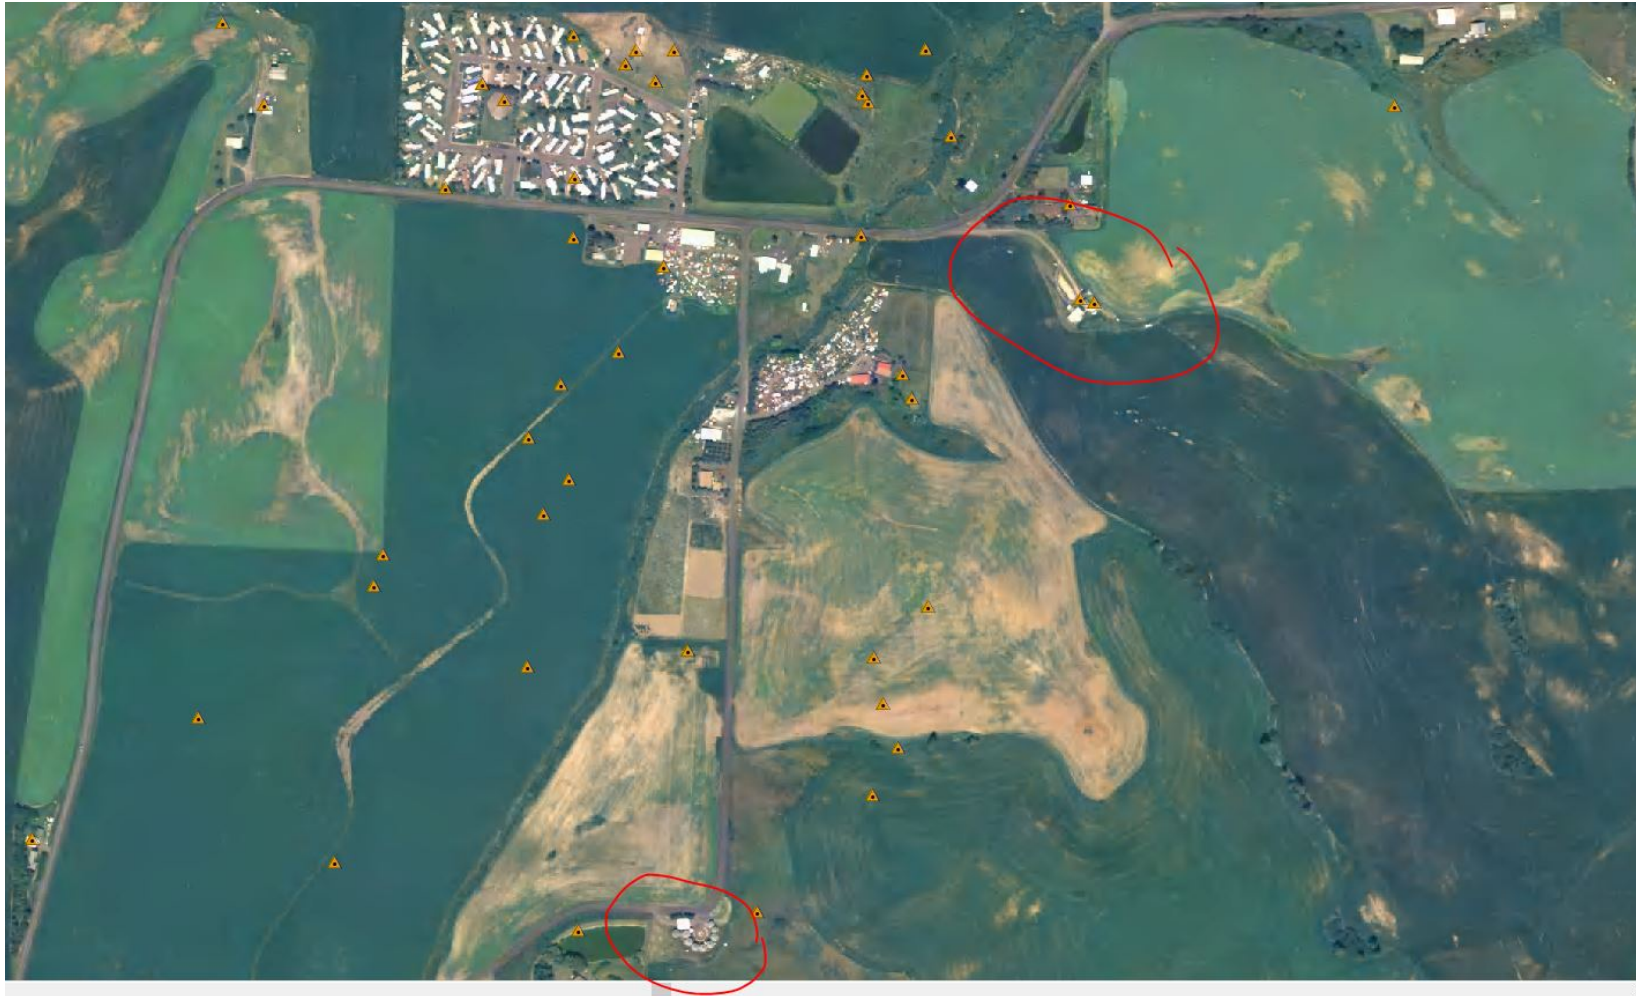
2004 imagery using Arcmap. North circle is claim 87-10301, southern circle is structures used as reference. Both structures visible.

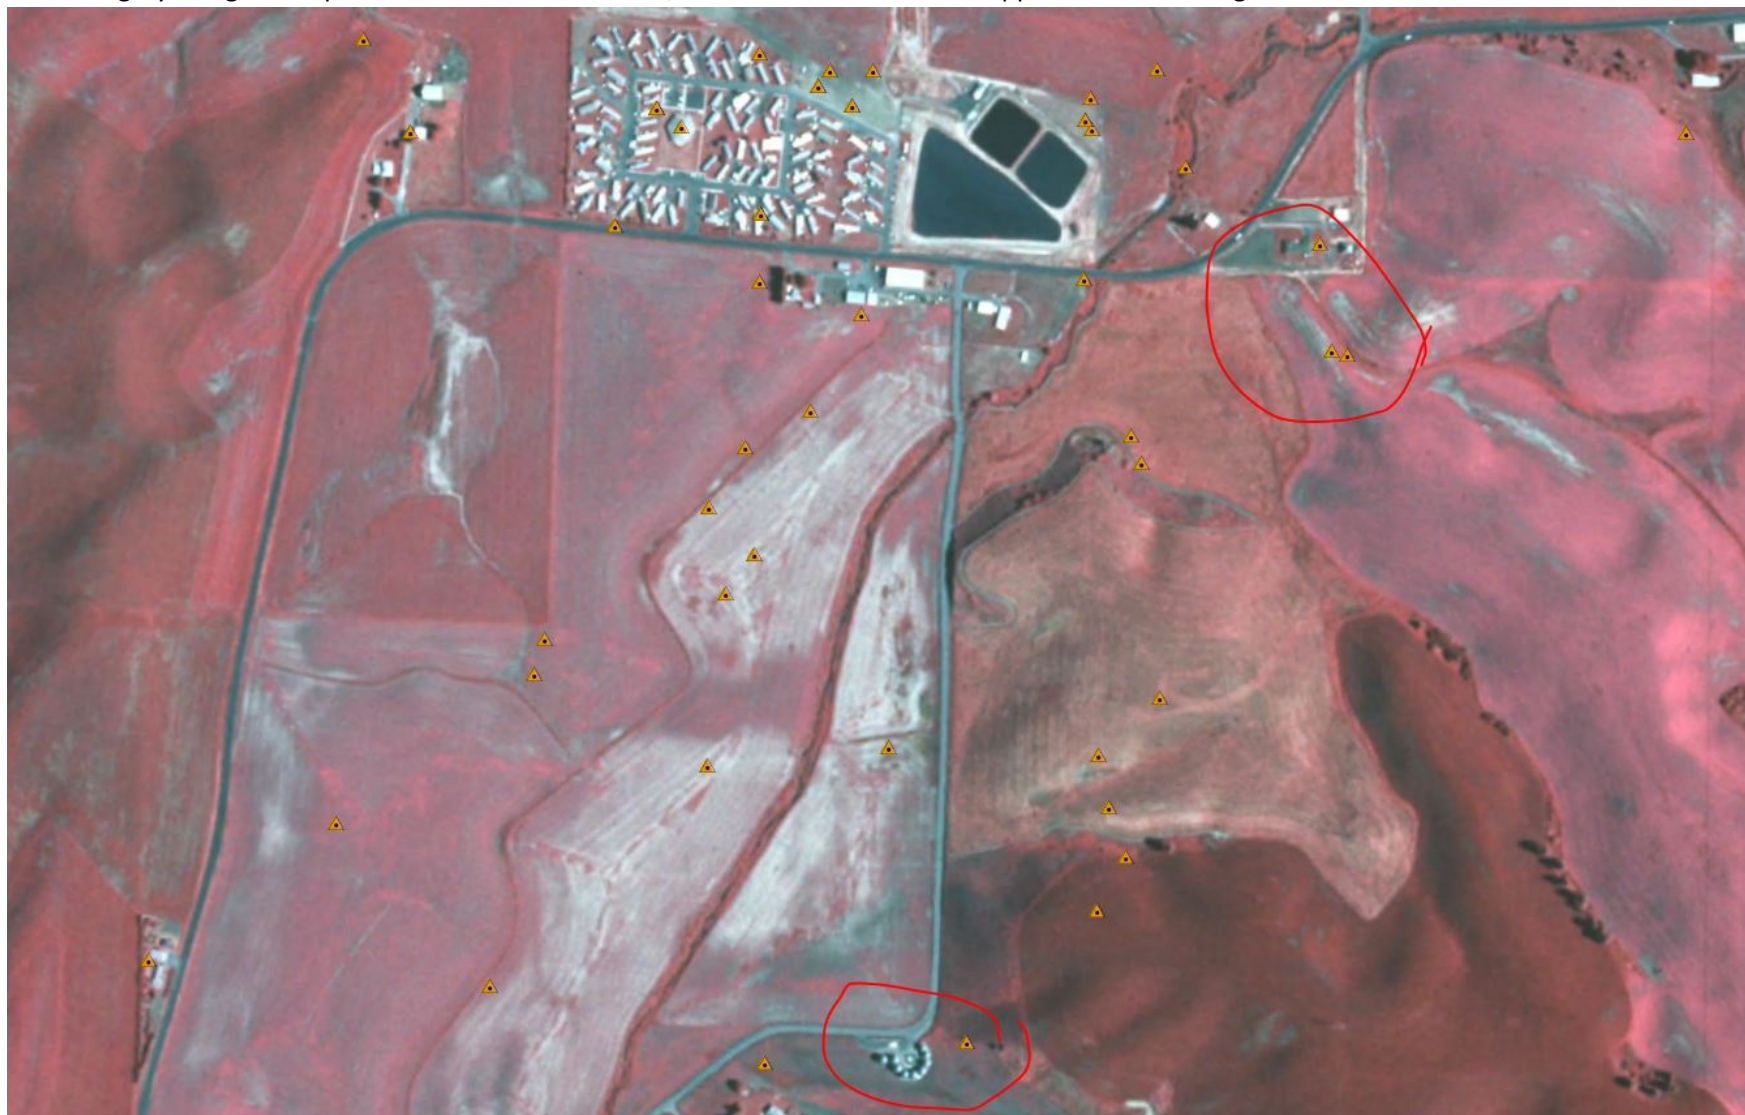
1985 imagery using ArcMap. Southern structure visible, claim 87-10301 structure appears to be missing.

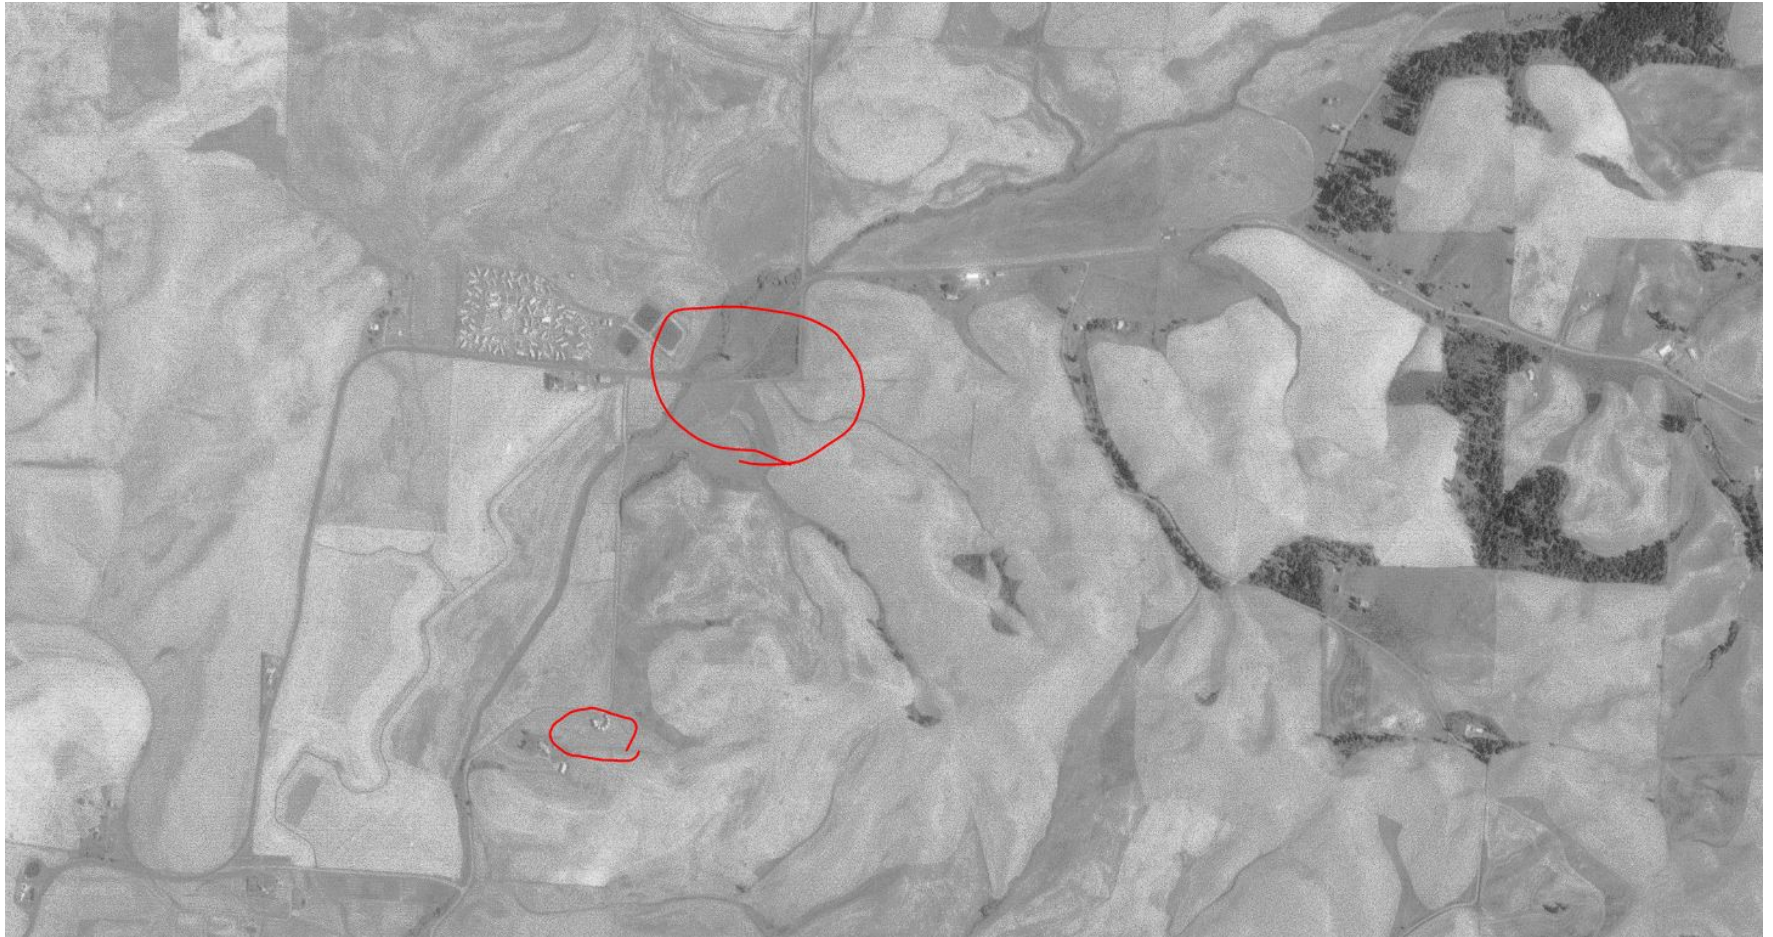
Switched to USGS EarthExplorer for earlier imagery. Lat 46.44.25, Long 116.56.17. Selected Data Sets, Aerial Imagery with Aerial Photo Single Frames. Downloaded 1975 image 1VDPX00030011. Southern structure visible, claim 87-10301 appears to be missing.

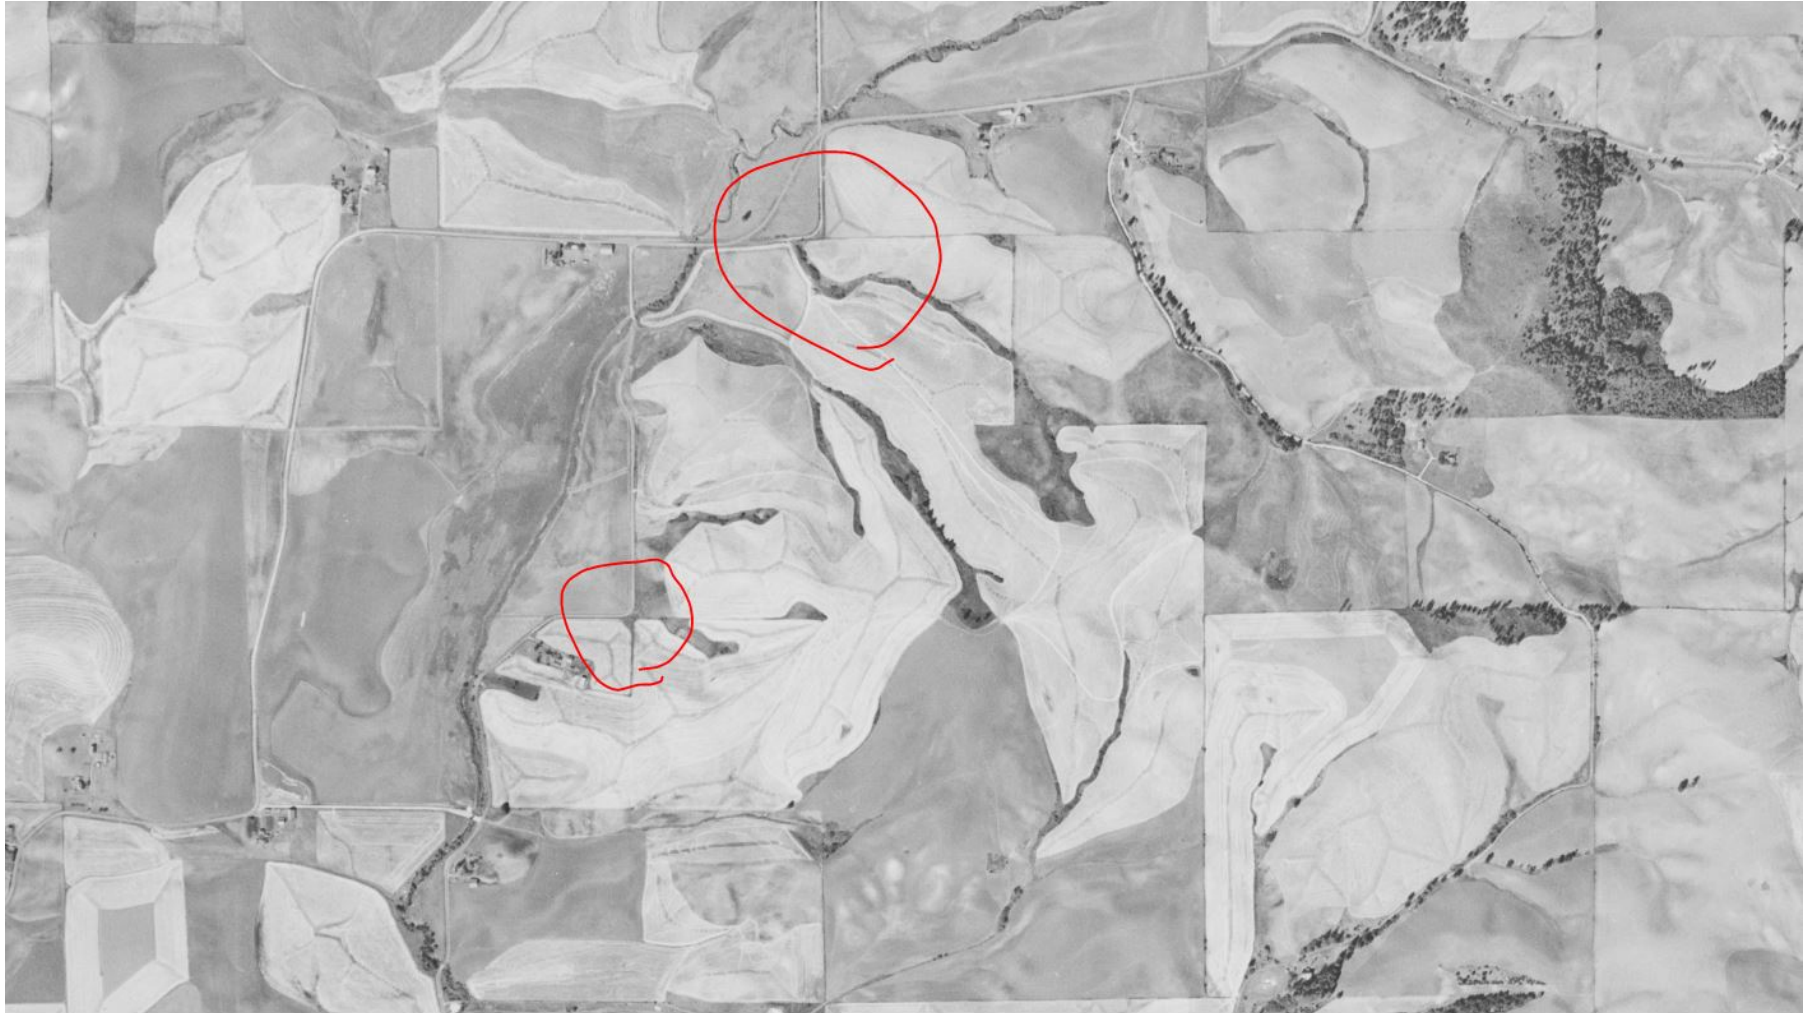
USGS EarthExplorer. Downloaded 1953 image A010905506856. Both structures appear to be missing. If you zoom in close, there may be a structure in the northern circle.

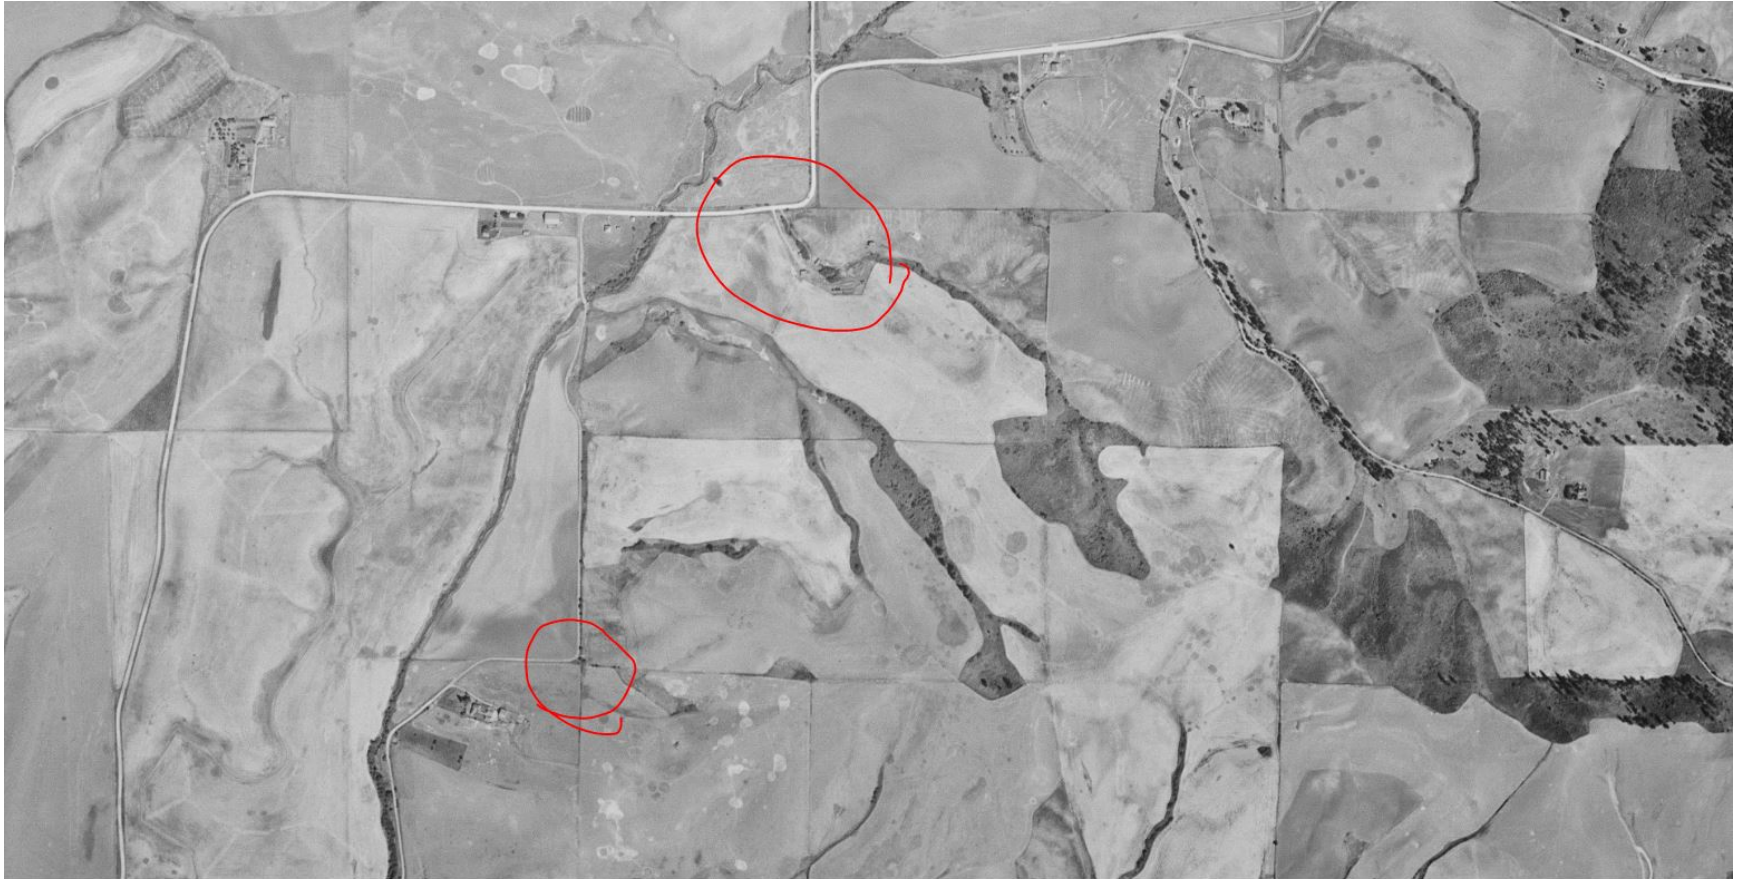
USGS EarthExplorer. Downloaded 1947 image 1CJ0000310065-1. The road location changed between 1953 and 1947, the 45 degree shortcut eliminated. Structures are visible at the 87-10301 location.

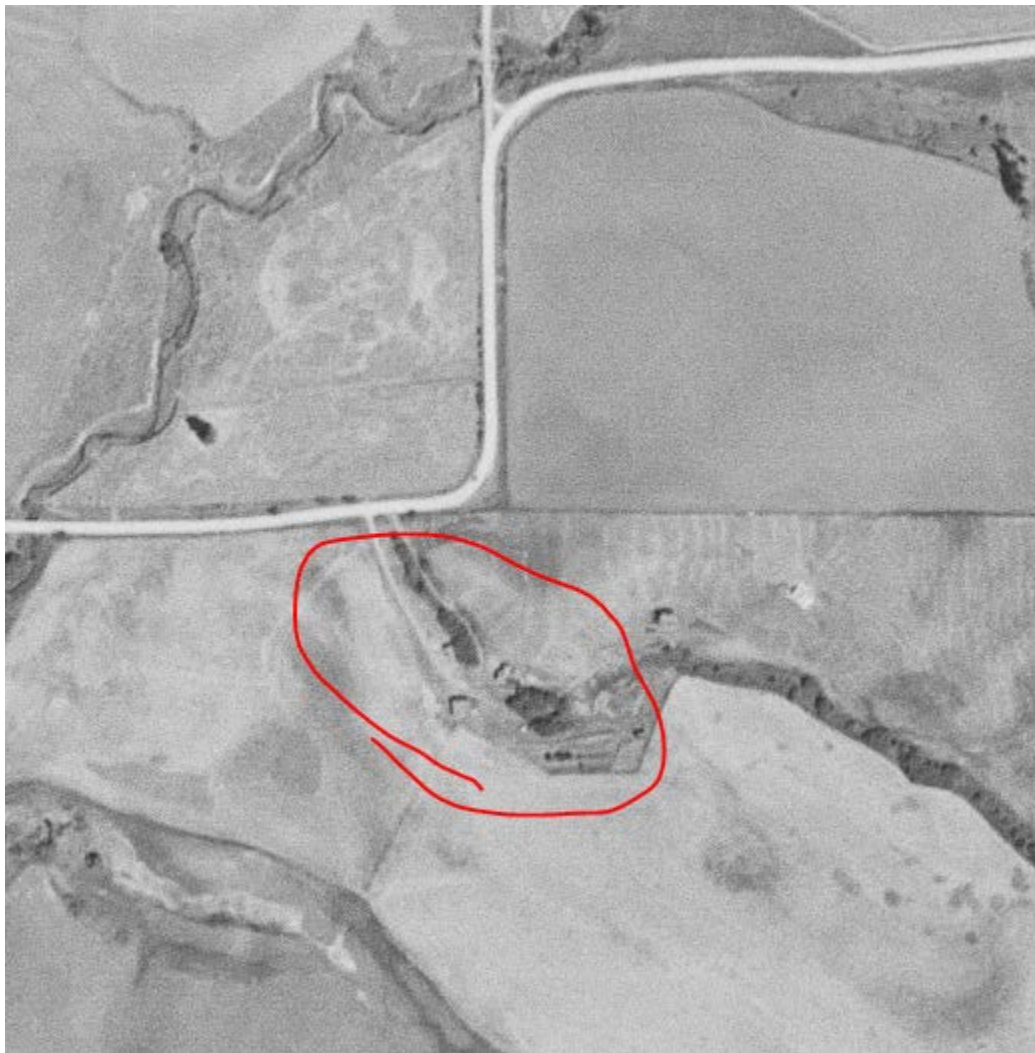
Zoom in on 1947 image, 87-10301 location. Structures are visible which may have been cabin using domestic water. Recommending priority date of 1/1/1949 as claimed.
