## Supporting Data and Analysis of Transfer No. 84788

**Water Right Nos. 22-131C, 22-238B, and 22-  
2029E, Teton, Teton County, Idaho**

**RMEA Project Number: 20-0055**

**August 27, 2021**

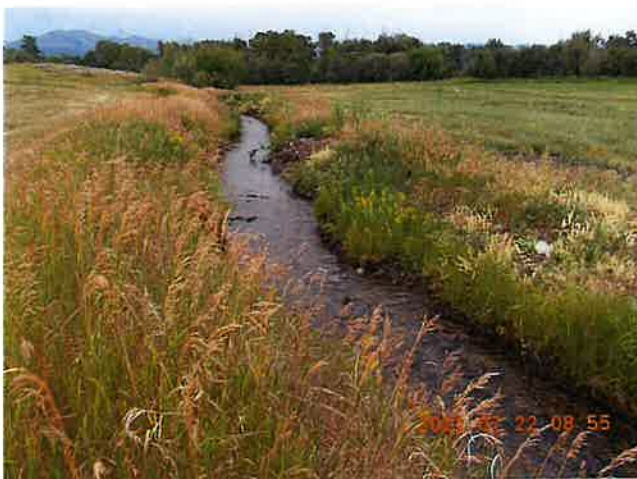
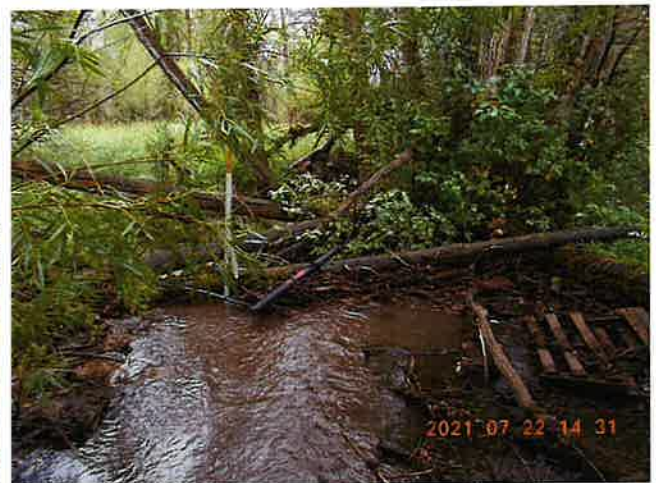
The images below demonstrate the differences between the state of the Hubbard Ditch and the Grouse Creek Ditch. Although these are taken at a single location, they are representative of the general state of each ditch.

Photo 2752. Looking upstream at Grouse Creek Ditch. Photo 2803. Debris in channel of Hubbard Ditch.

The existing system is in a poor state of maintenance, with multiple obstructions (see Attachment #1, Lines 151-154) affecting flow and preventing adequate water from reaching the subject property during periods of low flow. Even if the Hubbard is only evaluated downstream of the confluence of the North Leigh Canal and the Hubbard, there appears to be sufficient debris to significantly reduce flows. At each of these obstructions, the water in the Hubbard Ditch must maneuver under and through the debris in order to reach the other side and continue downstream. Based on the descriptions in Attachment #1, it appears that there is about 1 mile of the Hubbard Ditch downstream of the confluence that is described as alternating flowing sections and debris clogged areas.

The proposed conveyance system is in a better state of repair, as evidenced by the description and photos provided in Attachment #1. The applicant has invested resources and worked with Intermountain Aquatics to improve the quality of this system, both along the Grouse Creek Ditch and Grouse Creek, thereby improving the rate of flow in the channels.

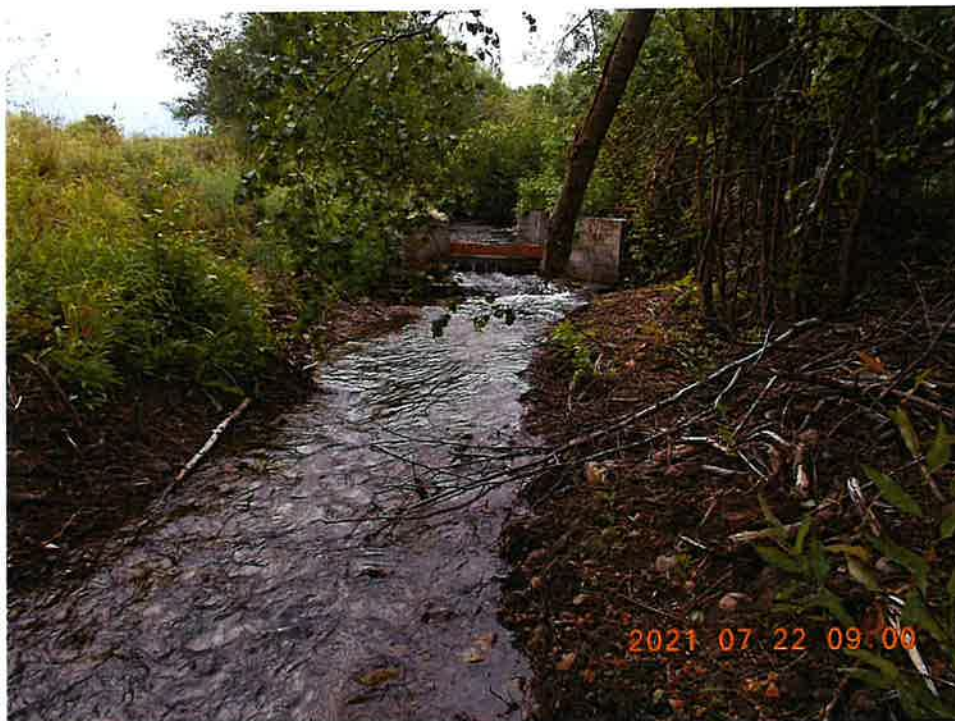
The east end of Figure 1 shows the split of the Grouse Creek Ditch from the North Leigh Canal at Location A. Photo 2763 is looking upstream on the Grouse Creek Ditch toward the structure at Point A. Photo 2765 shows the structure, with water entering from the top of the photo. North Leigh Canal water exits to the right of the photo and the Grouse Creek Ditch water exits toward the camera.

27  
28 Photo 2763. Looking upstream on the Grouse Creek Ditch toward the structure at Point  
29 A on the Figures.  
30

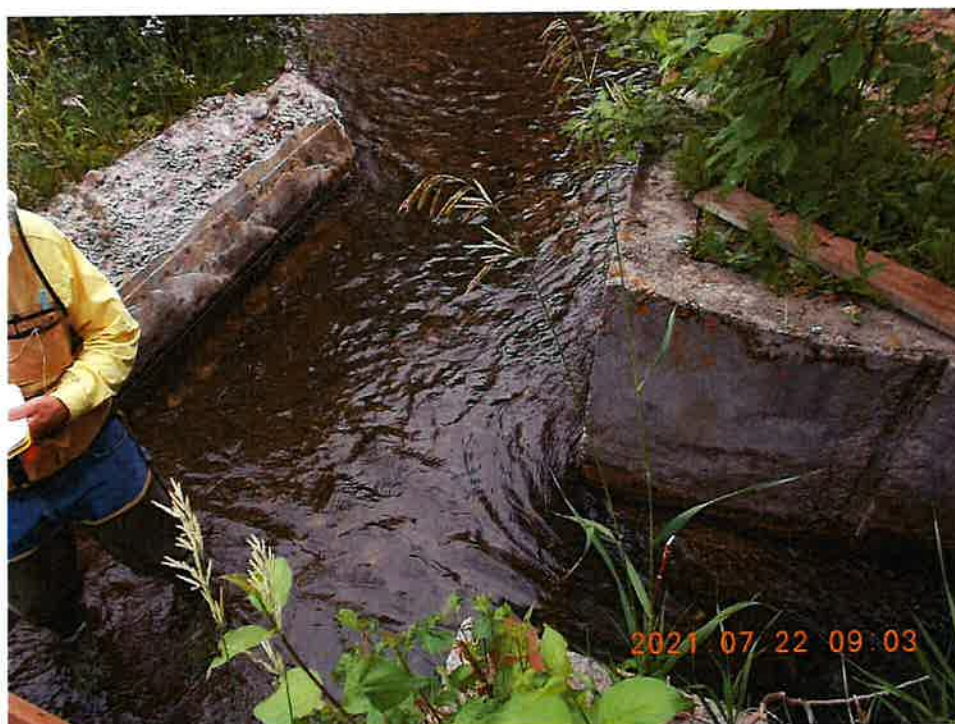
31  
32 Photo 2765. Structure at Point A.  
33

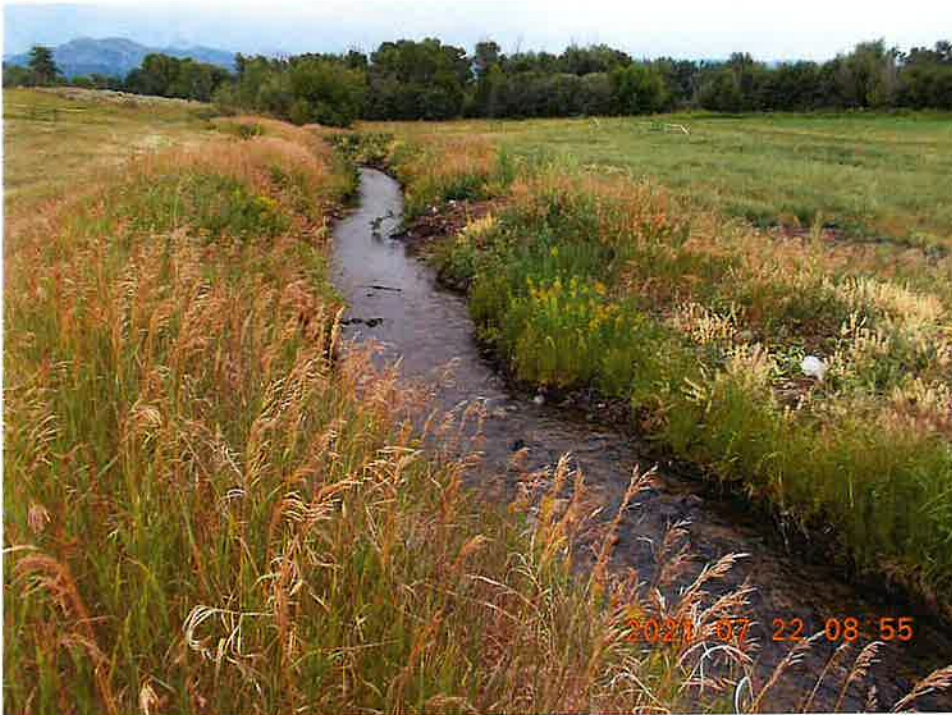
34 Photo 2762 shows the Grouse Creek Ditch looking upstream from Waypoint 2762.  
35 Photo DJI 0022 is a drone view of the same location, with the top of the photo aligned  
36 approximately east. Photo DJI 0019 shows the ditch between Waypoint 2759 and  
37 Waypoint 2760, also with the top of the photo aligned approximately east.  
38

39  
40 Photo 2752. Looking upstream at Grouse Creek Ditch.  
41

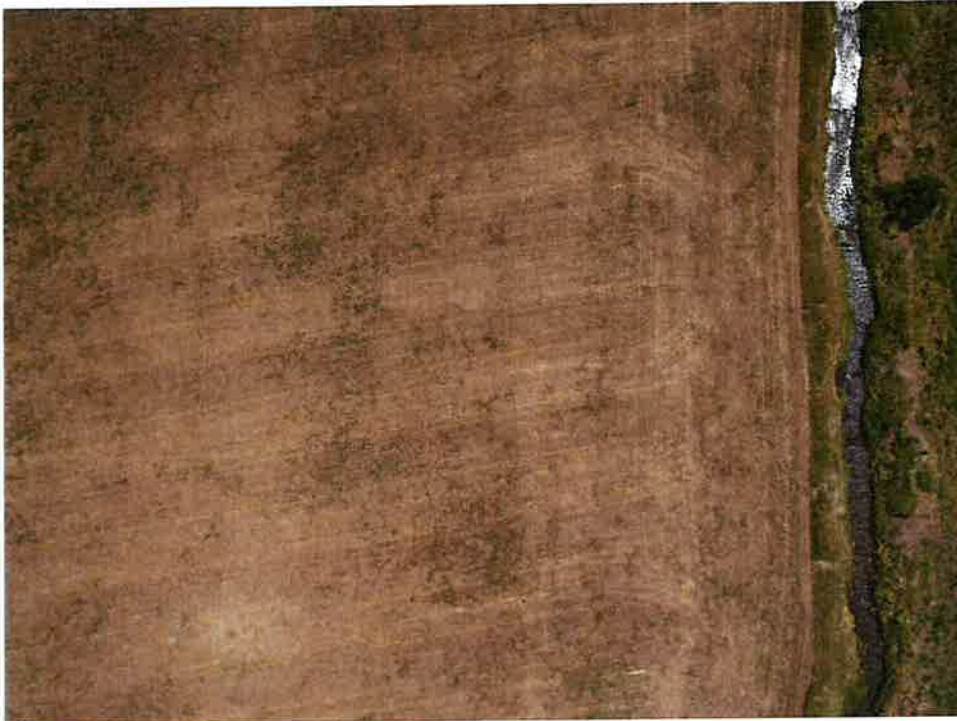
Photo DJI 0022. Drone view of the area near Waypoint 2762.

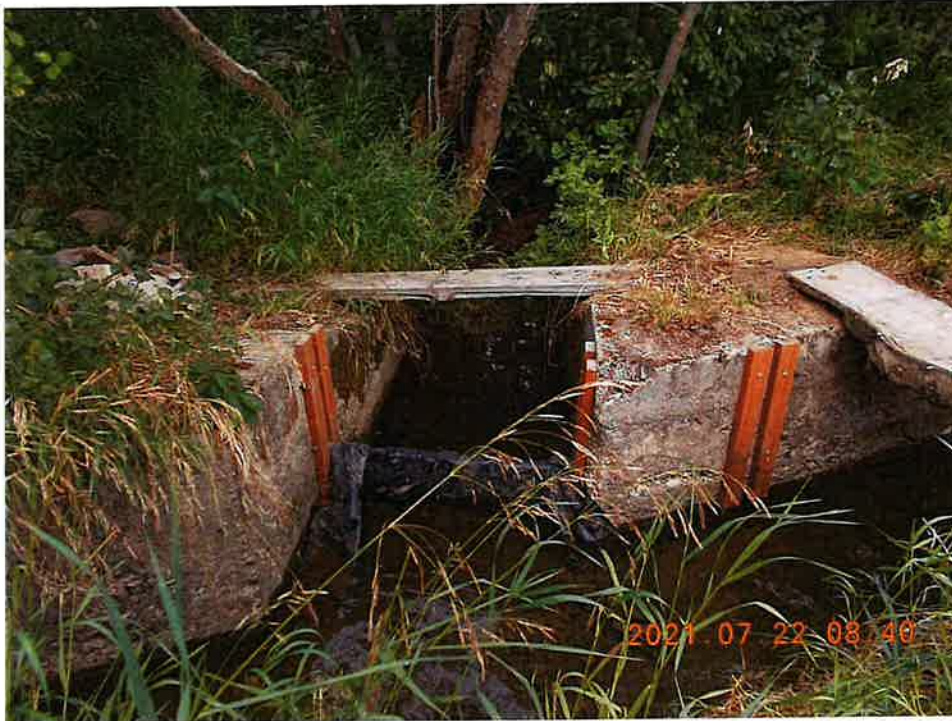
48 The structure at location B is shown in photo 2752. The Grouse Creek Ditch proceeding  
49 north exits at the right of the photo and the lateral proceeding west goes toward the  
50 top of the photo. Photo DJI 0015 is a drone view of the ditch at Waypoint 2746.  
51

52  
53 Photo 2752. Structure at Location B.  
54

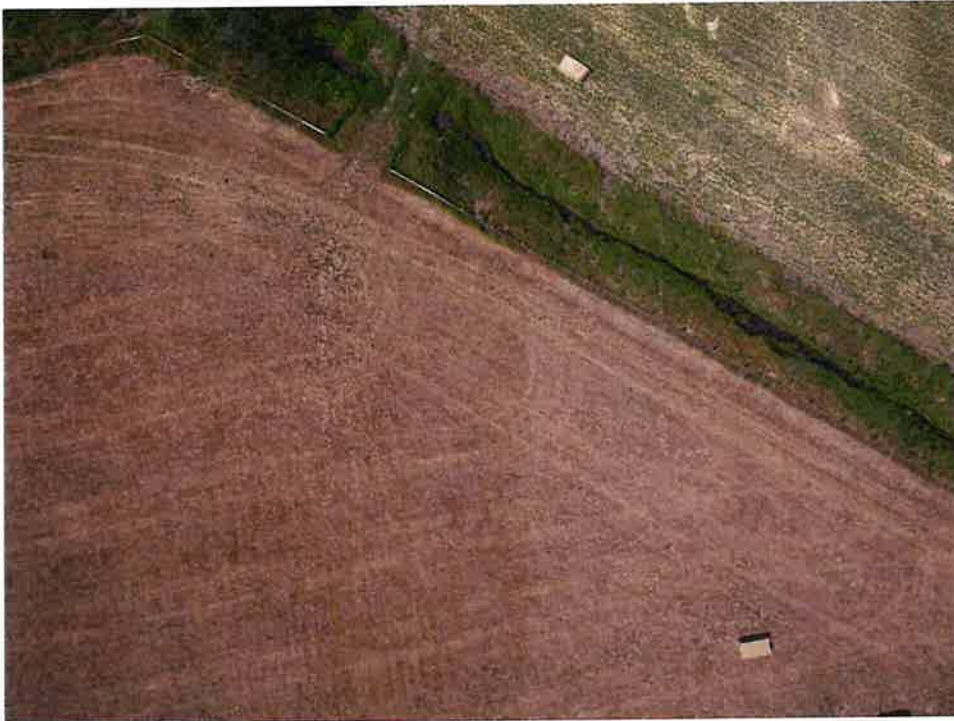
55  
56 Photo DJI 0015. The culvert crossing in the photo is at Waypoint 2746. The top of the  
57 photo is oriented approximately to the southeast.

58  
59 Near Waypoint 2746, I made a reconnaissance-level flow measurement and found 3.1  
60 cfs +/- approximately 0.6 cfs in the ditch. Water marks indicate that typical flows are  
61 considerably greater.

62  
63 From my observation, the Grouse Creek Ditch is well maintained, clear of obstructions  
64 and debris, and has considerable capacity beyond the typical water levels indicated by  
65 marks I observed on the banks.

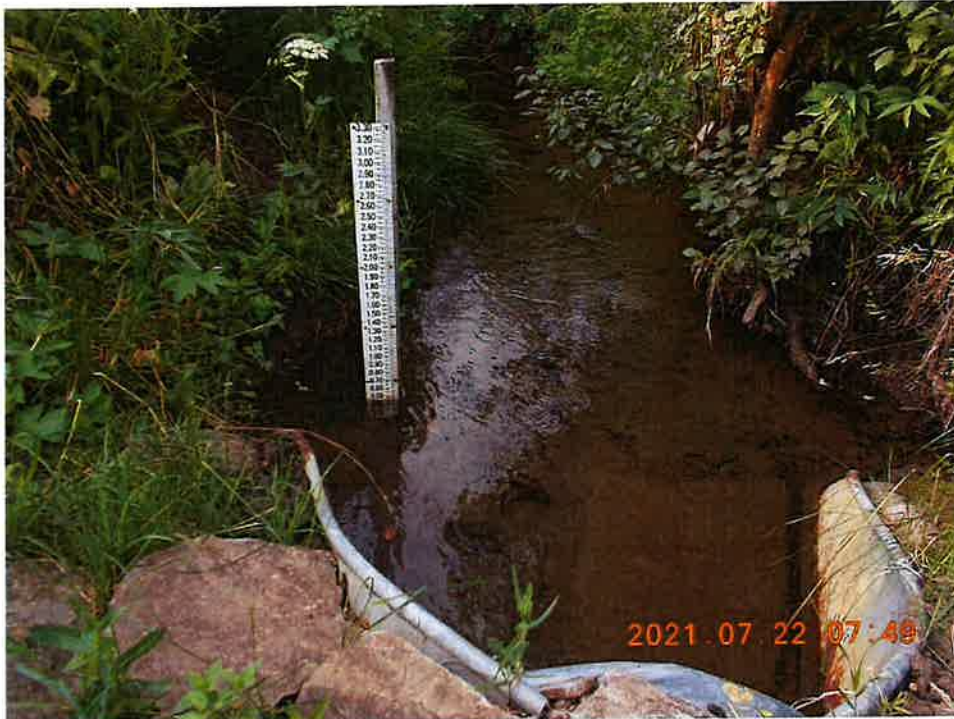
66  
67 I saw no measurement devices at Location A or Location B. Photo 2738 shows a staff  
68 gauge at the inlet of a culvert at the location mapped as "Staff Gauge" in Figure 2,  
69 which would be a good measuring device for the Grouse Creek Ditch if calibrated.

Photo 2738. Staff gauge at waypoint "Staff Gauge" (Figure 3)

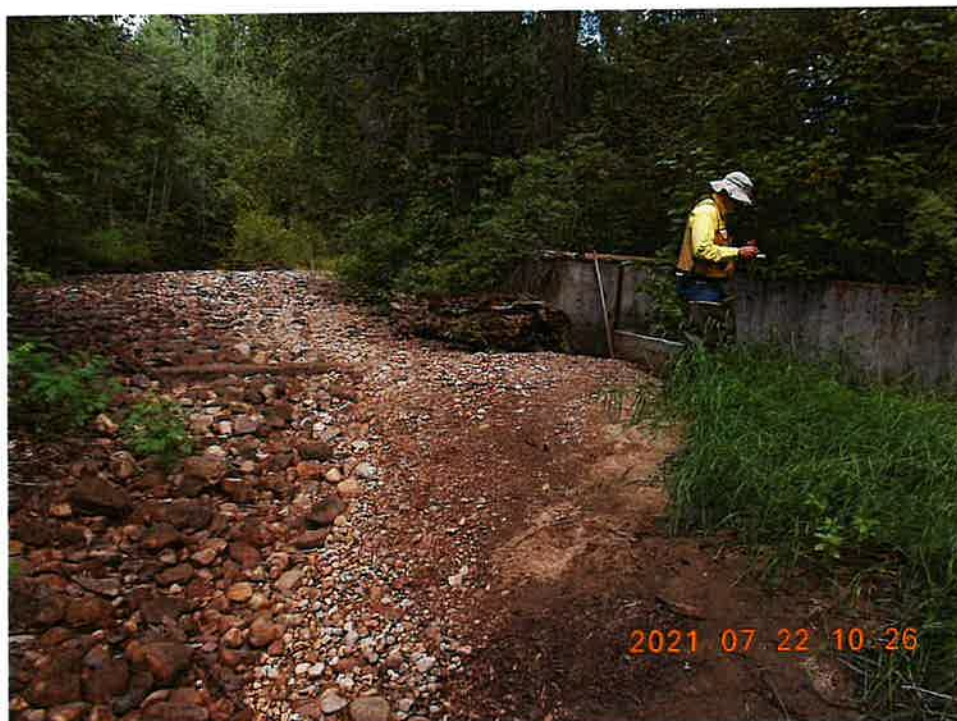
Label "C" in Figure 1 shows where I observed the Hubbard Ditch diversion from North Leigh Creek. There was no flow at this location. Photo 2779 is looking downstream at North Leigh Creek, with the diversion structure on the right. Photo 2785 shows the structure with a staff gauge attached to the wing wall visible on the left of the photo. IDWR site tag A0013865 is attached to the concrete structure, and a red/pink printed notice was on top of the concrete under a weight, reading in part "This headgate has been regulated by the Watermaster of this District." Hubbard Ditch immediately downstream of the diversion is shown Photo 2786.

Photo 2779. North Leigh Creek at Hubbard Diversion.

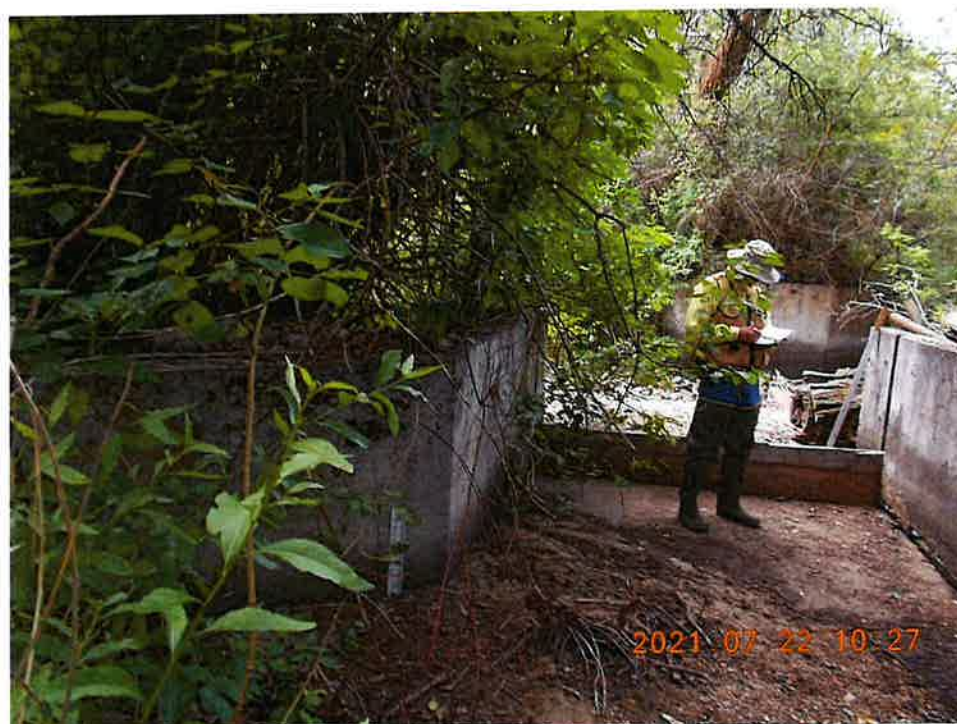
Photo 2785. Looking upstream at the diversion structure from the head of Hubbard Ditch.

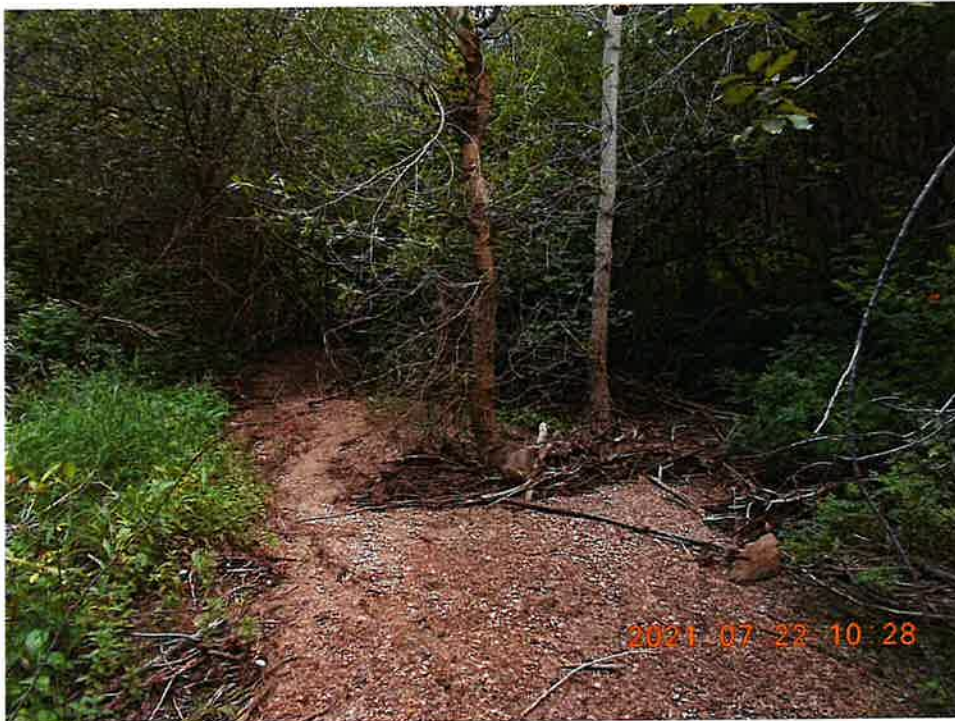
92  
93 Photo 2786. Looking downstream in the Hubbard Ditch immediately downstream of the  
94 diversion.

95  
96 Below the diversion, the Hubbard Ditch channel is steep, very wide (visual estimate 20 -  
97 25 feet) relative to its depth (approximately one foot), and the channel appears to be  
98 unstable. In my opinion the staff gauge seen in photo 2785 would be difficult to rate  
99 and the rating would not be stable. Even if stable and properly rated, precision would  
100 be low; a large change in flow would be reflected by a small change in stage and  
101 turbulence would make stage difficult to read. I measured the structure at this location  
102 but did not measure the Hubbard Ditch channel.

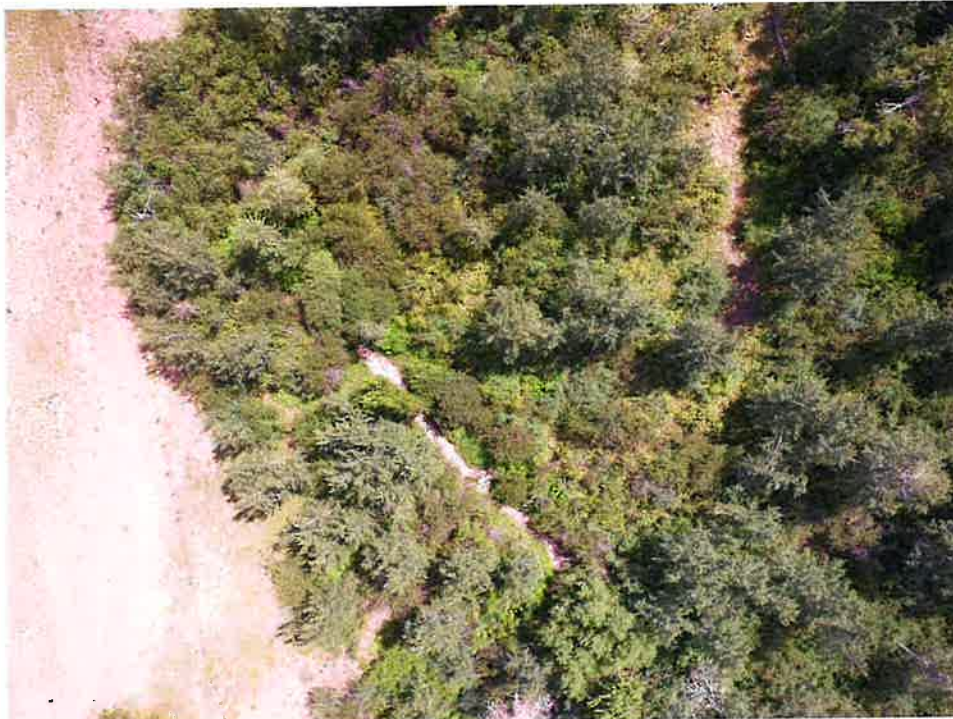
103  
104 Photo DJI 0052 shows a drone image of the Hubbard Ditch (without water) a little east  
105 of Point C. The top of the photo is oriented approximately to the east.

Photo DJI 0052. The white line through the trees is bed of the Hubbard Ditch, dry in this photo.

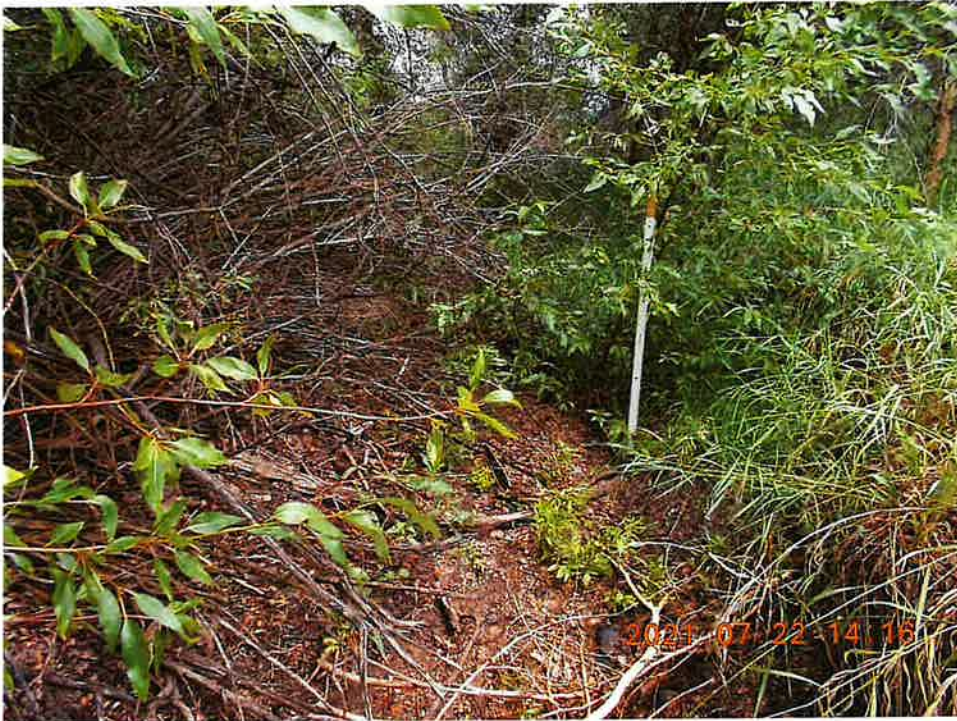
- 118  
119 Photo 2801. Hubbard Ditch upstream of the confluence. There is no water; the dark  
120 areas on the right are shadows.  
121  
122 Photos DSCN2794 through DSCN2797 show the channel between the confluence and  
123 Waypoint 2802. These are presented in upstream to downstream order, which is  
124 opposite the photo-numbering order.  
125

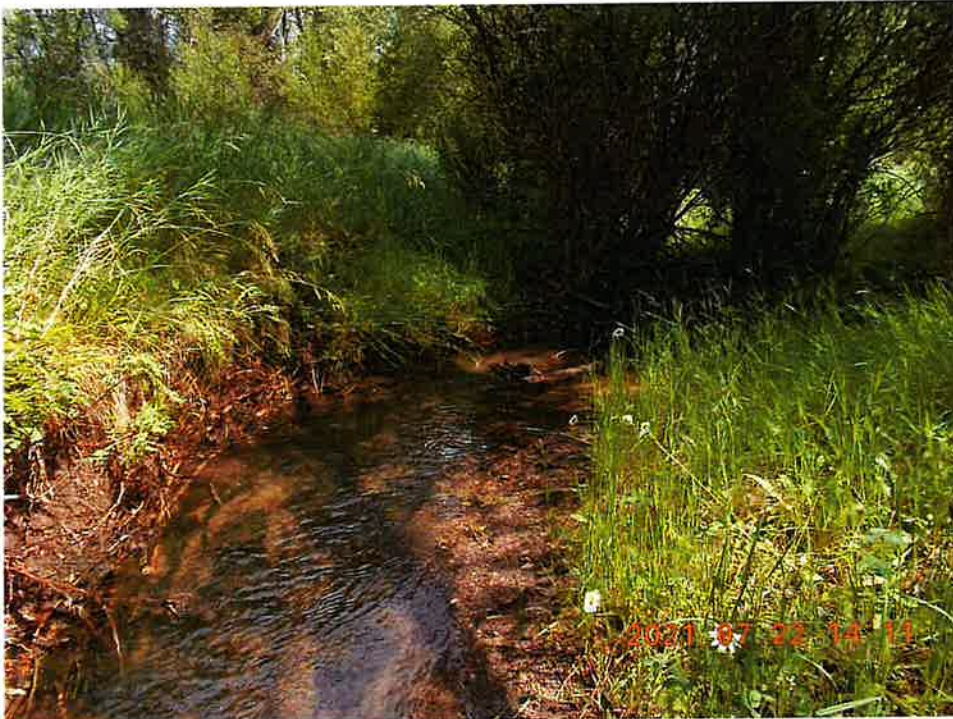
126  
127 Photo 2797. Looking upstream at the Hubbard Ditch between Point D and Waypoint  
128 2802.  
129

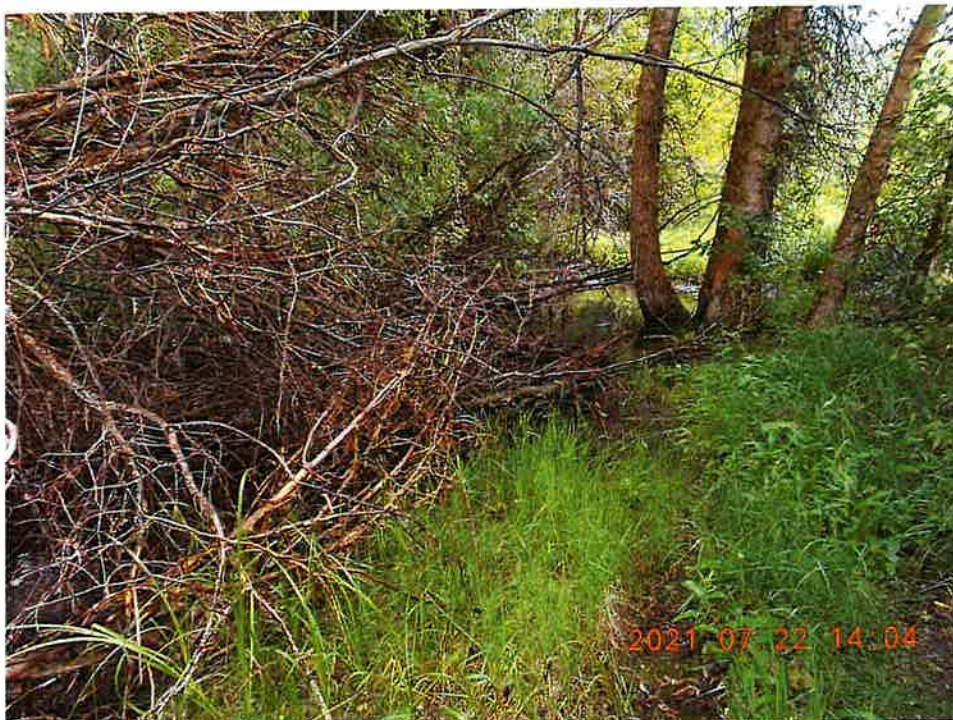
130  
131 Photo 2796. Looking upstream at the Hubbard Ditch between Point D and Waypoint  
132 2802.

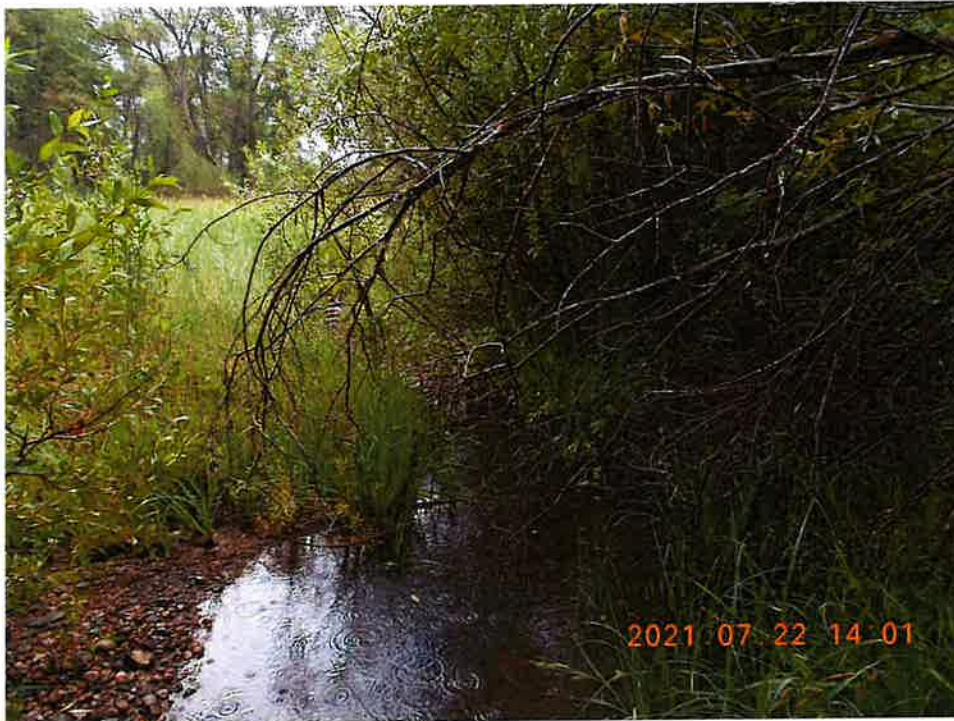
Photo 2795. Looking upstream at the Hubbard Ditch between Point D and Waypoint 2802.

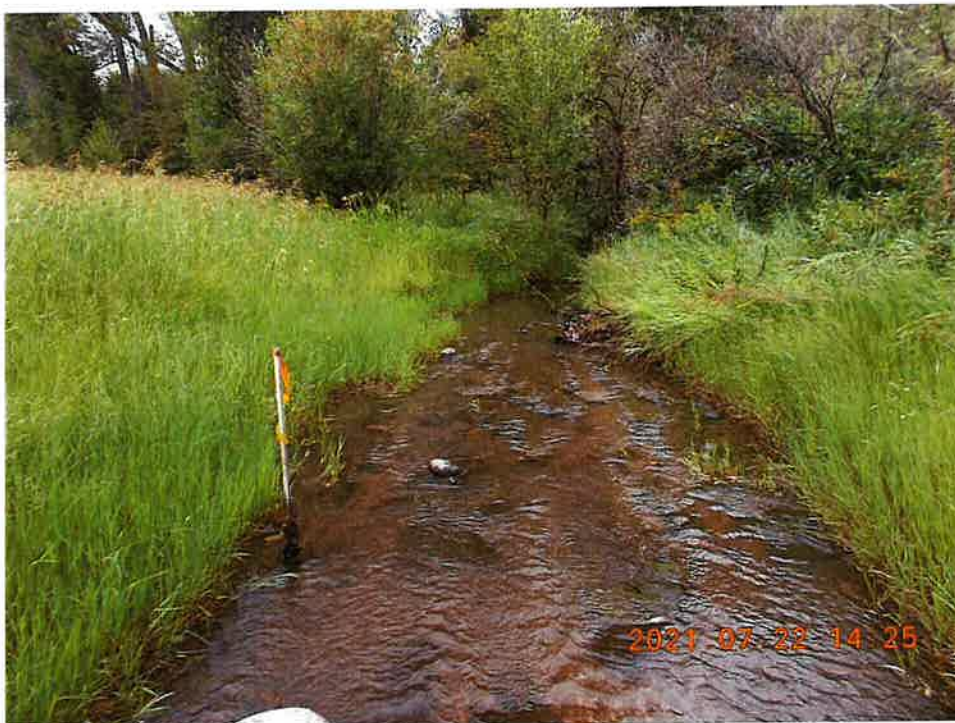
Photos DSCN2802 through DSCN2805 illustrate the character of the channel between the bridge at Waypoint 2802 in Figure 3 and the four-way splitter structure that is located near location "E" in Figure 4. The staff shown in some of the photos is approximately four and one-half feet long with a four-foot aluminum ruler attached. The general characterization of this reach of the ditch is free-flowing sections interrupted by fallen logs that have accumulated debris, with heavy brush crowding the banks in many locations.

Photo 2802. Hubbard Ditch channel immediately below the bridge labeled in Figure 3.

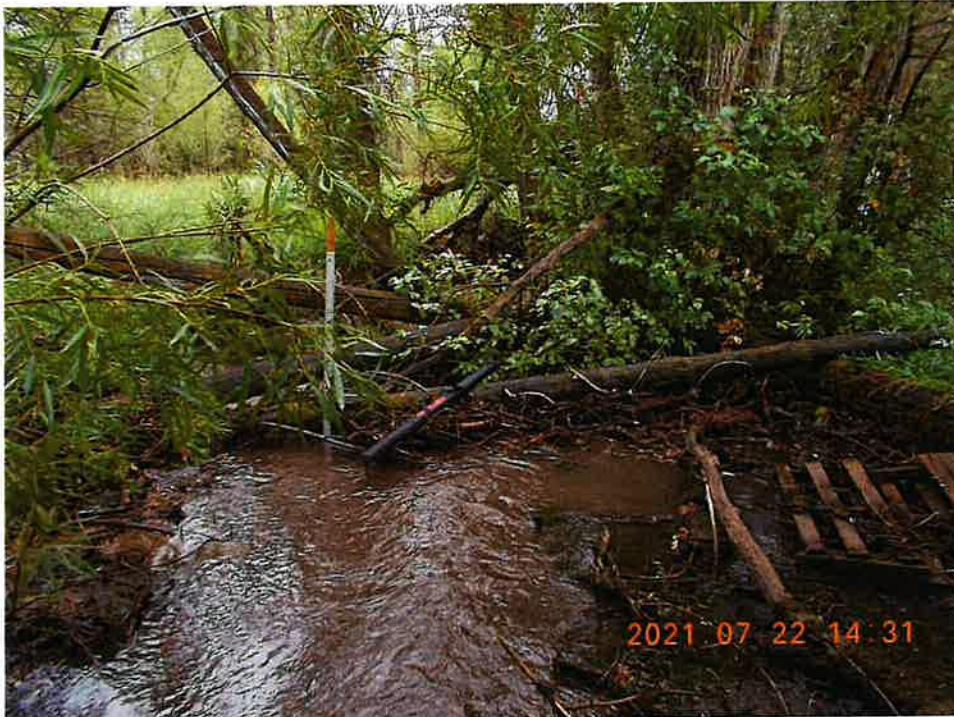
Photo 2803. Debris in channel of Hubbard Ditch.

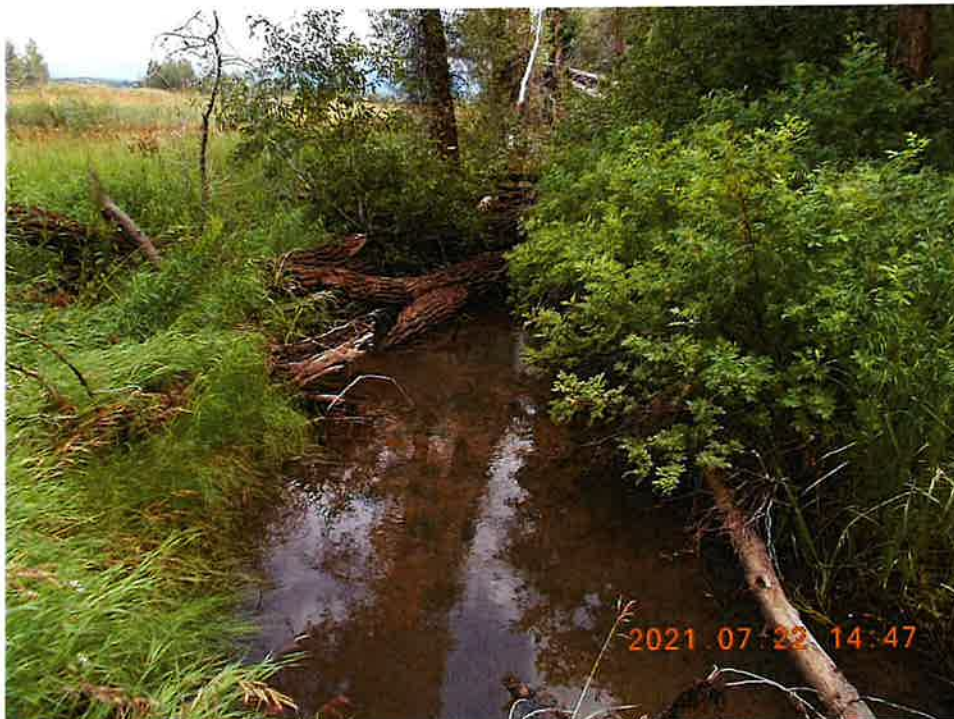
Photo 2804. Hubbard Ditch downstream of the bridge labeled in Figure 3.

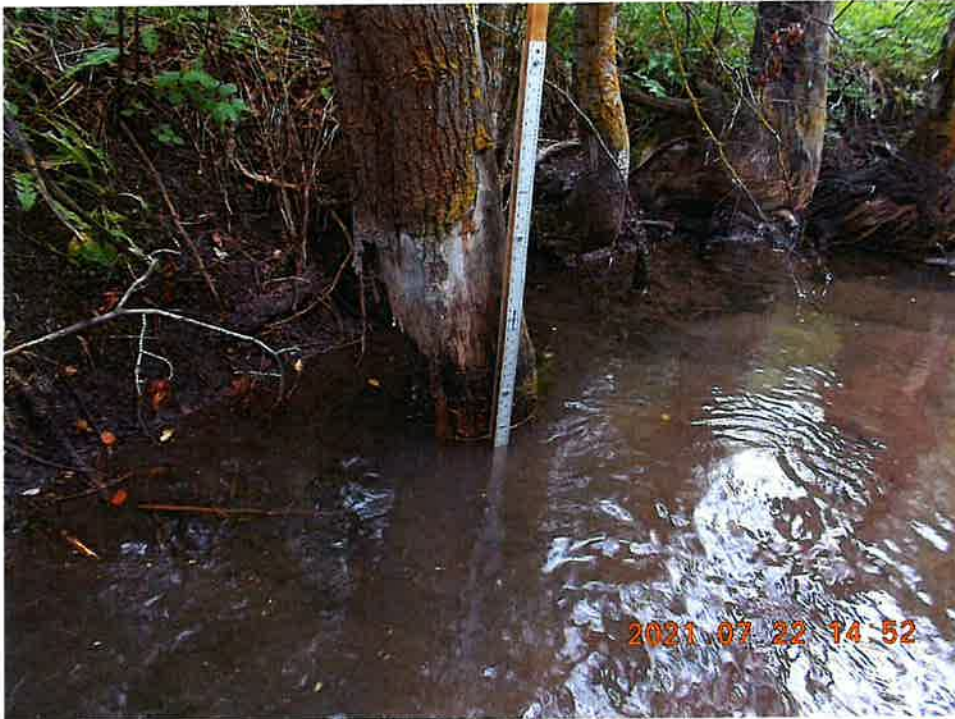
Photo 2805. Staff with water-marks on tree showing typical flows in the Hubbard Ditch.

Photo DSCN2805 shows that on July 22, flow depth was about half the recent depth as indicated by the marks on the bank and the tree trunk. Due to the effect on hydraulic radius and therefore flow velocity, doubling the depth will more than double the flow.

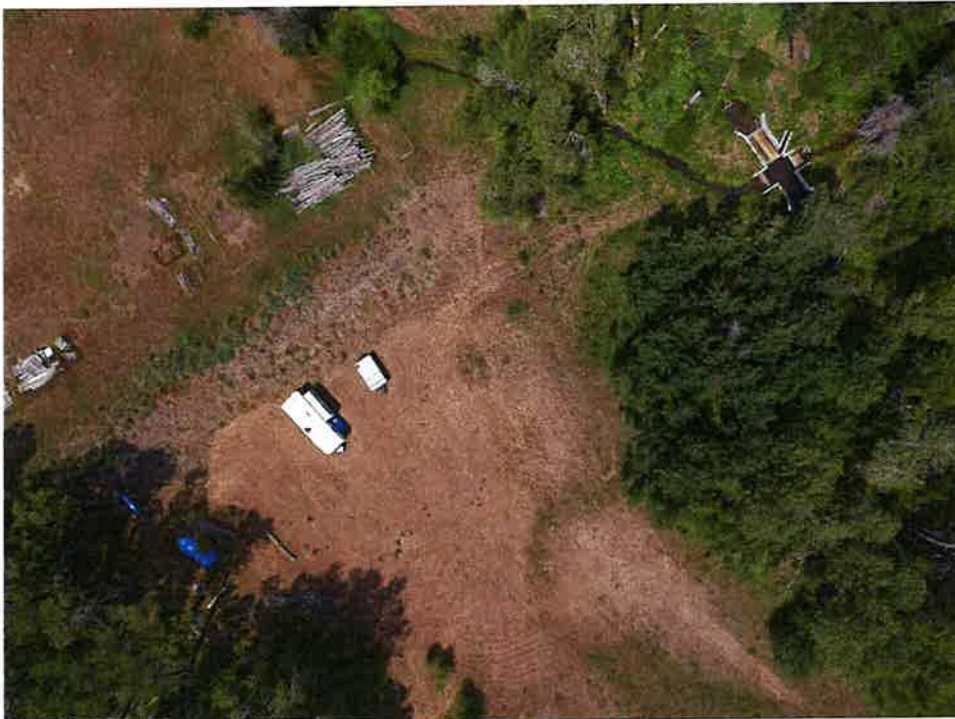
Near Location E on the maps, a recently-built splitter structure is located at Waypoint "Ditch Split" in Figure 4, with Figure 5 showing a not-to-scale schematic. Drone photo DJI 0063 shows the structure in the upper right corner, with the top of the photo oriented to the Flows to the west continue down the Hubbard Ditch, with the other three outlets serving laterals. The following photos illustrate the structure and the channels leaving it.

Photo DJI 0063. Drone photo of splitter structure.

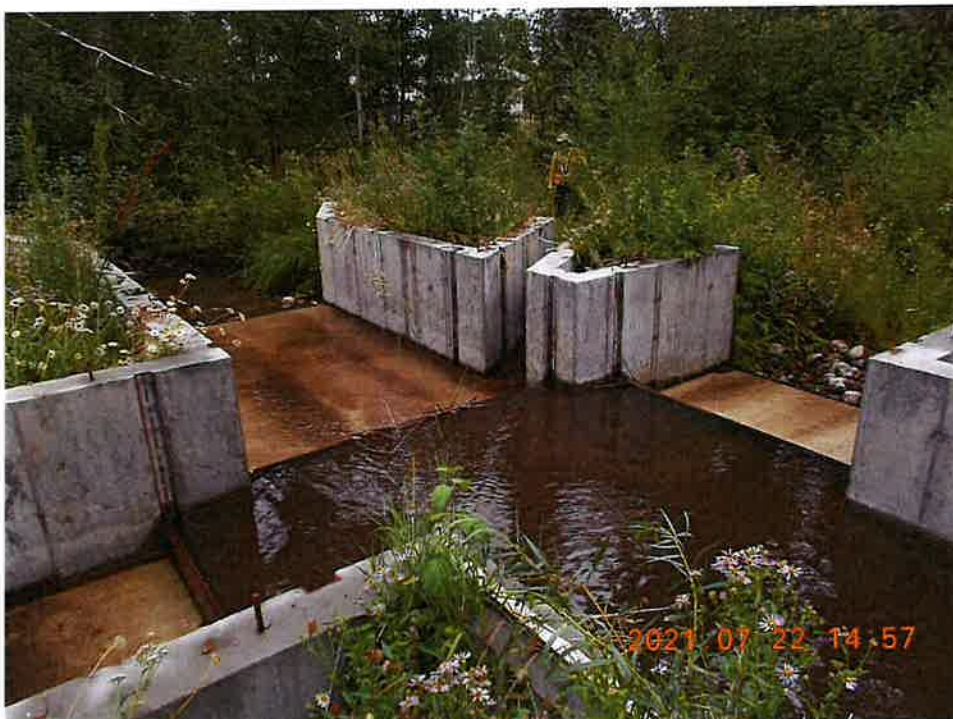
Photo 2807. Four-way splitter structure looking northwest.

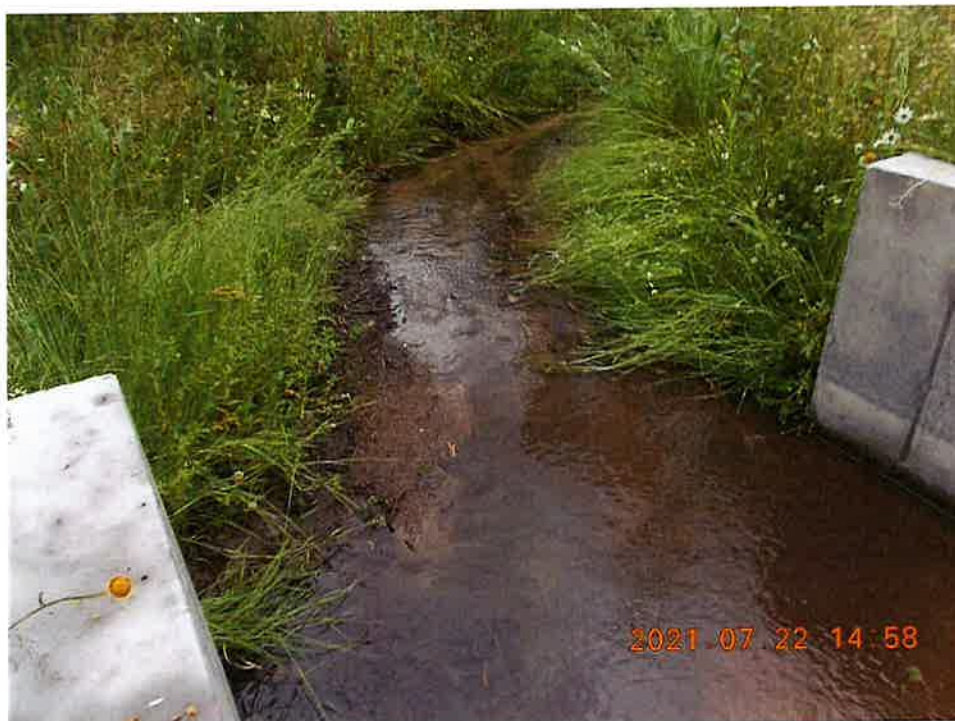
182  
183 Photo 2812. Looking downstream from the south outlet of the splitter structure. This  
184 outlet supplies a lateral that turns and heads due west.  
185

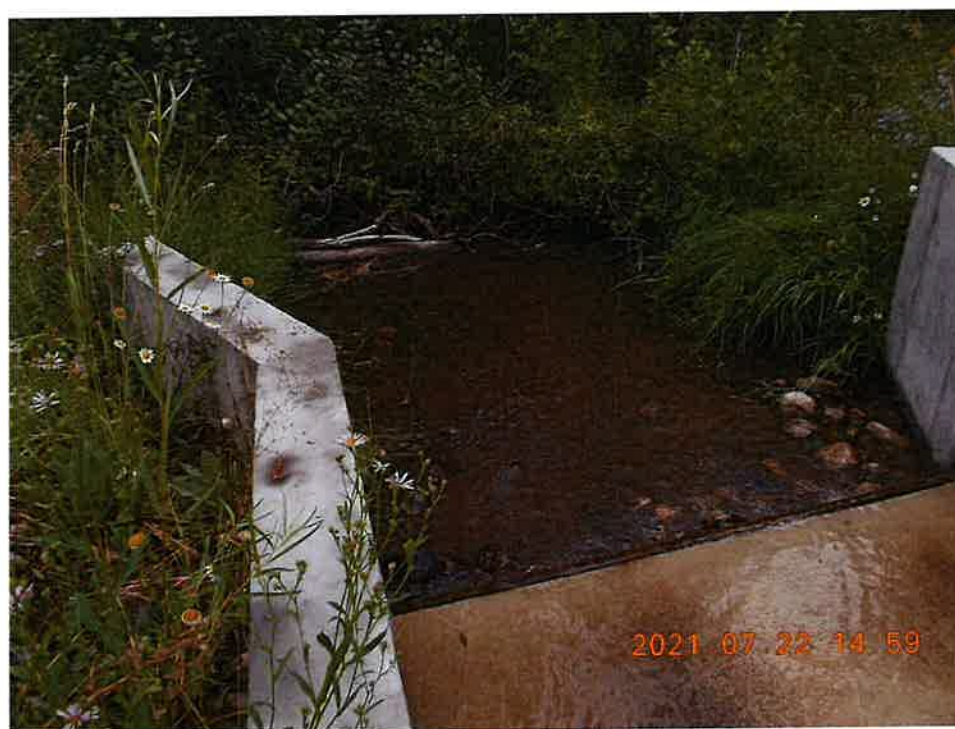
186  
187 Photo 2815. Looking downstream on the west (Hubbard Ditch) outlet of the splitter  
188 structure.

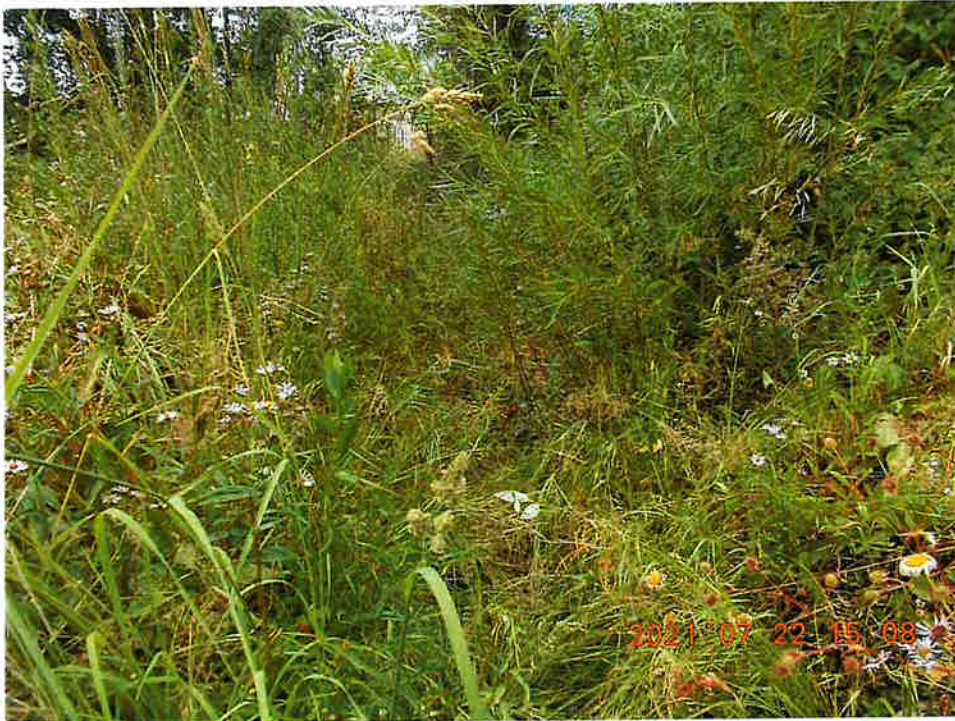
Photo 2822. Looking downstream at the ditch proceeding from the northwest outlet of the splitter structure.

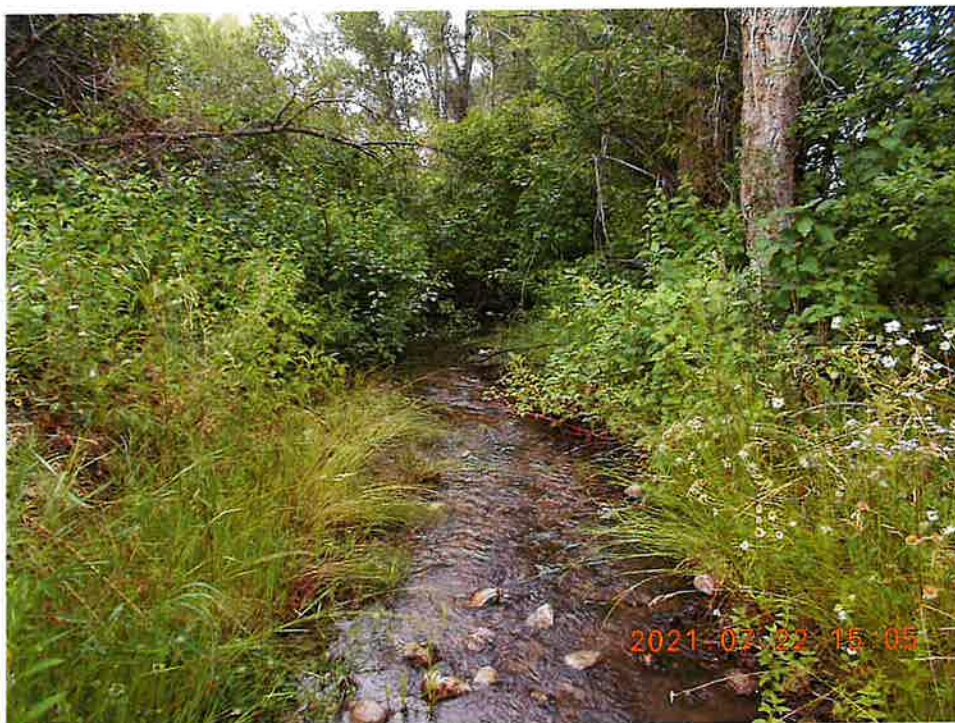
195 Photo 2819. Looking downstream at the channel that proceeds north from the splitter  
196 structure.

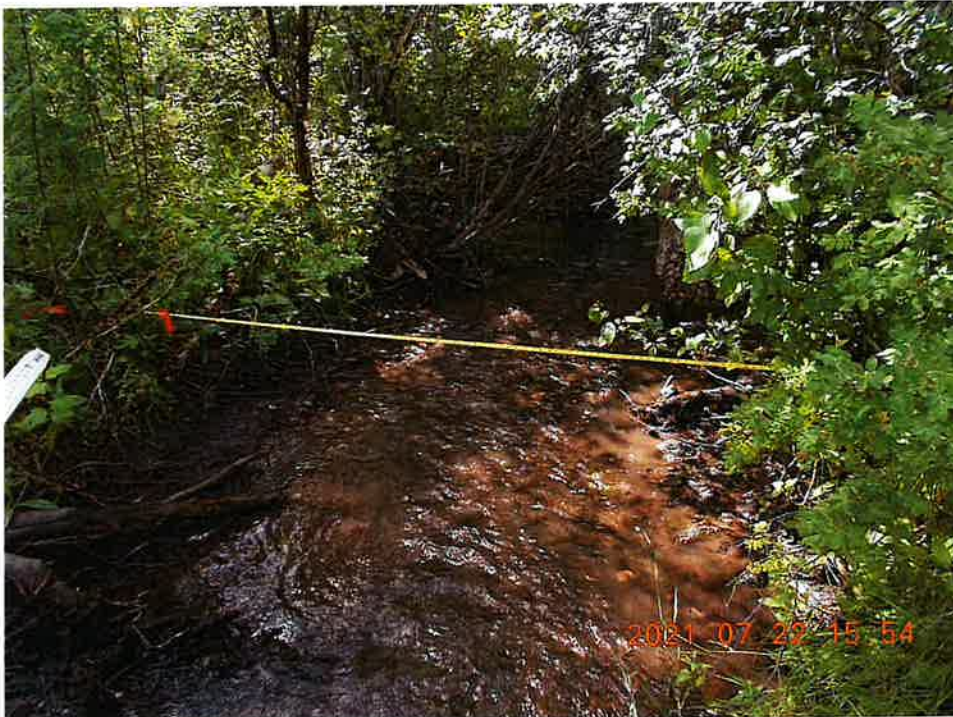
214  
215 The following photos in downstream order (not numerical order) show the typical  
216 configuration of the Hubbard Ditch west of the structure and south of the east-west  
217 road. For approximately 100 to 150 feet the channel is partially blocked with fallen  
218 trees and accumulated debris, similar to the reach upstream of the structure. Beyond  
219 to the crossing of the east-west road, the channel is cleaner and straighter, though  
220 trees and brush are immediately adjacent to the channel in places.

222  
223 Photo 2837. Hubbard Ditch about 40 feet downstream of splitter.  
224

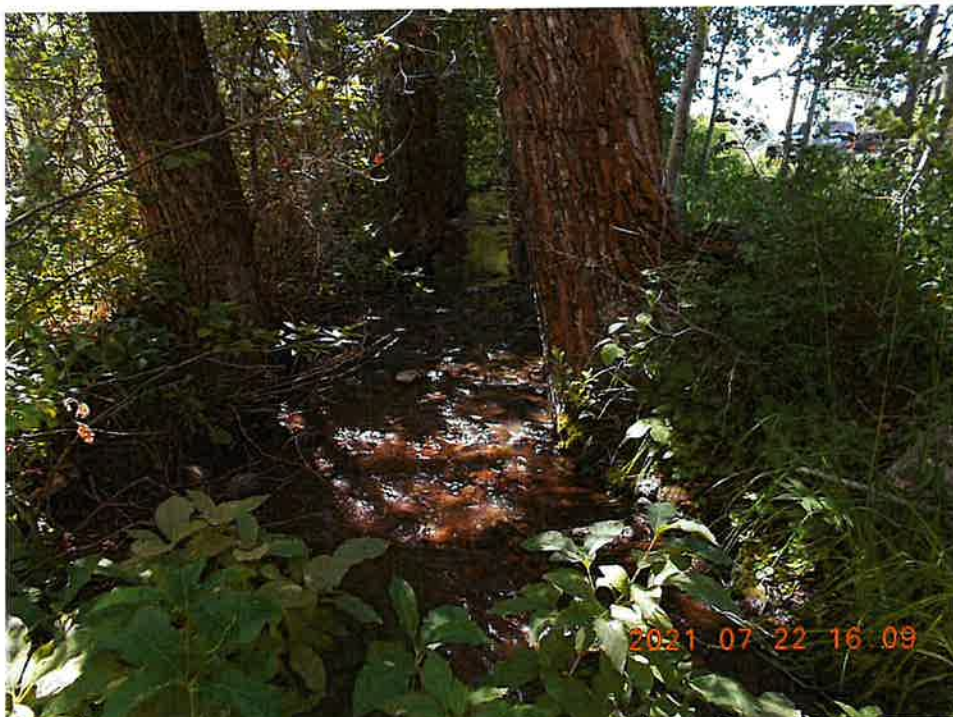
225  
226 Photo 2828. Hubbard Ditch downstream of splitter.  
227

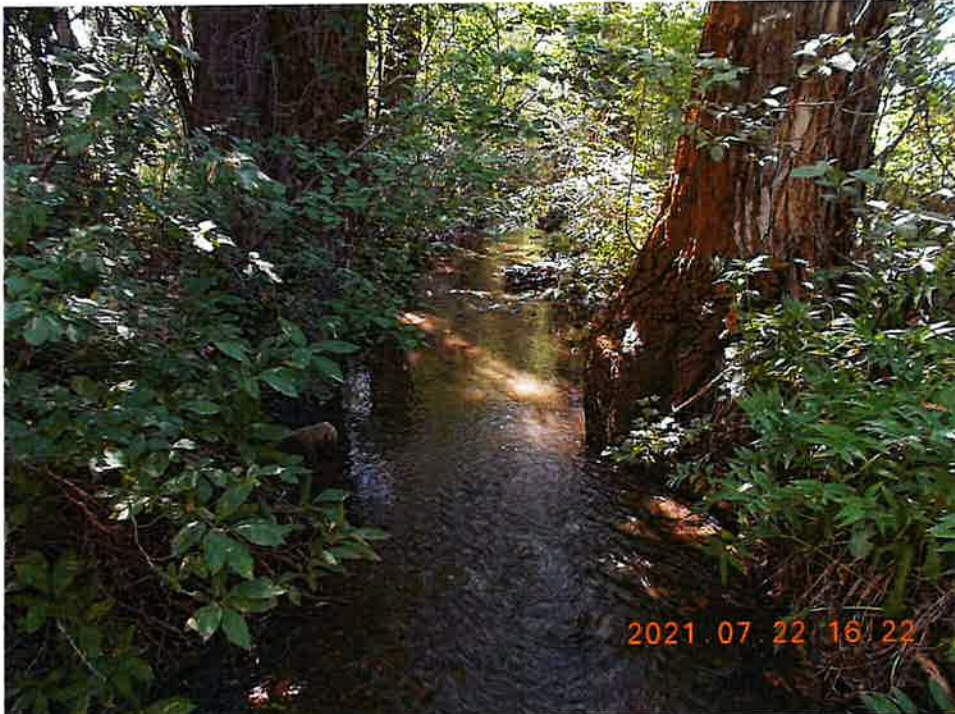
Photo 2831. Hubbard Ditch west of splitter.
