## Supporting Data and Analysis of Transfer No. 84788

**Water Right Nos. 22-131C, 22-238B, and 22-  
2029E, Teton, Teton County, Idaho**

**RMEA Project Number: 20-0055**

**August 27, 2021**

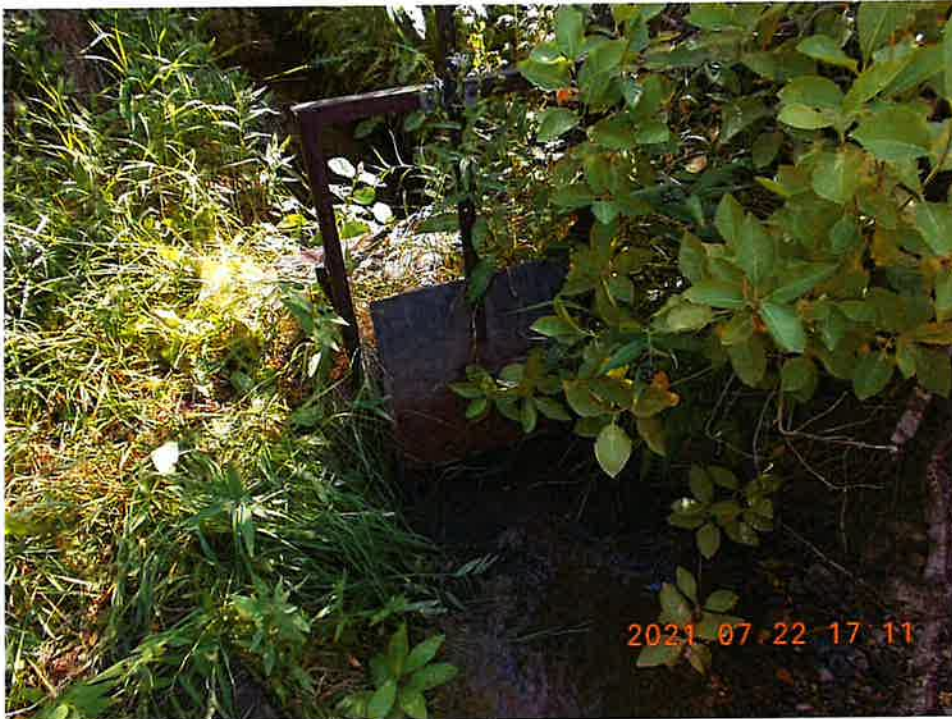
Photo 2832. Slide gate for a lateral ditch proceeding west at Waypoint West Lateral.

I measured flow down the west lateral at 0.6 cfs +/- 0.1 cfs, and the flow down the Hubbard Ditch at 0.4 cfs +/- 0.08 cfs. Water marks indicate typical flows are substantially more than this. I did not see any provision for flow measurement at this location.

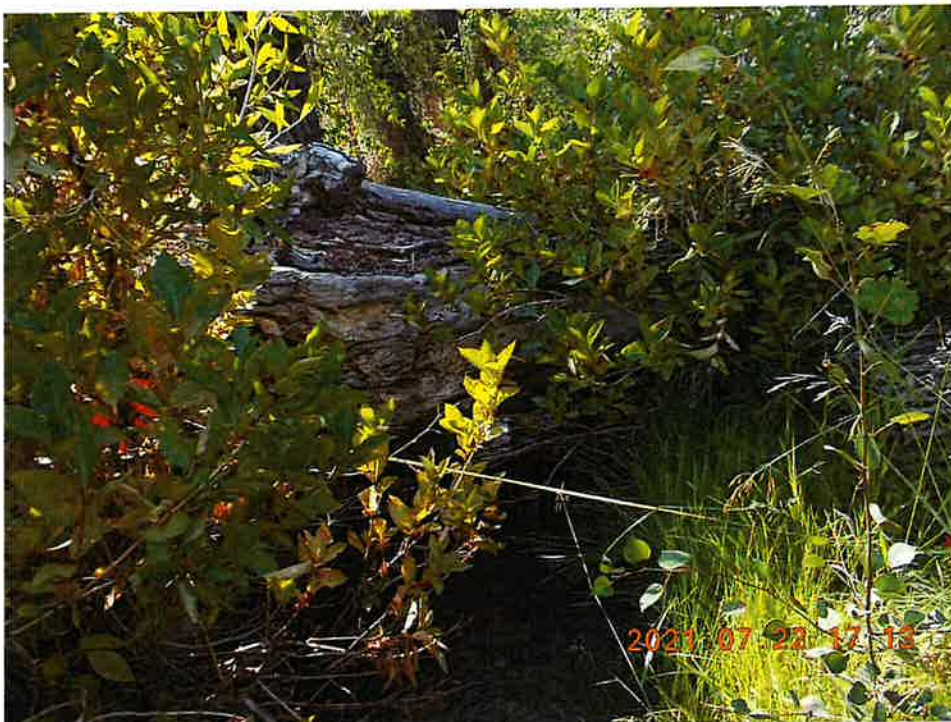
Photo 2833. Looking northwest down the Hubbard Ditch from Waypoint West Lateral.

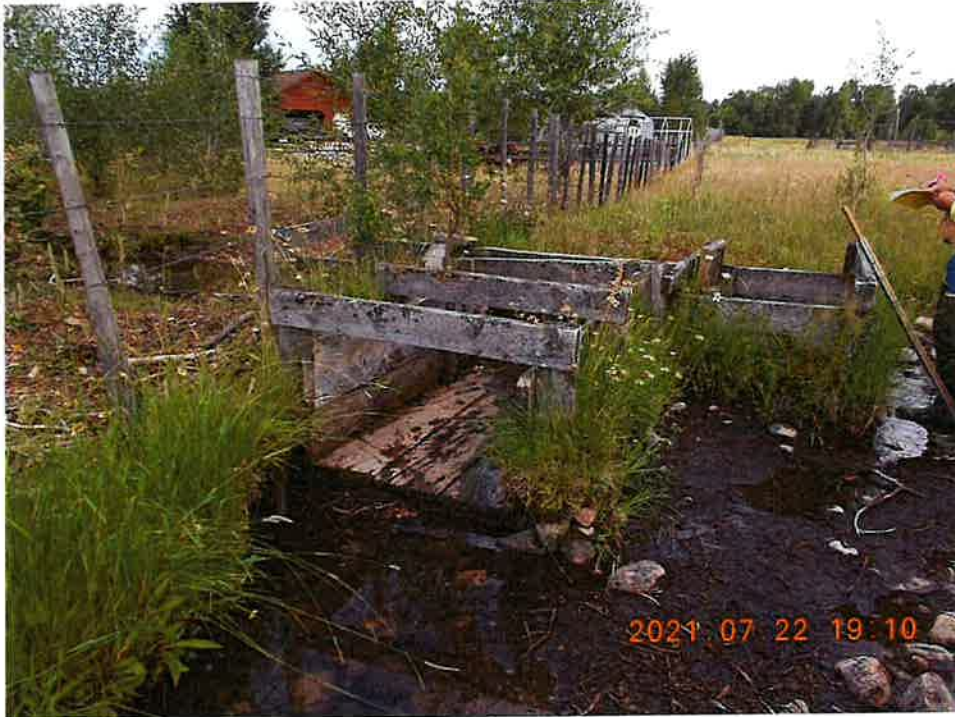
A wooden structure is located near mapped point "G," shown in Photo 2848. There was a small amount of flow at this point, mostly bypassing or running beneath the structure.

Photo 2848. Wooden structure near Point G on the maps. Hubbard ditch comes in from the left side of the photo and continues to the right. Coming toward the camera is a channel that heads towards Grouse Creek. I saw no provision for flow measurement at this location.

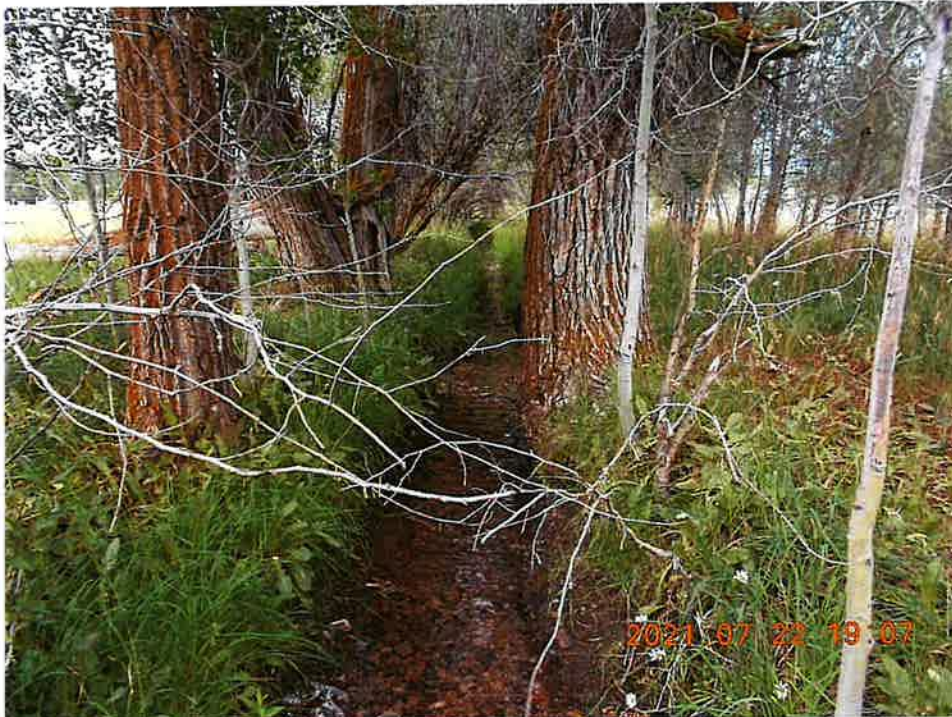
From Point G I walked the Hubbard Ditch to its final bifurcation near Point H. Photos 2845 and 2844 show this channel in downstream order. The small amount of flow seen in Photo 2845 sinks before reaching Point H; I did not see any withdrawal or use from the ditch. The ditch is clean and in reasonably good condition in this reach.

Photo 2845. Hubbard Ditch west of Point G.

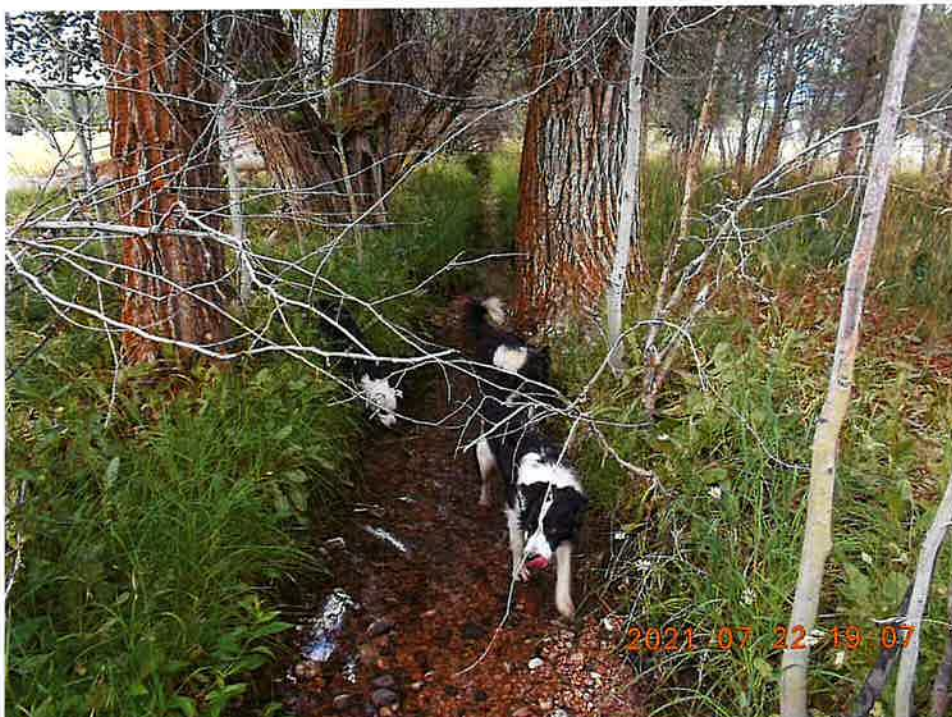
Photo 2844. Hubbard Ditch west of Point G.

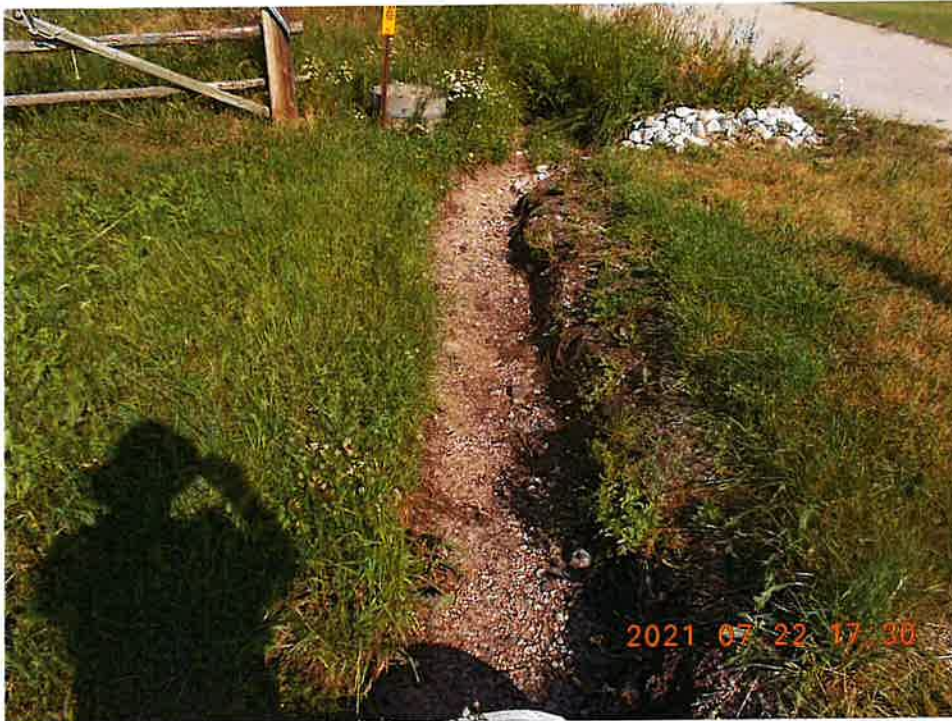
269 At location H where the ditch crosses the north-south road, the ditch is dry as shown in  
270 photo 2834 (looking upstream from the east edge of the road) and photo 2836 (looking  
271 northeast toward the west edge of the road).  
272

273  
274 Photo 2834. Looking upstream (east) along the Hubbard Ditch at Point H from the road  
275 shoulder.  
276

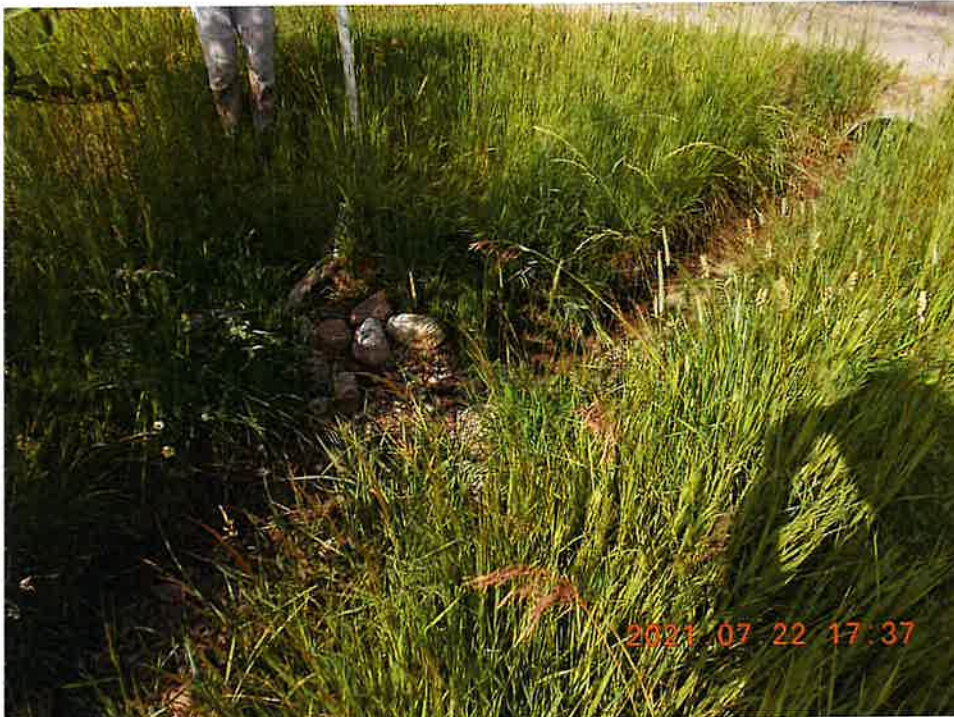
277  
278 Photo 2836. Looking northeast at the final bifurcation of the Hubbard Ditch on the west  
279 side of the road at Point H.  
280  
281 In photo 2836, flow would come toward the camera from the culvert at upper right. At  
282 the pile of cobble rocks near the center of the photo, flow would go north (toward the  
283 upper left) along the branch that serves the Thomas Ranch, or would continue west  
284 (toward the lower left of the photo).

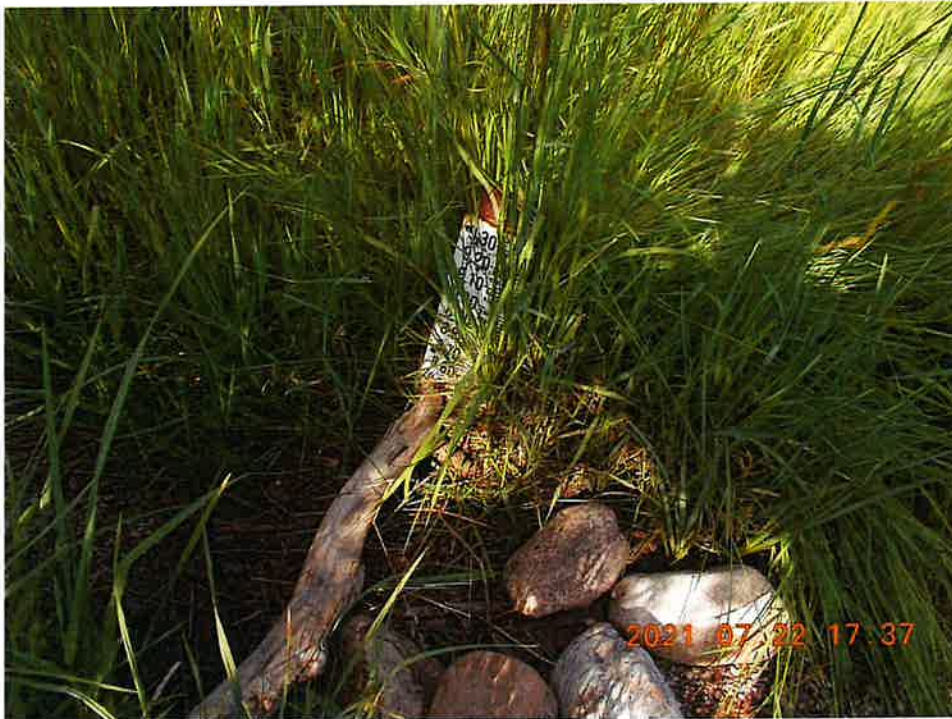
Photo 2835. Staff gauge at the final bifurcation.

The location on the right side of the ditch where cobble rocks are visible in DSCN2836 is the final bifurcation of the Hubbard Ditch, with a staff gauge present as shown in DSCN2835. There is no wooden, metal or concrete structure here; it appears flow is controlled by placing rocks and perhaps at times canvas dams. It is unclear how the staff gauge would be used to measure flow. Photo DSCN2837 is looking down and west at the same bifurcation. The branch that currently would carry the applicant's water goes to the right of this photo and the other branch goes straight away from the viewer.

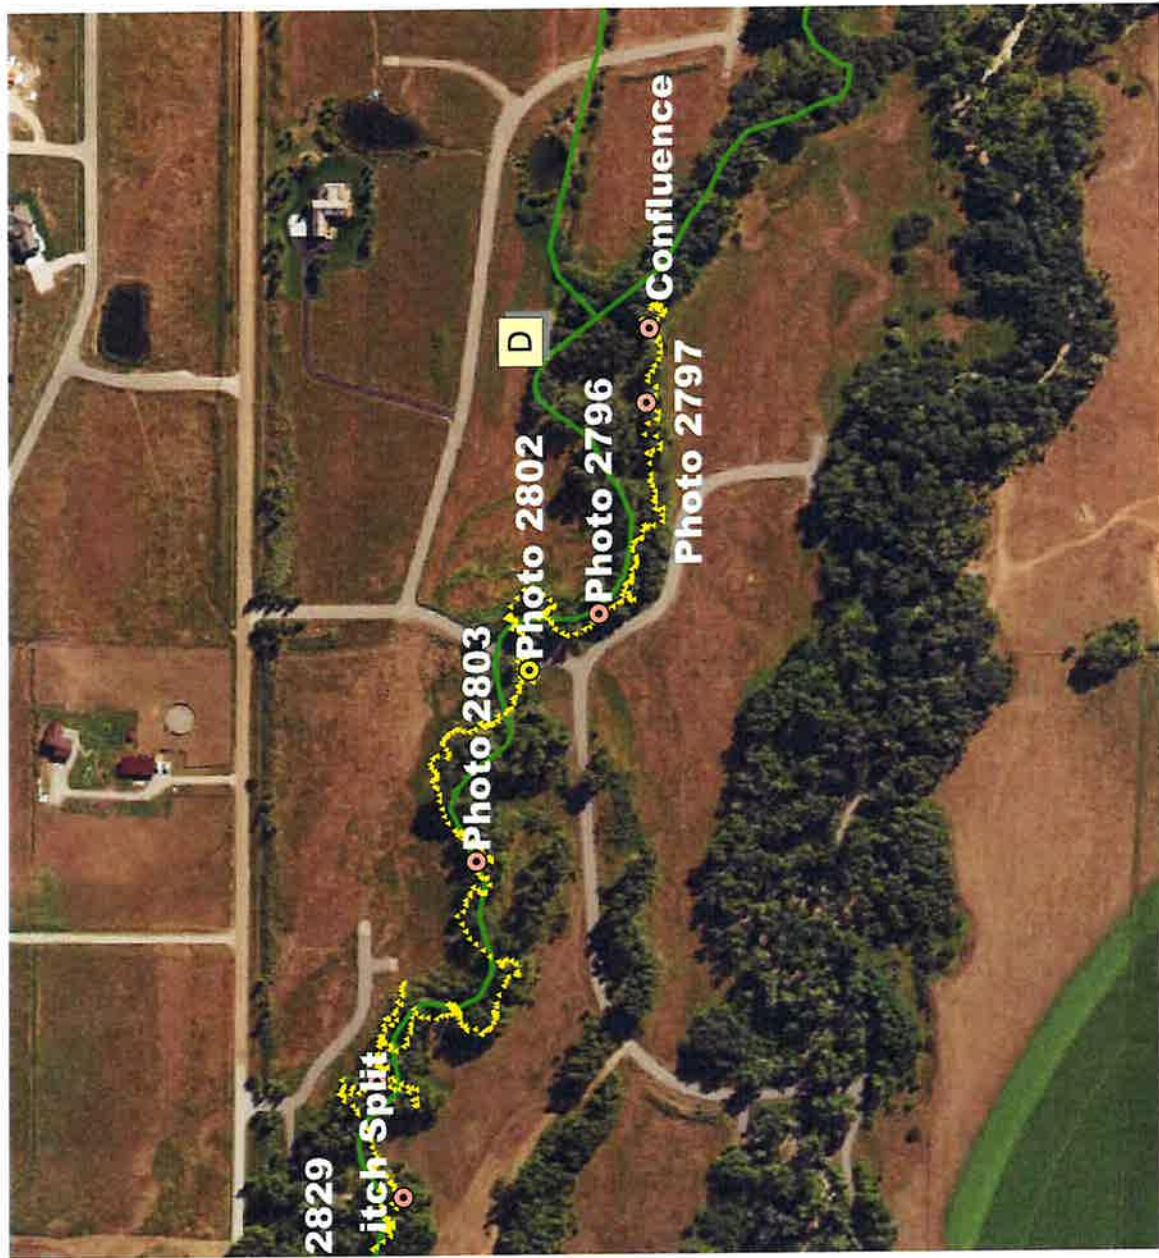
Figure 3: Ditch Confluence

Figure 3 shows the detail near point "D," where the North Leigh Canal joins the Hubbard Ditch. North Leigh Canal the northern-most and Hubbard Ditch is the southern-most of the two ditches coming into the figure from the east. Photo DSCN2801 is looking upstream (east) at the Hubbard Ditch channel just above the confluence. The silver part of the staff in the photo is a 4-foot aluminum ruler.

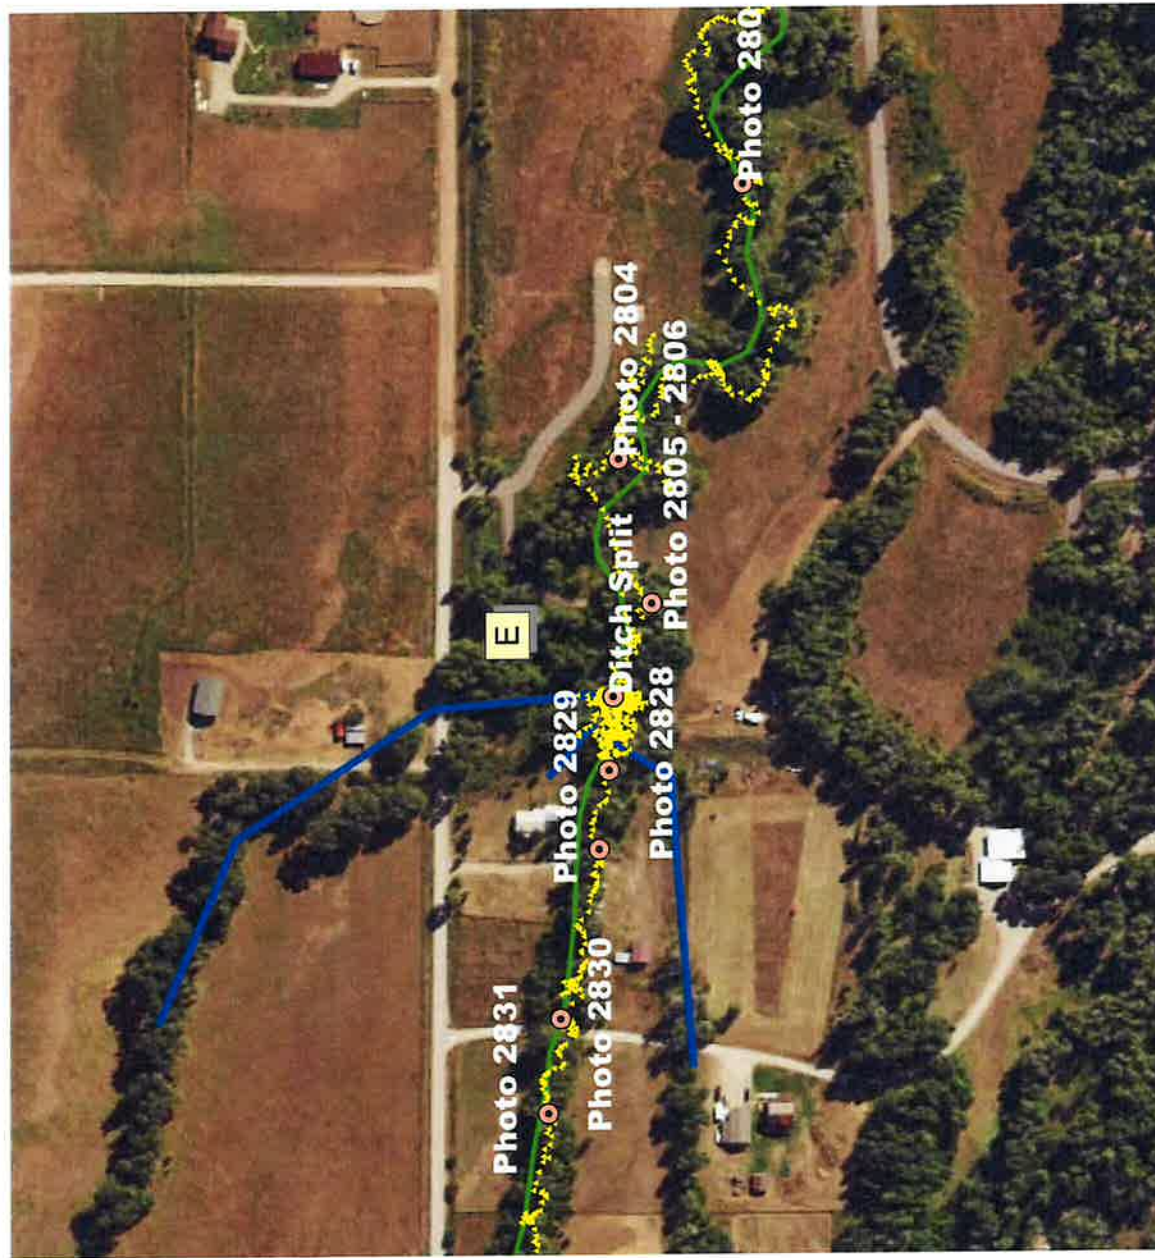
Figure 4: New Structure

Near Location E on the maps, a recently-built splitter structure is located at Waypoint "Ditch Split" in Figure 4, with Figure 5 showing a not-to-scale schematic. Drone photo DJI 0063 shows the structure in the upper right corner, with the top of the photo oriented to the Flows to the west continue down the Hubbard Ditch, with the other three outlets serving laterals. The following photos illustrate the structure and the channels leaving it.
