STATE OF IDAHO  
DEPARTMENT OF WATER RESOURCES  
IN-OFFICE REVIEW/BENEFICIAL USE FIELD REPORT

**A. GENERAL INFORMATION**Permit No: 75-14815Exam Date: 7/2/2021

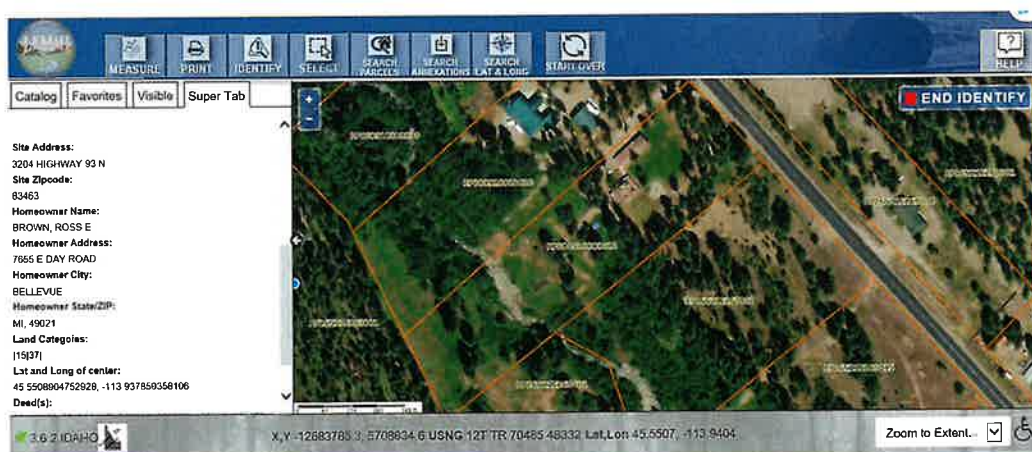
## Lemhi County Tax Maps

The owner stated in the application for permit that the parcel and aerial imagery locations don't match properly. There is an approximate 30 foot variation from what the county shows as the parcel location and what the aerial imagery shows as the parcel location. Please see the county maps shown above for the county's designation of the location of this parcel. Our GIS analysts state that there is an approximate 50 feet of possible error in the imagery, so the parcel data is more reliable than the aerial imagery. There is a fence around the neighbor's property, so I do believe it could be the aerial imagery that is incorrect. Due to the very small irrigated area, I had to use the aerial imagery to determine the actual acres irrigated. All of the actual irrigated ground is in the SE $\frac{1}{4}$ SE $\frac{1}{4}$  of Section 26 in Township 26 North, Range 21 East. The 30 foot variation will not change to the legal description of the place of use or the point of diversion, so this really shouldn't be an issue. Both the point of diversion and the place of use are located entirely in Lot 1 of Lost Trail Lodge Subdivision. If the neighbor does try to claim a portion of this right, that can be settled by a court.

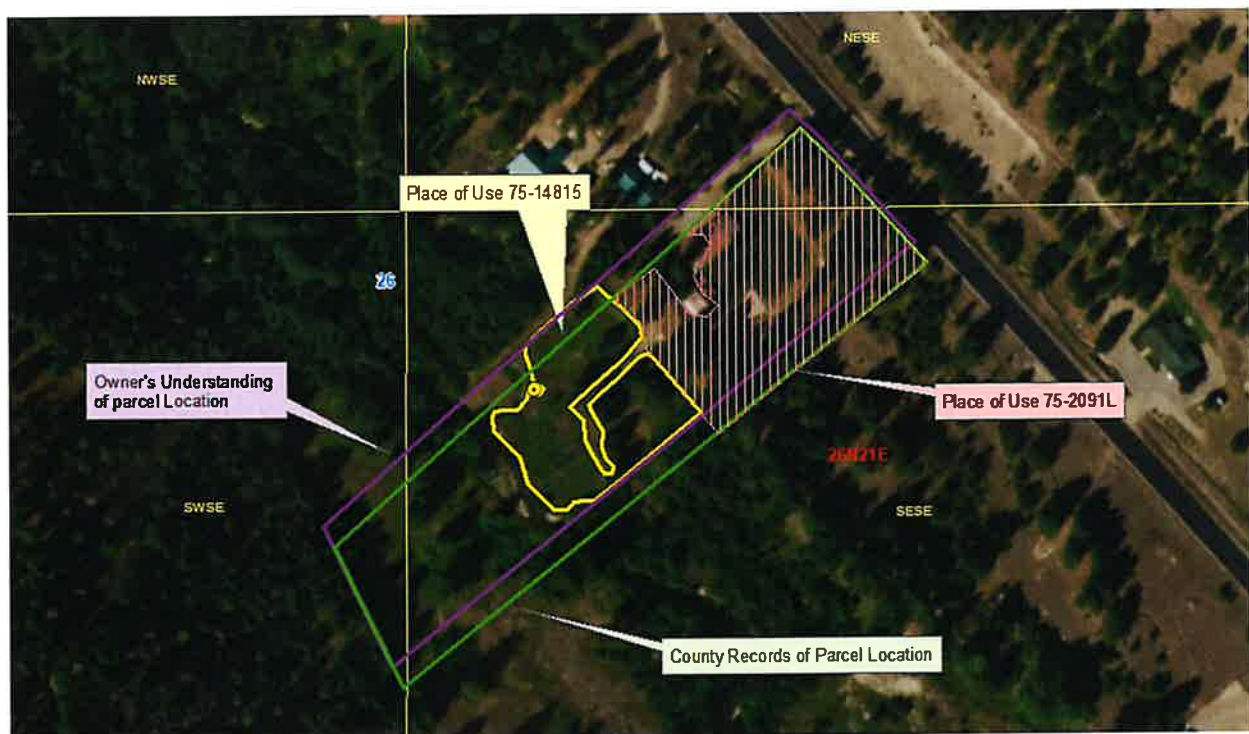
**Imagery vs. County Parcel Location vs. Owner's Understanding of Parcel Location:**

The yellow border and yellow dot are the locations of the irrigated acres and the point of diversion as shown in the aerial imagery. The green border is the tax parcel border that has been supplied to the Department by Lemhi County, and the purple border is the border adjusted to the neighbor's fence line. Due to the fact that the fence goes around the neighbor's property, it is safe to assume that they are in agreement with the shared property. This really appears to be an issue with the registration of the imagery to the county records.
