STATE OF IDAHO  
DEPARTMENT OF WATER RESOURCES  
BENEFICIAL USE FIELD REPORT

**Permit No:** 34-14339  
**Exam Date:** 04/29/2021

3. **SOURCE:** Tributary  
ROCK CREEK Sinks

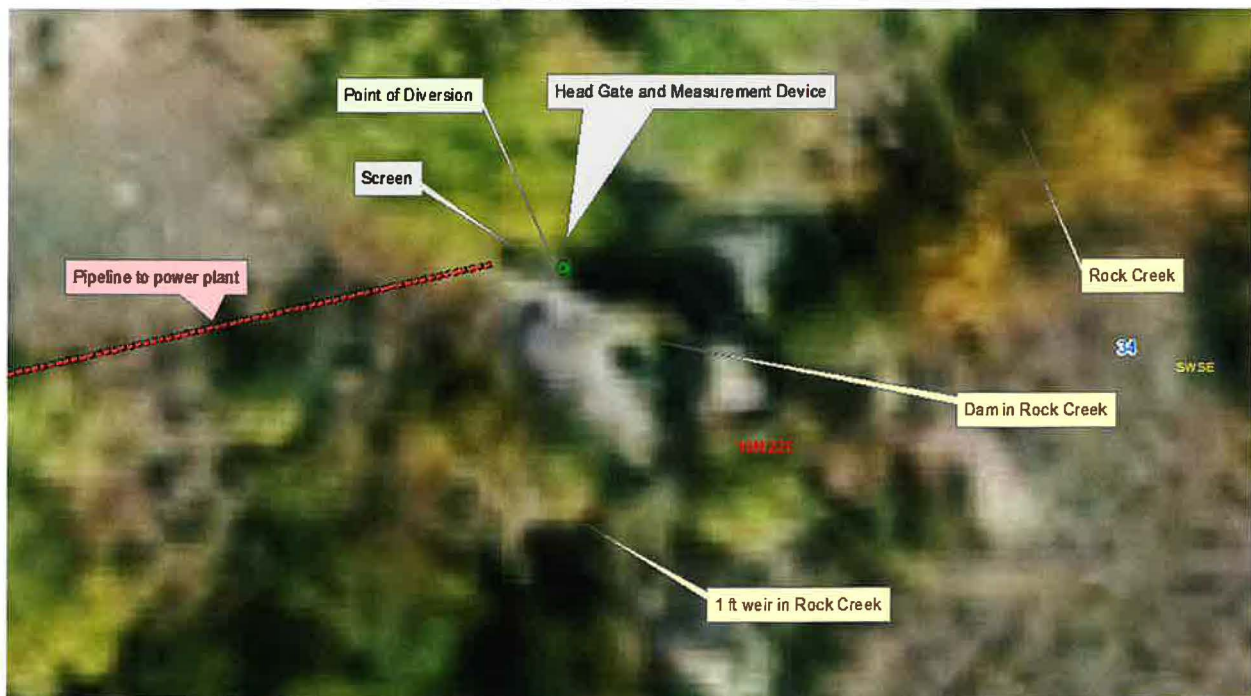
The image below is a close up of the point of diversion. The water is diverted out a small pool backed up by a dam in Rock Creek. The water flows through a 2X4 headgate and then directly across a 4 ft. Cipolletti Weir onto a screen. The water flows through the screen into a 24 inch pipeline, which necks down to 20 inch pipeline that delivers water to the power plant. The 1 ft. rectangular weir in the creek is approximately 30 to 40 feet below the dam. Rock Creek ran approximately 100 ft. below the dam before it sank into the streambed. There doesn't appear to be any vegetation usually found around a creek more than 1,000 feet below the dam.

At the point of diversion there is an earthen dam that some leakage that continues down Rock Creek. The headgate for the pipeline is on the north side of the dam and has a 2X4 headgate located a few inches ahead of the dam. If the headgate was regulated, the weir would no longer be usable. As it is, the measurements from the weir are suspect with the headgate located so close to the weir. This shouldn't be an issue as far as the water flowing to the powerhouse is concerned, since all outflows from the powerhouse go directly to headgates that are used to distribute the water to two separate farms.

The water flowing through the point of diversion headgate flows out onto a screen to remove the debris in the creek water. The water flows through the screen into a vault that distributes the water into a 24 inch pipeline. The permit holder stated that the 24 inch pipeline necks down to a 20 inch pipeline shortly after it leaves the point of diversion.

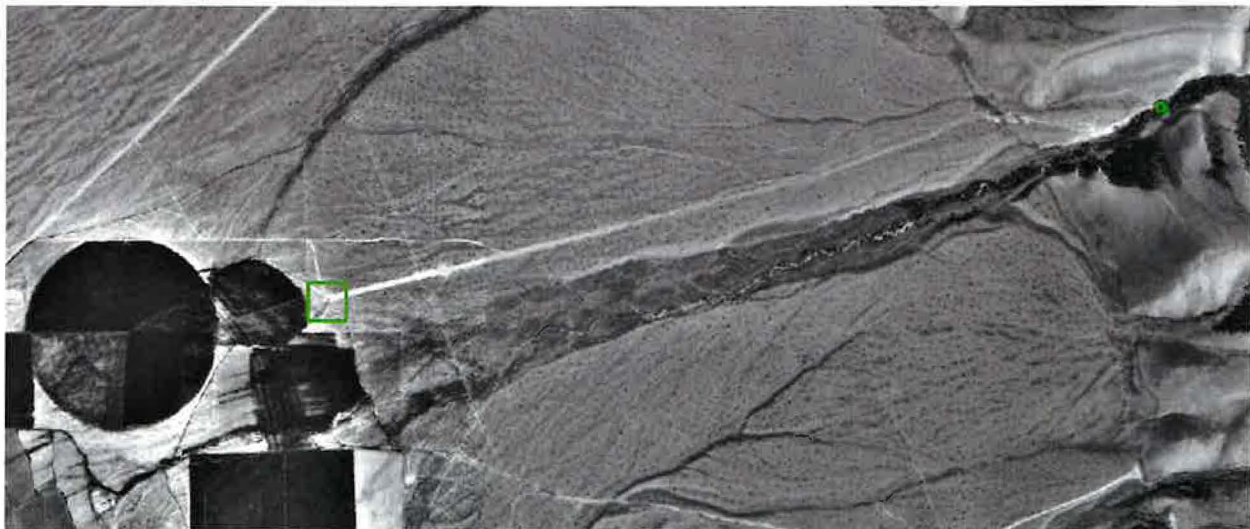
The 1992 aerial image below shows the same location. You can clearly see that Rock Creek gets smaller and begins to braid long before it reaches the farms. There almost isn't any channel by the time it reaches the farms downstream. The green dot is the point of diversion and the green box is the current location of the powerhouse.

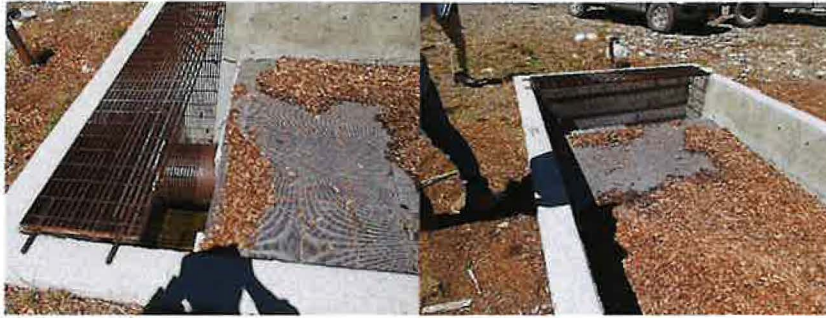
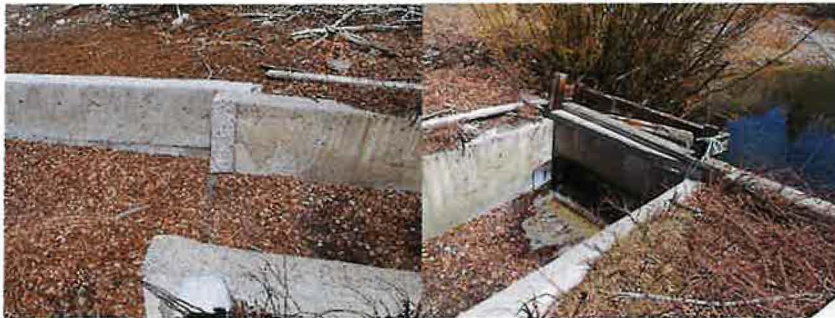
The photos above and below show the point of diversion. The water comes through a headgate and then directly through a 4 foot Cipolletti weir. There was 0.24 feet of head going over the weir providing a measurement of approximately 1.57 cfs or 705 gpm. It should be noted that weir was not properly installed with the headgate directly in front of it, so there was some concern about that flow reading. I did measure the pipeline at the power house, and found a diversion rate of 644 gpm or 1.43 cfs. I feel the measurement at the power house was more accurate than the improperly installed weir.

At the point of diversion, I measured 0.24 feet of head of water going over the 4 ft. Cipolletti Weir. Using the University of Idaho Measurement Book this equaled 1.57 cfs or 703 gpm. The Bureau of Reclamation Water Measurement Manual confirmed the flow rate at 1.58 cfs. The weir was set up directly behind a 2X4 board headgate, so I was concerned about the accuracy of these measurements.

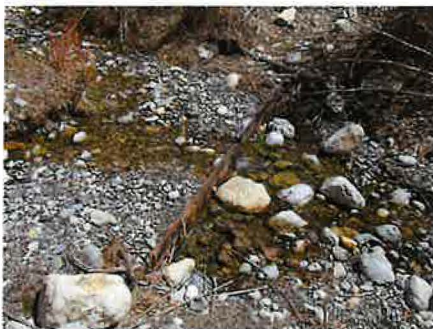
The photo below shows the bypass flow. There was a 1 foot rectangular weir there to measure the water. This weir had a bit better installation. I measured 0.08 feet of water going over the weir. Using the formula  $Q=3.33(L-0.2h)h^{1.5}$ , the diversion rate would be approximately 0.07 cfs. The conditions of the permit require that a minimum of 0.20 cfs is required to bypass the power house. I informed the permit holder that he needed to address this issue.

I then measured the 1 ft. rectangular weir for the overflow water requirement according to the conditions. I found 0.08 ft. of head of water flowing over the weir. The University of Idaho Measurement manual only provided a flow rate to a minimum of 0.10 ft. of head. At 0.10 ft. of head the flow rate would be limited to 0.106 cfs. The bureau of Reclamation Water Measurement Manual does not provide a water flows over a 1 ft. weir with less than 0.20 feet of head. Using the formula supplied in the Bureau of Reclamation Manual for Contracted Rectangular Weirs ( $Q=3.33(L-0.2h)h^{1.5}$ ), I determined that the flow rate would be approximately 0.07 cfs through a 1 ft. rectangular weir with 0.08 ft. of head. It doesn't appear as though the 0.20 cfs required bypass was flowing over the weir at the time of my measurement.

The owner has claimed that the diversion has not been changed, and that the same amount of water is bypassing the diversion as there was when the watermaster measured Rock Creek in 2013. When the measurement was made by the watermaster to establish the 0.20 cfs, a different weir (6 inch rectangular weir) was used. I also noted in the photos that plastic was used to ensure all water in Rock Creek was diverted through the weir. It is difficult to tell from the photos how much water was flowing in the Rock Creek during that measurement, but it appears to be more water than was flowing at the time on my measurement. At the time of my measurement, there was no plastic funneling the water to the weir, and a different weir was being used. It also appears as though the watermaster's weir was located slightly closer to the dam. I do have to concede that some of the water in the creek could have been flowing through the rocks and around the weir, but I can't confirm that assumption. In review of the historic power records, this creek varies flows throughout the day, so this flow rate could change depending on the time of day the measurement was done. All I can confirm is that approximately 0.07 cfs was flowing over the weir at the time of my measurement.

The conditions have not been met, because less than 0.20 cfs is flowing in Rock Creek below the diversion dam. However, as mentioned above, it doesn't appear from the photos in the permit review, and the site visit as though any changes have been made to the dam. I cannot determine at this time if the measurements made by the watermaster or my measurements correctly depict the water flow bypassing the dam throughout an entire day. The two flows do seem somewhat similar, and the system doesn't appear to have been changed since the measurement in 2013. There is currently no way to adjust the flows of the water flowing by the dam, except to completely shut down the point of diversion or breach the dam. Shutting down the flows could also result in the failure of the dam, since there is no spillway on the dam. There are no conditions requiring a bypass flow past the dam on the irrigation and stockwater rights, so to reduce the flow to the irrigation and stockwater rights would injure their water use. The field exam was performed the day before the beginning of the season of use for the irrigation rights of May 1<sup>st</sup>, so I am concerned that if we require this bypass flow during the irrigation season it could result in injury to the irrigation uses.

I have presented this issue to other Department staff, and it was determined that we cannot allow the condition to go unaddressed. Therefore, a Notice of Intent to void the permit will need to be sent to ensure that the 0.20 cfs is being diverted through the dam. In order to do this, the permit holder will need to provide some type of device or assurance that this condition can be met.

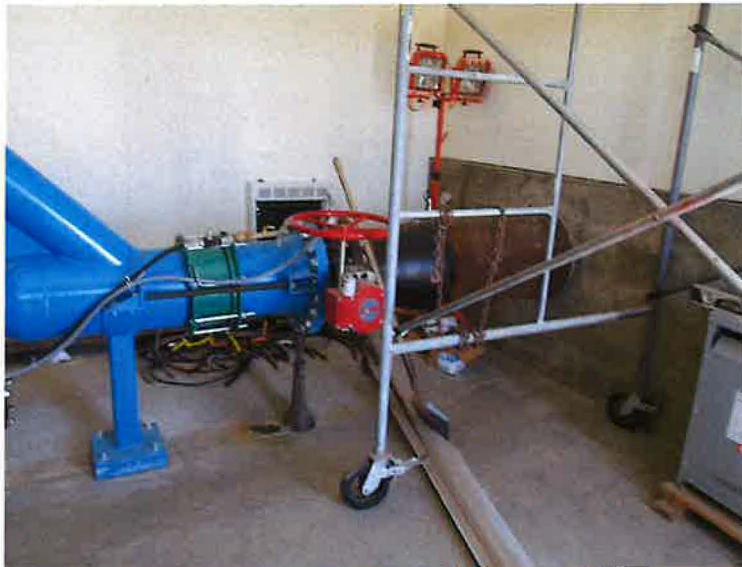
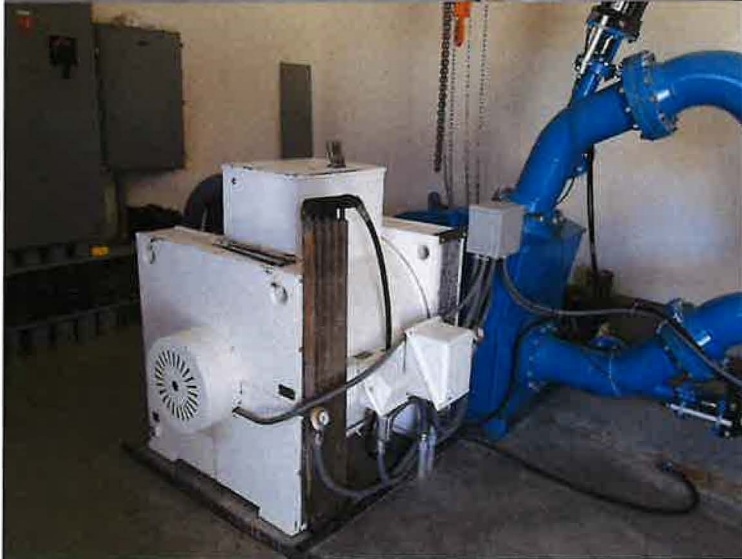
These photos show the 20 inch pipeline entering the power house. The 20 inch pipeline then splits into 2 6 inch pipelines.

The two 8 inch pipelines discharge into the turbine. Both pipelines use an 8 inch pin nozzle. The pin nozzle is adjusts the size of the opening going into the turbine to maintain a constant head pressure regardless of the flow. This provides a better efficiency at lower flow rates.

Inside the power house the 20 inch line then splits into 2 – 8 inch pipelines that flows into the turbine. You can clearly see the power rams used for the pin point or adjustable nozzles used on the turbine. At the split there is a pressure gauge that showed a pressure of 250 psi or 577.5 feet of head on the turbine. During the field exam, the pressure did not vary at all.

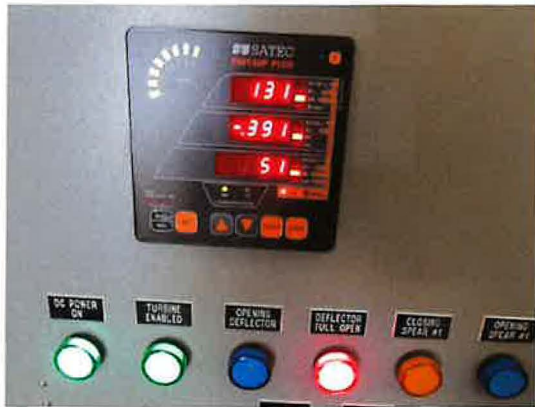
The above gauge shows that the turbine was producing 51 Kw at this time. The nameplate photos are a bit fussy, but they do show the turbine is designed to operate at 390 Kw, 480 Volts and 60 Hz. The Serial number was H2718231081.

I reviewed the power panel and found the generator was producing between 51 to 53 Kw at the time of the field exam. The permit holder went through the power panel, and provided me with an understanding of the gauges on the panel. When we first reviewed the power panel, the permit holder told me that the water flowing into the turbine was only going through one of the 8 inch pipelines and nozzles. I felt the pipelines and noticed that both pipes appeared to be cold, and I asked if he was sure if water wasn't flowing through both pipes. He was convinced that water was only flowing through the upper 8 inch pipeline. I set up our flow meter on the upper 8 inch pipeline and measured a flow rate of 230 gpm. Which was less than ½ of the amount measured at the upper diversion.

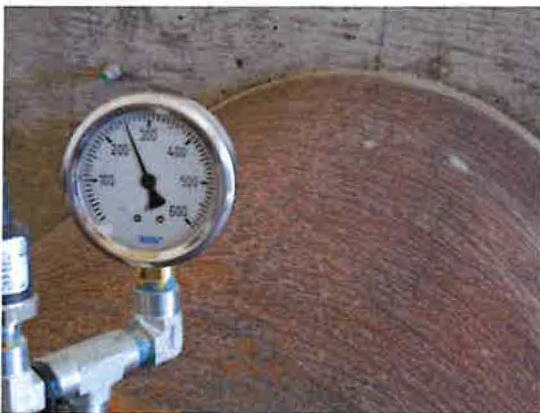
The pressure gauge below shows a pressure of 250 psi, which equates to 577.5 feet of head against the turbine ( $250 \times 2.31 = 577.5$  ft)

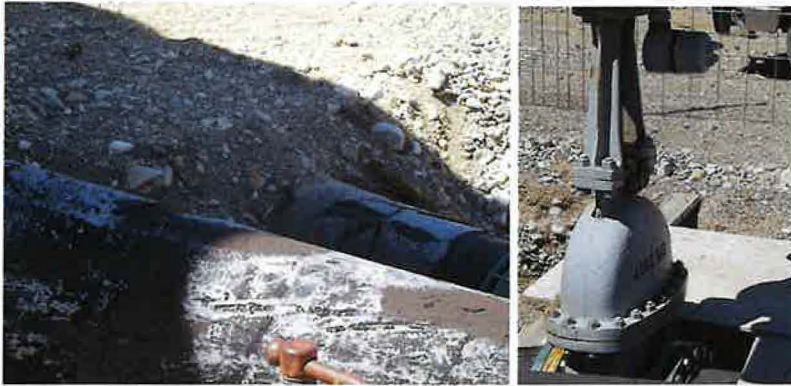
The photos above show the valve and the bypass pipelines. The pipeline in the foreground of the photo goes to the power house and the other lines goes to the headgates shown below for irrigation.

We then went to the powerhouse. A 20 inch pipeline comes out of the ground and splits into two 20 inch pipelines. One split has a valve to a pipeline that runs along the north side of the power house and into a vault with the irrigation headgates. The headgates supply the ditches associated with the overlapping water rights discussed in the overlap analysis. The headgates both have lockable controlling devices and can be measure using an orifice equation. The second 20 inch pipeline flows directly into the power house. All of the water at the time of the field exam was going into the power house.

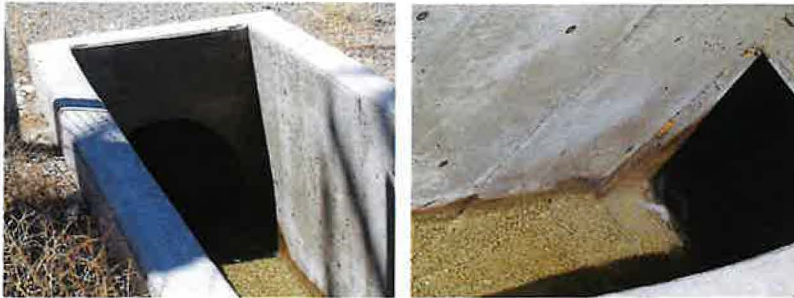
The photos above show the exit channel from the power house. Water is flowing out of the power house from the left through a channel that goes into a pipeline that transports the water to the head gates shown below for irrigation.

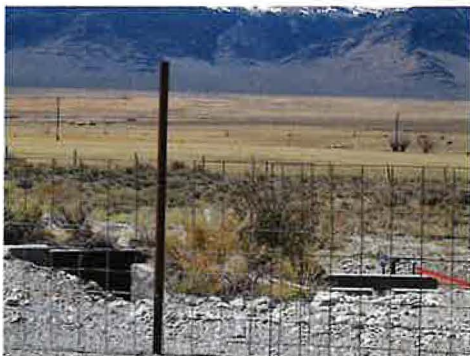
The photo above shows the head box and the headgates that distributes the water coming out of the bypass or power house to the farmers who use this same water for irrigation and stockwater.

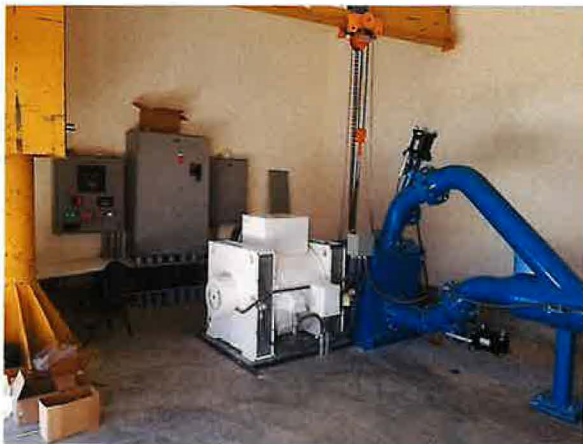
Two Nozzle Pelton Hydro Turbine Generator

- ◆ Turbine: double nozzle Pelton
- ◆ Generator: 390kW Potencia @ 900 RPM
- ◆ Rated head: 164m
- ◆ Rated flow: 0.3m<sup>3</sup>/sec
- ◆ Commissioned: 2019

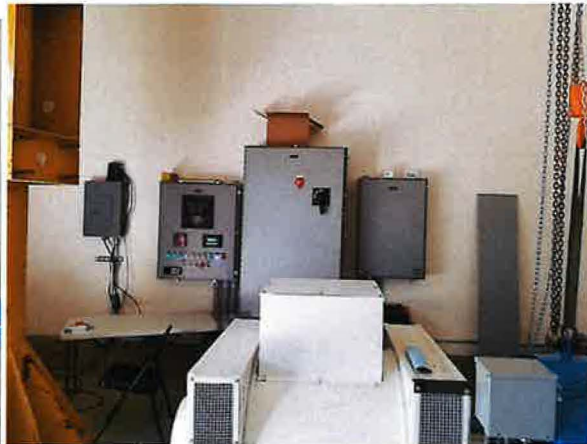
Wall Mounted Hydro Turbine Switchgear and Control Panels
