STATE OF IDAHO  
DEPARTMENT OF WATER RESOURCES  
BENEFICIAL USE FIELD REPORT

**Permit No:** 74-16218  
**Exam Date:** 8/21/2020

3. **SOURCE:**  
SPRING

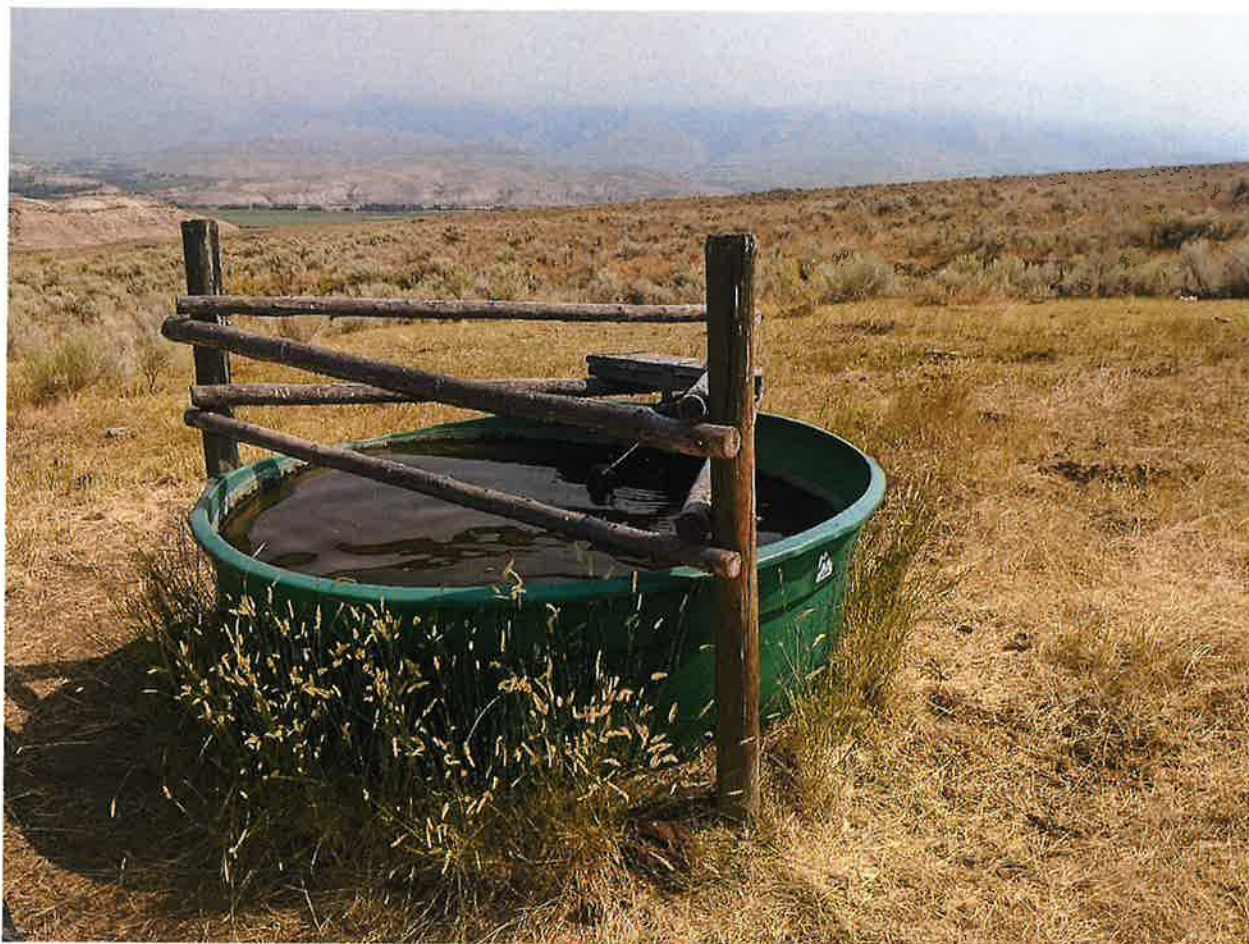
Photo 1: View of the closer of the two troughs, located ~200 feet from the point of diversion.

Water is collected at the emergence of the spring via a buried 6" perforated pipe, and diverted through a buried pipeline to two water troughs (estimated 500 – 750 gallons each) located ~200 feet and 500 feet from the point of diversion. Each trough has a float to engage an automatic shutoff when full. The entire collection system and pipeline were buried.

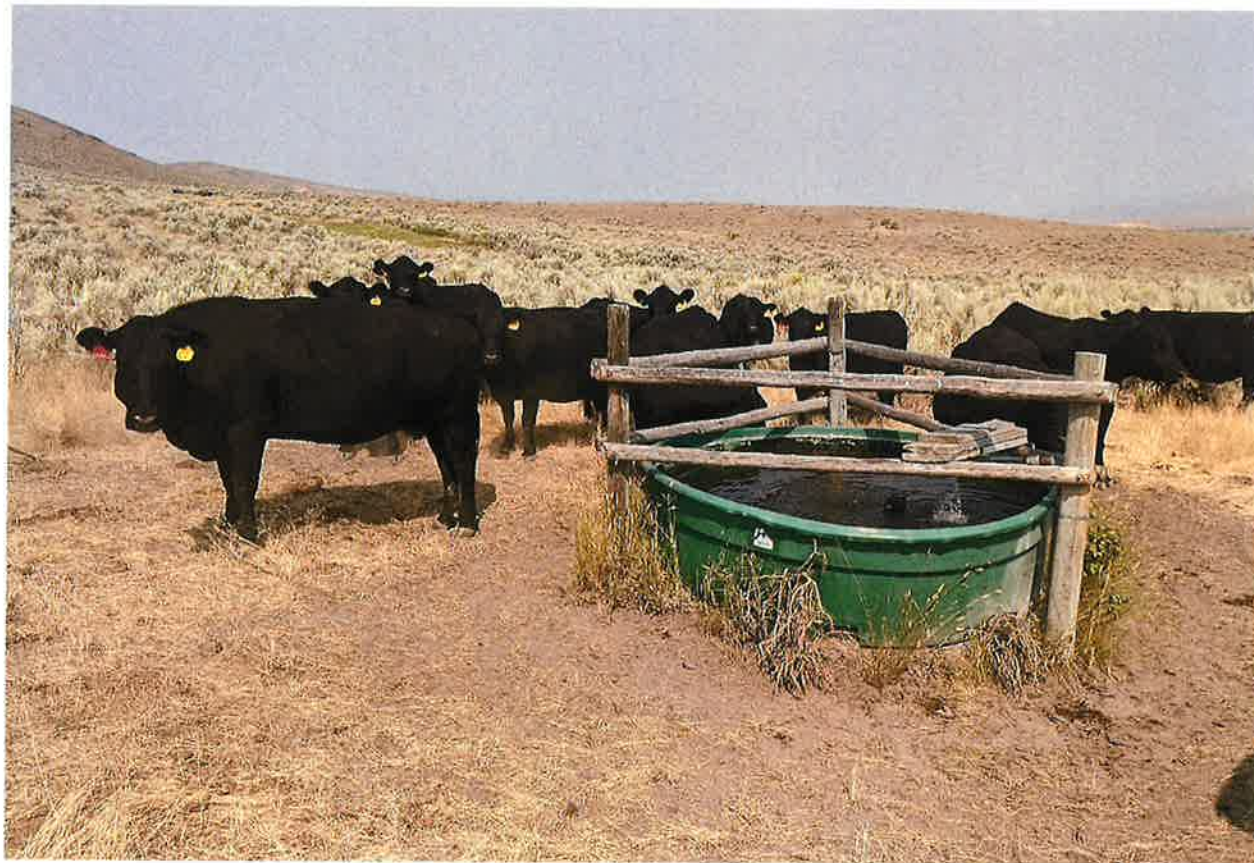
Photo 2: View of the second trough located ~500 feet from the point of diversion.

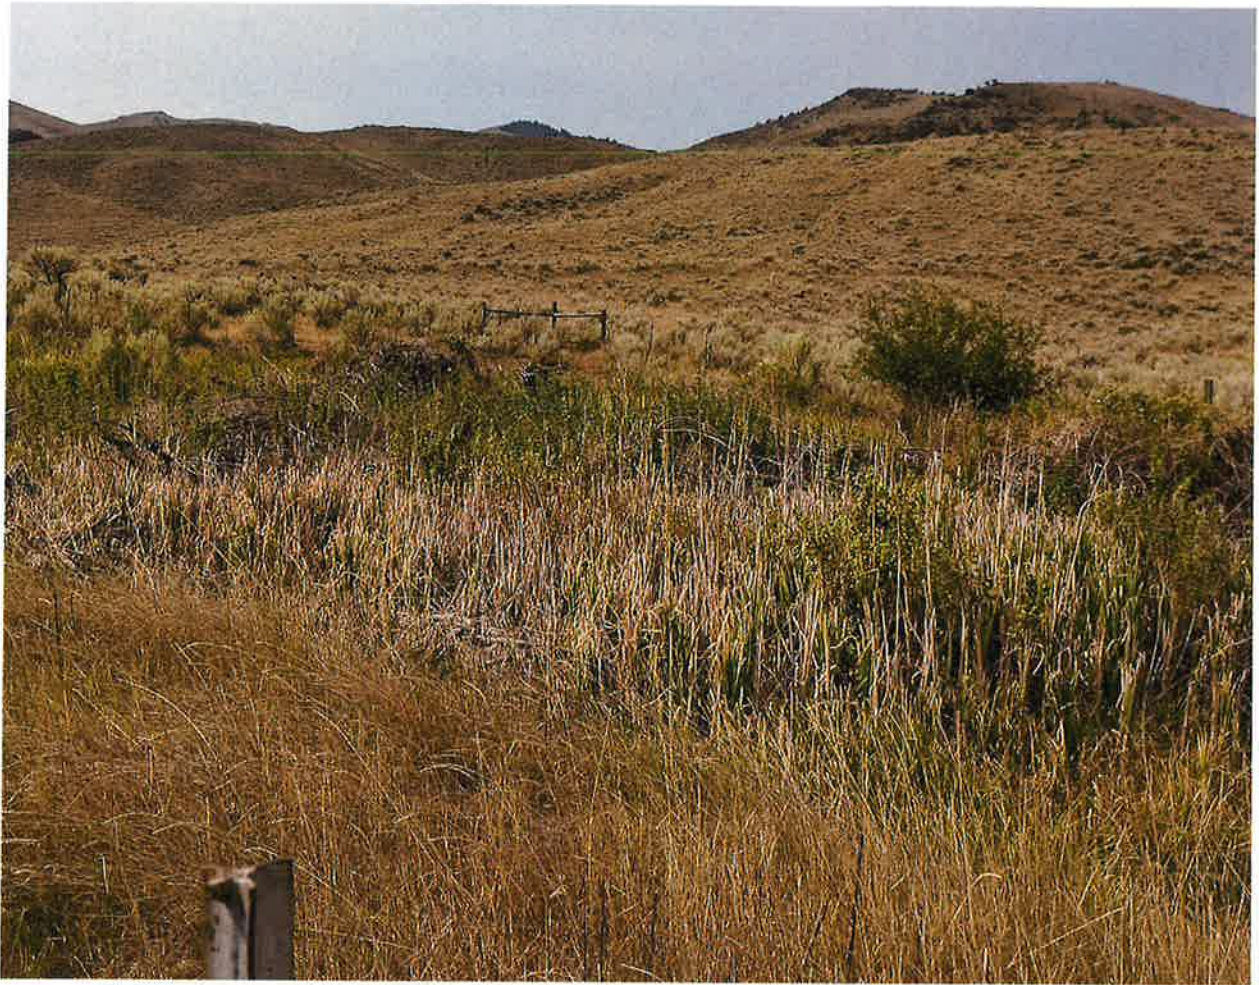
Photo 3: View of the spring indicated by dense, green vegetation. Although not entirely obvious from this photo, it was evident on-site that this was the location of the spring. It was reported that the perforated collection pipe is buried within this fenced-off space.

The spring was observed to essentially rise and sink in the same general location. There was no measurable flow from the spring, or evidence of any connection to other surface water sources.
