Permit No: 95-17882 Page 1

STATE OF IDAHO DEPARTMENT OF WATER RESOURCES IN-OFFICE REVIEW/BENEFICIAL USE FIELD REPORT

Well Photos for Water Right Exam 95-17882

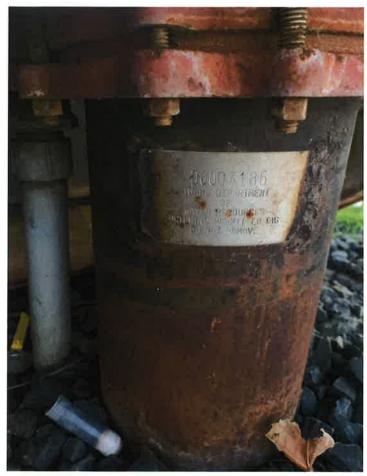
Photo that William Ranney sent me of the well on his property. Well head shows metal tag No. D0003186.

The spatial data location of the well was recorded in the wrong location. At the time of the in-house exam, the well was located in the NESW QQ of Section 1, Township 50N, Range 06W. However, the POD for this permit and right 95-13035 is logged in the neighboring QQ in the NWSE QQ of Section 1, Township 50N, Range 06W. Due to the nature of an in-house review, I could not collect GPS coordinates for the actual well location. So I requested that the permit holders send me photos of the

metal tag on the well head and a photo showing the location of the well relative to the structures on the property. Mr. Ranney sent me photos fulfilling this request. I took this information to the Groundwater Protection Section and they moved the well record to the spatial data point associated with this permit and water right 95-13035.

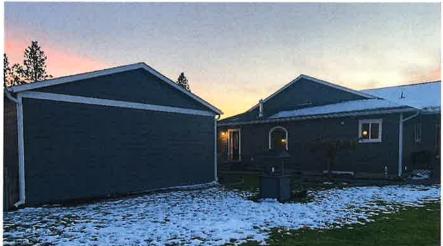
This photo shows the location of the well head in relation to the domestic structures on the property. The structure on the left is a garage and on the right is the home. The well head is located on the north side of the garage.
