STATE OF IDAHO  
DEPARTMENT OF WATER RESOURCES  
BENEFICIAL USE FIELD REPORT

**Permit No:** 65-23669  
**Exam Date:** 08/27/2019

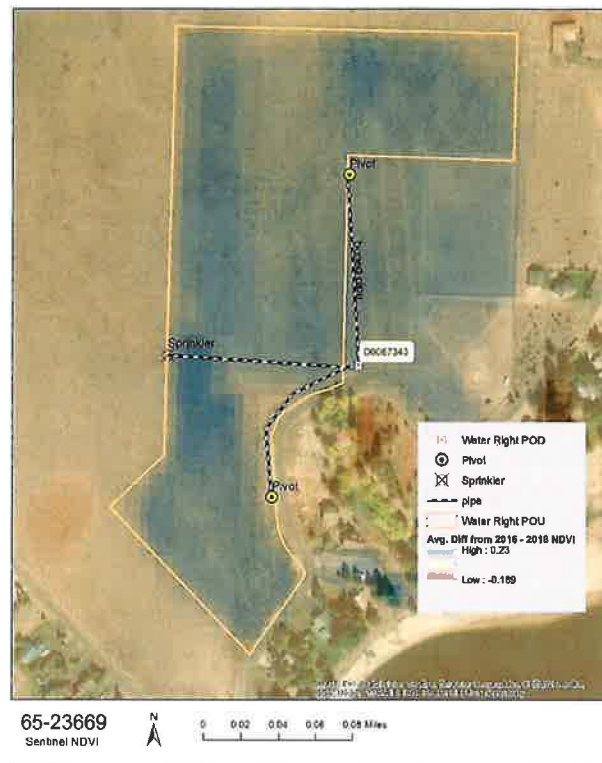
Figure 1: Mean difference of 2018 growing season NDVI from 2015 – 2017 mean growing season NDVI. Calculation based on Sentinel satellite imagery.

In addition to the diversion system being in place, I confirmed beneficial use during the permitting period using imagery from the Sentinel satellite to calculate the NDVI (Normalized Difference Vegetation Index). NDVI is a proxy for photosynthesis and ranges from 0 to 1, with 1 indicating more plant activity. NDVI calculations were made using the remote sensing tools from Climate Engine (<http://climateengine.org>) to calculate the mean 2018 growing season difference in NDVI from the mean growing season NDVI from 2015 to 2017. The figures in the attachments to the report demonstrate a noticeable increase in the place of use NDVI during 2018 growing season. Heightened NDVI is also clear relative to neighboring non-irrigated rangeland.

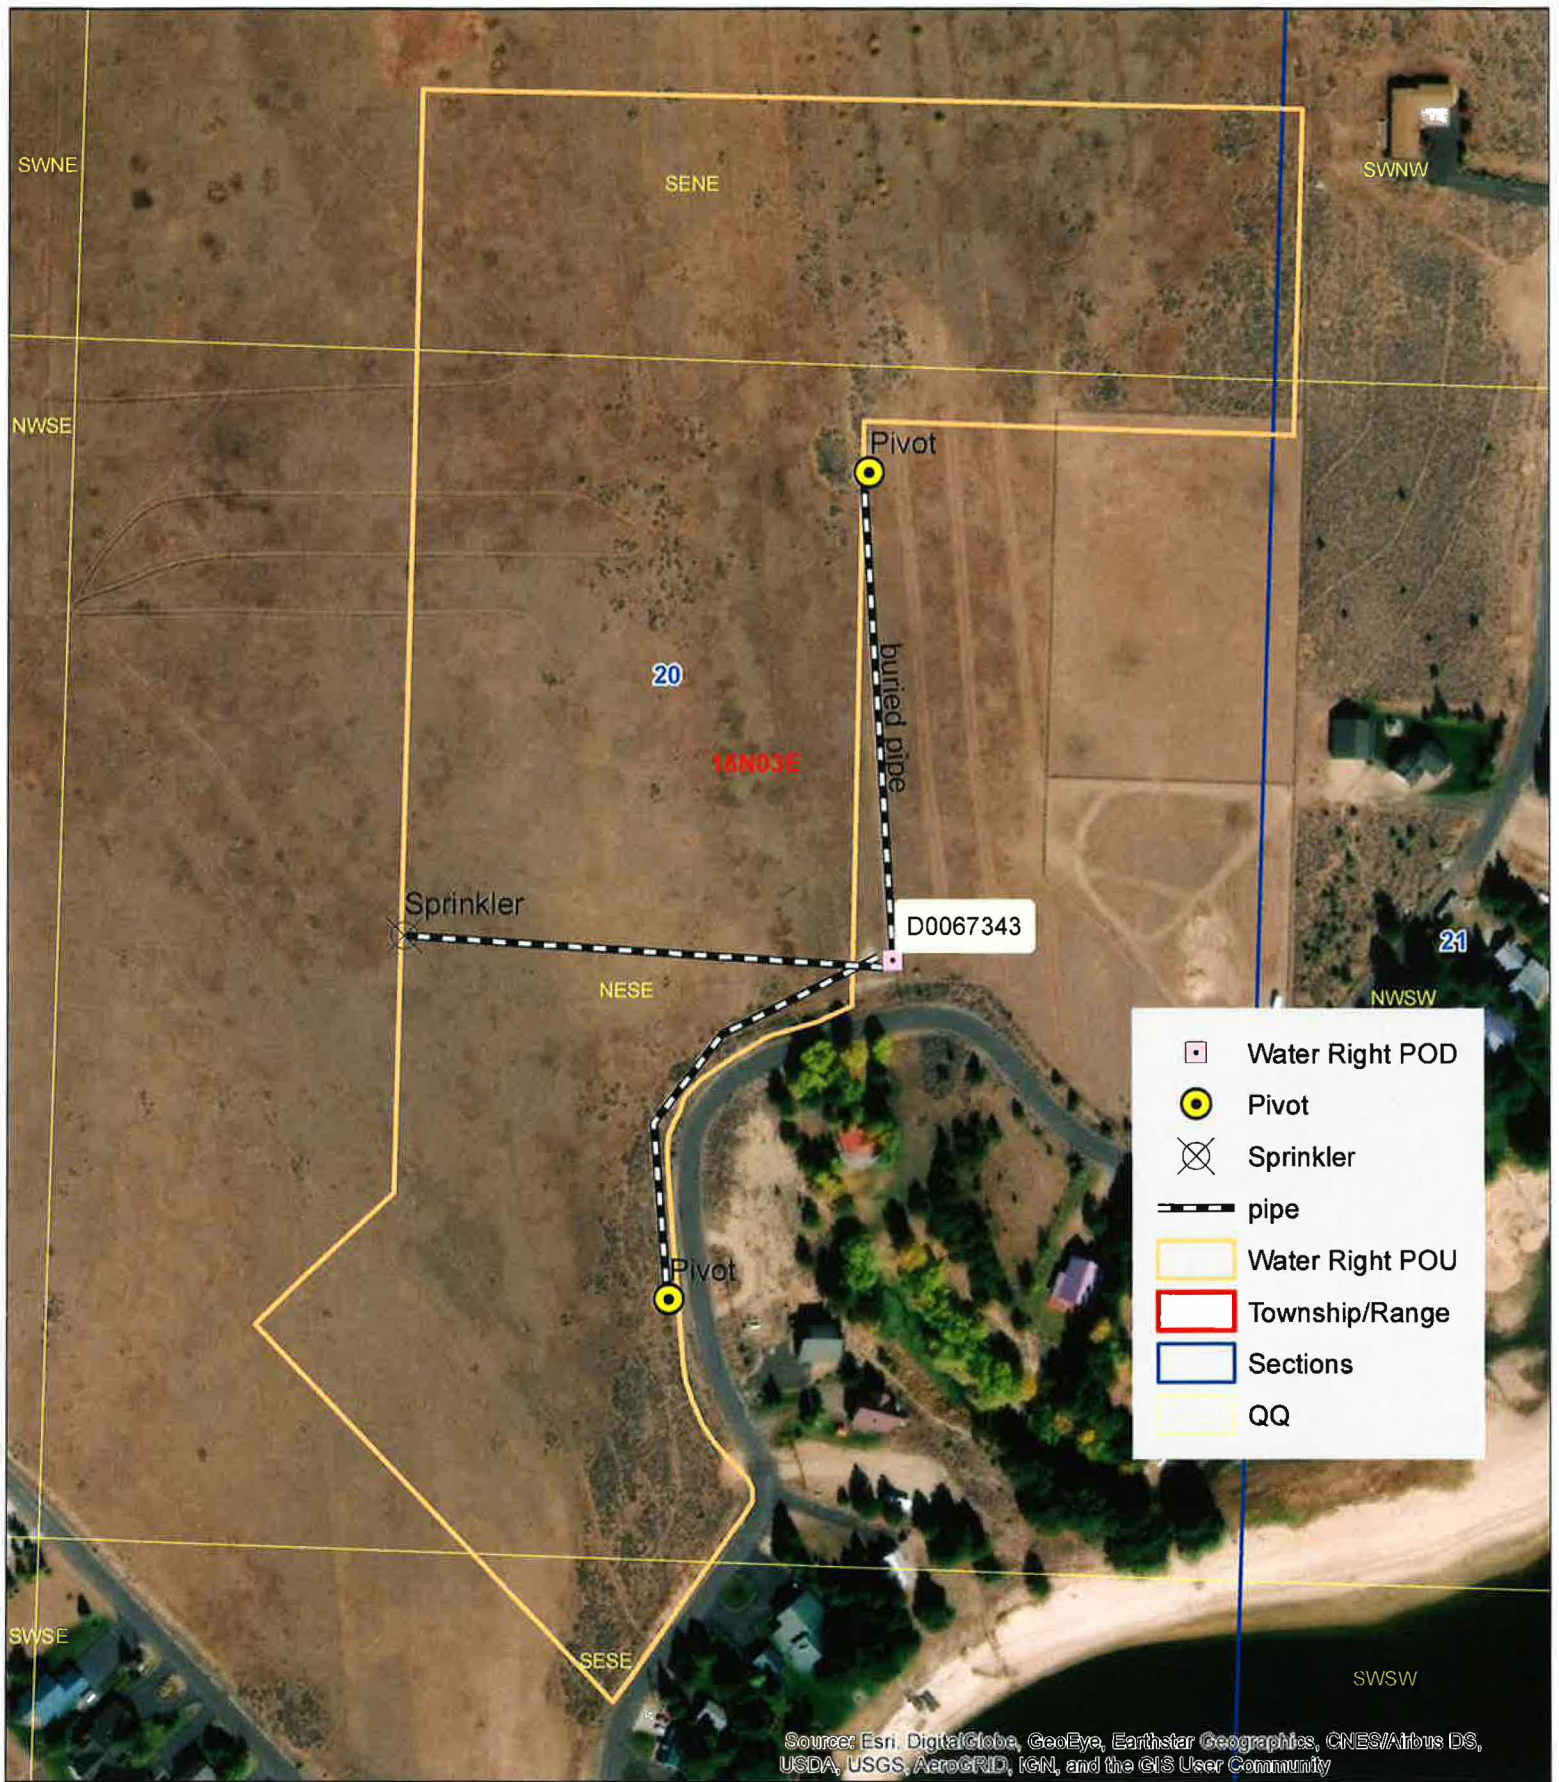
65-23669  
System Diagram

From the diversion point, buried pipes carry the water to two pivots and several sprinklers that fill in the corners. Two measurements were made for this permit by running each pivot separately. We measured an average flow rate of 58.5 GPM

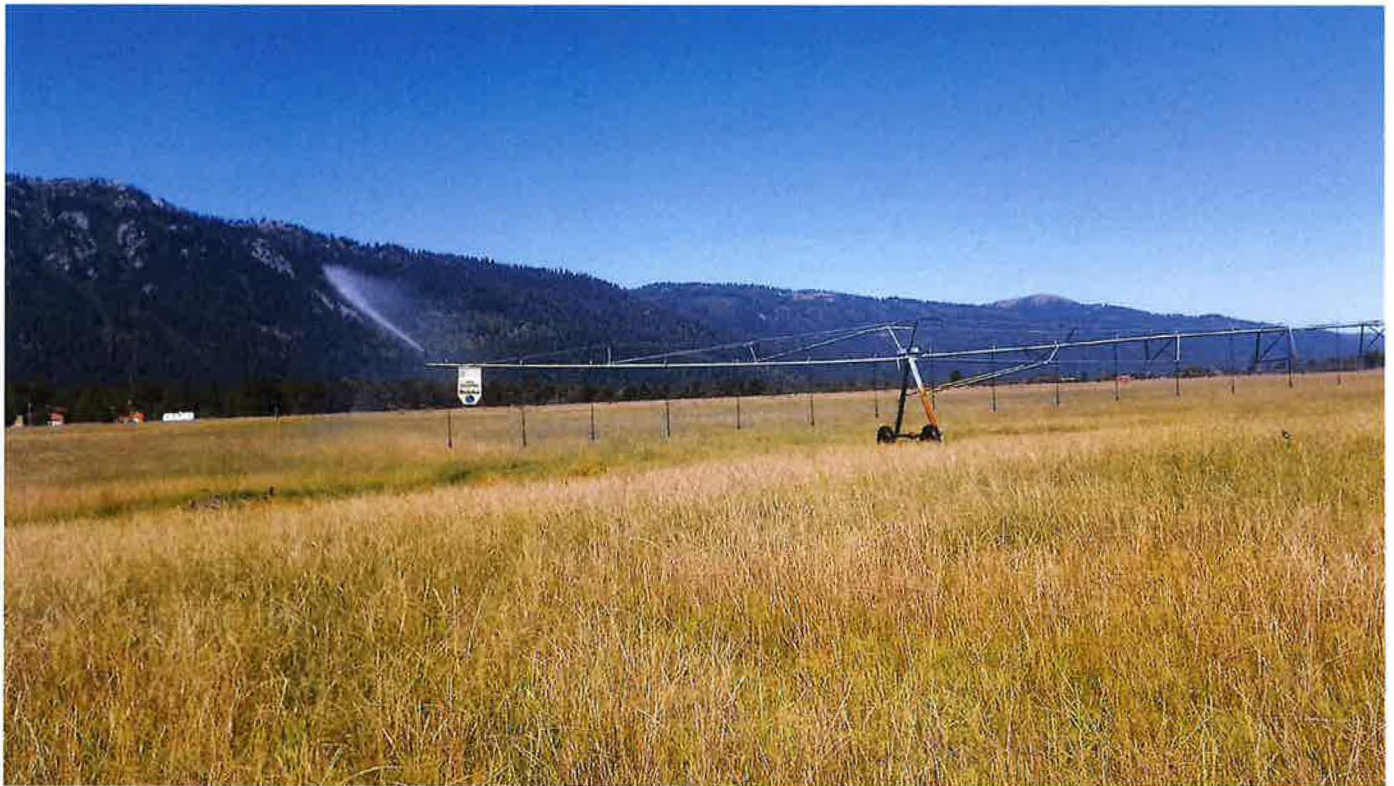
End of large pivot.

(.13 cfs) at the smaller southern pivot and 138 GPM (.30 cfs) at the larger pivot to the north.

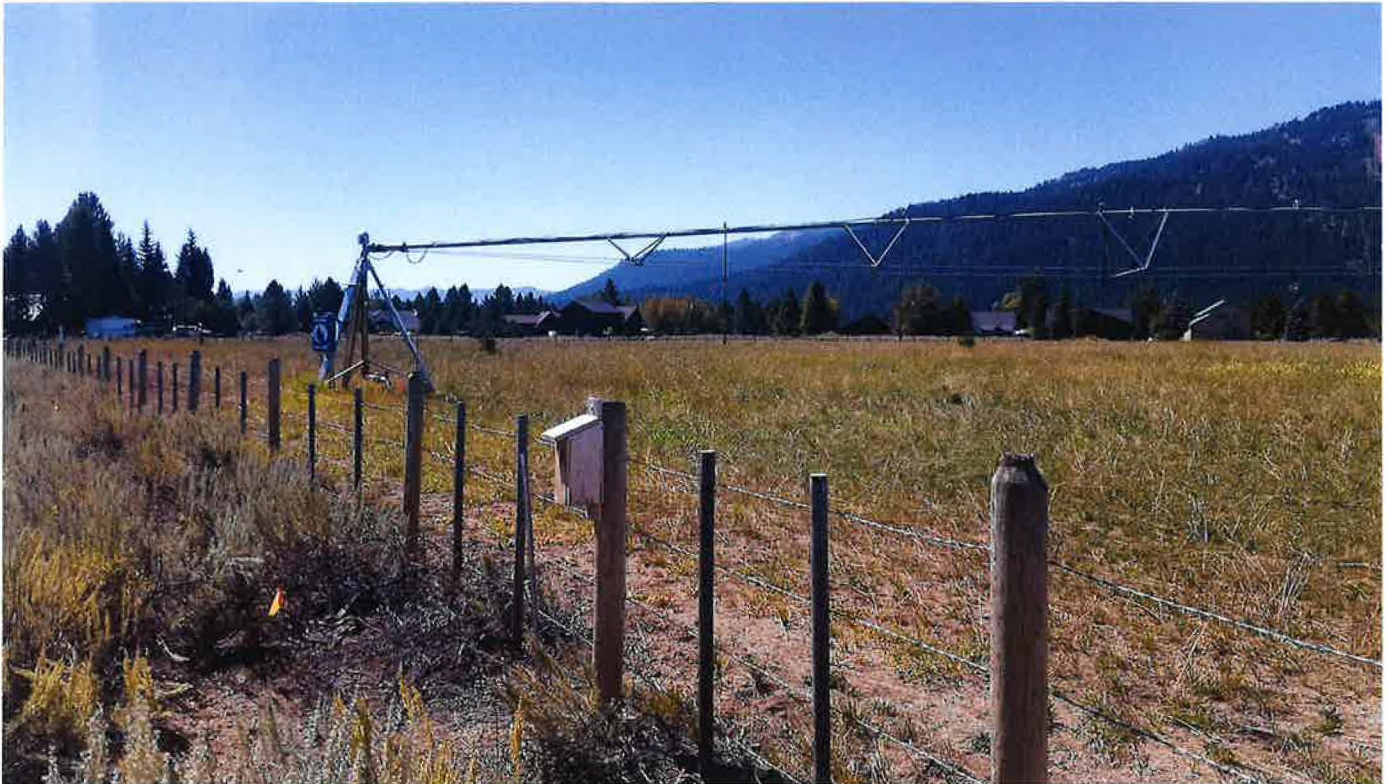
Beginning of smaller pivot at southern end of place of use.

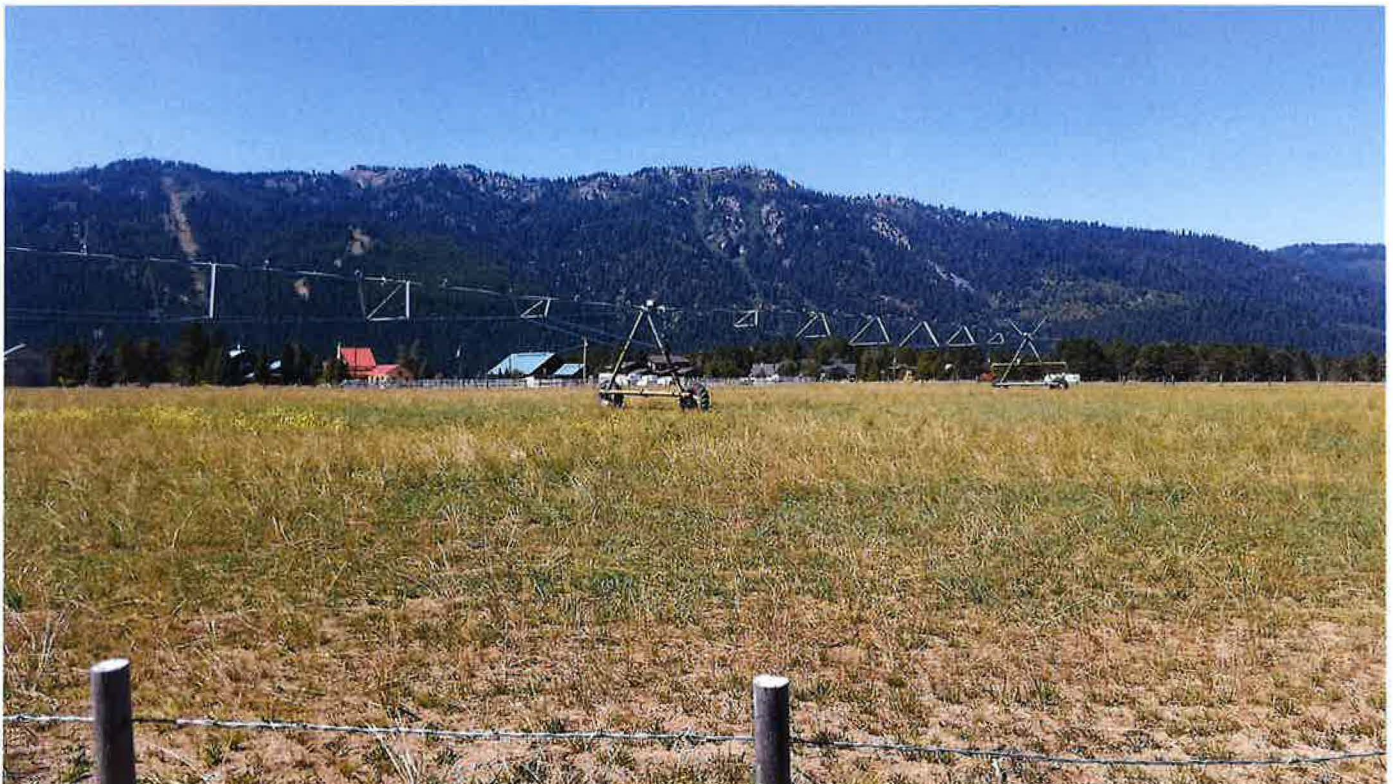
Remainder of smaller pivot at southern end of place of use.
