STATE OF IDAHO  
DEPARTMENT OF WATER RESOURCES  
**BENEFICIAL USE FIELD REPORT**

**A. GENERAL INFORMATION**Permit No. 65-13392

1. Owner Tina Marie Hoven, Shirley C Hoven Phone No. \_\_\_\_\_  
Current address same
2. Examiner's name Phill Hummer EXAM DATE 10/15/2018
3. Accompanied by Nick Miller (IDWR) Email \_\_\_\_\_  
Address \_\_\_\_\_  
Relationship to permit holder \_\_\_\_\_ Phone No. \_\_\_\_\_
4. Source Dodge Creek tributary to SF Payette River

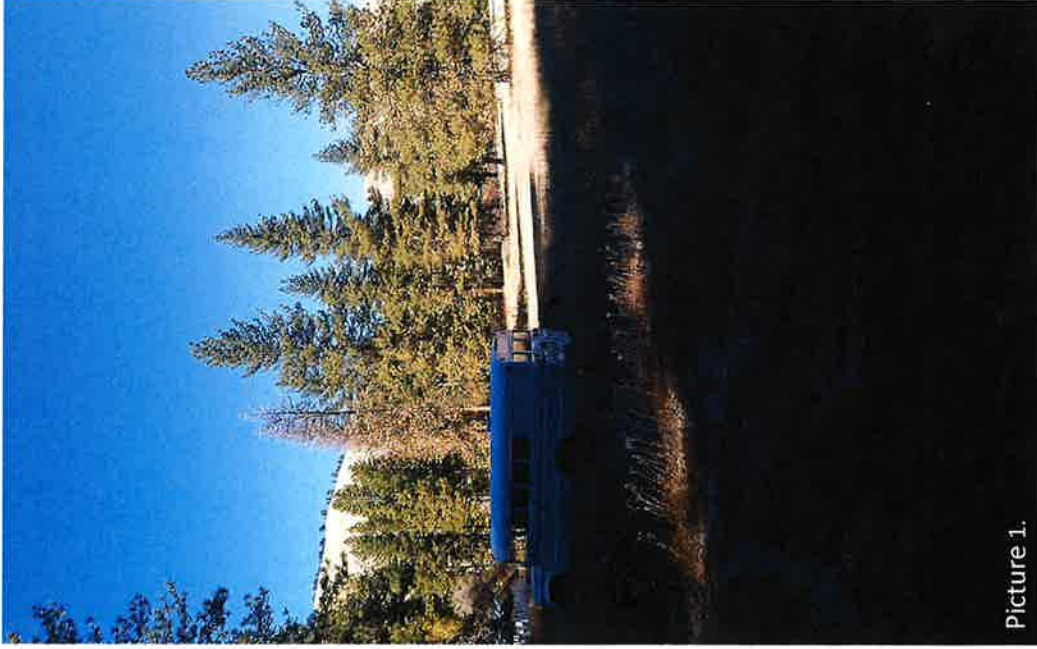
Picture 1.

Photos 1 and 2 are the views North/Northwest and East across the property from the unused well. Photo 3 shows the area between the house and the shed, as well as the undeveloped lots in distance. The place of use north of the two are not pictured.

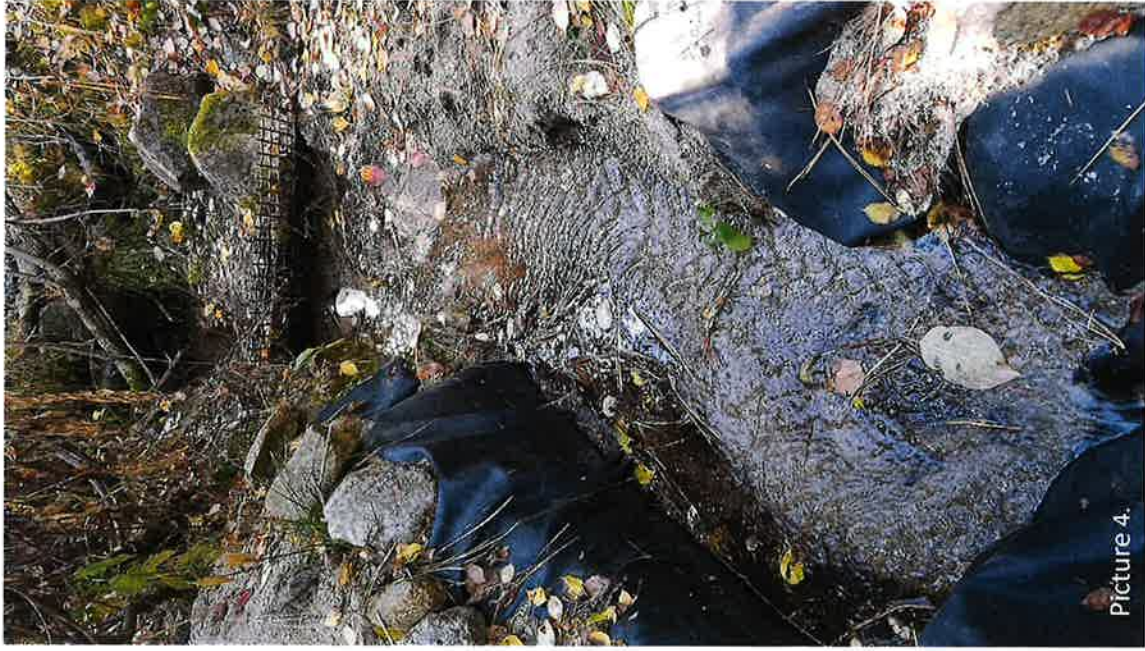
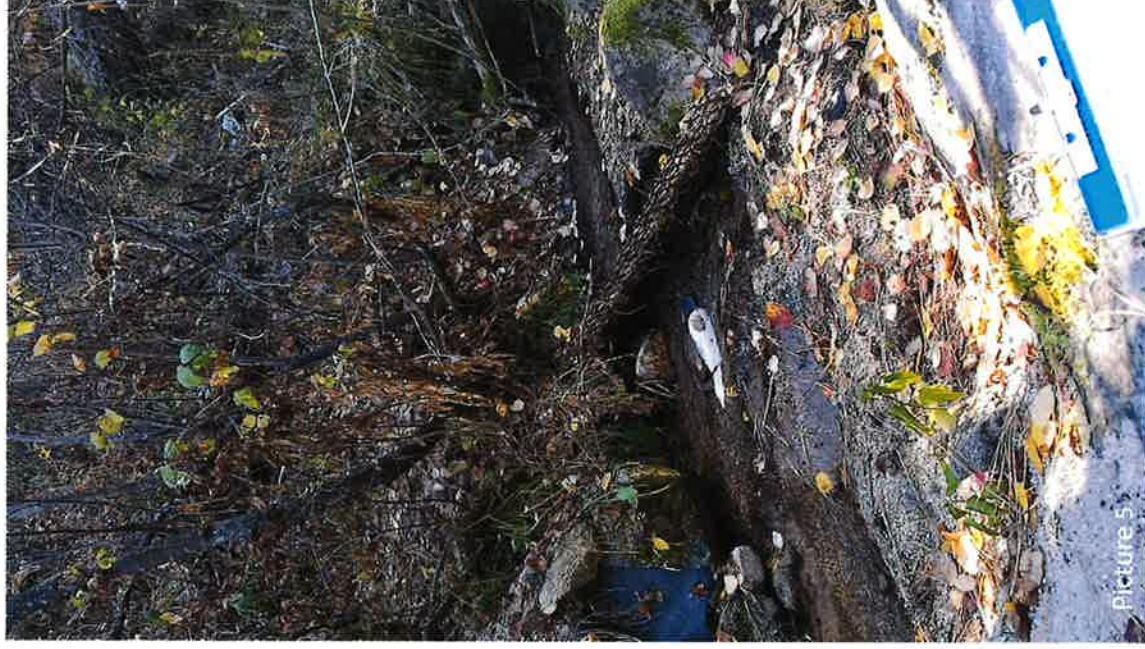
The open end of the pvc pipe was capped at the time of the field examination. Ms. Hoven said she has had trouble with rocks and sand getting into the pipe so she needs to redesign the system. The same 4 in pvc will be used but she plans on making an enclosure of some kind to prevent sabotage and filter sand more effectively.

Pictures 4 and 5 show the diversion end of the pvc pipe in the bed of Dodge Creek. Photos submitted by Ms. Hoven that show the rest of the pipeline were scanned to the records for 65-13392 and 65-13963 on 04/04/2018 under "Order Voiding Permit & Supporting Documents". Photos submitted by Ms. Hoven that show the lockable controlling device are also in the same location.
