STATE OF IDAHO  
DEPARTMENT OF WATER RESOURCES  
**BENEFICIAL USE FIELD REPORT**

Permit No: 51-7319

State of Idaho  
Department of Water Resources  
**Attachment to Field Exam**  
51-7319

# Water Right 51-7319 System Diagram

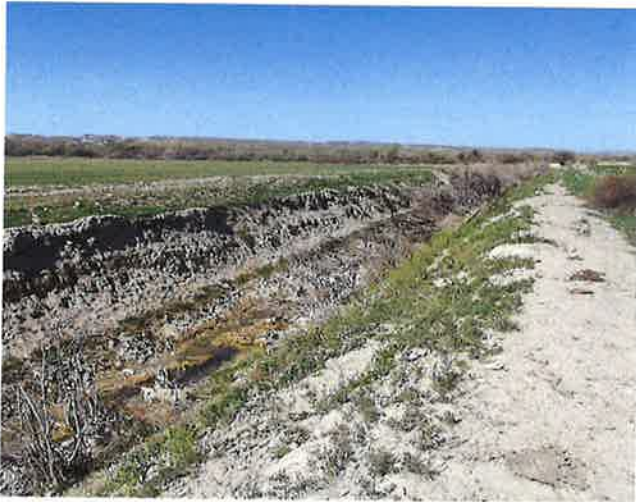
"South drain" looking east

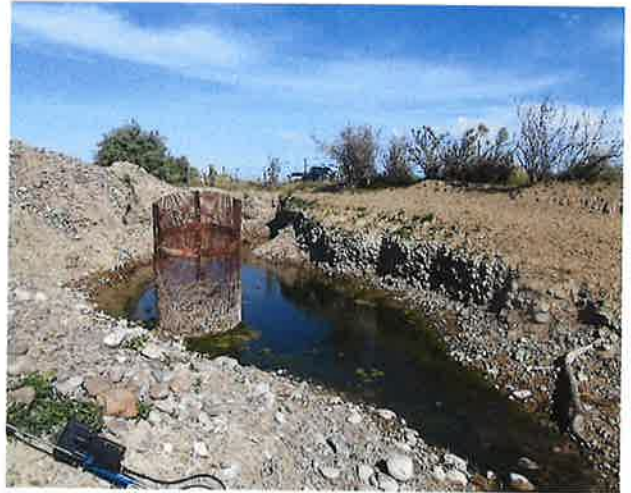
Downstream of the point of diversion for water right 51-7319 where the waste ditch from the south joins the "south drain"

Bruneau Buckaroo Coop Ditch Company water rights overlap the place of use and additional wastewater is combined with water for this water right to irrigate the place of use including the waste ditch from the south which connects in to the drain after the POD for this permit, and additional seepage into the drain from the surrounding fields. The license will be conditioned to address the overlap with BBCDC water rights and the applicant is in the process of applying for permits for these additional sources of water.

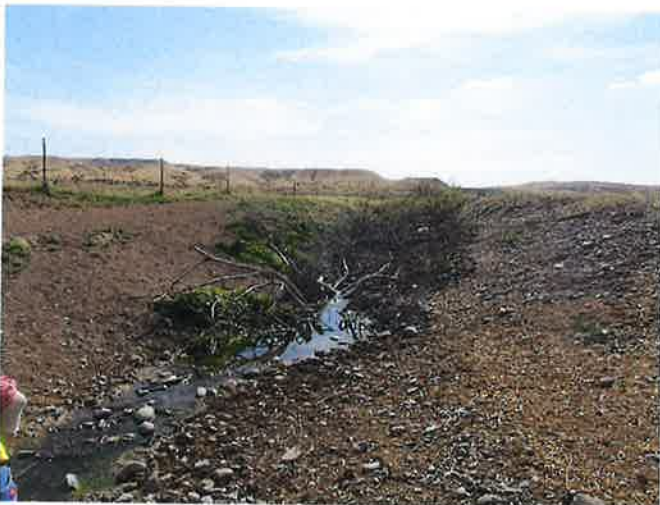
"South drain" upstream of the point of diversion where flow was measured

A second site visit was conducted on June 7, 2018 in order to measure the flow at a time where flows are typical for the irrigation season. A flow rate of 0.04 cfs was measured using a FlowTracker.

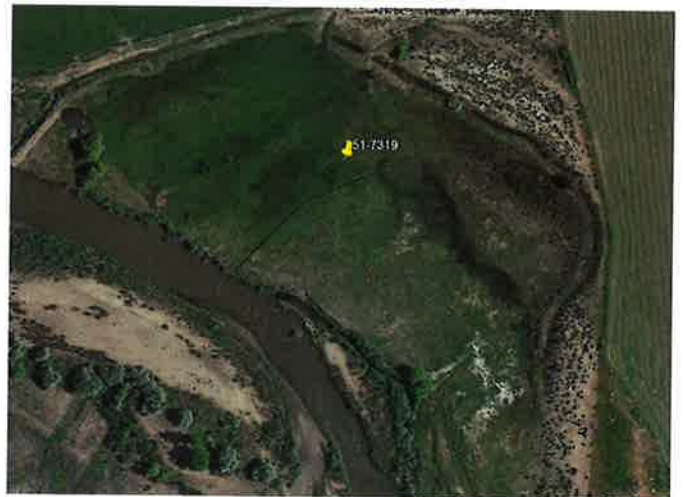
Aerial imagery of the place of use

According to available tax parcel data, Ace Black Ranches is the owner of the place of use. The water is used to flood irrigate approximately 11.3 acres. The place of use for the permit only included the NWNE of Section 31 and did not include the NENW where the water is actually used so an amendment will be needed for the place of use.
