STATE OF IDAHO  
DEPARTMENT OF WATER RESOURCES  
**BENEFICIAL USE FIELD REPORT**

Permit No: 51-7318

State of Idaho  
Department of Water Resources  
**Attachment to Field Exam**  
51-7318

## Ace Black Ranches

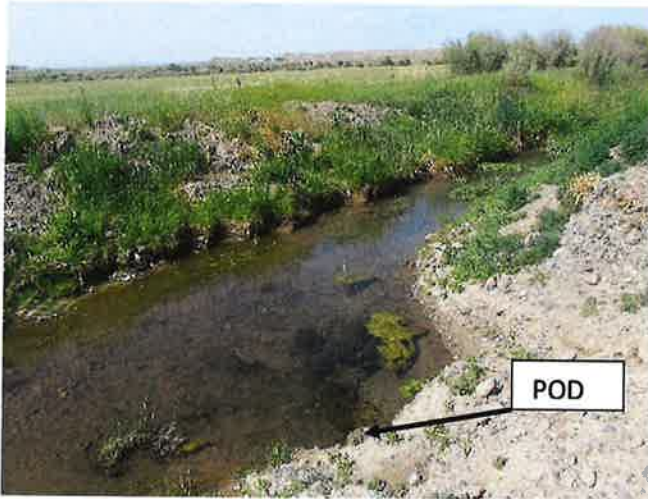
51-7318 According to available tax parcel data, Ace Black Ranches is the owner of the land at the point of diversion. The point of diversion is the location where the drain tile joins the Jones Wasteway.

POD for water right 51-7318  
(location where drain tile drains to Jones Wasteway)

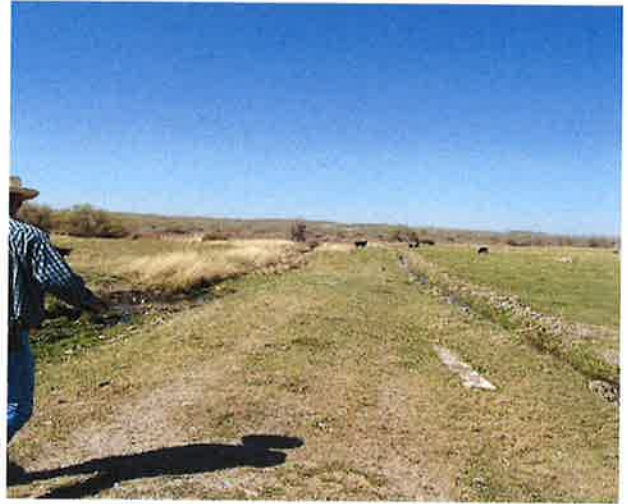
The ditch on the right is split from the main wasteway  
on the left and used to irrigate the field on the right

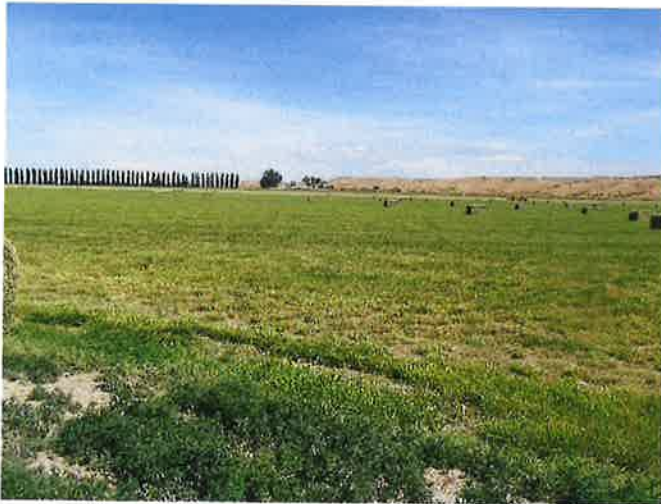
Dan Nelson and I visited Ace Black Ranches for a field exam on April 27, 2018. At that time, there was some flow from 51-7318; however, the owner said the flow increases over time during the summer as the fields are irrigated. The water source for this permit is a drain tile running north-south through the field. The tile drains to what Terry Black referred to as "Jones' Wasteway" (see attached Field Exam Map) and is then later diverted from the wasteway to flood irrigate the place of use at a lower elevation closer to the Bruneau River. A pivot has also been recently installed which irrigates some of the originally permitted place of use using wastewater and collected drain tile water from numerous locations on the property. After consultation with Department staff, based on the fact that the flow increases over the summer as the fields are irrigated and there is minimal flow during the non-irrigation season, it was advised that the source of water for this license should be defined as an unnamed drain tributary to the Bruneau River.

The field with the drain tile (unnamed drain) which serves  
as the source for 51-7318
