STATE OF IDAHO  
DEPARTMENT OF WATER RESOURCES  
**BENEFICIAL USE FIELD REPORT**

**A. GENERAL INFORMATION**Permit No. 63-324671. Owner Tree Top Ranches LPPhone No. 208-377-0998Current address PO Box 8126, Boise, 837022. Examiner's name Scott King, P.E. (Examiner No. 133)EXAM DATE November 29, 20173. Accompanied by William MulderEmail wjmulder@treetopranches.comAddress same as aboveRelationship to permit holder Manager

4. Source Boise Rivertributary to Snake River**B. OVERLAP REVIEW**

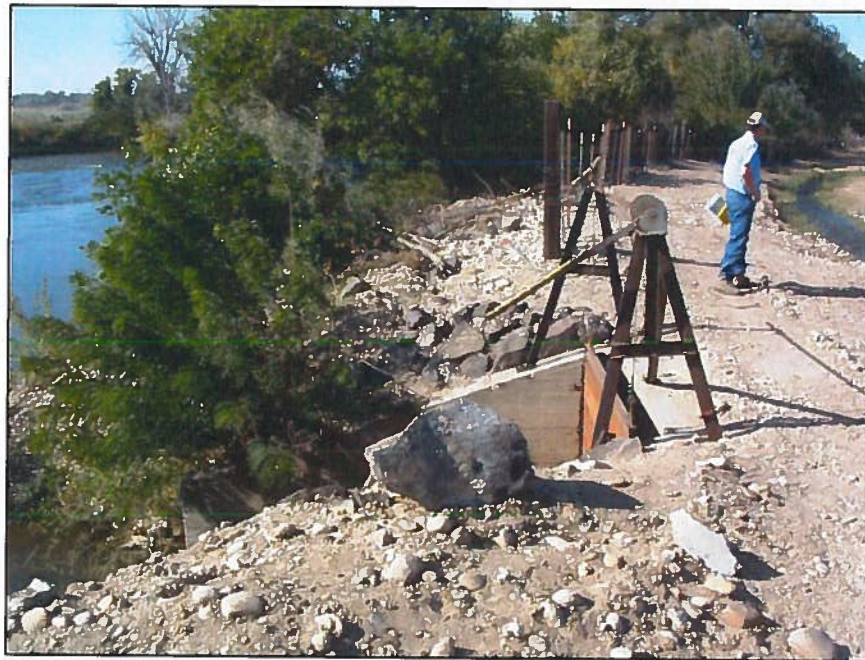
**Figure 1: Andrews Ditch diversion from Boise River.**

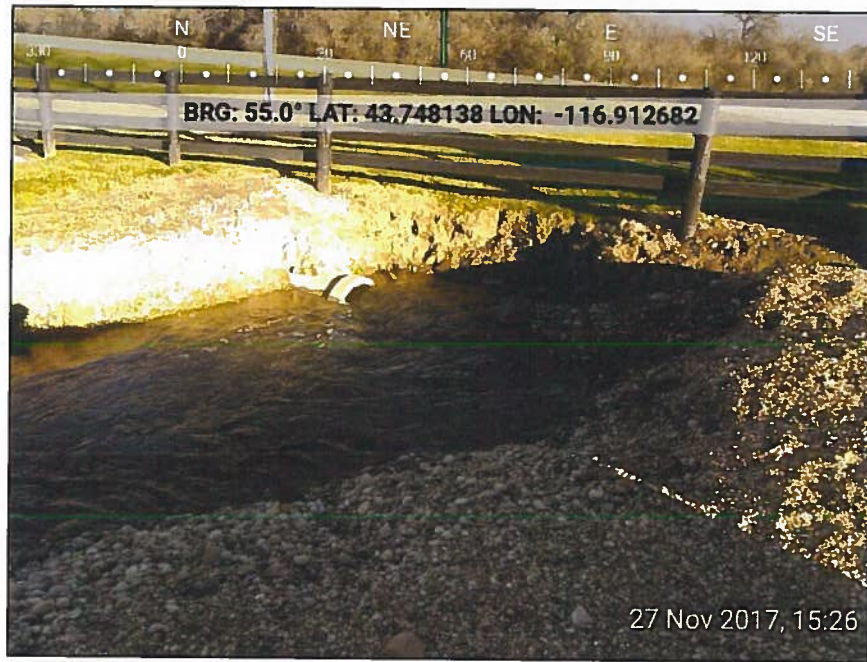
**Figure 3: Andrews Ditch flow entering Tree Top Ranches property on west side of Hwy 95.**

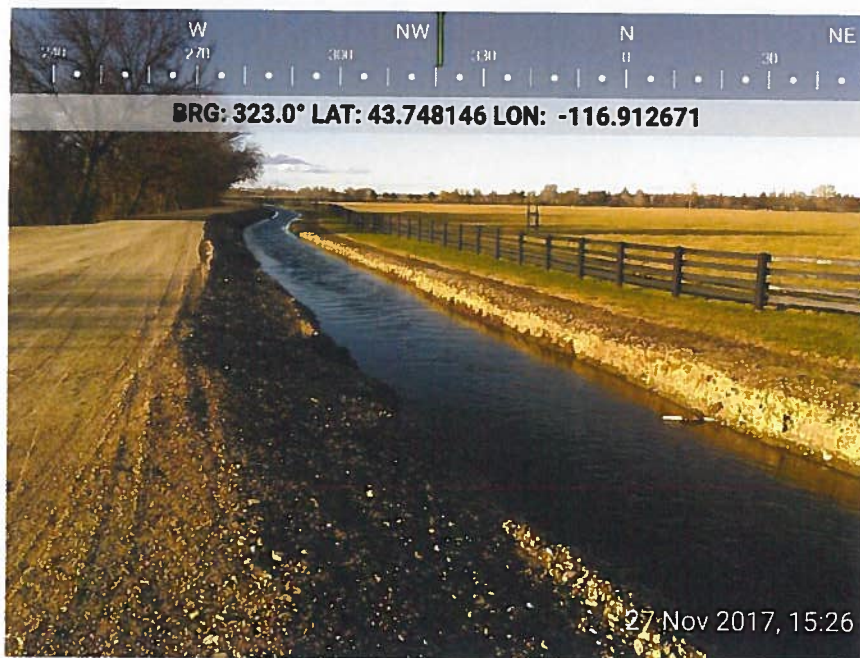
**Figure 4: Same location as above figure facing northwest .**

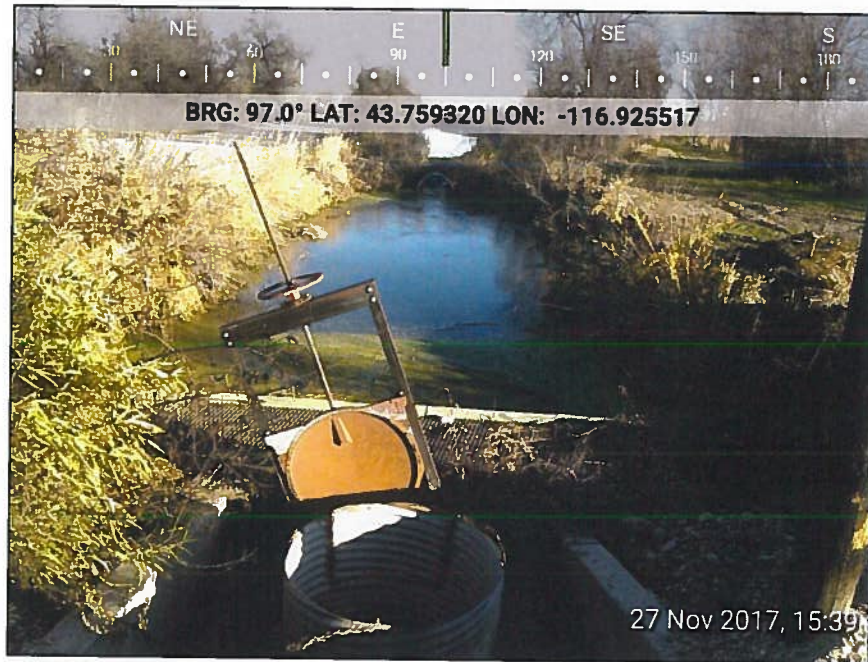
Figure 5: Lower end of Boise River source water collection ditch and entrance to pipeline under Parma Ditch.

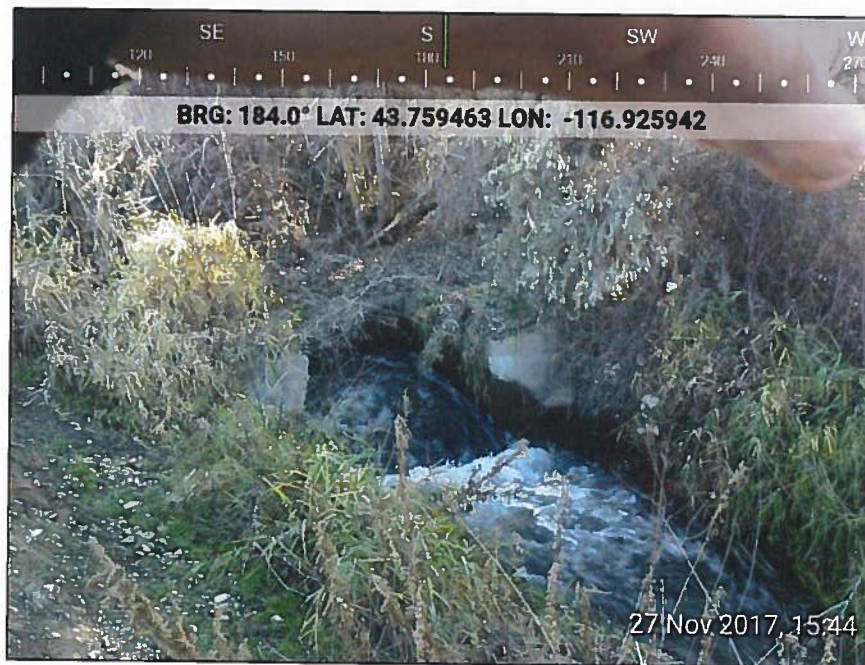
Figure 6: Boise River source water is piped under the Parma Ditch and returned to the Boise River.

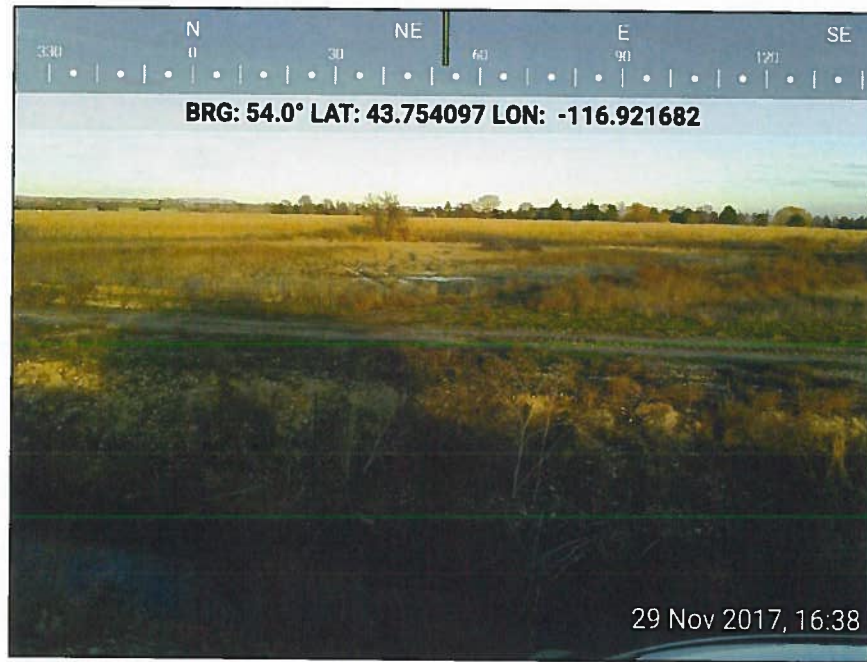
**Figure 7: Sweet Corn Pond is typical place of use with flooding starting for the season.**

| Water Body | Flooded<br>Area No. | Ac. | Depth | AF | Source | Permits |
|---|---|---|---|---|---|---|
| Sweet Corn Pond | 5 | 2.7 | 4.5 | 12.2 | Boise River | 63-32467 & 63-32911 |
| Sweet Corn Flooding | 5 | 3.4 | 1.5 | 5.1 | Boise River | 63-32467 & 63-32911 |

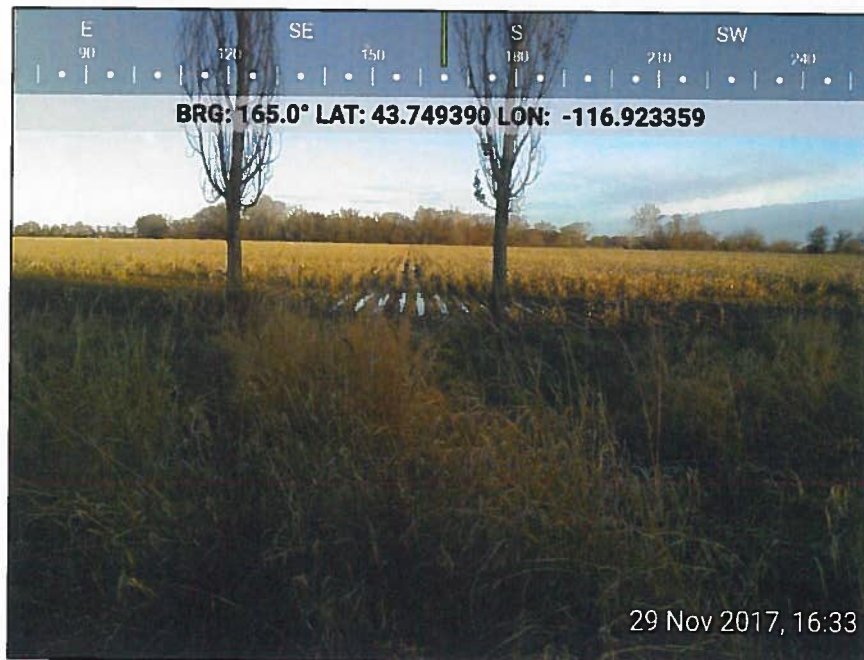
**Figure 8: South Field place of use.**

| Water Body | Flooded<br>Area No. | Ac. | Depth | AF | Source | Permits |
|---|---|---|---|---|---|---|
| South Field Flooding | 6 | 13.1 | 2 | 26.2 | Boise River | 63-32467 & 63-32911 |

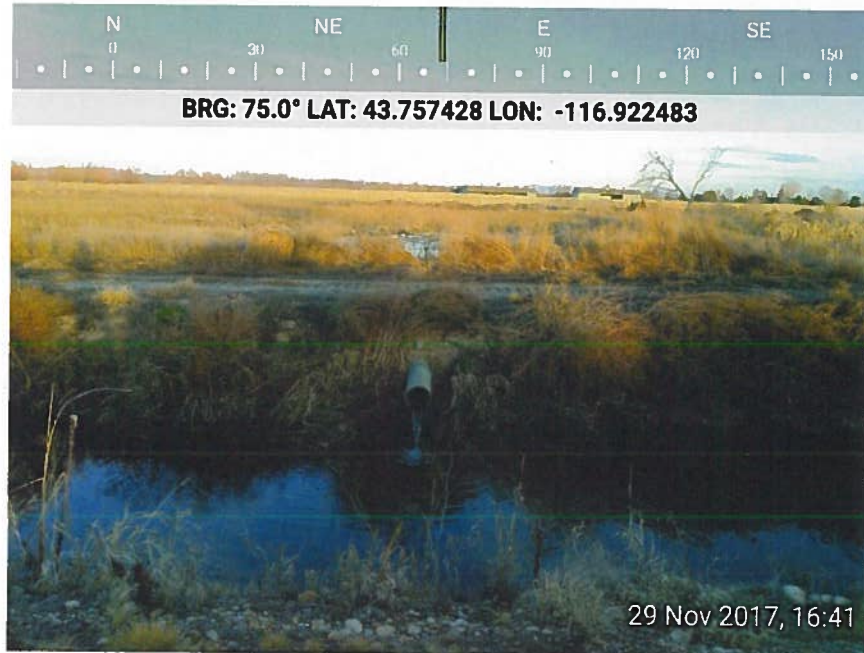
**Figure 9: Lower end of Shop Pond.**

| Water Body | Flooded<br>Area No. | Ac. | Depth | AF | Source | Permits |
|---|---|---|---|---|---|---|
| Shop Pond | 4 | 3.7 | 4.5 | 16.7 | Boise River | 63-32467 & 63-32911 |
