**IDAHO DEPARTMENT OF LANDS  
FOREST PRACTICES REPORT**

Notice No: 52379C    Sale Name:    Inspection Date: 8-8-17    Report Date: 8-8-17    Report #: 3

Subdivision   Pts S2N2    Section   15    Township   54N    Range   2W

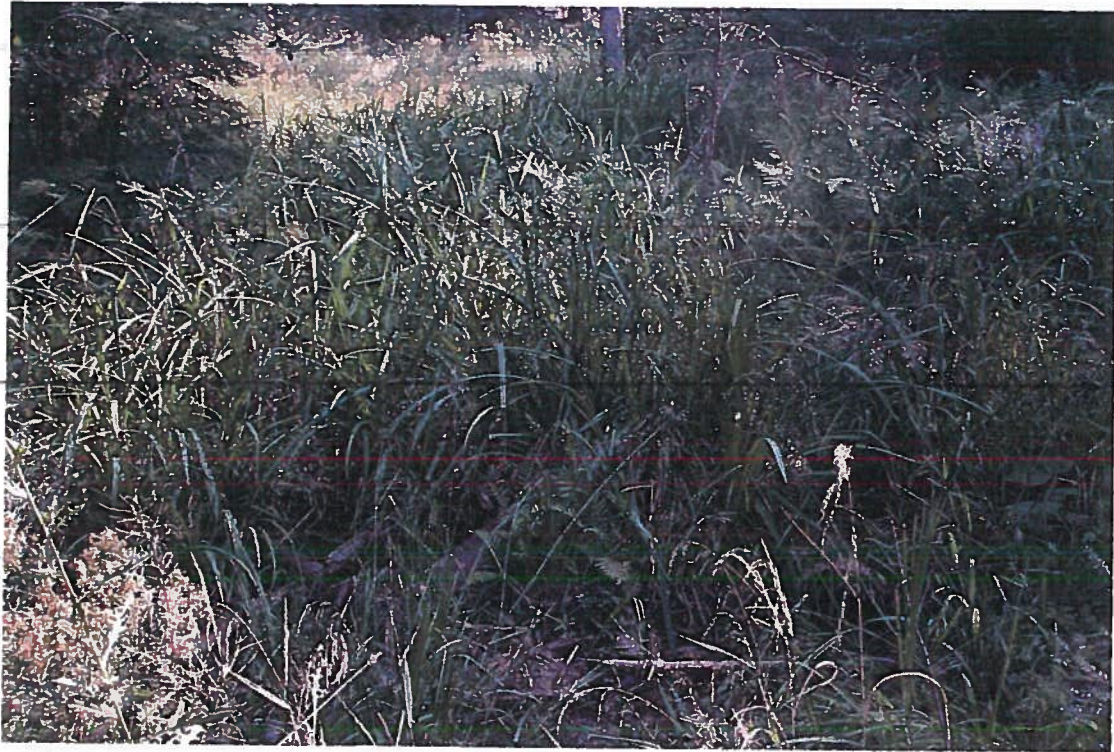
1 - After

I met with Steve to look at the work completed to date. The "legacy crossings" have been removed (pic. 1&2). The log road crossing has been removed and a 30" diameter culvert installed. The road was also re-aligned for a better approach (pic.3&4). We next looked at the road repair and installation of cross drain culverts (pic 5). A ditch has been constructed to catch overland flow water and culvert it across the old and new road to return it to its natural drainage. The water continues subsurface in a shallow draw to were the Barnhart's constructed a drainage ditch to divert the water away from the home. Currently, the water has a short flow in the drainage ditch before going subsurface again. The overflow drainage ditch crossings the main road is dry. Work remaining: 1) grass seed exposed soil at the culvert crossing this fall. 2) construct rolling cross-ditches on the north side of the new and old crossings. 3) maintain erosion control on all roads going into the fall rains. 4) remove any temporary stream crossings immediately after use

One of the "Legacy crossings"
