Permit No. 21-7432  
Name Dale B. Harmon

**STATE OF IDAHO**  
**DEPARTMENT OF WATER RESOURCES**  
**In-Office Beneficial Use Examination**

Subject: Enhanced Sanitary Survey conducted on 25 June 2015

# State of Idaho Public Water System Enhanced Sanitary Survey

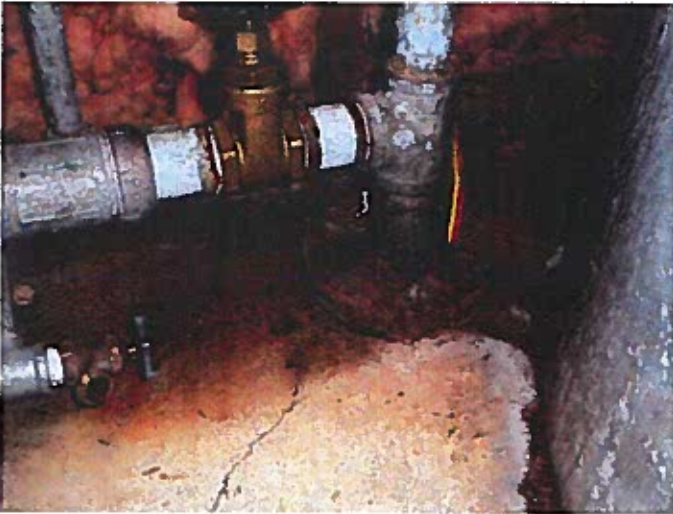
the well casing extends 42 feet below the ground level. It was drilled in October 1962 and has a 6-inch well casing diameter. A Ground Water Under Directly Influence (GWUDI) analysis was performed in September 1999 to determine if the well is being influenced by giardia, cryptosporidiosis, or other microbial contaminants. The results show the well being classified as groundwater. The setback distances are being met to septic systems, bodies of water and grazing animals. The casing does not extend 12 inches above the pump house floor but the flooding potential is limited in the area. At this time, there is not a flow meter present and this does not have to be corrected. There is a working pressure gauge in the pump house which was reading around 30 psi. A pump to waste is provided next to the well for the system to be purged of any contaminants. Within the pump house is ample lighting and is locked so unauthorized personnel cannot enter it. The pump house is kept clean and is organized.

1. The wellhead located in the pump house and the height of it.

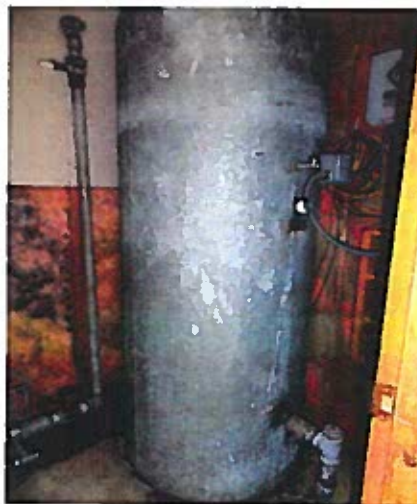
**Hydropneumatic Tanks:** Just one pressure tank is provided for the system. It is housed in the pump house next to the well. It is unknown the manufacturer of the tank and the model number. The tank is located above normal ground use and has a limited potential for flooding. Each year, Bruce needs to manually add air to the tank so there is ample amount of pressure. The recharge air is free from contaminants and has a place to drain the tank. This tank was installed many years ago and is still providing enough pressure for the system. The support for the tank is structurally sound and adequate. This tank serves water to less than 150 homes.

3. The only pressure tank for the system which can have air added manually.
