## IN-OFFICE BENEFICIAL USE EXAM REPORT

Permit No. 55-13917

State of Idaho  
Department of Water Resources  
**55-13917 In-Office Beneficial Use Field Report Map**

STATE OF IDAHO  
DEPARTMENT OF WATER RESOURCES  
BENEFICIAL USE FIELD REPORT

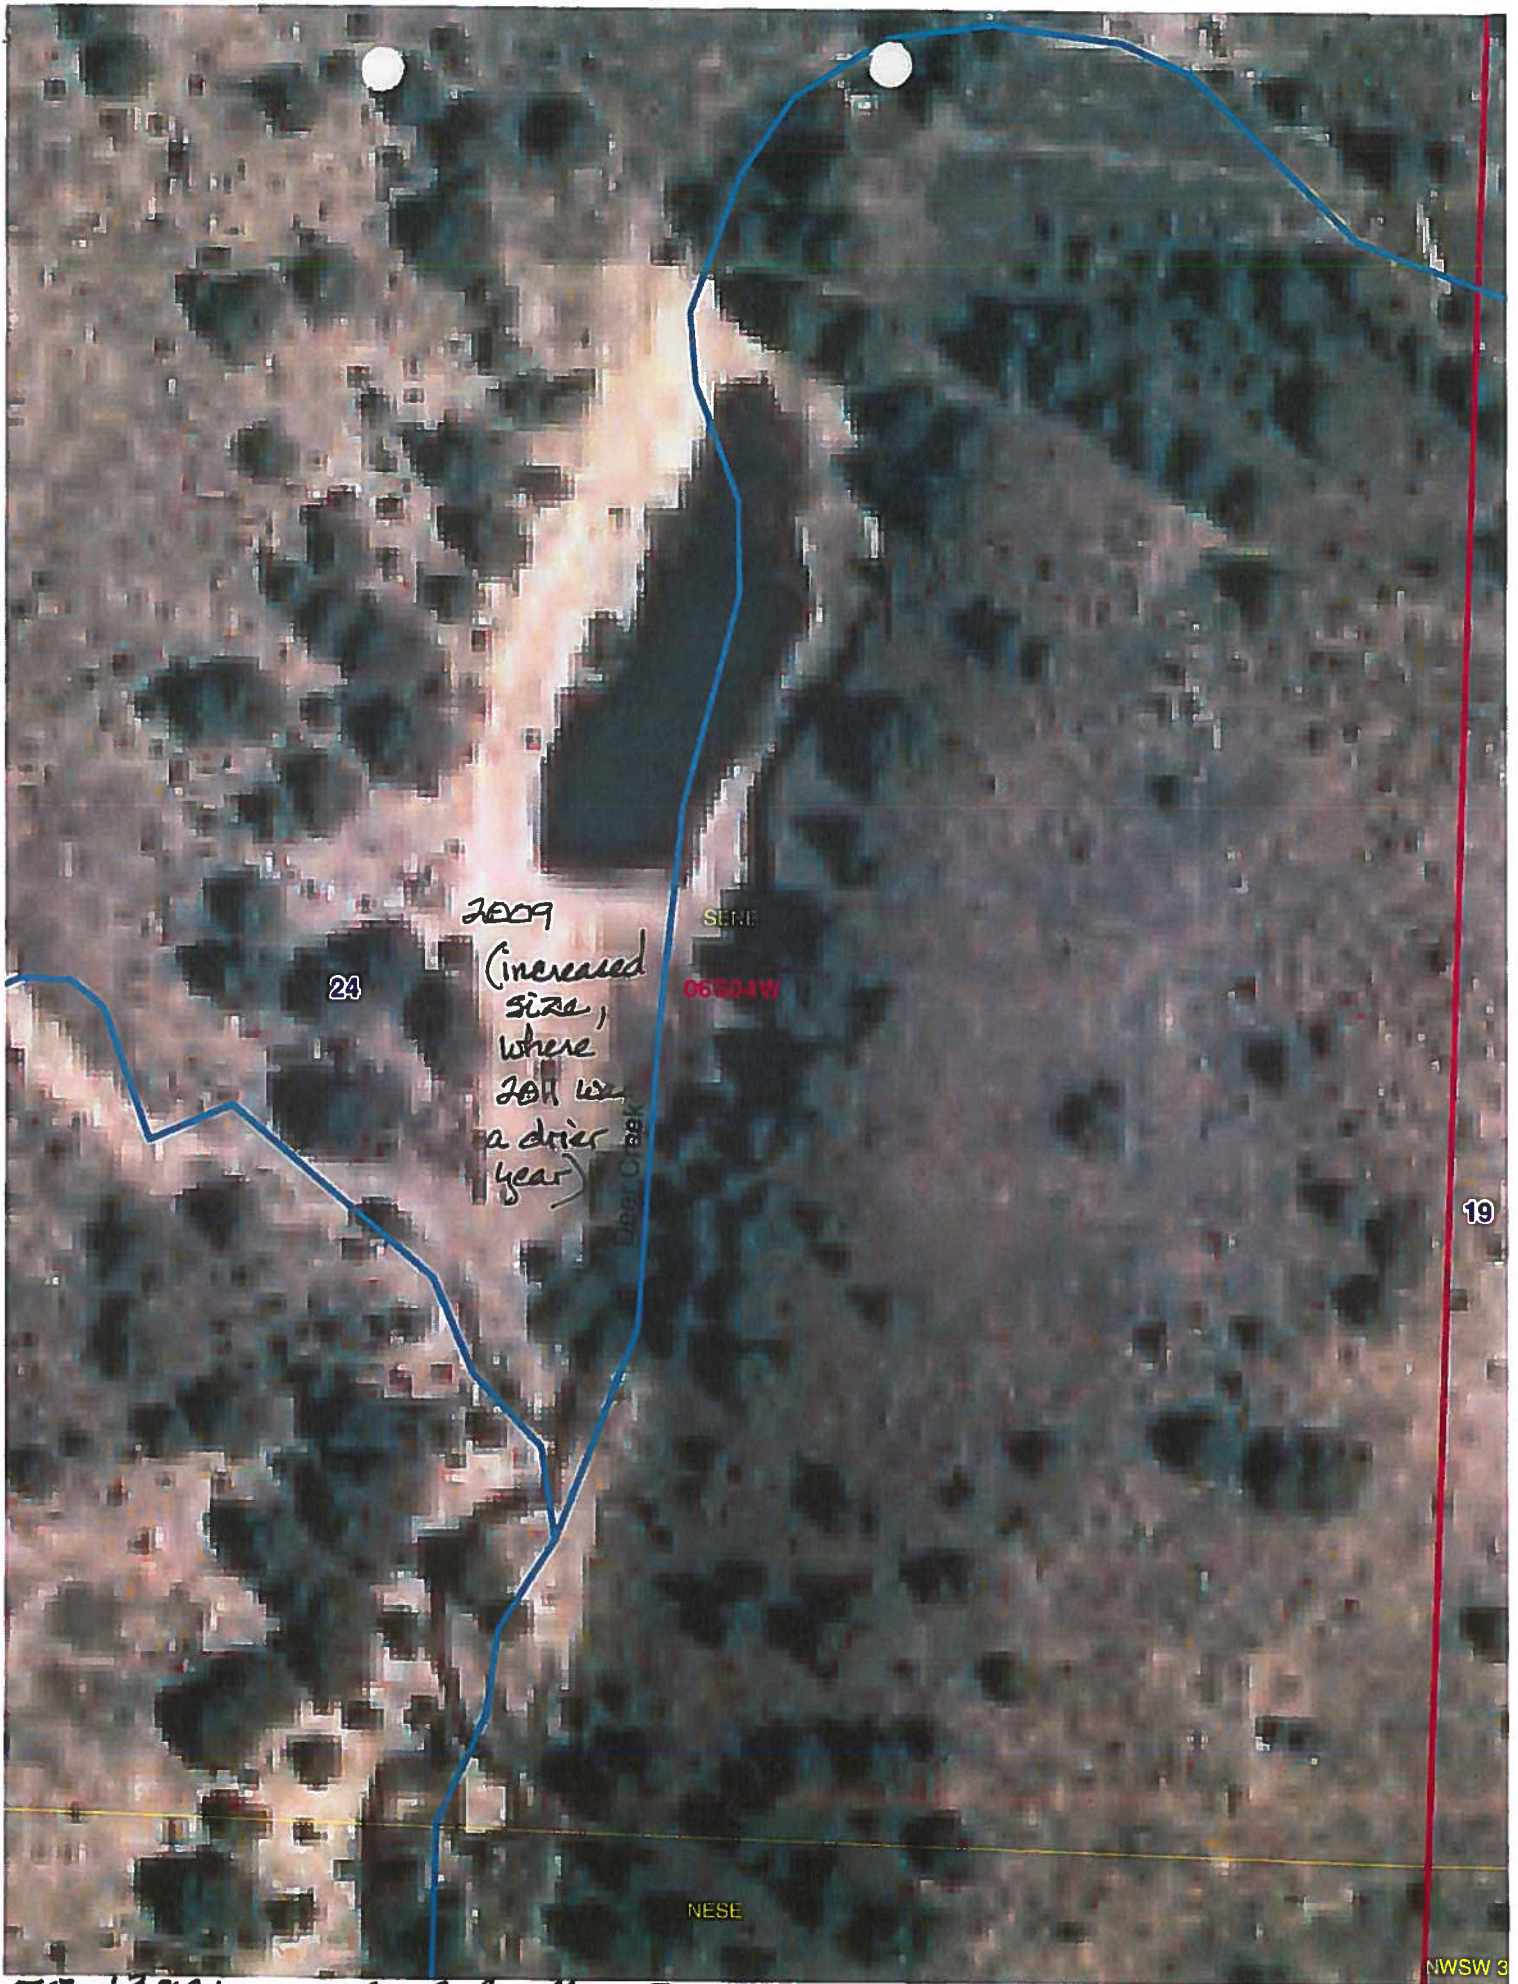
2009  
(increased  
size,  
where  
2011 was  
a drier  
year)

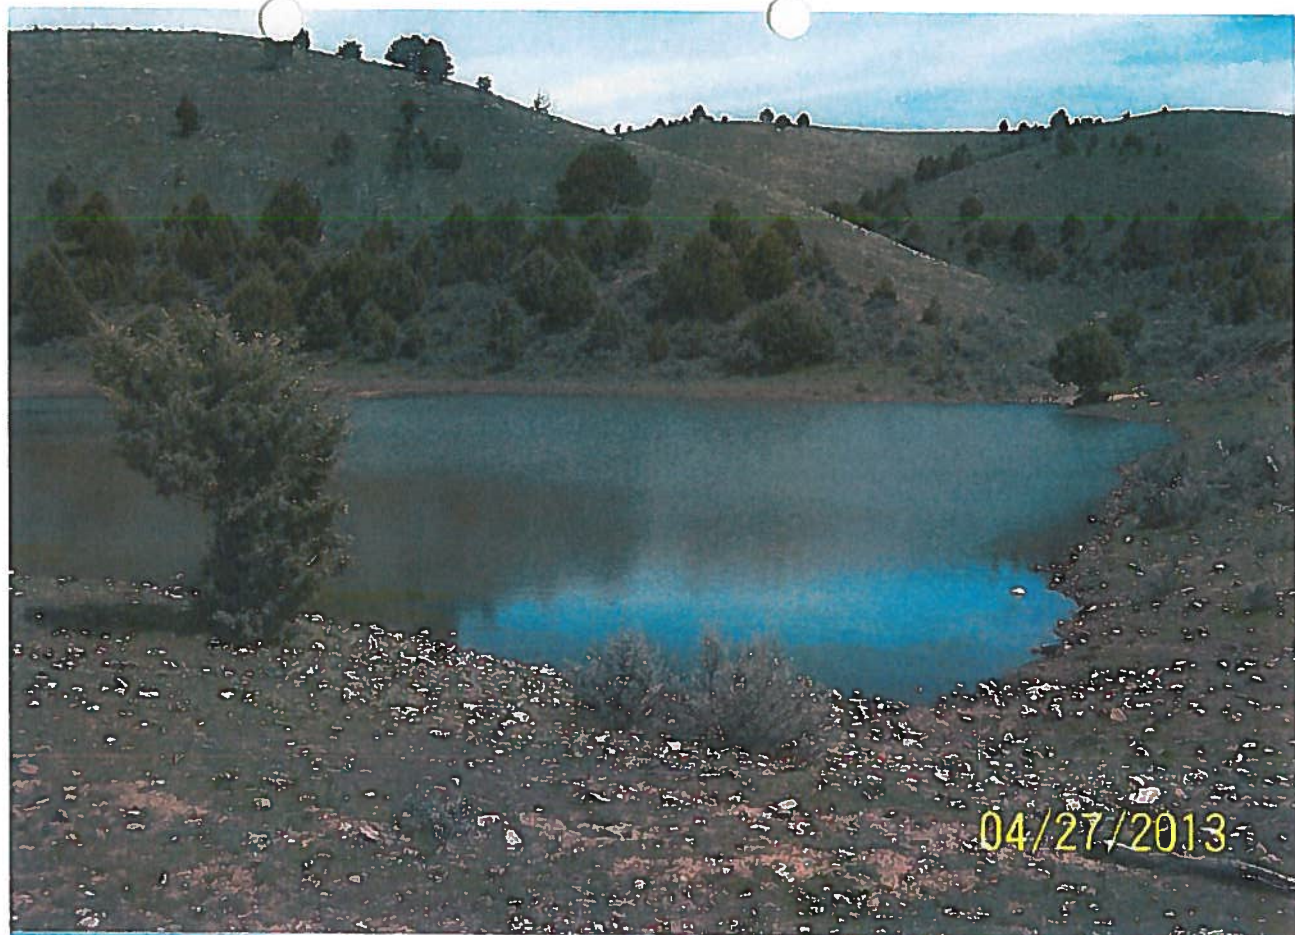
Pond #1  
POU:  
Pond #1  
Sec. 25

Average  
depth  
at time  
of field  
exam 3',  
but  
evidence  
on bank  
shows  
historical  
reaching  
7' deep

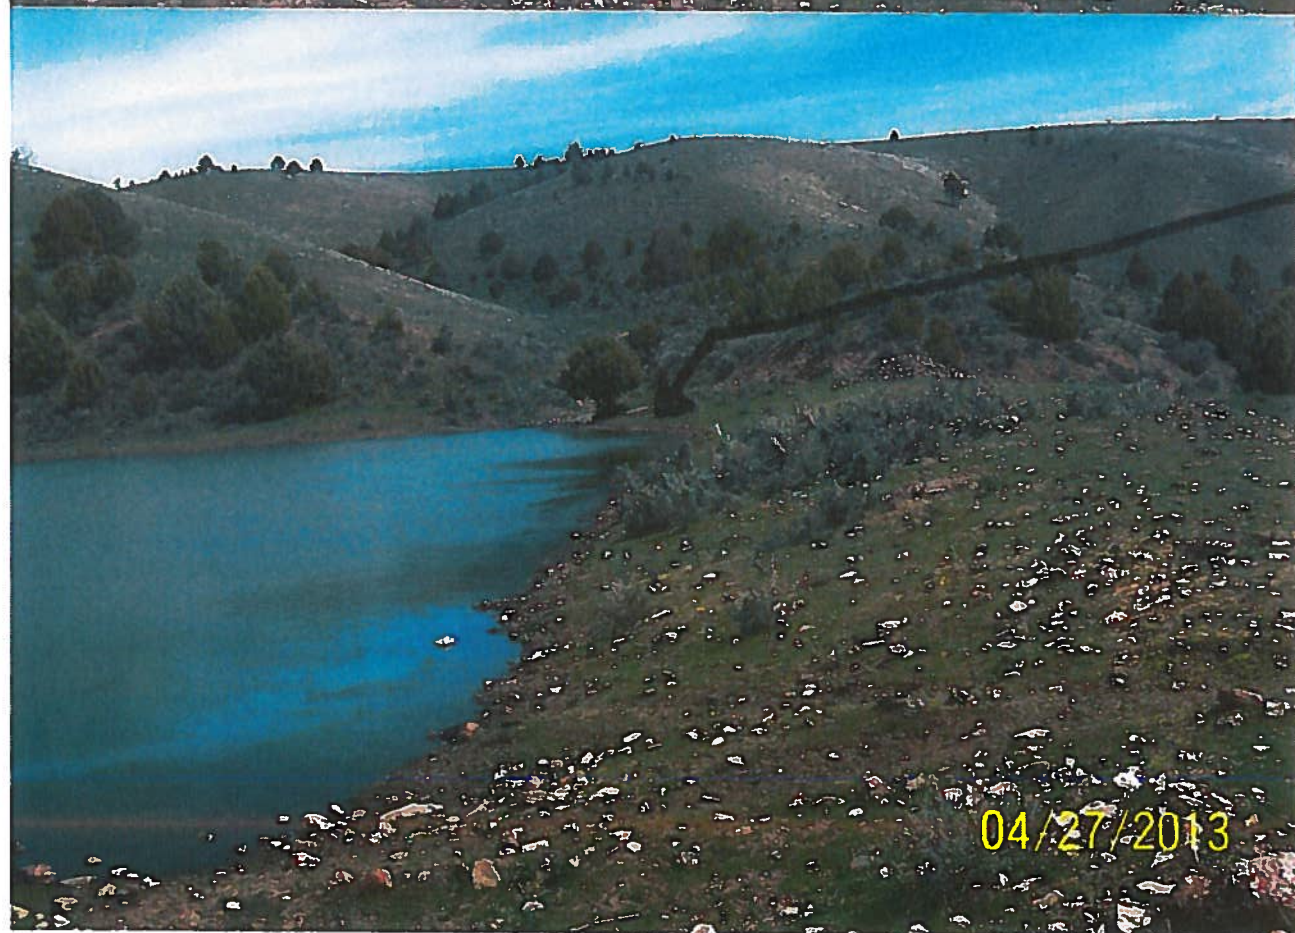
Pond #1  
POD  
spillway

9' dam

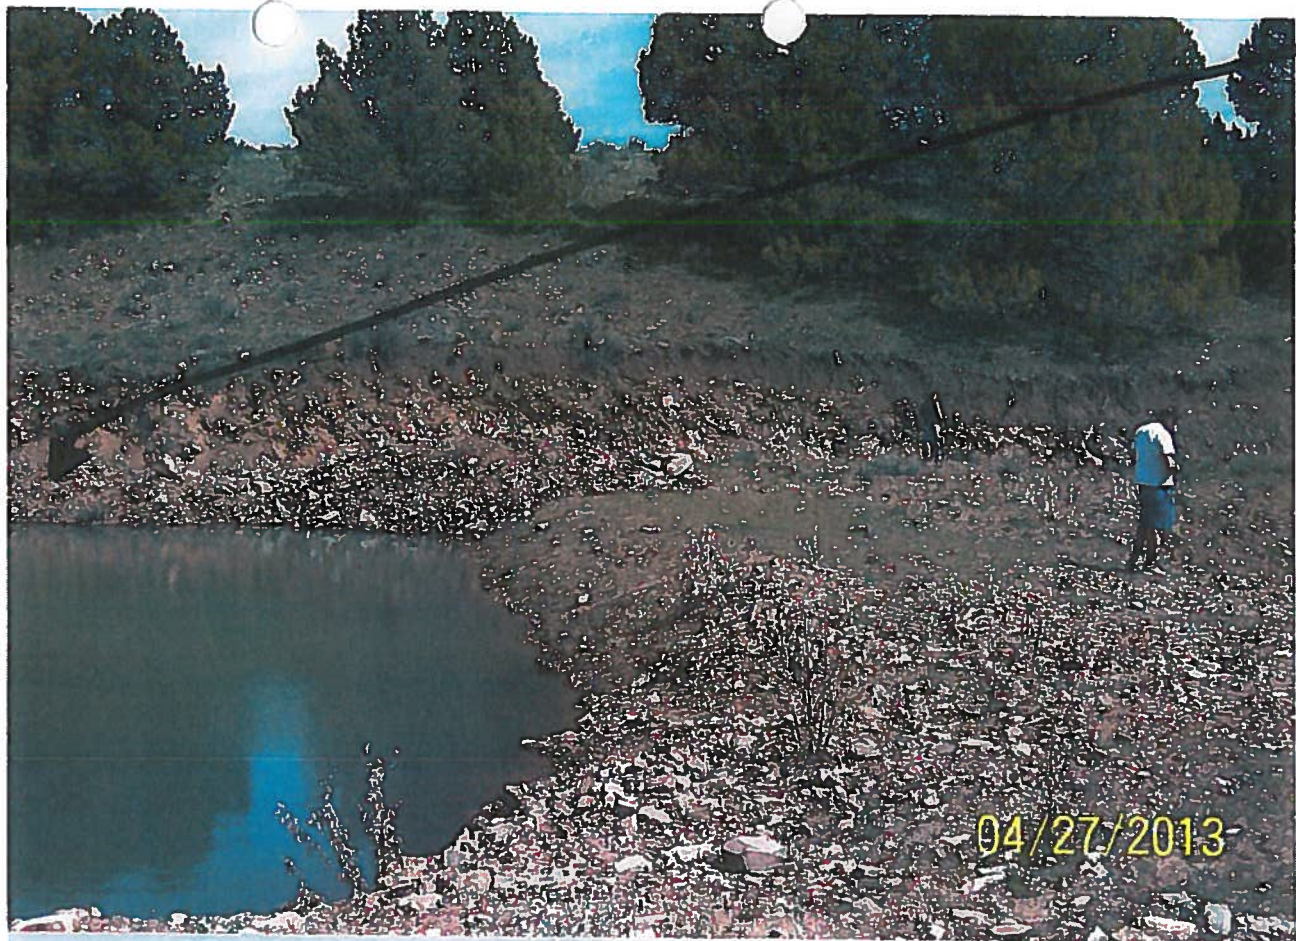
Pond #1  
POD

spillway  
on the  
dam

7' dam  
3' average  
depth.  
At time  
of field  
exam,  
it was  
at  
normal  
depth.

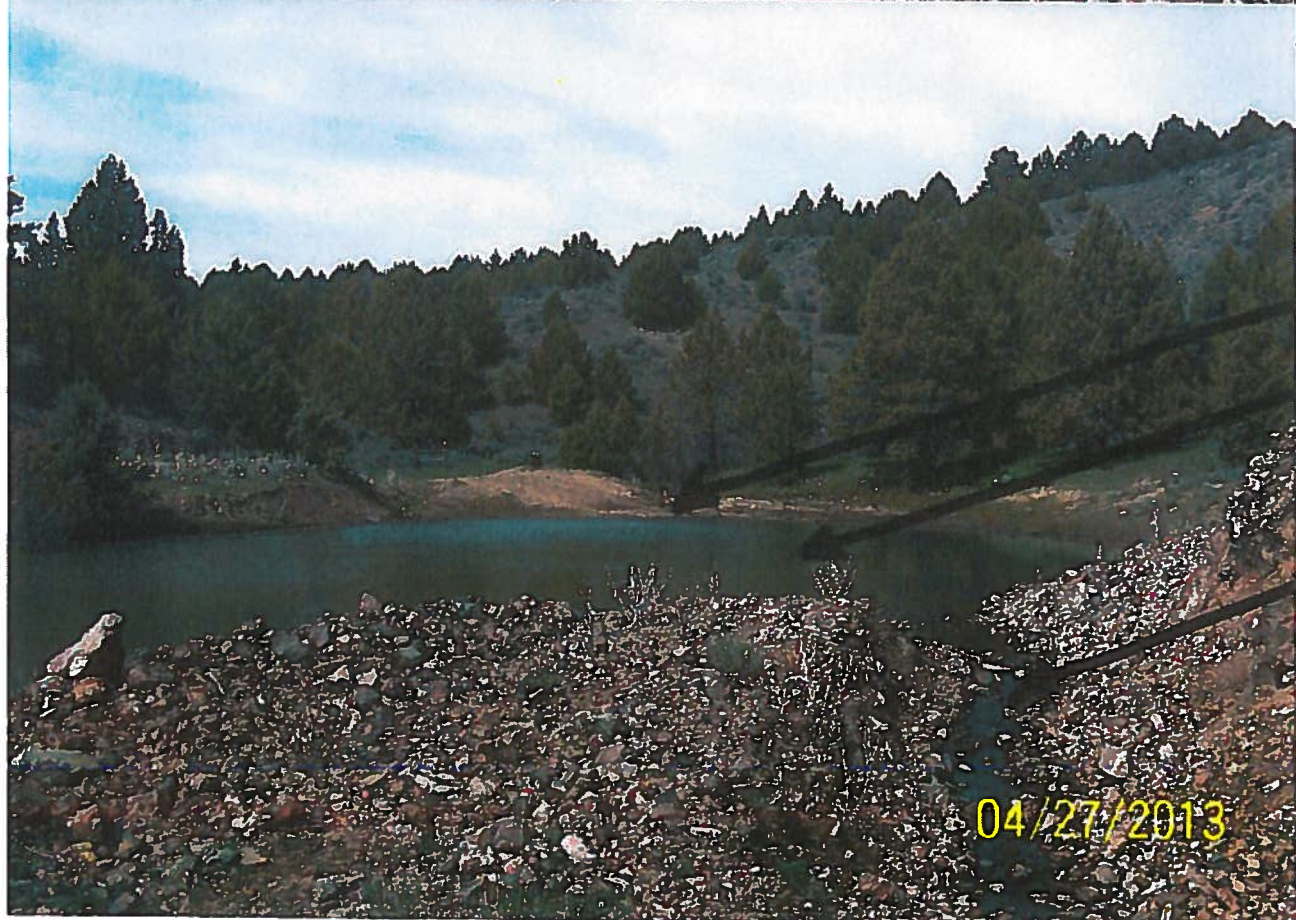
T63  
R4W  
Sec. 24  
SENE

Inlet  
for  
Deer  
Creek

Pond #1  
POC  
spillway  
@ dam

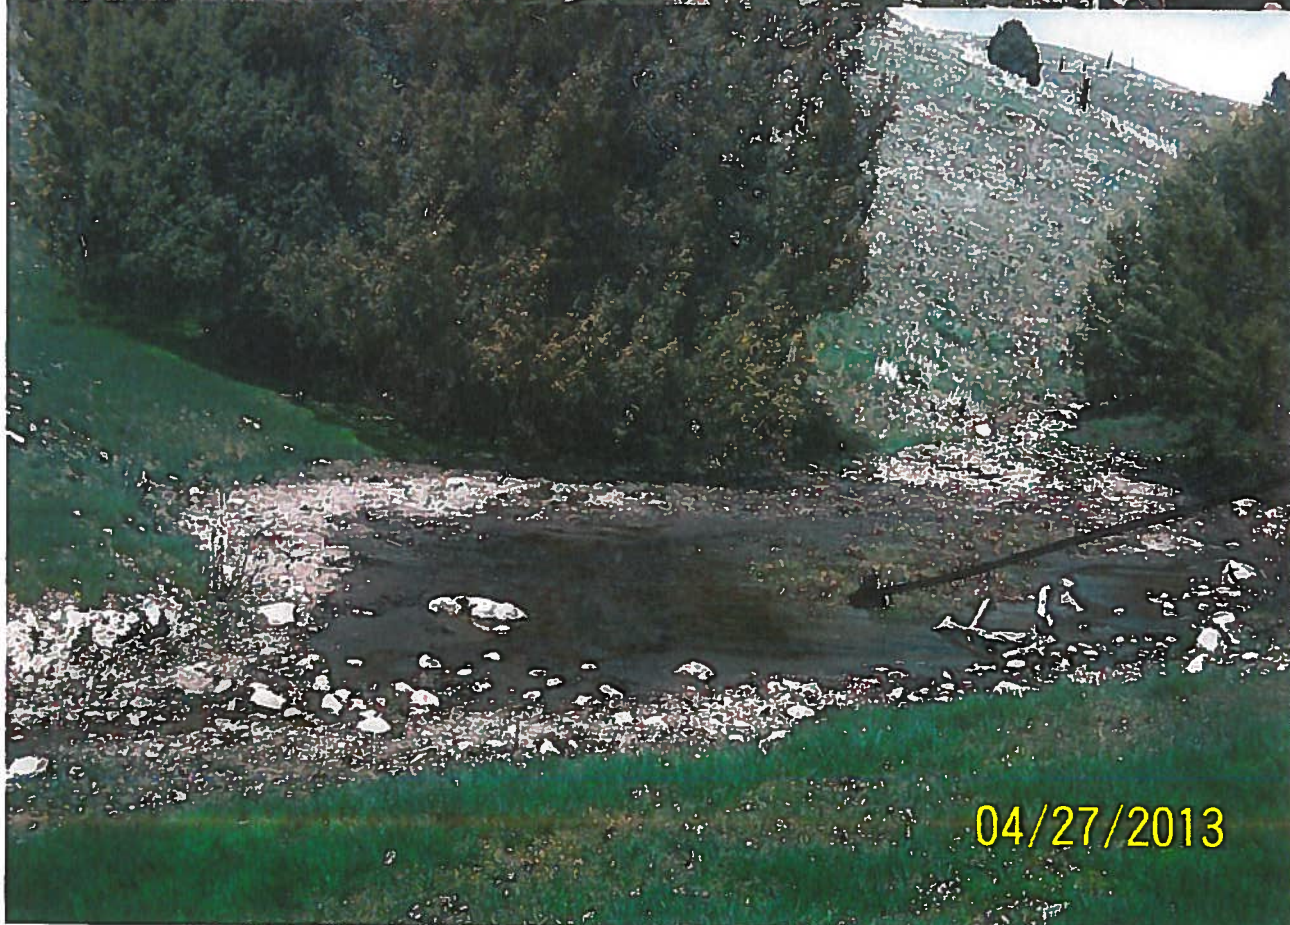
**Pond Requiring Permit**

4' dam,  
with  
average  
depth  
3 1/2 ft.  
deep  
pond.  
Pond  
size is  
0.04  
acres.  
(0.14 af)
