STATE OF IDAHO  
DEPARTMENT OF WATER RESOURCES  
**BENEFICIAL USE FIELD REPORT**

Permit No: 11-7388

Exam Date: 9/8/2014

Church of Jesus Christ of Latter Day Saints, Girls Scout Camp

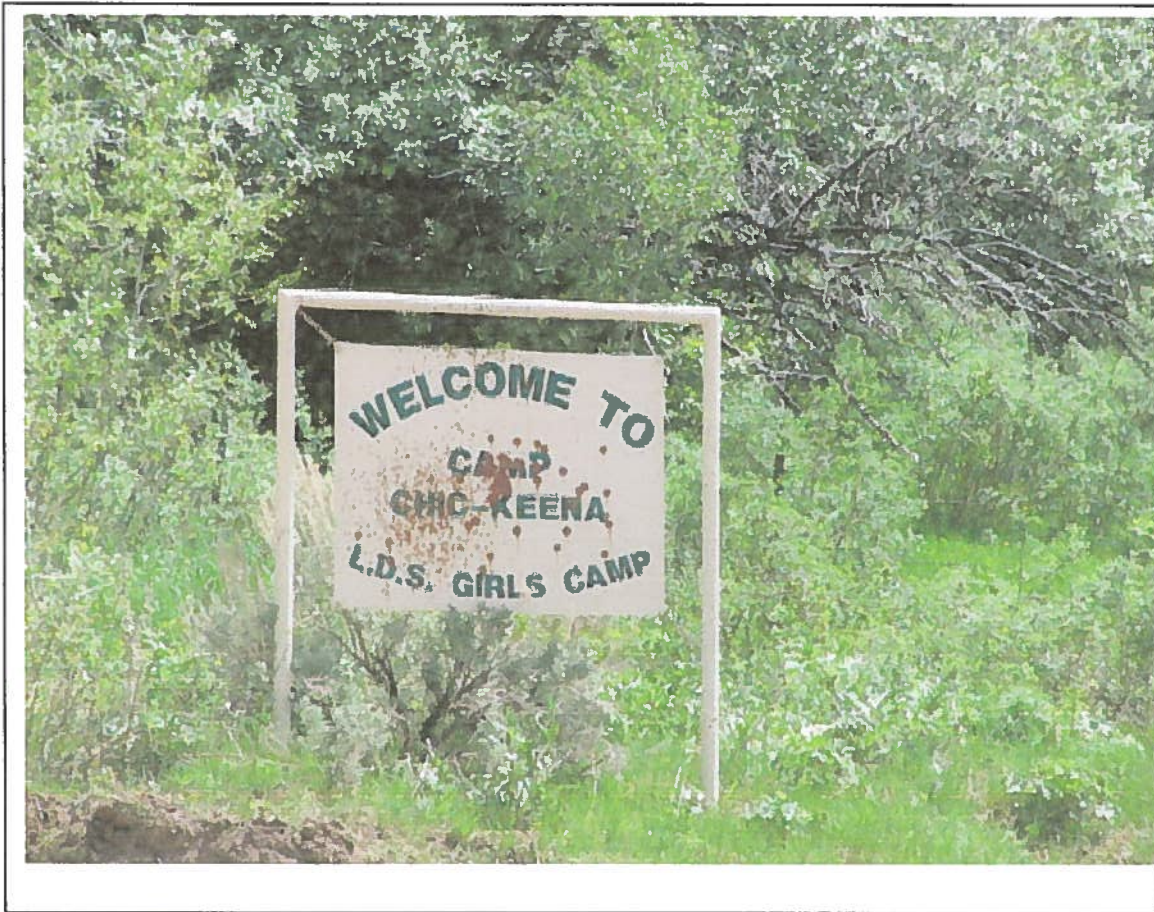
IMG\_1566

This sign is at the entrance to the Camp ground.  
Up the road about a 1/4 mile on the other  
side of the road is the boys campground.

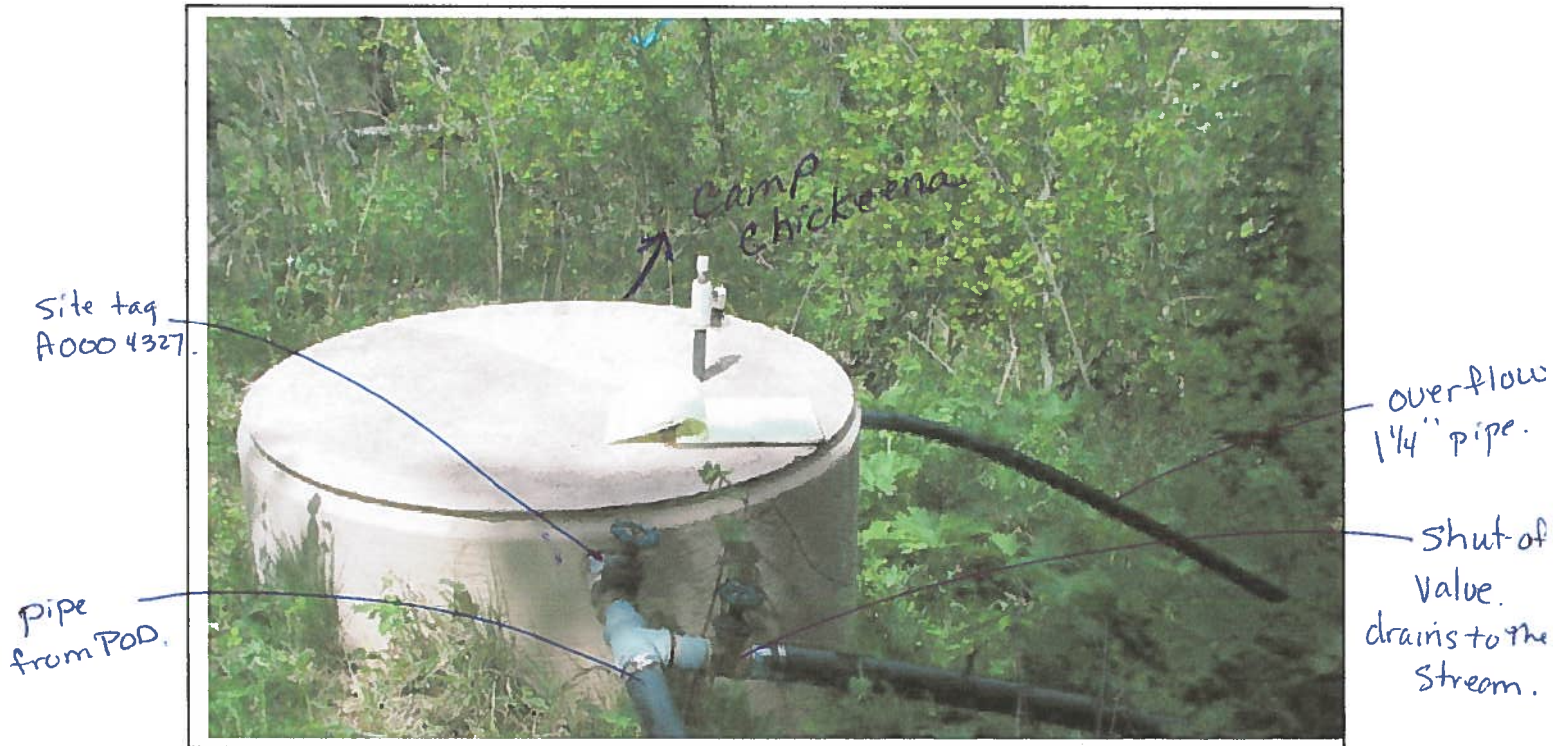
IMG\_1554

GPS'd N42° 32.124' W111° 33.890' The site tag was already on the pipe. Photo was taken looking in a Northerly - NW'ly direction. The lodge is located just through the tree and down a small hill. legal description is SESE Sec. 20, T10S R42E - B.M.

Storage tank is 4' wide & 5' deep.  $A = \pi r^2 = \pi (2')^2 = 12.567 \text{ ft}^2$ .

$\text{Vol} = 5' * 12.567 \text{ ft}^2 = 62.8 \text{ ft}^3$ .

Slope from POD to storage = rise/run =  $140' / 1300' = 0.107 \text{ ft/ft}$ .

Using the Manning Equation for circular pipe, PVC = 0.01 coefficient the  $Q = 0.01 \text{ cfs}$

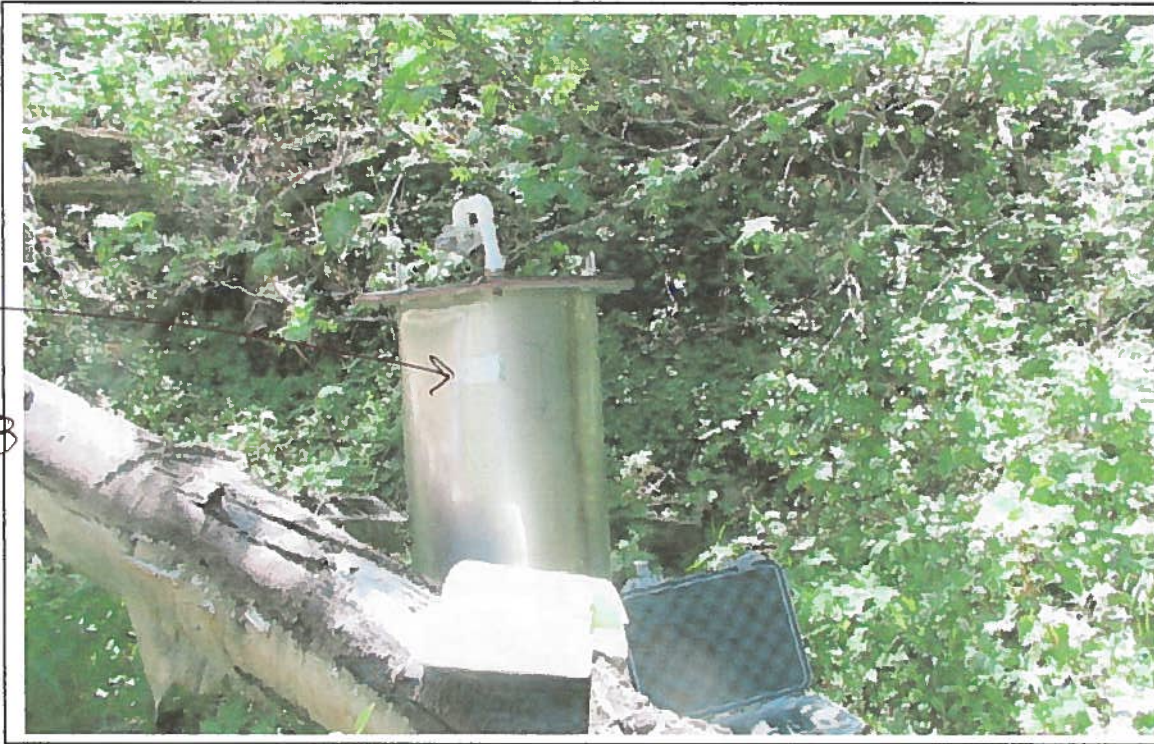
IMG\_1552

Photo taken looking easterly at the  
Spring, pod for the girl scout camp  
ground.

Site tag was applied to the front of the  
casing surrounding the spring.

Coordinates for the POD:

N 42° 31.996' W 111° 33.662'

This may not be the original POD developed  
by the Church.

Legal: SE SW SW sec. 21 T10S R42E B.M.

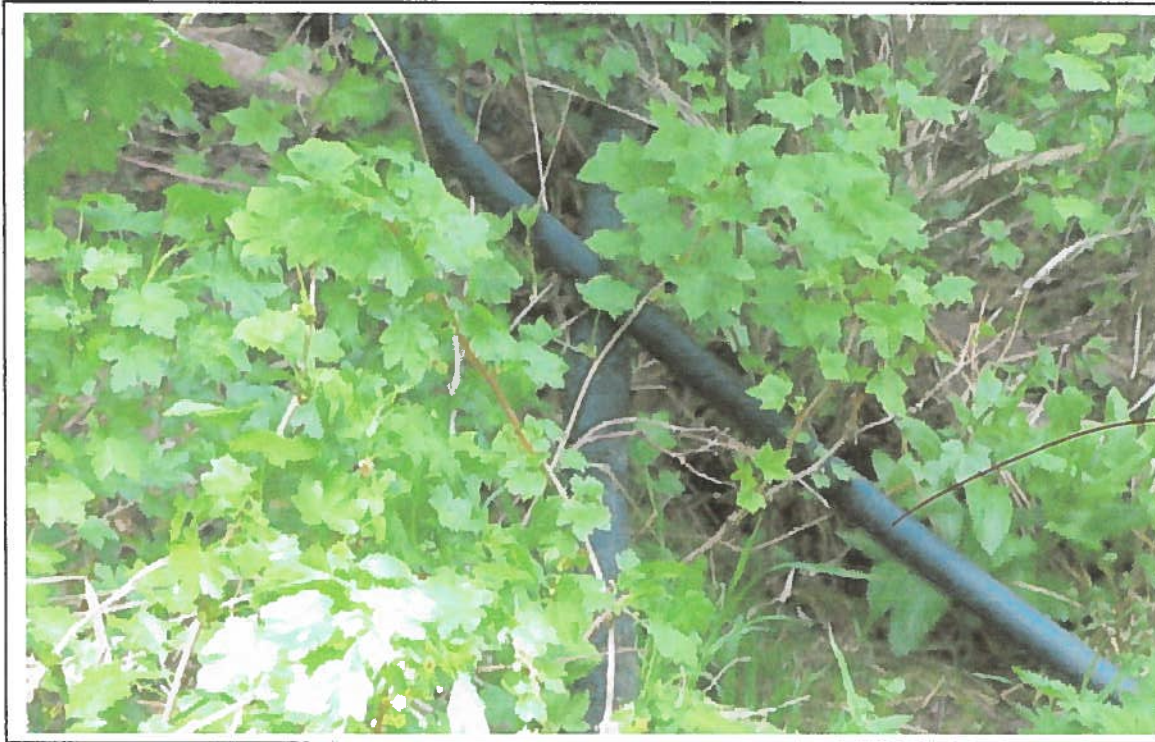
IMG\_1553

This photo was taken standing at the  
POD and looking in a Northwestly direction  
at the 2" Black PVC Pipe that runs  
1300 ft to a storage tank. The  
pipe runs above the ground the  
entire way.

The larger 4" Black PVC pipe runs  
to a pond just below the pod.

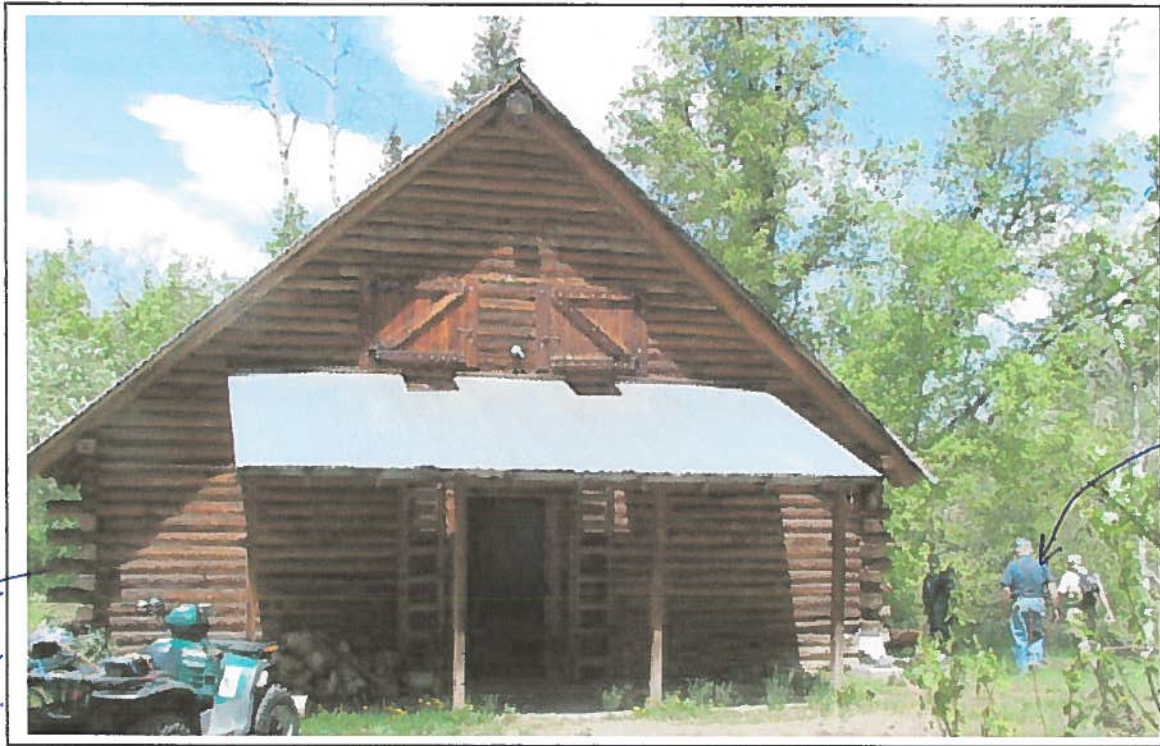
IMG\_1555

GPS'd location N42° 32.163' W111° 33.951'

NESE Sec. 20, T10S R42E

Photo taken looking North at the Meeting house  
Lodge at Camp Chickeena. No water is  
used inside the meeting house. There is a  
sink to the west of the lodge where  
water is used.

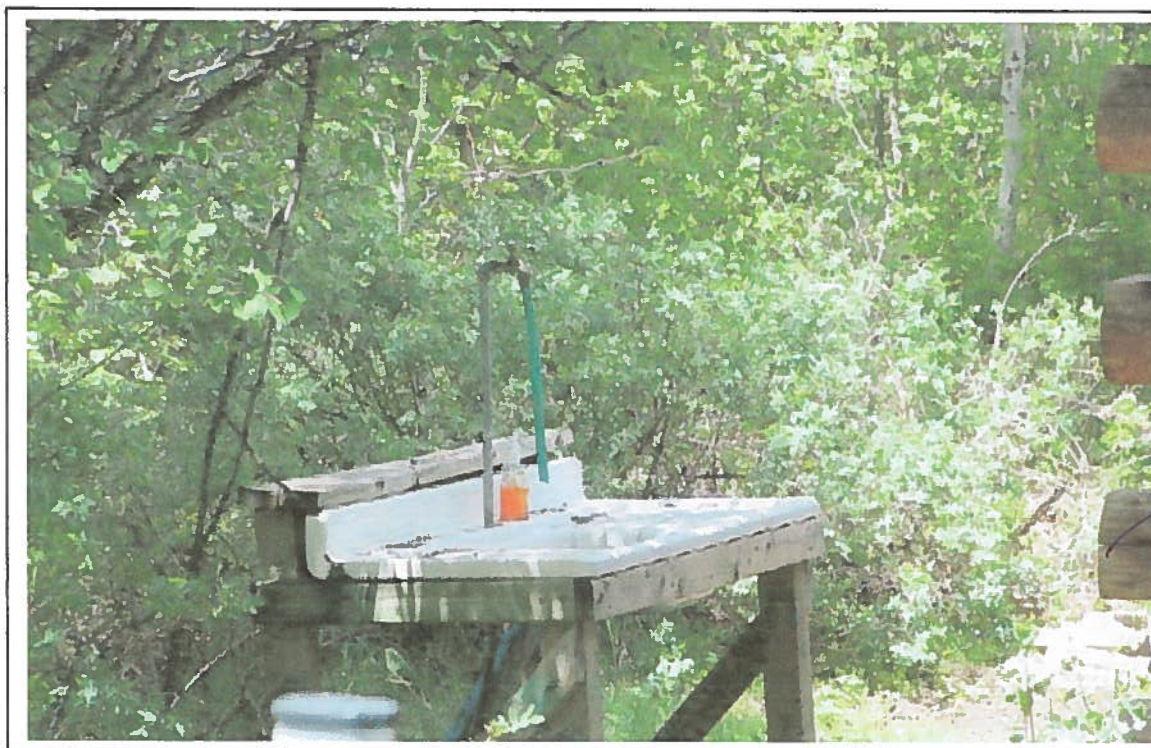
IMG\_1556

West side  
of the lodge  
(meeting house)

Outside sink is located west of the meeting house  
1/2 inch black hose is connected to the sink

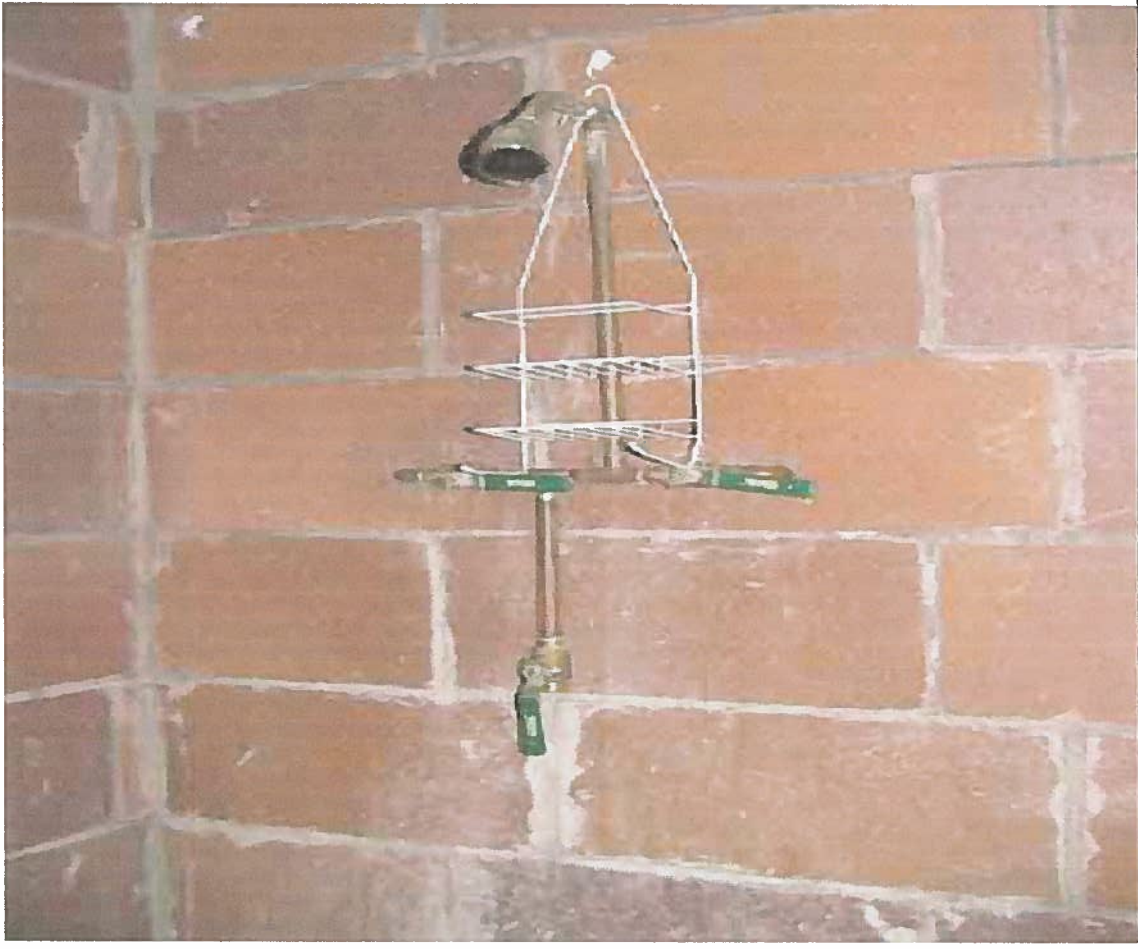
IMG\_1557 rotate

Photo of one of the shower stalls in the shower house. 4 shower stalls in a row located in the SESE of Section 20; T10S R42E; N42° 32.162' W111° 33.993'  
Pipe diameter 3/4"; brass.

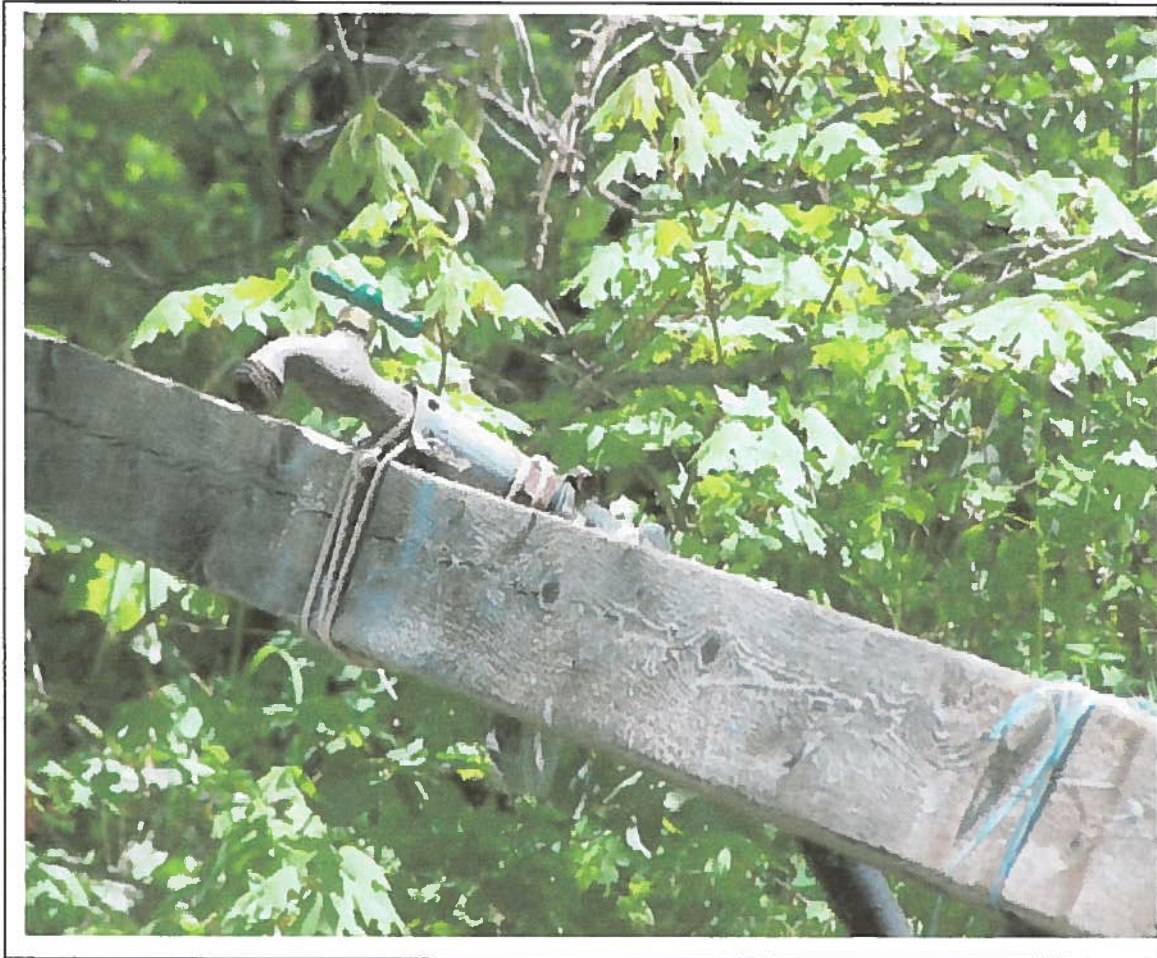
IMG\_1559

Camp Chickeena - Campsite 1. GPS'd. location:  
N 42° 32.192' E of Sec. 20, T10S R42E. BM  
W 111° 33.995'

As you can see from the photo this system is very  
primitive. The spigot is tied with twine to a  
2x4 and the 2x4 is tied to branches of  
the tree.

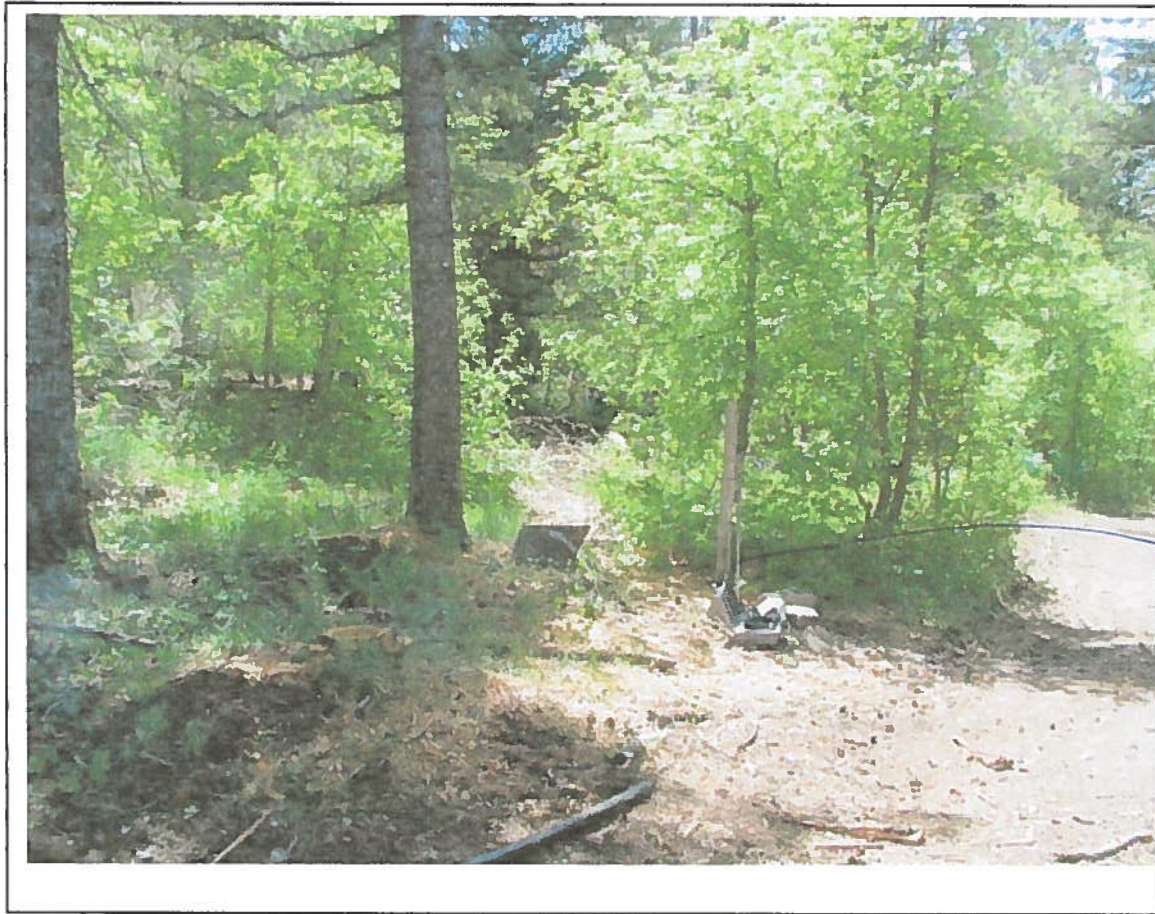
IMG\_1564

spigot

Campsite #5. GPS location N42° 32.136'  
W111° 33.983' ; SESE of sec. 20 T10S R42E  
of the B.M. This photo was taken looking in a westerly  
direction, the campsite is south of the spigot.  
The lodge is east of here (behind me).

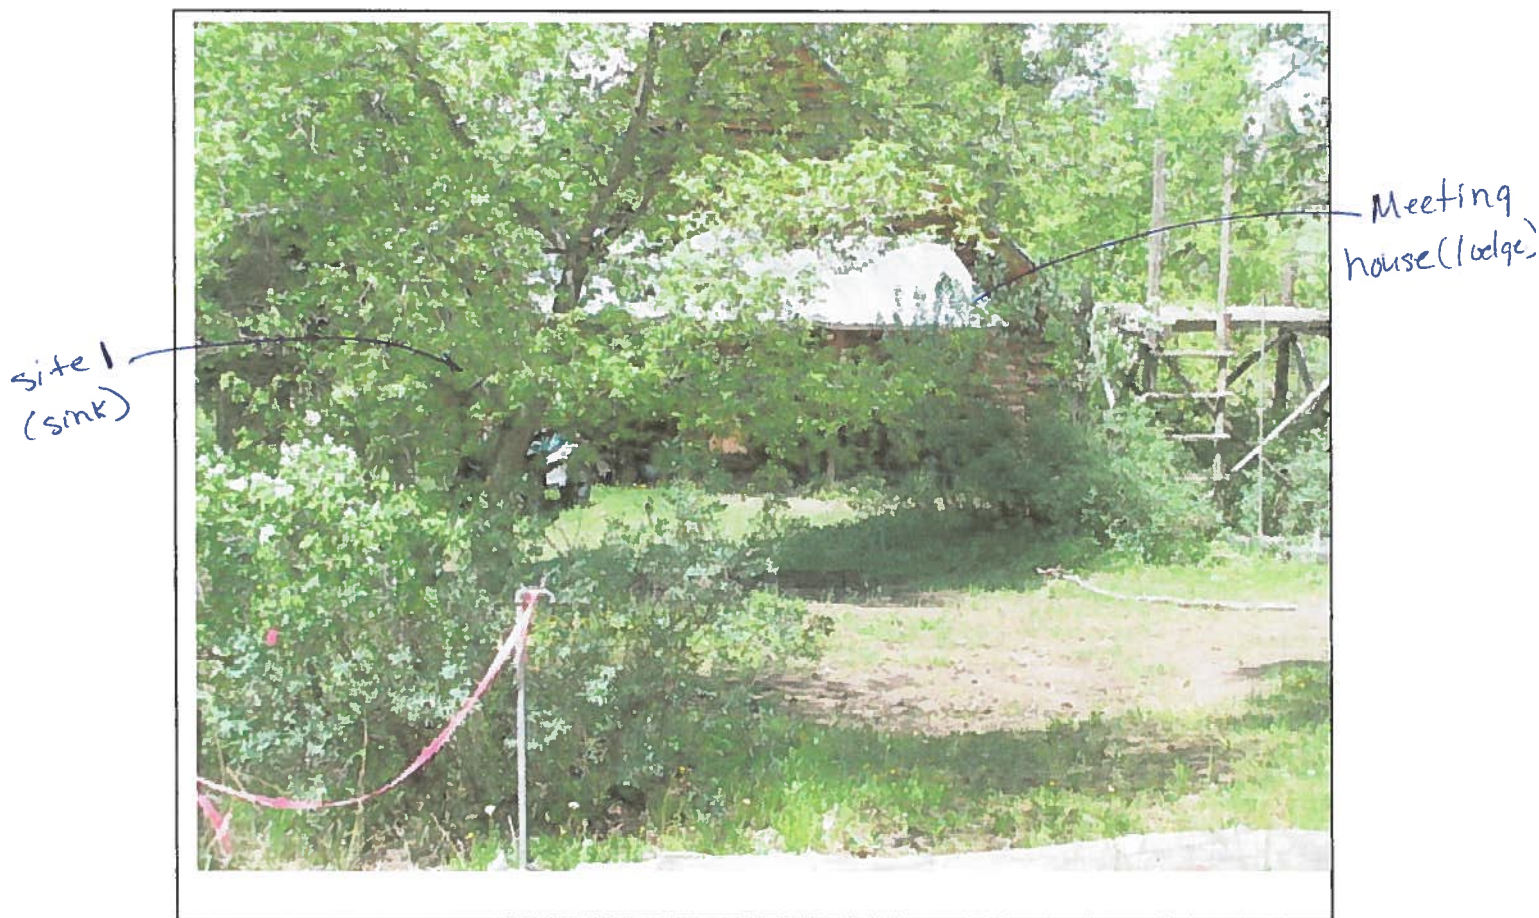
IMG\_1565

Spigot located in front of the lodge (meeting house).

GPS location: N42° 32.146' W111° 33.953'

This spigot is out by the road.

SESE of section 20, T10S R42E of the B.M.

Photo was taken looking in a Northerly direction.

The red tape was put on the spigot to keep the logging trucks from hitting it.

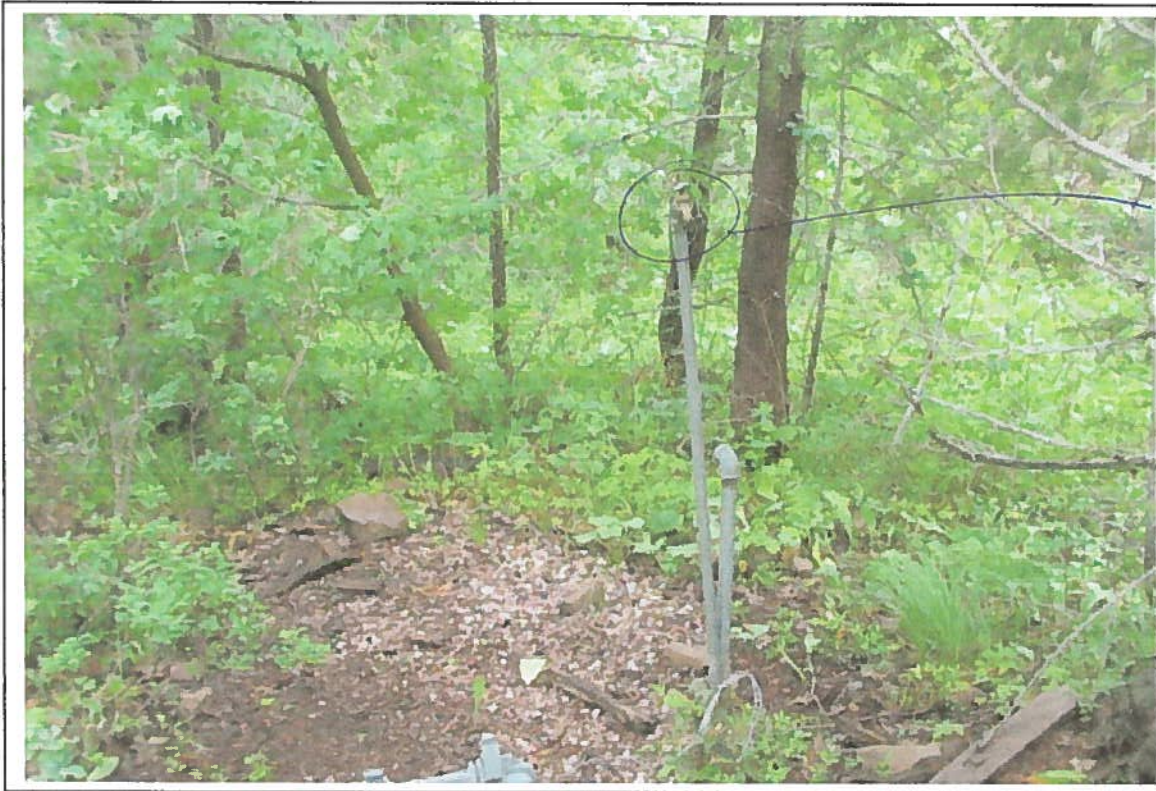
| IMG 1598 | | 6/8/2007 | 10:36 | AM |

Site # 6; above the amphitheater. This spigot is on the trail east of the lodge. Just above the amphitheater you can see a trail that crosses over the spring and heads in a northerly direction. Photo was taken looking north. No site tag was applied.

GPS coordinates: N42° 32.132' W111° 33.904'. T10S, R42E SEC. 20 NESE.

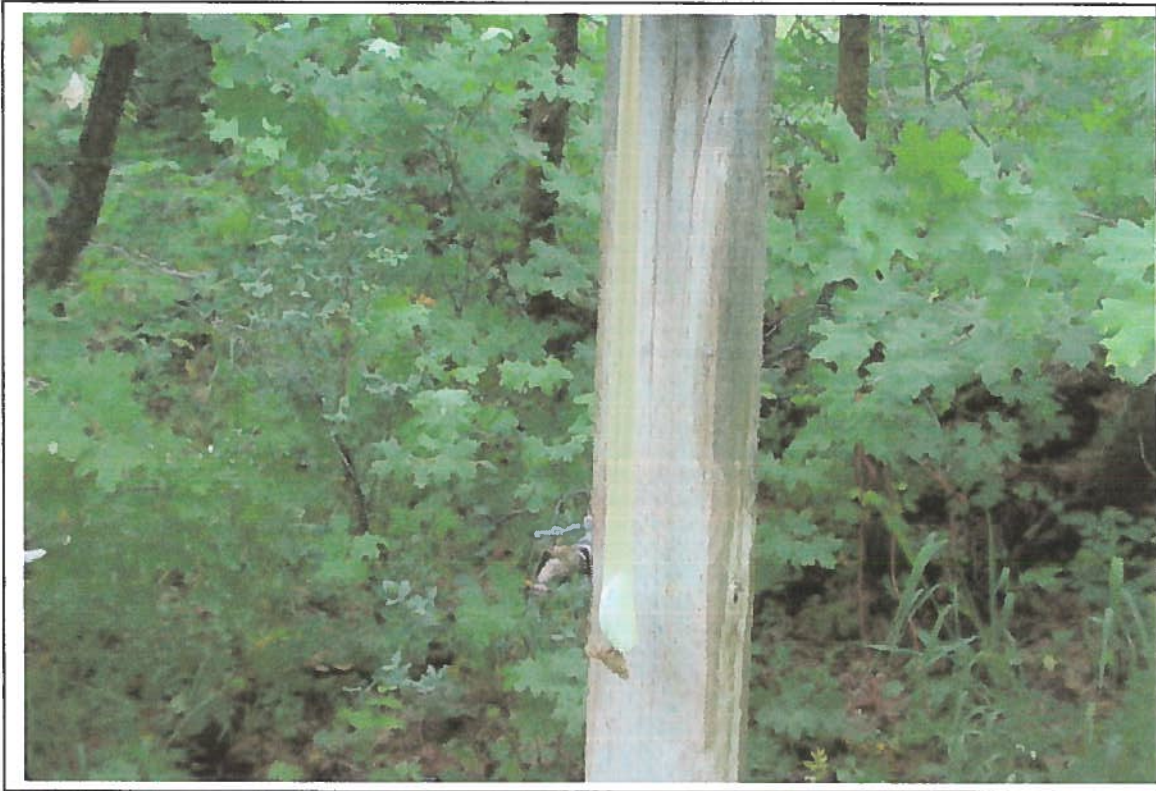
| <u>IMG 1599</u> | <u>6/8/2007</u> | <u>10:51</u> | <u>AM</u> |

Site # 7; east of site # 2. Photo was taken looking south at spigot. No site tag was applied.

GPS coordinates: N42° 32.177' W111° 34.038'. T10S, R42E SEC. 20 NESE.
